Phase I Environmental Assessment
Units A & B, Oxford Business Park
Oxford, OX4 2ZY, Oxfordshire
UK

The Wellcome Trust

A walk over survey of the site was carried out on 12th February and 23rd February 2010, consisting of an inspection of the exterior of the buildings and the external areas. Photographs of the site are presented in Appendix B.

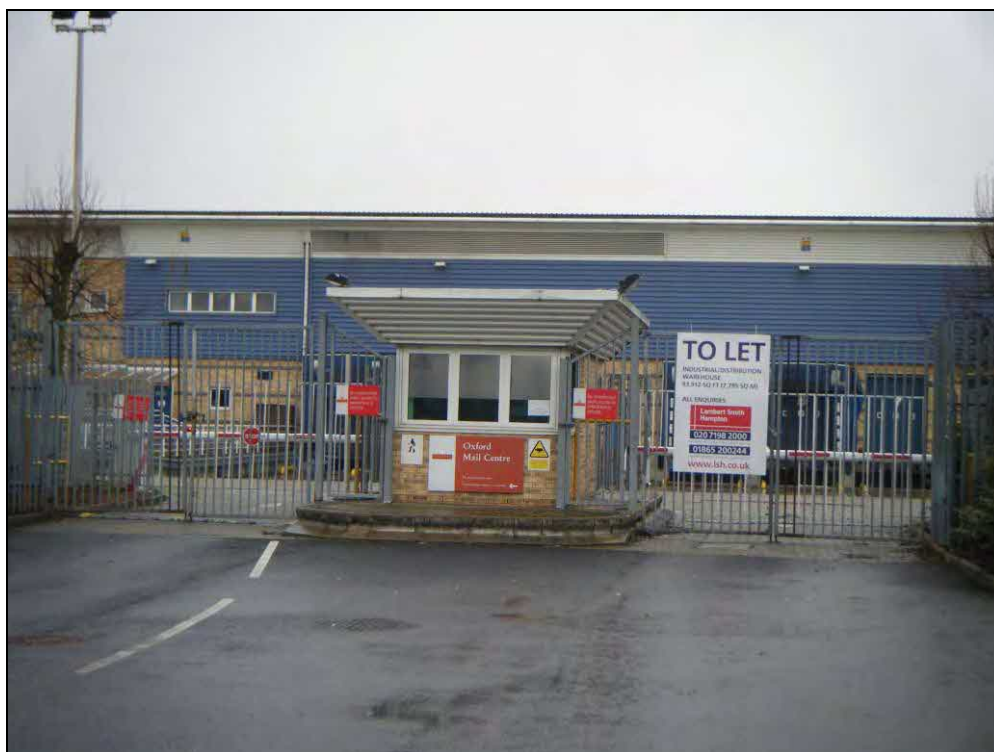
Unit A of the subject site comprises a large vacant warehouse building with offices on the first floor. Twelve loading bays are present along the eastern side of the building, together with three loading doors on the northern flank. Car parking for 151 vehicles is present to the south of the unit, with a lorry wash and a decommissioned refuelling area along the eastern boundary of the site. A site operative indicated that the unit has not been used for the last year.

PLATE 1: Entrance to Unit A.

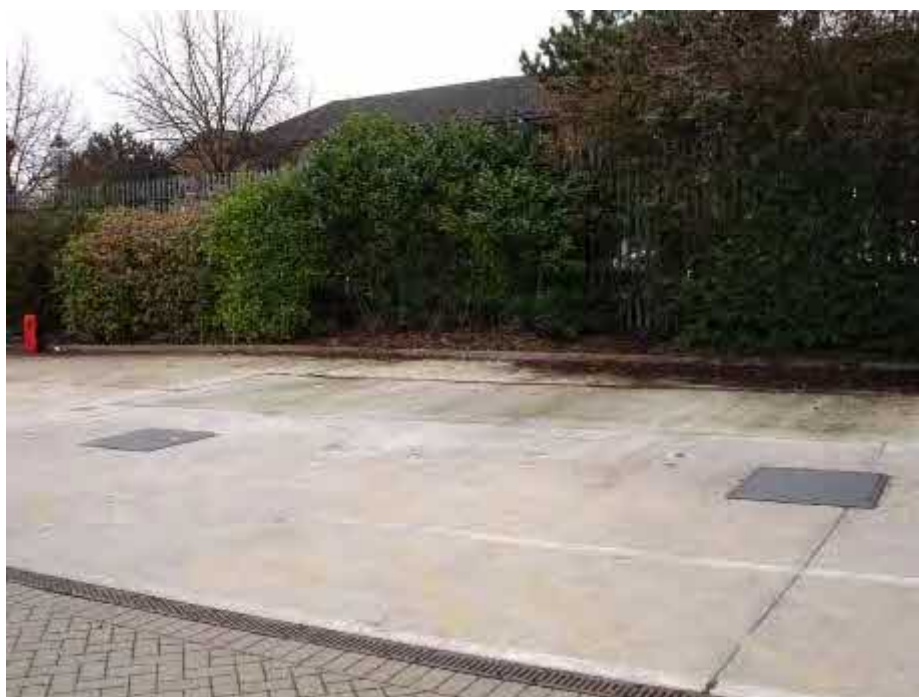
The managing agents for the site indicated that an underground storage tank (UST) previously used for vehicle refuelling was either concrete filled or removed. Two manhole covers were present in the refuelling area, together with a number of test borehole caps.

PLATE 2: Location of reported UST

Subsequently, WSPE has been provided with a Certificate of Decommissioning which indicates that two 20,000 litre USTs were decommissioned. This included the removal of any remaining fuel/bottom waste, the filling of the USTs with RG22 Bacel Hard Form and the cutting off of the suction and vent pipes.

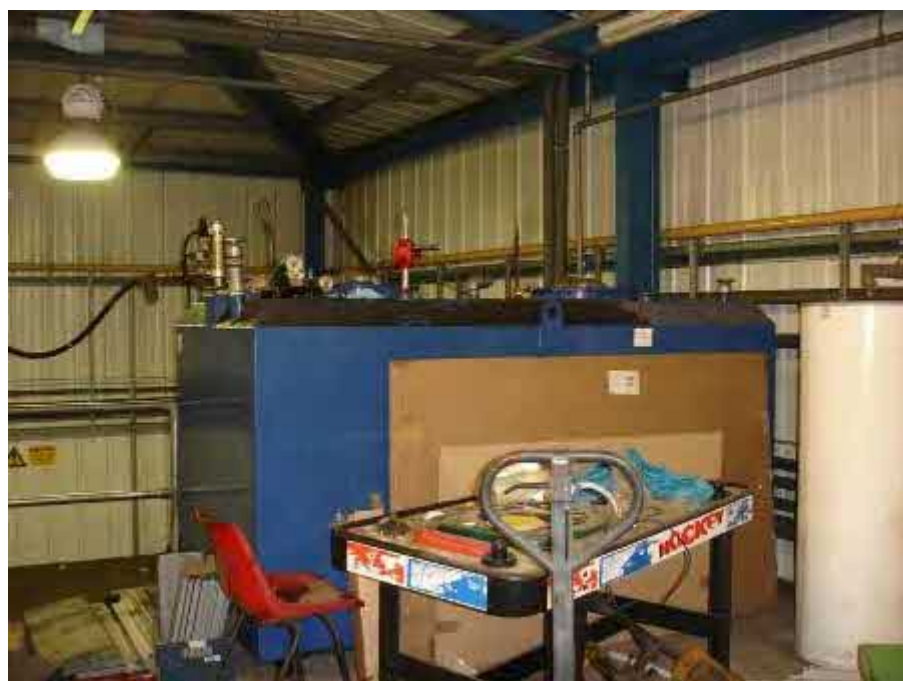
-
- A waste engine oil fill point is located along the southern boundary of Unit B, and is connected to two 750 litre self bunded tanks located on the mezzanine floor inside the unit.
 - A battery store and two drums storing engine oil and other hydrocarbons were located along the northern boundary of the site within the front car park.

PLATE 4: Oil Tanks within Unit B

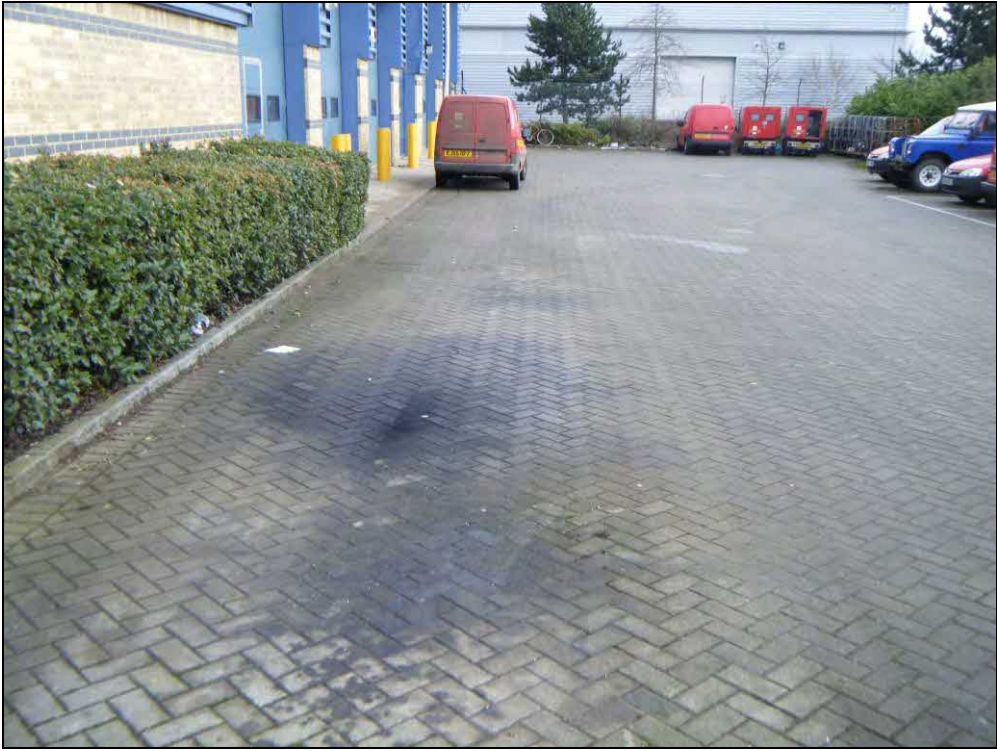
Unit B consists of a warehouse building which is utilised as a MOT centre for Royal Mail with offices (with shutters at the front and rear of the property) and 11 car parking spaces. The block paving in the car parking areas appeared to be in good condition, although there was evidence of oil spills.

PLATE 5: Evidence of hydrocarbon spills at Unit B.

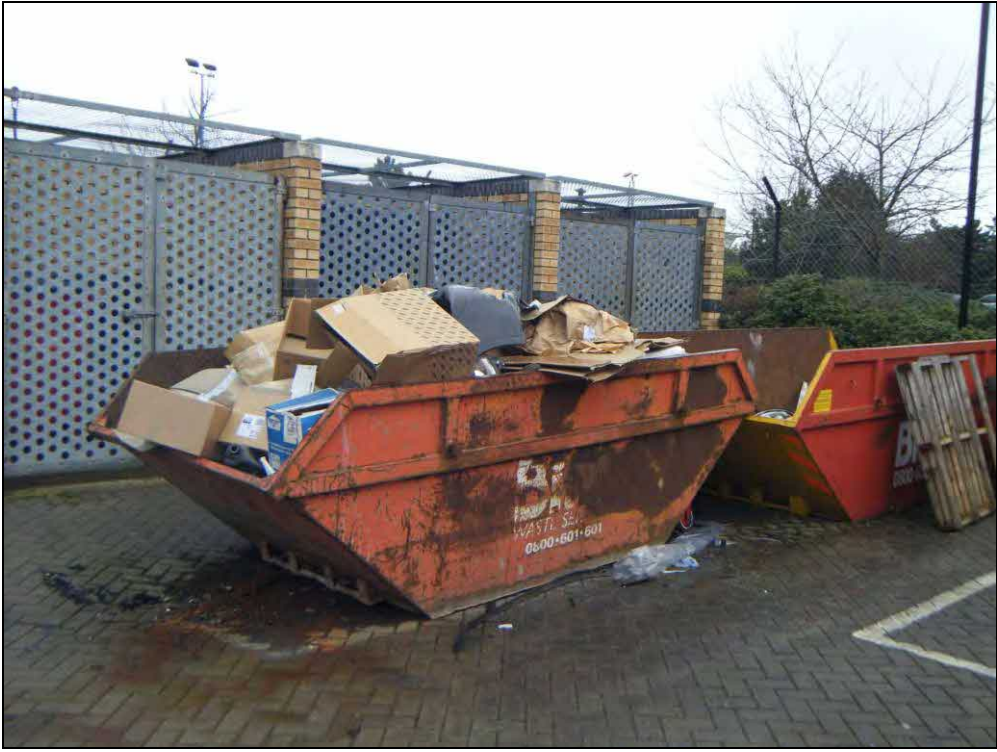
Two skips (one containing cardboard and other packaging, and the other containing scrap metal/car parts) were located to the front of Unit B within the car park. Three caged areas containing a large dustbin, cleaning equipment and car tyres were located adjacent to the skips. A trailer and several caged trolleys (containing scrap car parts) were located to the rear of Unit B.

PLATE 6: Skips and storage cages at the front of Unit B.

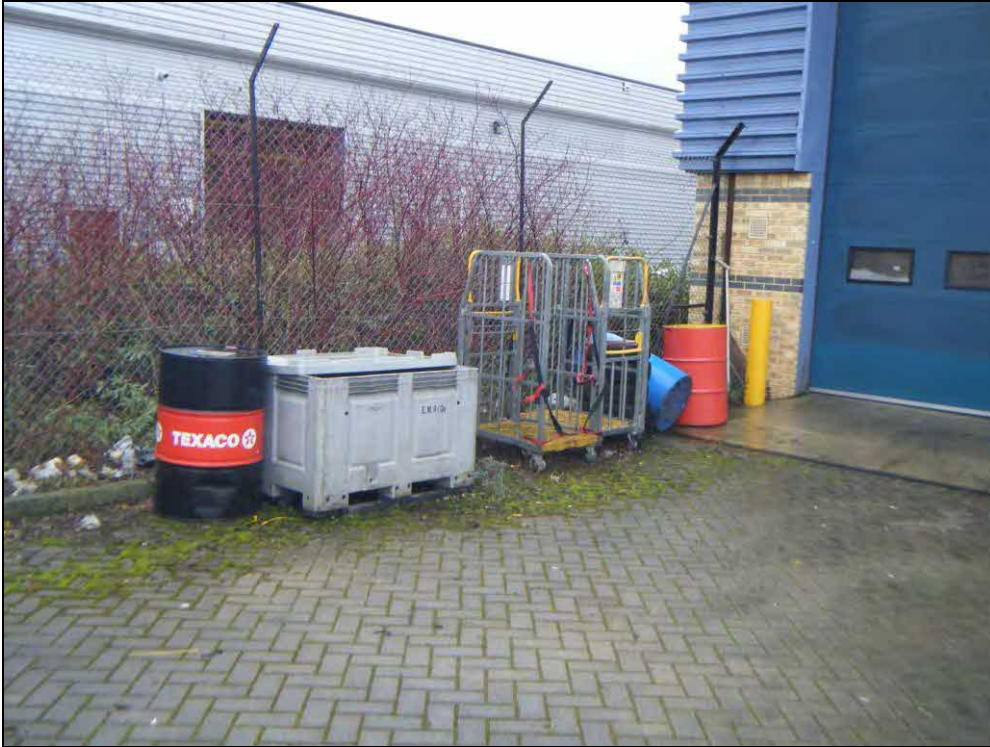
PLATE 7: Oil drums and battery store at the front of Unit B.
