## Preliminary bat roost assessment

| Site Location | 27 Magdalen Road, Oxford, OX4 1RP |
| Document reference | CE4292 |
| Date of Site visit | 27 <sup>th</sup> June 2023 |

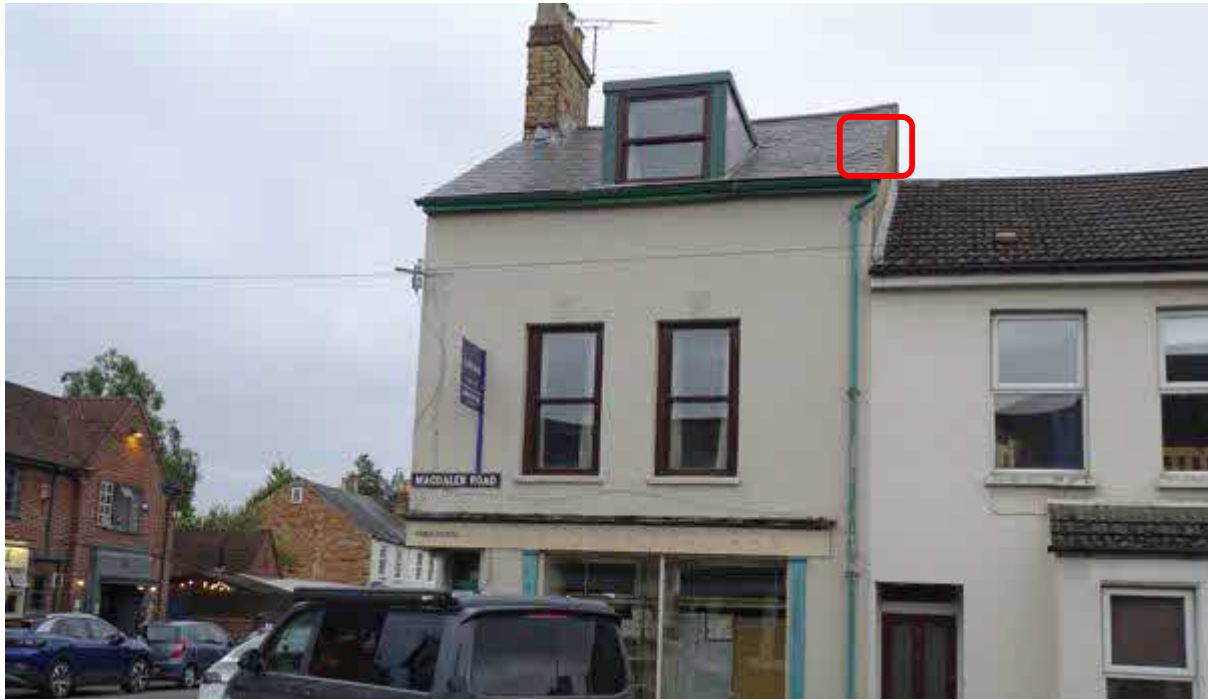
Image 1 – South facing elevation of the building where an area of raised tiles looks to provide likely shelter/access opportunities for bats within

- 6.6** In line with best practice guidelines, a further single emergence or re-entry survey will be required to rule out or confirm activity from bats. This survey should be carried out within the recommended survey season from May to August.

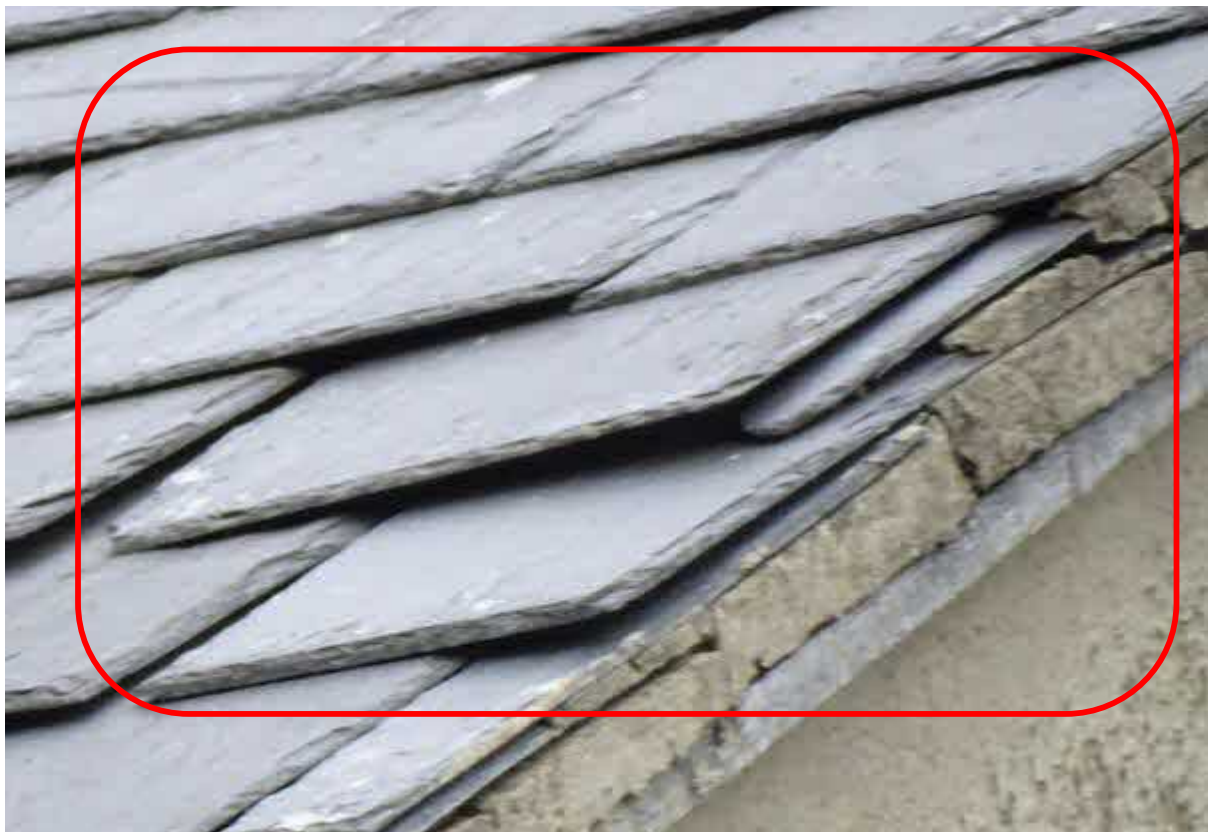
Image 2 – As per image one above

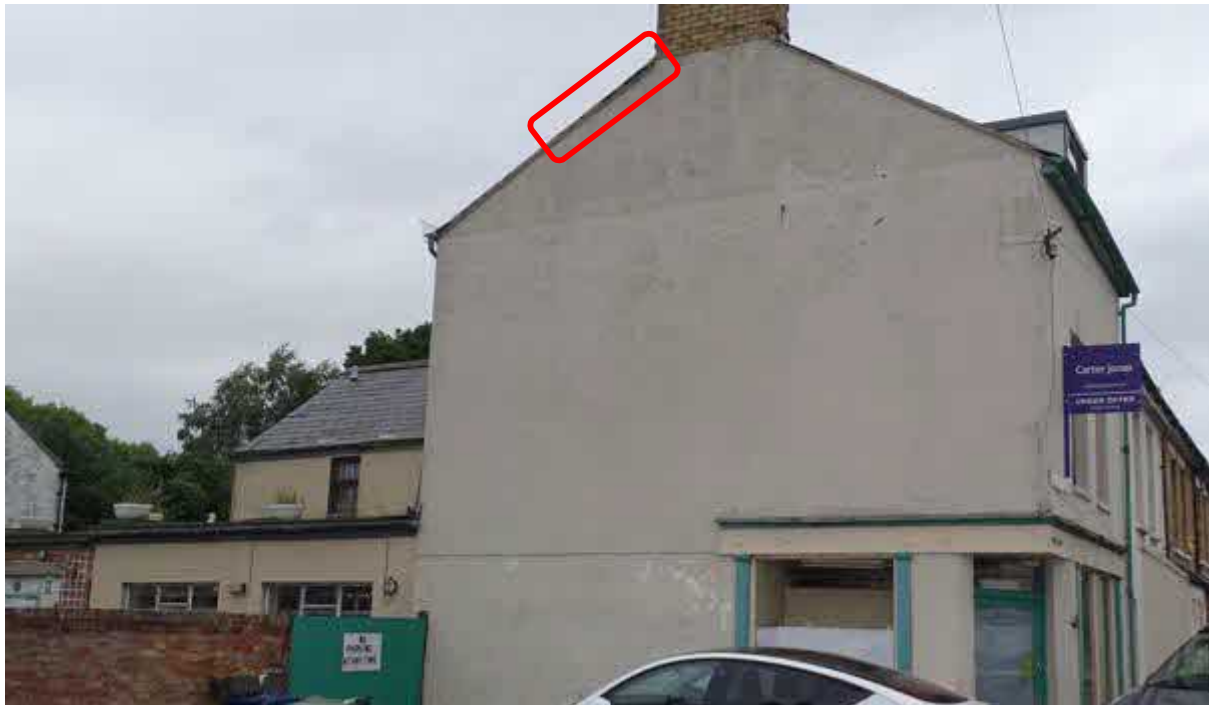
Image 3 – West facing elevation of the three storey section where gaps between the roof coverings and stonework's below look to provide further opportunities for bats

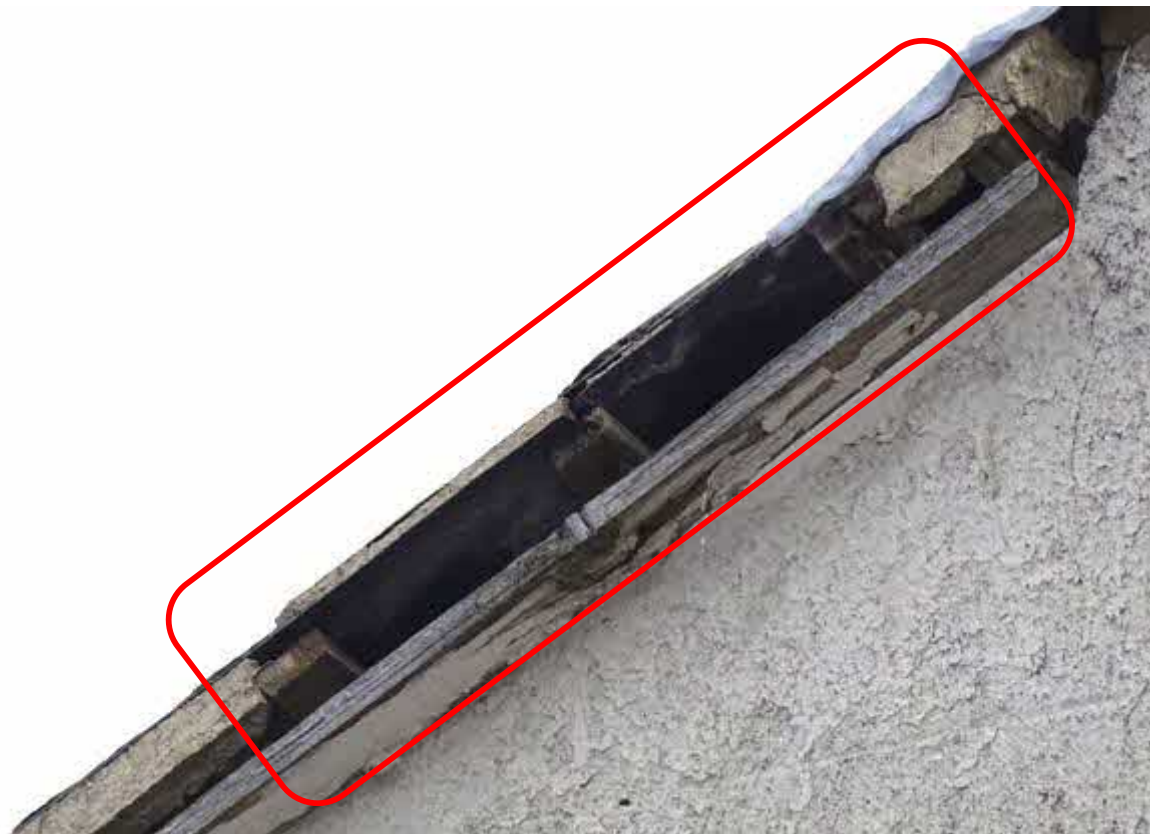
Image 4 – As per image three above

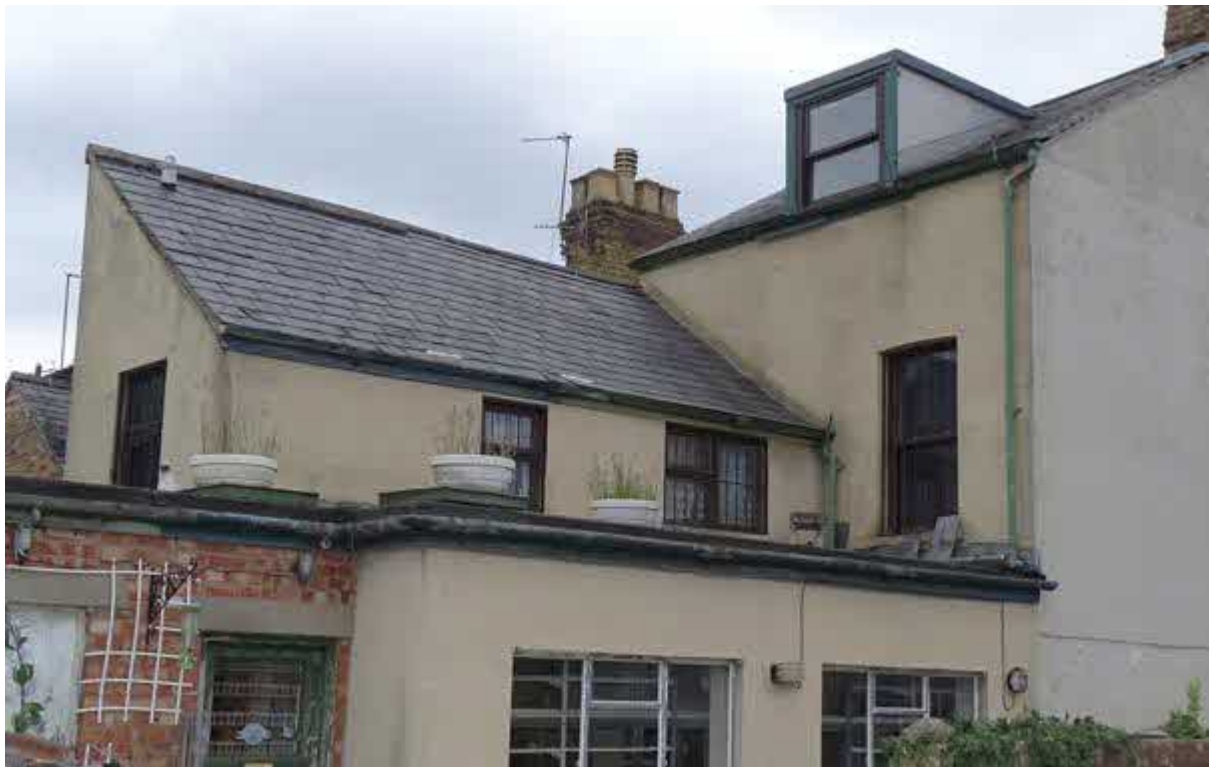
Image 5 – Rear North areas of the two/three storey section of the building

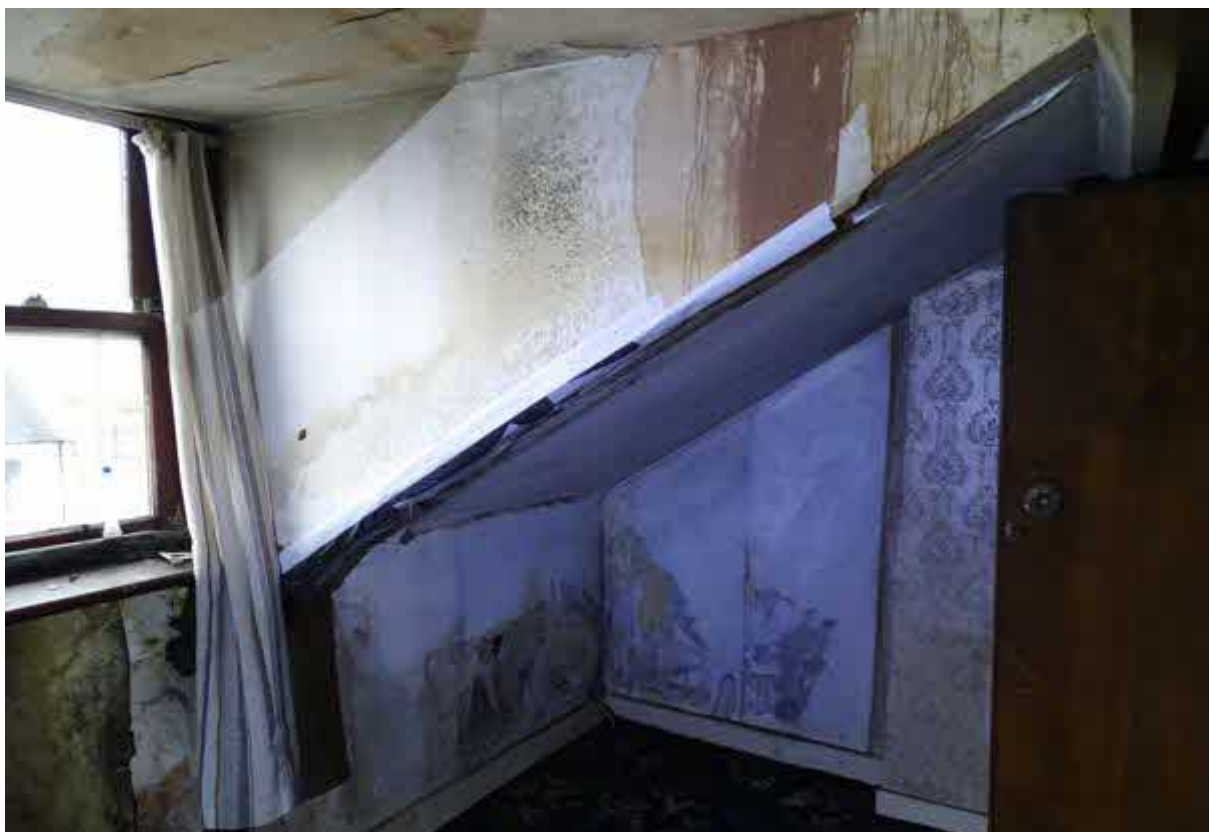
| Internal | Features of value to bats | Notes |
|---|---|--|
| Membrane coverings | Unknown | Both the three storey section and two storey section have demonstrated vaulted ceiling coverings with no visual inspection opportunities below the roof tiles.<br><br>Such coverings would offer further daytime roosting opportunities for crevice dwelling species of bats where external gaps provide access. |

Image 6 – Internal view from within the three storey section of the building where no accessible roof void spaces are provided

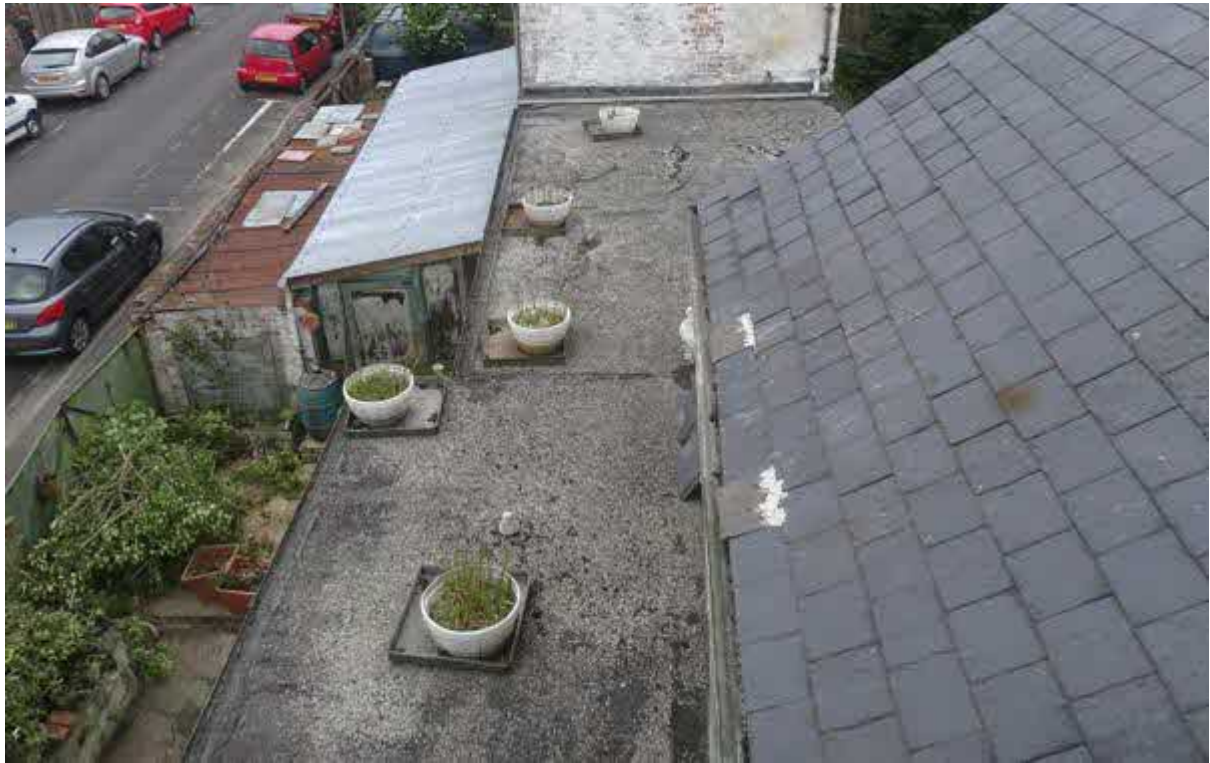
Image 7 – View across the flat roof areas of the mid section of the site

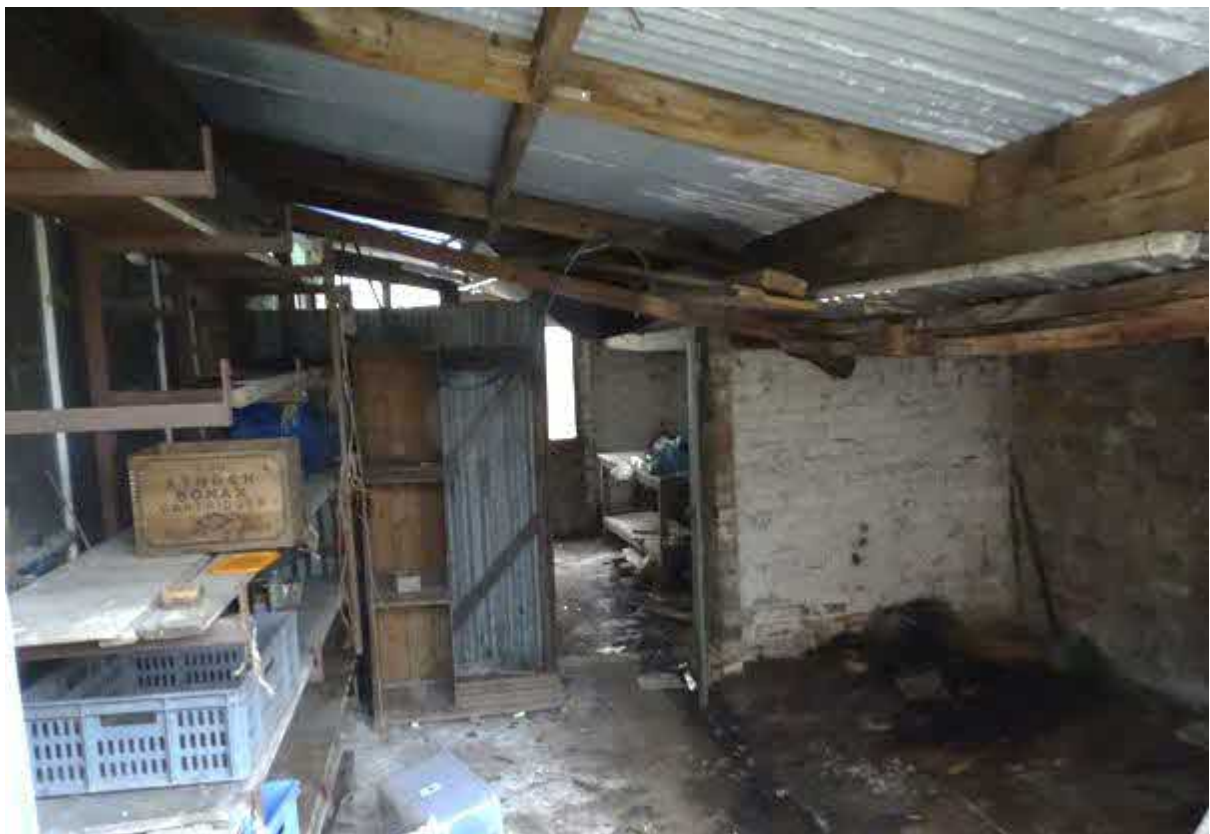
Image 8 – Internal view from within the fabricated section of the building to the rear of the three storey building

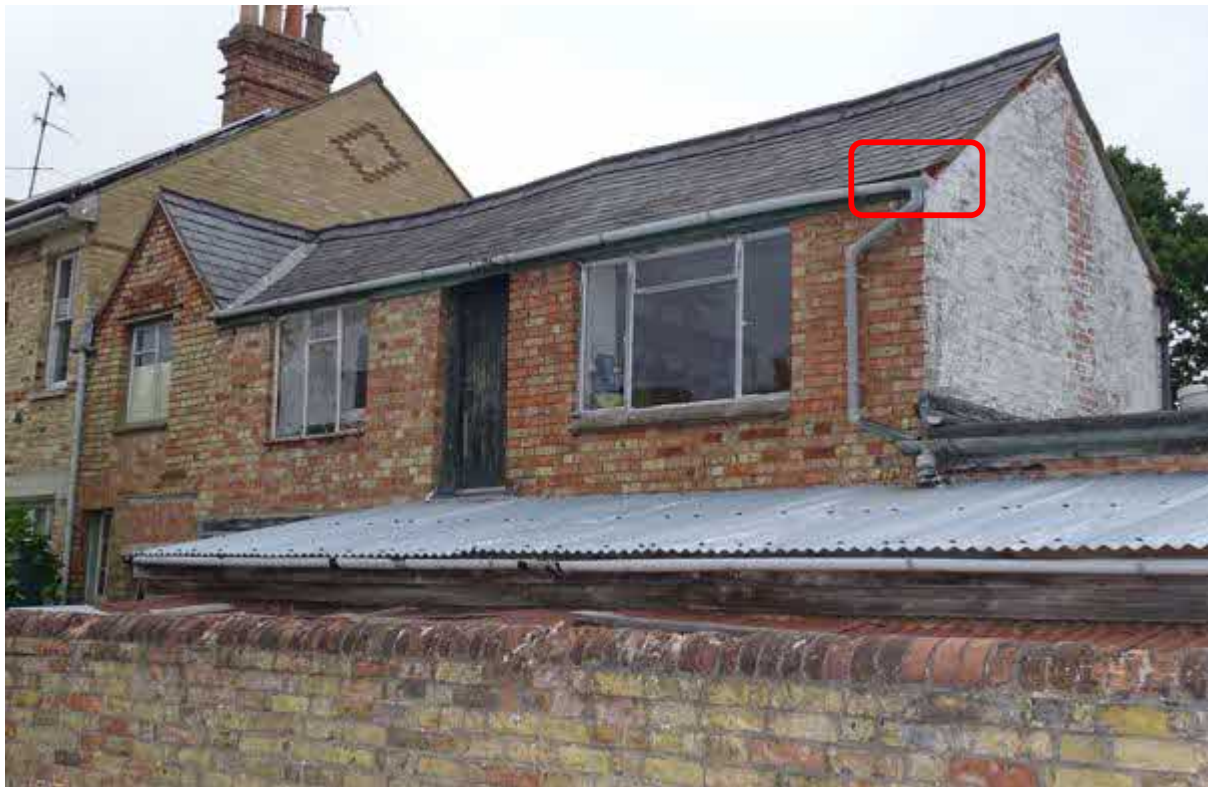
Image 9 – West facing elevation of the two storey structure to the far North of the site where gaps between the roof coverings and brickworks look to provide further shelter/access opportunities for bats

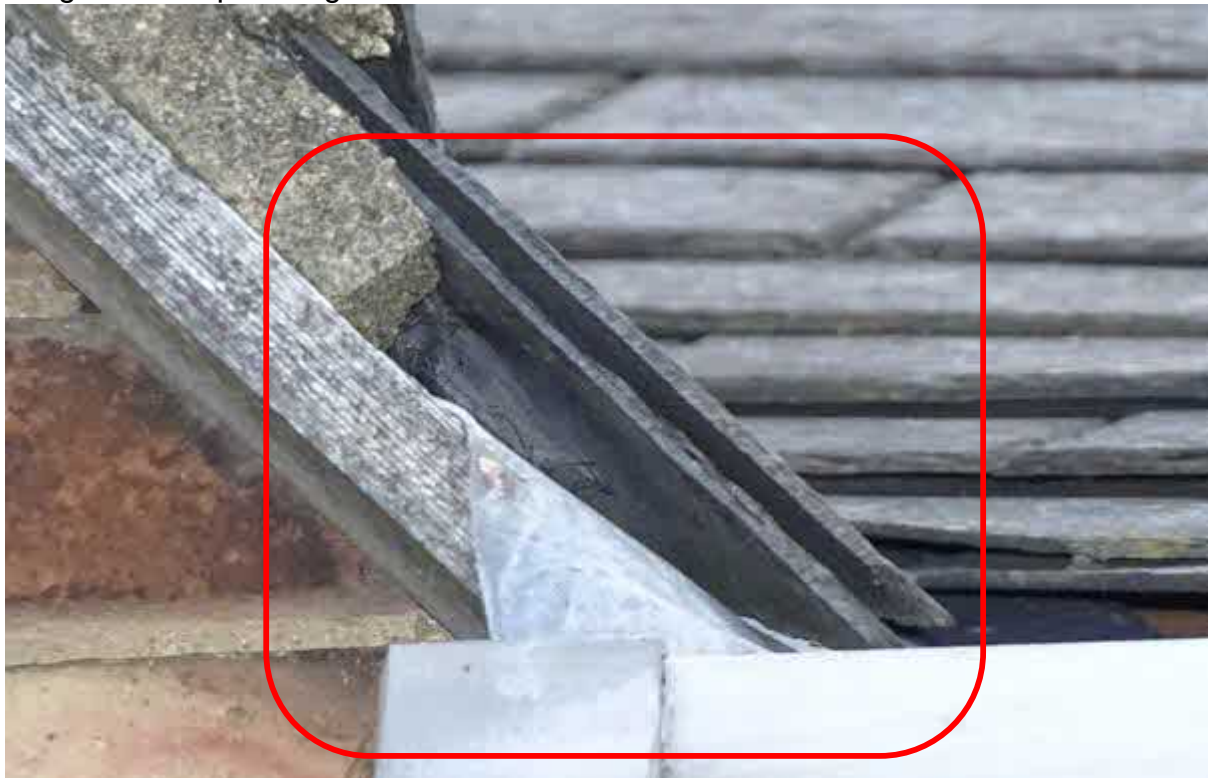
Image 10 – as per image nine above

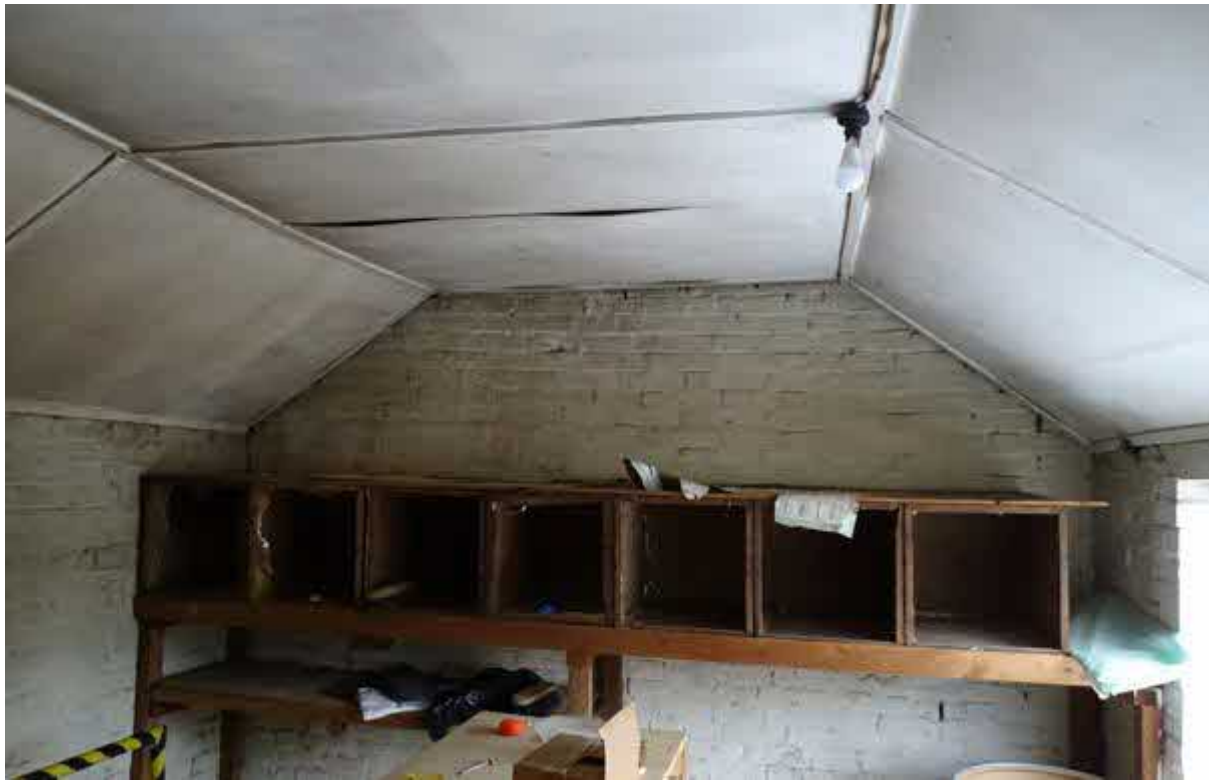
| Internal | Features of value to bats | Notes |
|---|---|--|
| Evidence from bats | No | No internal evidence of bats was identified within the roof void areas; however, we are unable to rule out or confirm any roosting evidence within the spaces between the roof coverings/vaulted ceiling coverings where evidence such as droppings wouldn't always be visible within the enclosed habitats, |

Image 11 – Internal view from below the roof areas as per image nine on the previous page

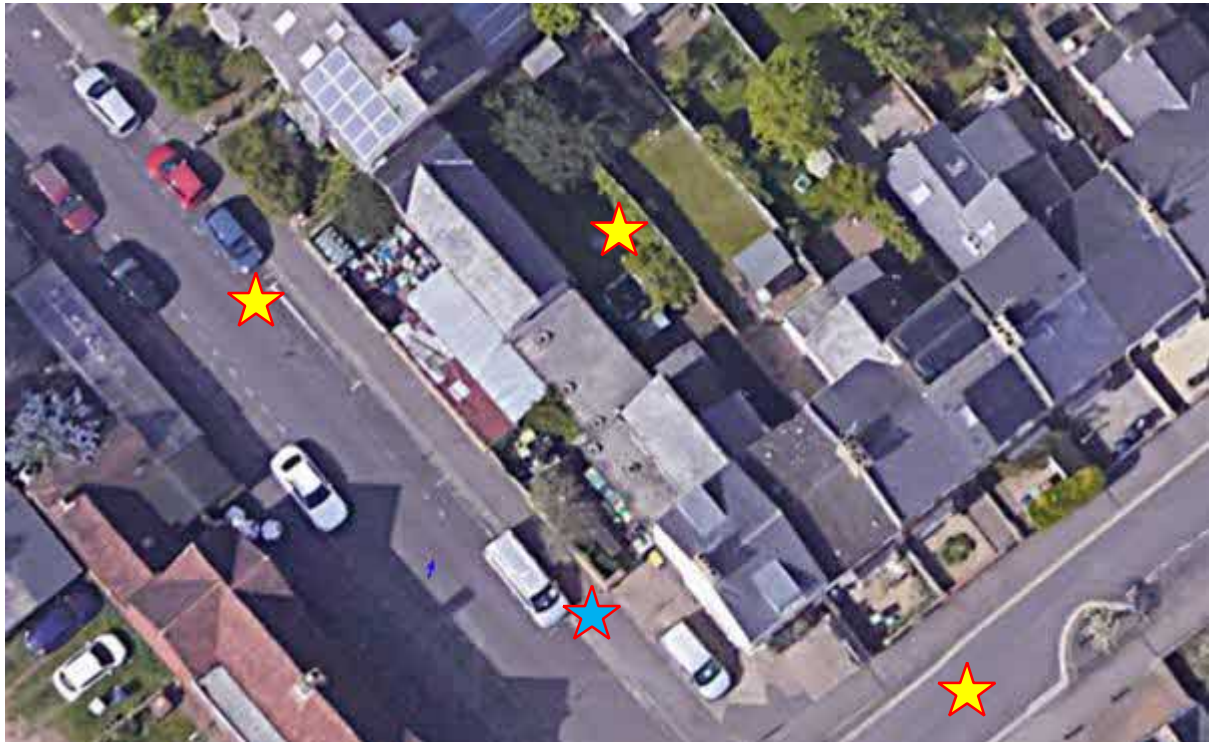
#### Appendix 4: Emergence Survey Location Points

Below site view to show suitable surveyor location points during each emergence survey to maintain visibility of the property.

In line with best practice guidelines, a total of three surveyors will be required to suitably cover all elevations which offer value to bats with support from IR/Thermal imaging cameras to reduce the number of surveyors required.
