# PLANNING, DESIGN & ACCESS and HERITAGE STATEMENT

# The Britannia Inn, London Road, Oxford, OX3 7AA

December 2023

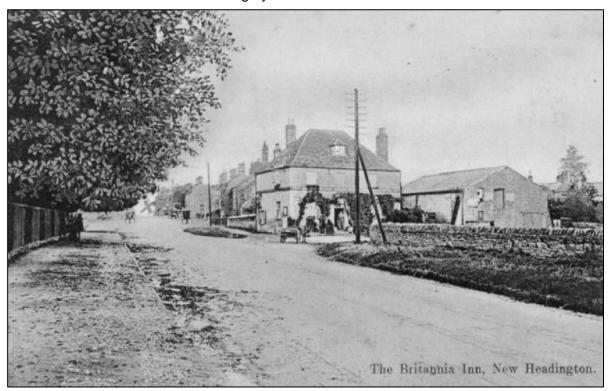
Figure 3: The Britannia Inn Circa 1915

Figures 3 and 4 are images of the property dating from 1915 and 1941, respectively. A buttress can be seen in both images, confirming that the stone barn has been moving for many years. The barn appears as a separate building in the 1915 image, but appears to have been linked to the main building by 1941.

The stone barn was originally a freestanding building which had, by the late C19<sup>th</sup>/early C20th been linked to the public house. It was originally used to house horses with lofts above, which were subsequently removed. This has caused instability issues as the lofts, effectively, tied the walls together. The external walls have long been moving outwards and interventions have had to be made – as is evidenced by the 1915 image (see Figure 3).
