Dover District Council Ref. 22/01245

Historic and Archaeological Record of former Railway Cutting

Site: Land adjacent to Hours, Church Road, Coldred CT15 5AQ

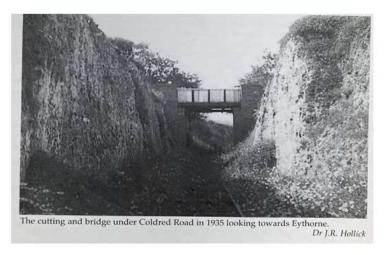
- 2.6 There is a photograph from around 1935 that shows what the section of the cutting within the application site was like, (see Fig: 1). It had straight sides cut into the chalk and was quite deep. The application site was heavily overgrown until recently when several Ash trees were felled. This has opened up views of the site. From these views, including from the adjoining public footpath, it is possible to get a sense of the original depth and shape of the cutting. Nevertheless, erosion has altered the shape and depth of the cutting so it now is more of a 'V' shape, (see plan 3 in Appendix A), which has reduced its archaeological significance.

Figure 1 View looking north from the site, taken in 1935. Note the chalk walls had started to collapse, and scrub was taking over.

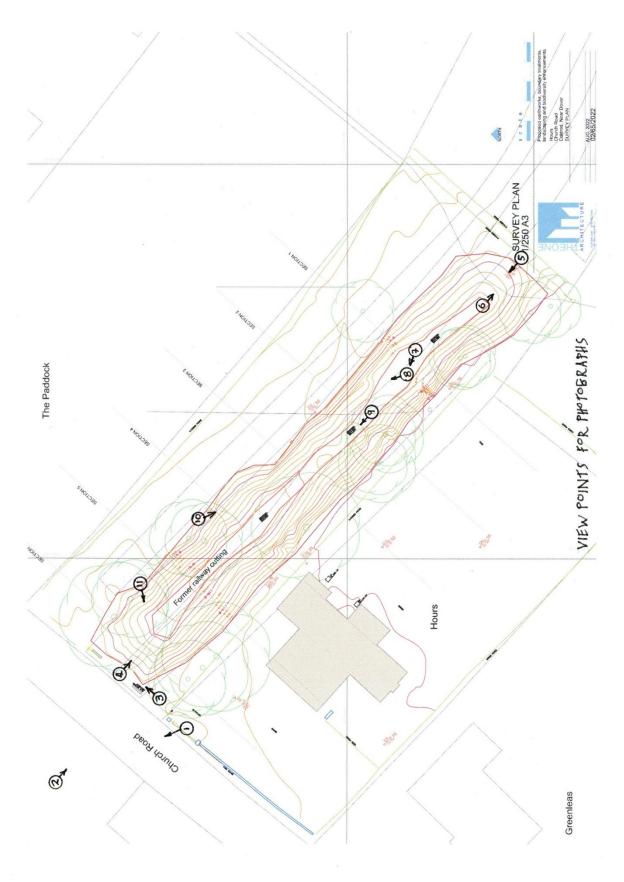
Plan 4, Photographic Viewpoints

Note; All photographs in Appendix B were taken on 26/10/2023 by Clive Alexander; see plan 4 for location of view-points.
