PRELIMINARY ECOLOGICAL APPRAISAL REPORT

Windrush
Hawsley Hill
Lydbrook
Glos
GL17 9SS

December 2023

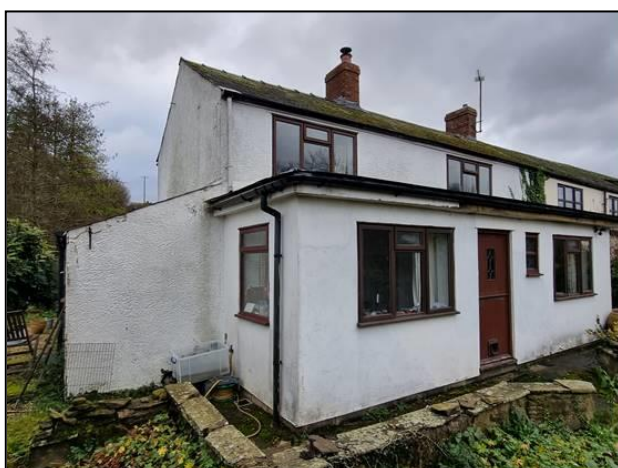
The house is semi-detached, of traditional masonry construction. The walls are in good condition with no cracks, and no gaps around windows, doors etc. The eaves and verges are also sealed with no suitable gaps.

Photo 1 – General north-west elevation view

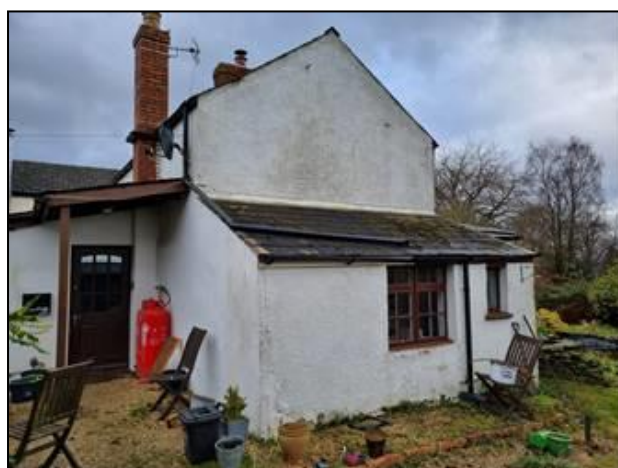
Photo 2 – North elevation

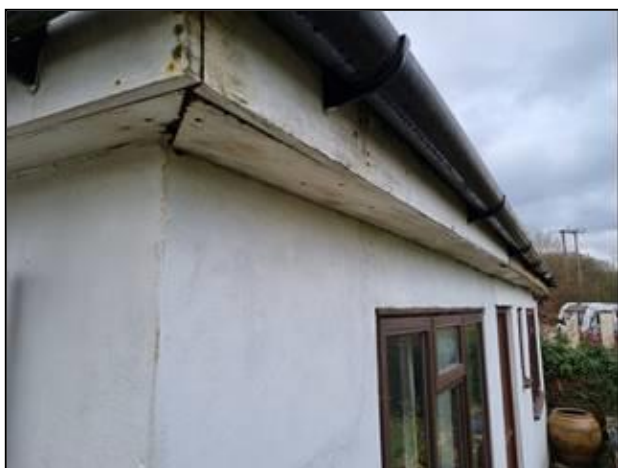
Photo 3 – Ground floor lean-to – sealed soffits

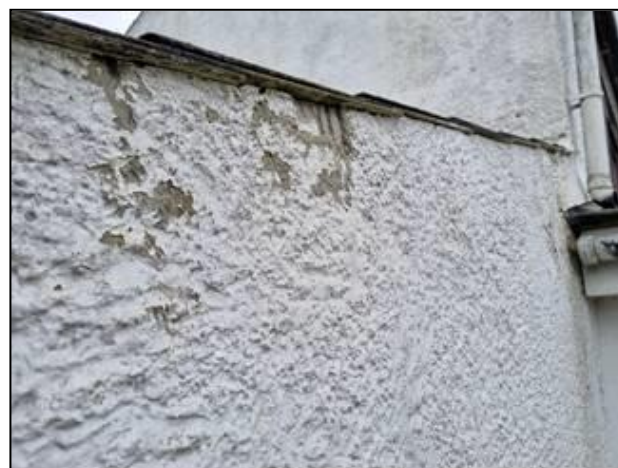
The roof is clad with close-fitting slates with no gaps at ridges, verges or lead flashings.

Photo 4 – Close-fitting tiles – no gaps at verges
