## **Internal & External Building Assessment for Bats**

**Land at Hook Farm  
Effingham Common, Norwood Farm,  
KT24 5JE**

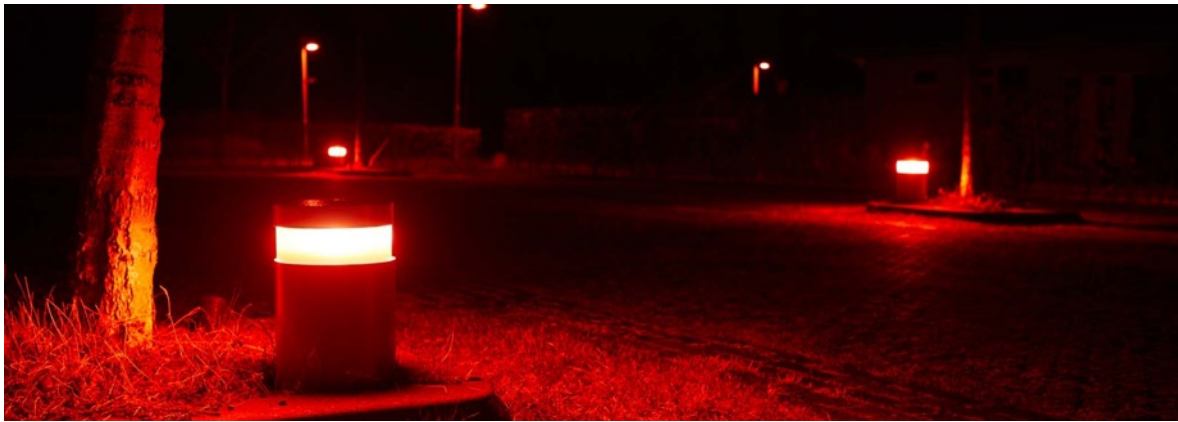
*Figure 7: Example of low level bollard lighting*

- 4.10 Where lighting is necessary near potential commuting features, bollard lighting is recommended, in place of full street lighting (Figure 7). This will maintain the integrity of these corridors for foraging bats. Warm-white or red lights are recommended to be used if health and safety concerns are great as these are said to limit the impact on insects and therefore bat activity.

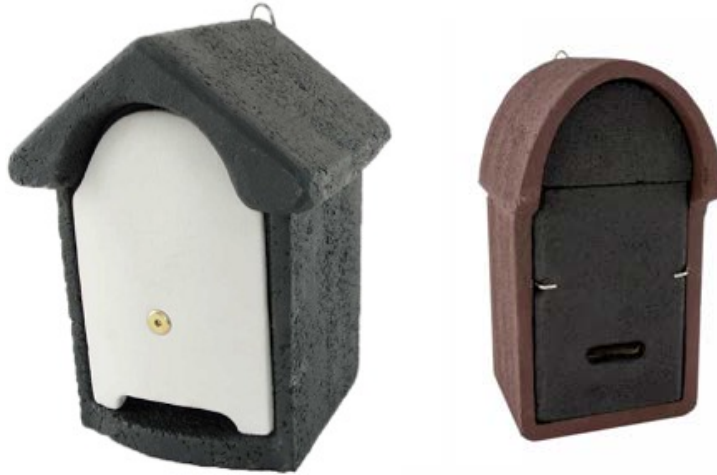
**Figure 8: Vivara Pro WoodStone Bat Box (left) and Large Multi Chamber WoodStone Bat Box (right)**

- Vivara Pro WoodStone Bat Box – A general purpose bat box that supports a range of species (Figure 8). These can be hung on trees in a variety of heights and aspects in order to provide a variety of micro-climates.

- Large Multi Chamber WoodStone Bat Box – This is a multipurpose box designed for larger colonies and a range of bat species including pipistrelles, noctules and brown long-eared bats. These should be hung on mature trees around the site (Figure 8).

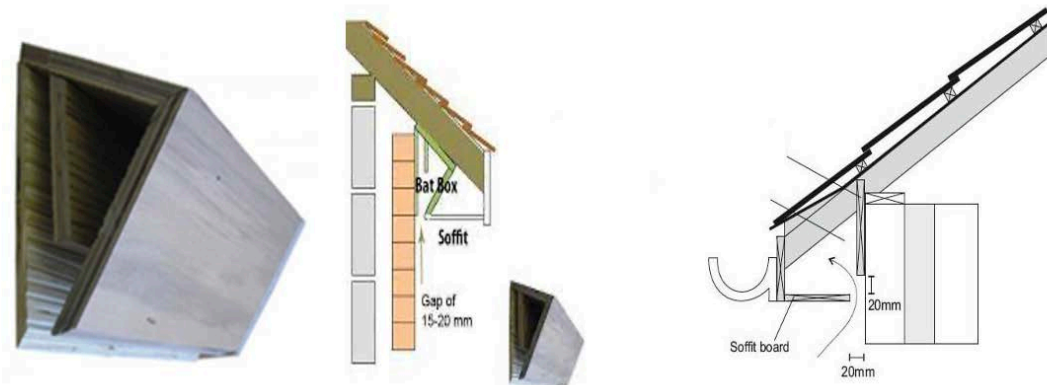
**Figure 9: Example of an integrated bat box**

4.13 Integrated bat boxes may be incorporated into the proposed new buildings. The use of these boxes within the structures of the new buildings would provide features which bats, particularly pipistrelles would be able to exploit. This should be detailed in the building design and be located on a south facing soffit, if possible. Figure 9 shows how the boxes can be inserted into the structure of the buildings.

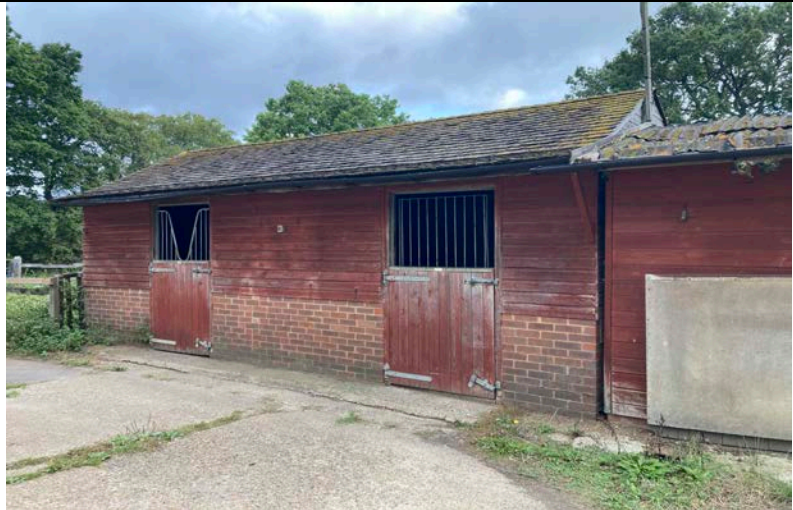
**Photo 1:** The stables to the north east (B1)

- Building B1: This is a stable block which is in active use. The base of the stables was brick, with a wooden structure for the remaining building. The roof was pitched with wooden tiles located across, but with no internal void. The tiles were in locations warped, but this was superficial, with the tiles directly laid onto internal wooden boarding. Internally, there was no void, with the building open and supporting gaps. There were no cervices which could be exploited. This building was considered to have '**negligible**' potential to support roosting bats.

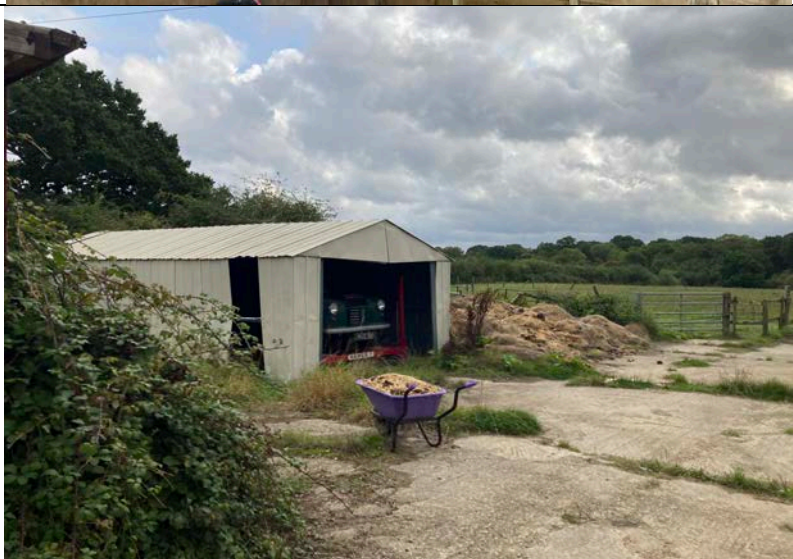
**Photo 3:** The metal barn (B2)

- Building B2: This building is a corrugate metal structure with no internal voids. The building is open and does not support any structures which bats would utilise. The potential suitability is considered to be '**none**'.

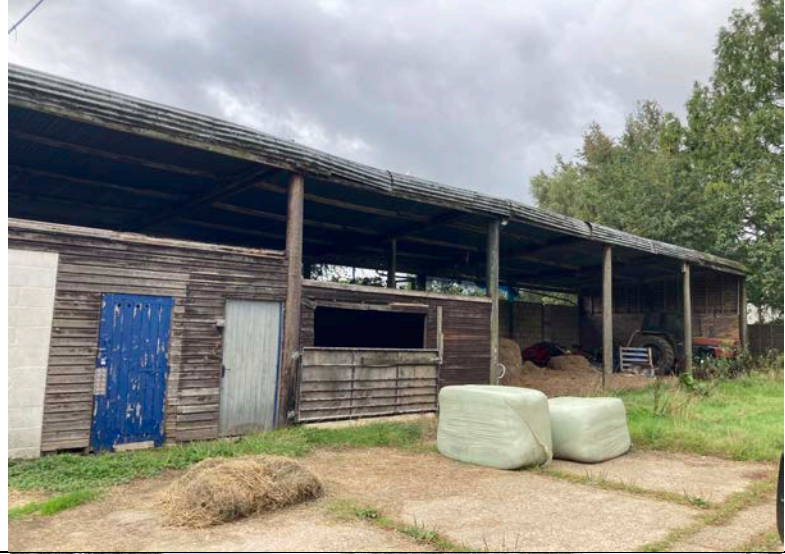
**Photo 4:** The eastern barn, with open roof structure (B3)

- Building B3: This building was an open barn structure with a corrugated metal sheeting roof structure which support agricultural stored goods. The walls, where present, supported closed boarding and sheet metal. An office room, with a flat roof

and boarding was present. The building did not support crevices or voids which could be exploited by bats. Considering the open nature of the building this building was considered to have **'negligible'** potential to support roosting bats.

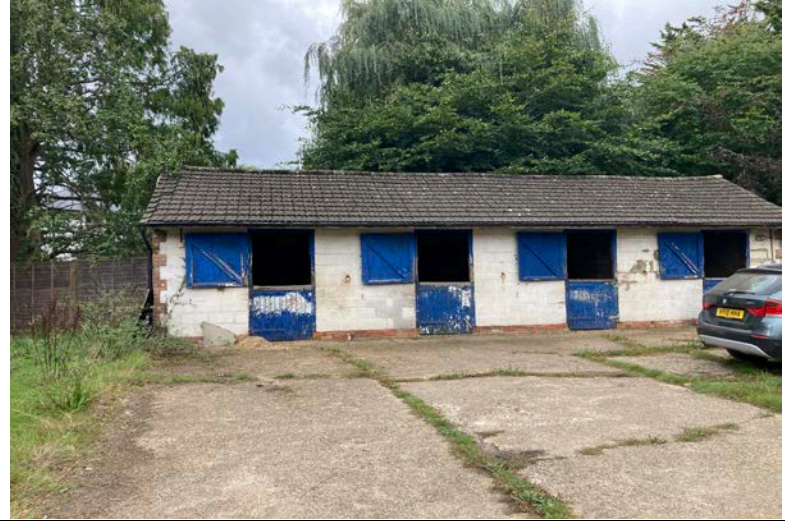
**Photo 5:** The stables to the south west of the site (B4)

- Building B4: This building was also a stable block which was in active use. The block was constructed of a brick base and supported a pitch roof, with concrete interlocking tiles directly attached to wooden boarding. The ridges were well sealed with concrete. There was no internal roof void, with the void open to the stables below. Considering the open nature of the building this building was considered to have **'negligible'** potential to support roosting bats.

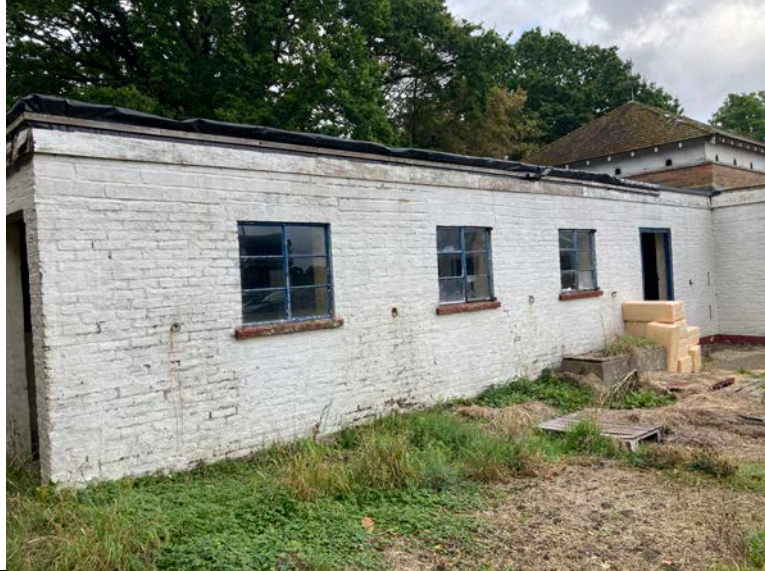
**Photo 7:**  
Buildings B5 on the western side of the site.

- Buildings B5, B6 and B7 are all connected. Building B5 was a single story brick built, painted structure. The roof was flat with sections of what appeared to be plastic and then bitumen on the wooden roof. Wooden barge boards were present around the edges. These were fitted directly onto the brick structure. On the western end of the building the wooden boards were frayed, but did not provide sufficient crevices to support roosting bats, Internally, there are no enclosed voids and no boarding with no crevices to roost within. Considering the open nature of the building this building was considered to have **'negligible'** potential to support roosting bats. Building B6 supported a pitched roof, which was not fully accessed at the time. However, externally the wooden tiles were directly placed on wooden boards. Whilst some were lifted, these appeared to be superficial. As such, it was considered to have **'negligible'** potential to support roosting bats. The final section of this building, B7, was the same build as B5, with the same roofing structure and features and supported stable in active use. it was considered to have **'negligible'** potential to support roosting bats.

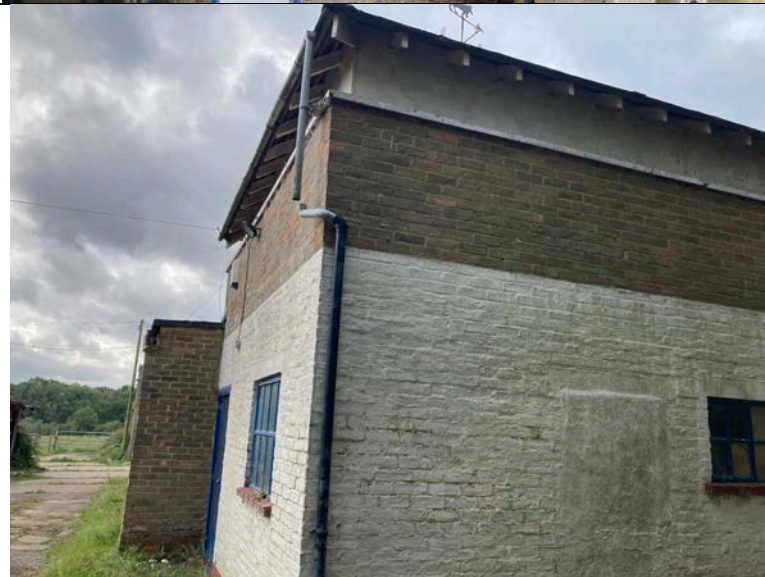
**Photo 9:** Building B6

- 4.3 Several of the buildings supported tiles. Building B1 and B6 supported wooden tiles which were fitted on wooden boarding. Several of these tiles were warped, with some of the wood lifted. However, these features were considered to be superficial and were therefore considered to be '**negligible**' potential, as per table 1 of this report. The metal shed was considered to have no potential.
