**Building at Spooners
The Heath
Woolpit
Suffolk**

ANGLIA DESIGN LLP

Bat Mitigation Strategy

12 September 2023

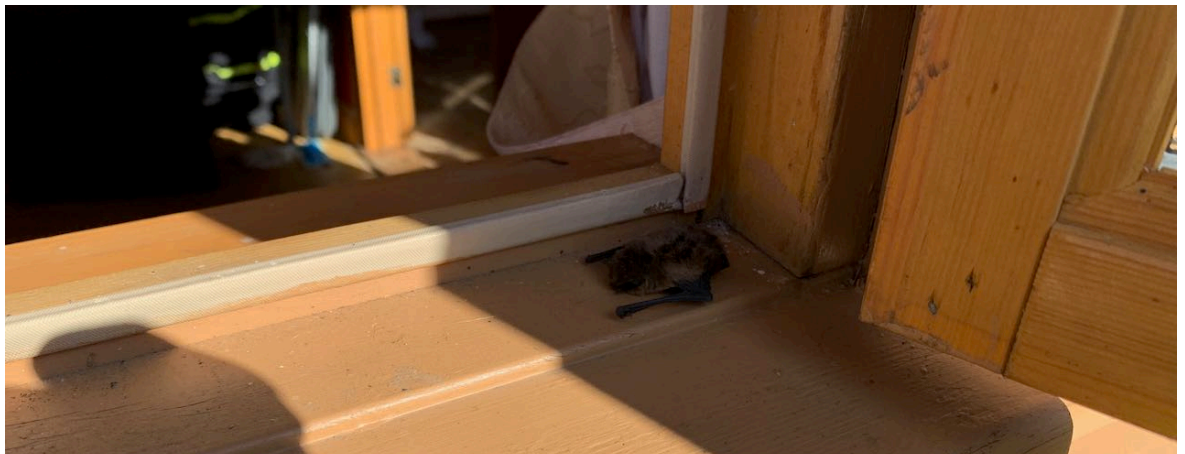
Photograph 2. Deceased Common Pipistrelle

This survey recorded a deceased Common Pipistrelle on a window ledge of the bungalow, below what was considered to be an occasionally used day roost of likely a single bat within the window frame/broken vent (**Photographs 2 & 3**).
