December 2023

**A Preliminary Bat Roost Potential Assessment  
from**

**Oak Cottage  
for**

**Mr A. Hicks**

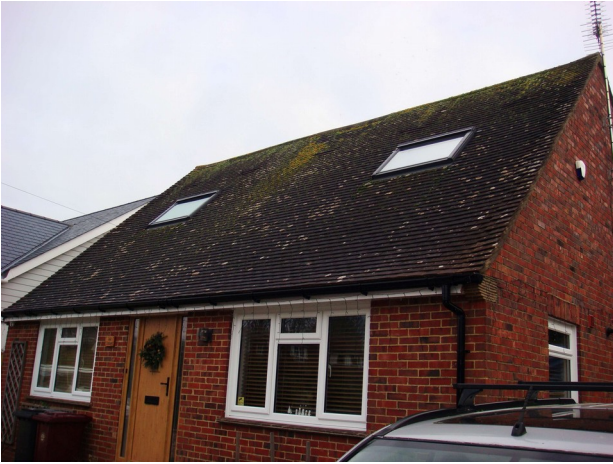
House front/west

An external inspection of the bungalow found it to be constructed from clay brick with a gabled apex roof design. The roof was covered with close fitting cement tiles. Three short lines of thicker vent tiles were observed on each roof elevation, per the example shown in Photo 1. However, close examination revealed that there was no gap beneath these tiles. There were two Velux style roof lights on the western roof elevation and three similar ones on the eastern roof elevation. The doors and windows were in good order and the frames were well

sealed. UPVC soffit boxes were present on the west and east elevations only. These were also in good order and were well sealed. There were no bargeboards present on either of the gables. The exterior of the bungalow revealed no features suitable for bats to use or for bats to gain access into the building. Thus, 'Negligible' potential for roosting bats.

- Provide this report as part of the planning application.
- If new/replaced cladding materials may subsequently allow bat access (e.g. tiles, slates, timber boards), all lining membranes must not be breathable, fibrous types. 1F 'traditional' bitumen lining is preferred but other materials (e.g. Pavatex) may be acceptable. The only 'bat-safe' breathable membrane that we are aware of that is currently approved by the necessary parties is TLX Batsafe.

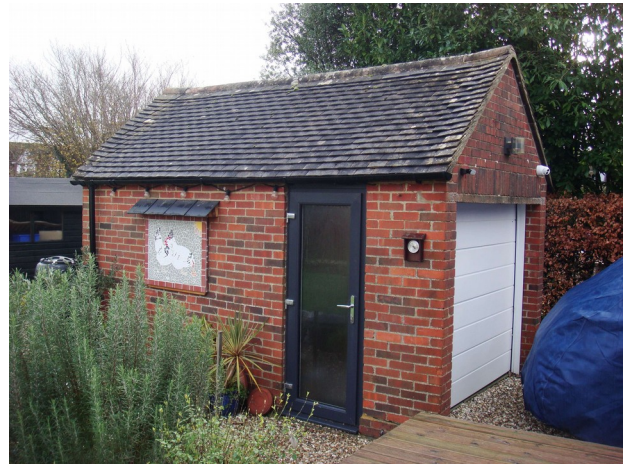
The Garage was located in the rear garden, to the south-east of the bungalow (well away from the proposed impact area at the front entrance of the bungalow, on the west elevation) and was constructed from clay brick with a gabled apex roof design. The roof was covered with loose fitting cement tiles, which were considered to offer potential for bats to access (Photo 13). The doors were close fitting and provided no access features for bats. There were three large windows within the walls, which allowed plenty of natural light to enter the building. The interior space was open to the rafters, visible beneath a 1F hessian-backed bituminous felt roof lining. The lining had a small tear, which exposed the tiles above. No evidence of bats was found within the garage, but there was a 'Low' potential for bats to roost between the tiles and the lining of the roof, and to gain access into the garage space.

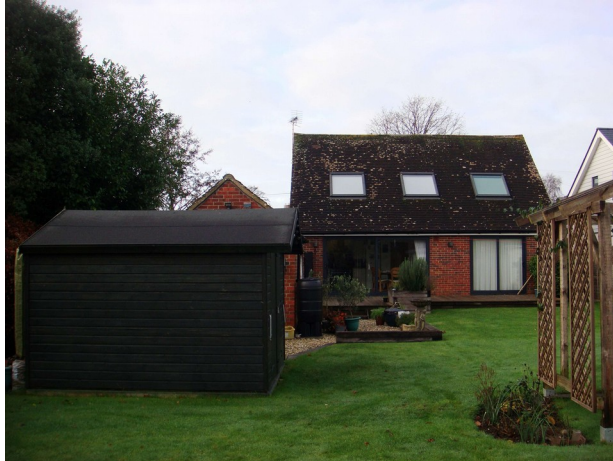
House rear/east and shed

The garden also contained a wooden shed and a wooden summerhouse. However, these were both considered to offer 'Negligible' potential for bats.

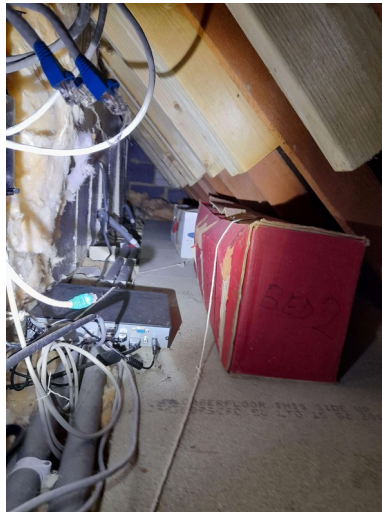
Roof void

An internal inspection of the bungalow found the roof area to be in use for residential habitation. It retained only a small partial skeeling void, with no access hatch. In addition to this there were two crawl spaces under the eaves – only the eastern crawl space was accessible, which was via a small hatchway. The interior of the eastern crawl space was boarded. The rafters were visible beneath a roof lining comprising 1F hessian-backed bituminous felt. There were no tears or holes suitable for bat access in the lining. No daylight was visible. The void contained some household items, which were in storage. No evidence of bats or other animals was found within this space.
