DESK TOP STUDY REPORT

Site Address:	Prestwick, Ermine Street, Buntingford, Herts, SG9 9RT
Report Date:	November 2023
Project No.:	18610
Prepared for:	LW Developments Ltd
Planning Application	East Herts Council - 3/23/1881/FUL

PRELIMINARY RISK ASSESSMENT – DESKTOP STUDY - PHASE 1 REPORT

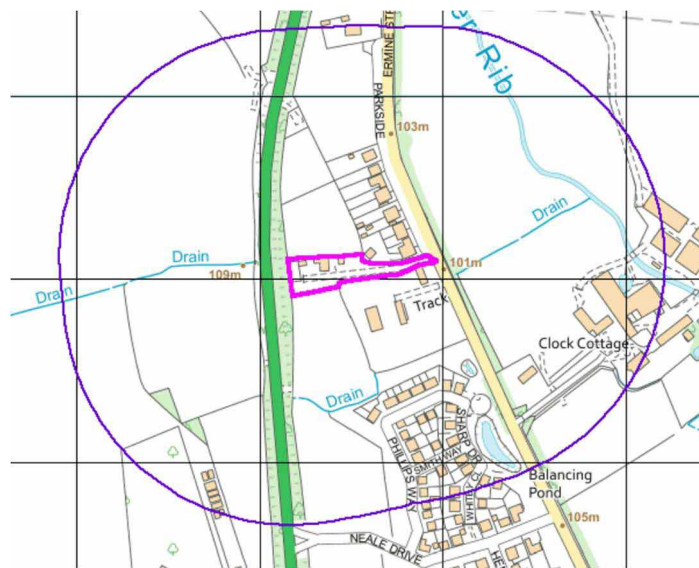
The site is recorded as an irregular shaped parcel of land which runs along from the main road and entering the site through a track leading up and into the site area. Upon gaining access into the site, the site opens out into somewhat of a construction site where the former structure in place, (a residential house), has been demolished and only partially remains. This includes some brickwork and a window frame, although, this has only been retained to retain the existing electric network for the site until it can be removed.

Debris from the demolition of all previous structures has been split into two stockpiles on site, both which appear to contain brickwork, concrete and demolition waste / debris.

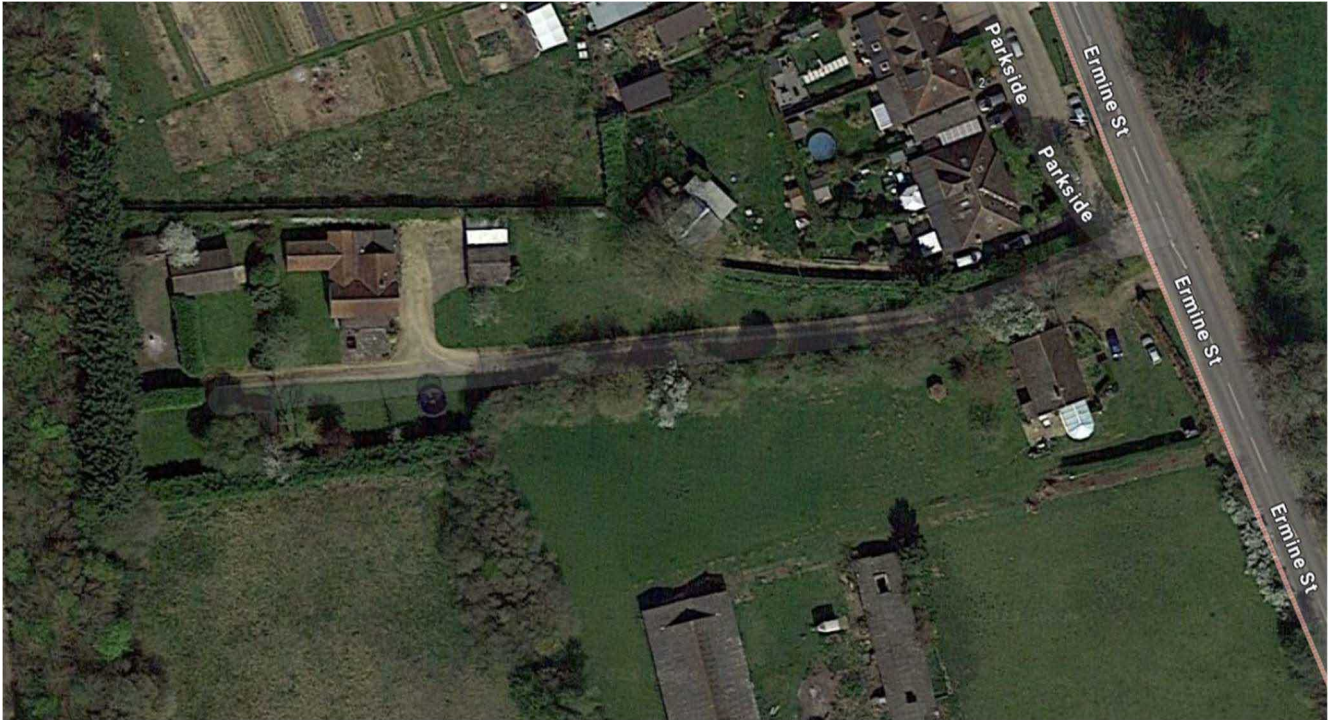
No obvious trees are recorded in place within the site. Aerial photography of the site would suggest that some trees and vegetation have been identified within the site area.

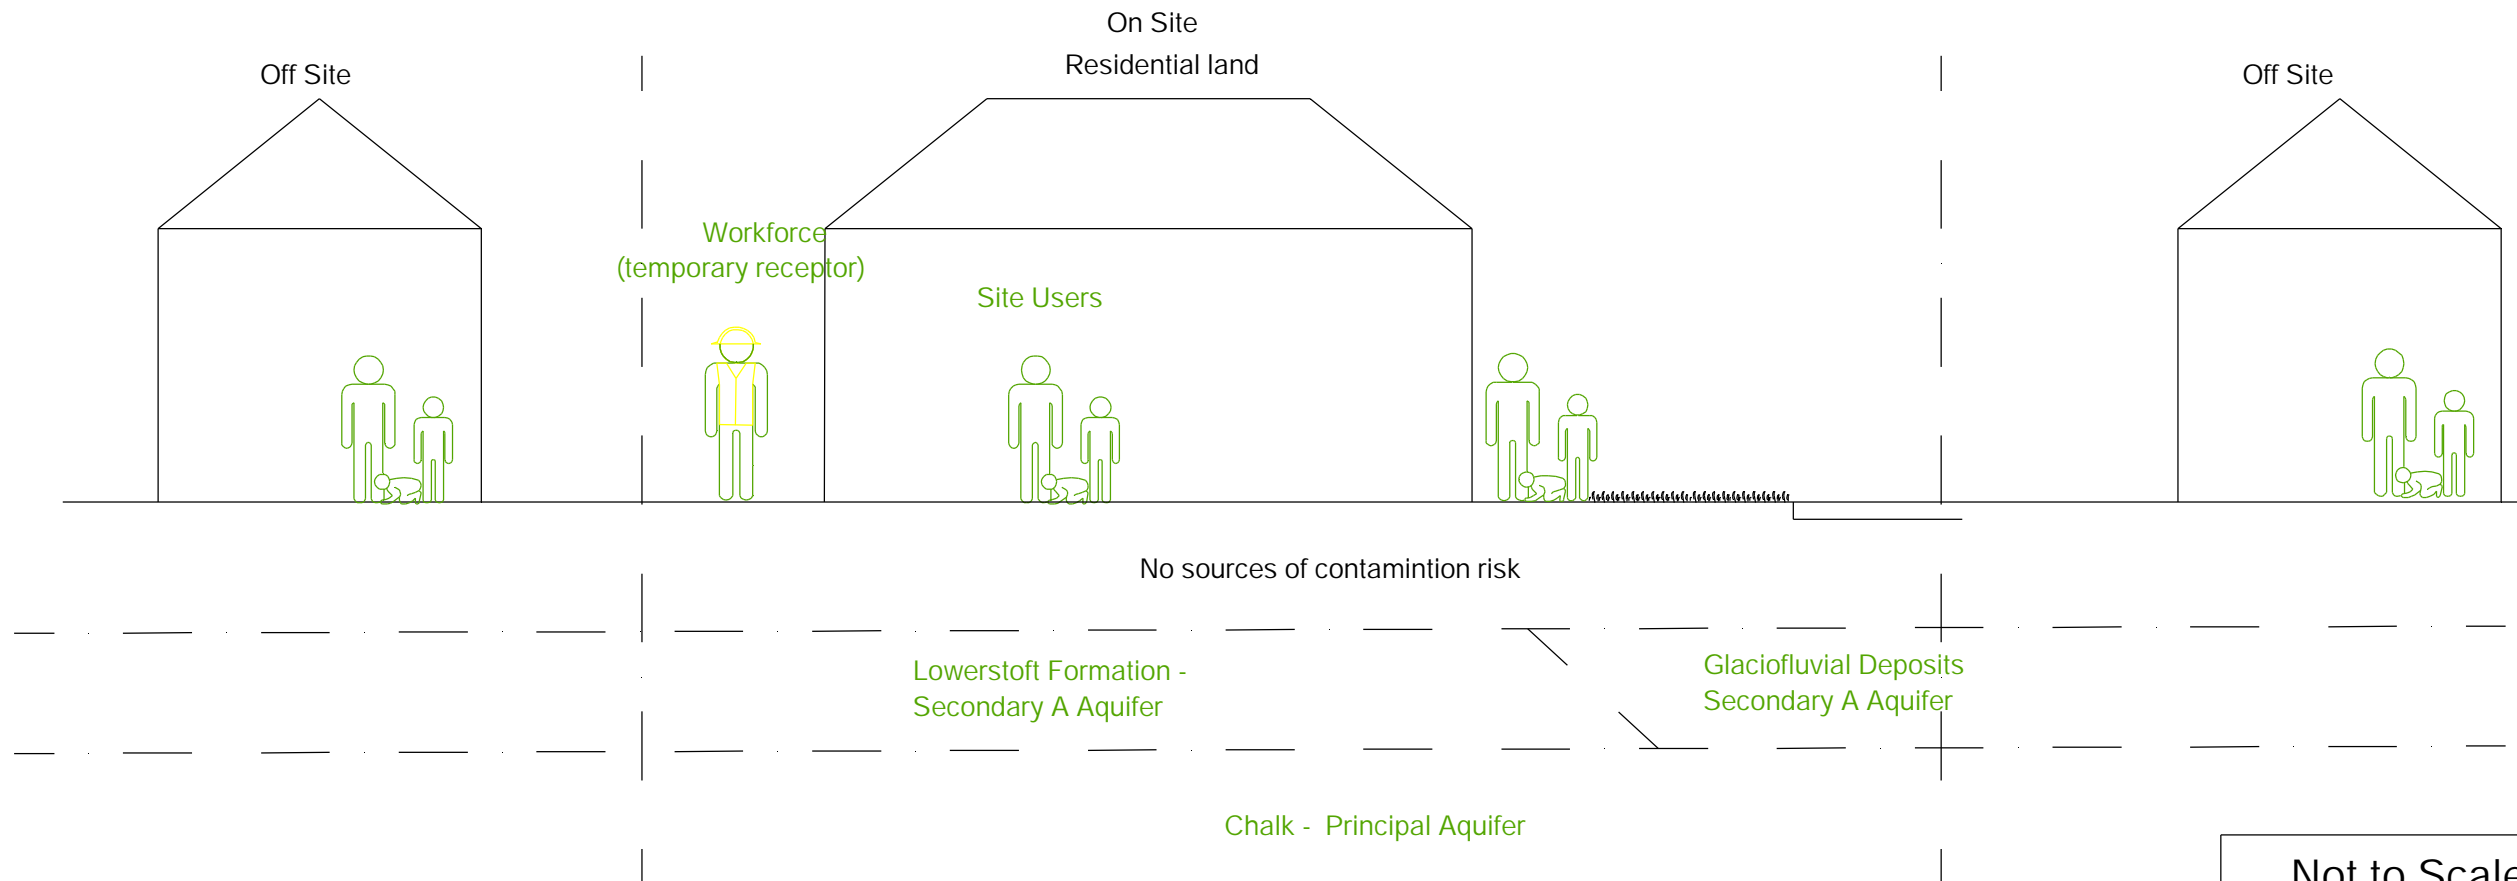
Not to Scale
Sketch No. : DTS / 18610 / 01 / 01

Key

- Purple =Possible pathways
- Green =Possible receptors
- Red =Possible sources

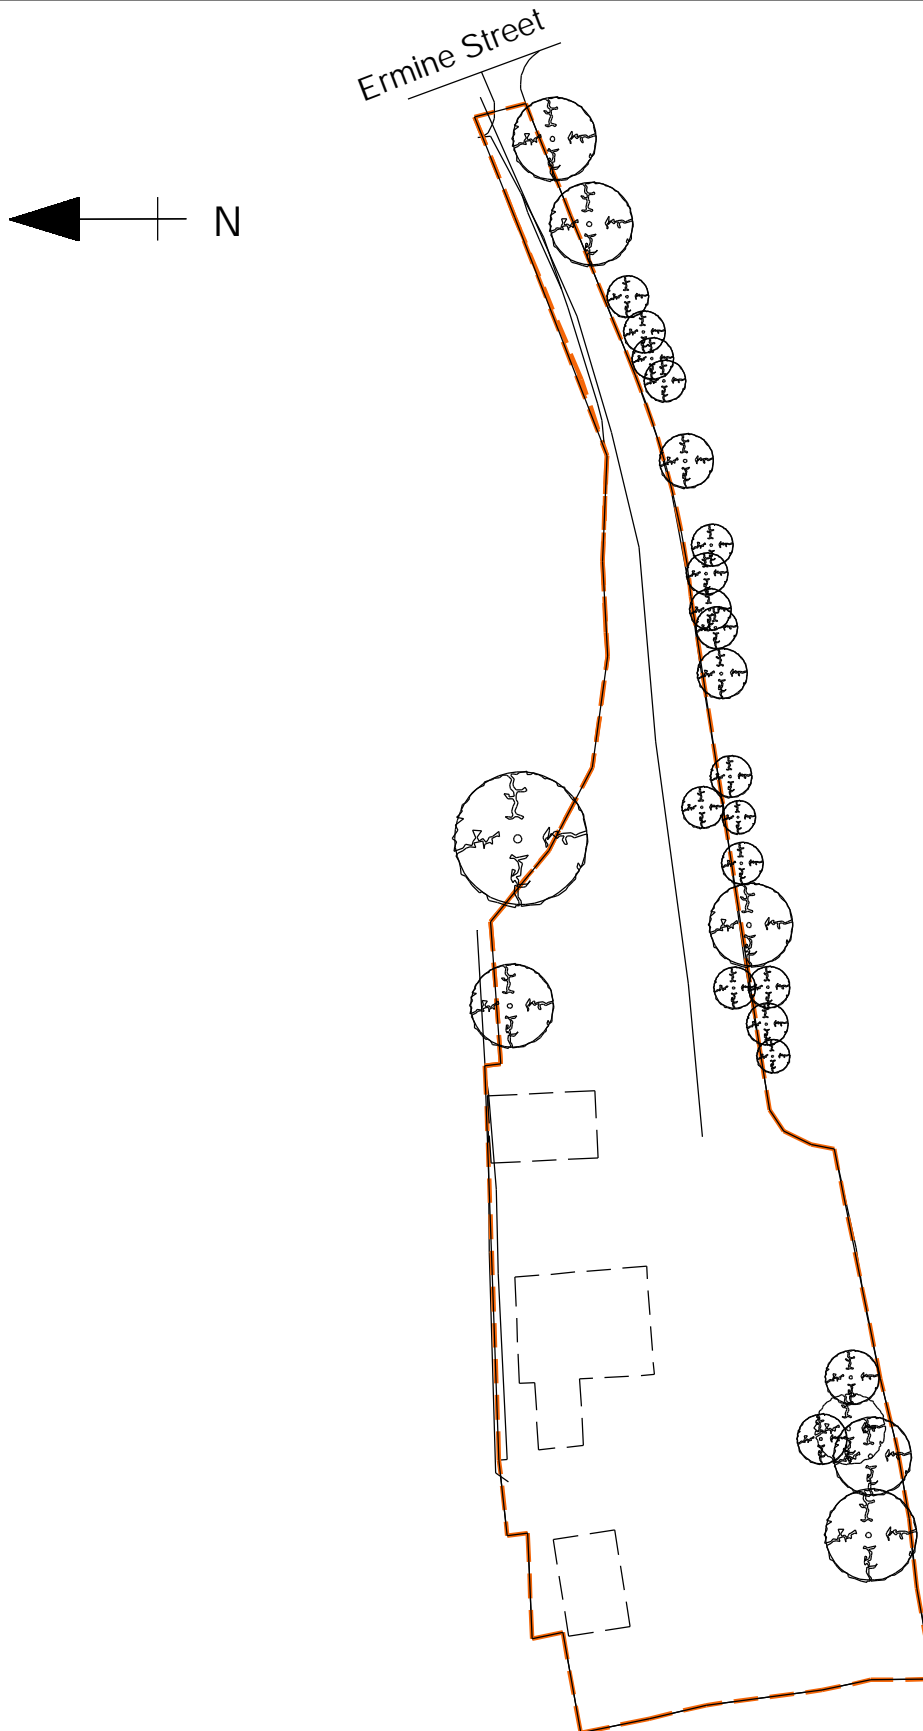
Not to Scale
Sketch No. : DTS / 18610 / 02 / 02

Existing Site Plan

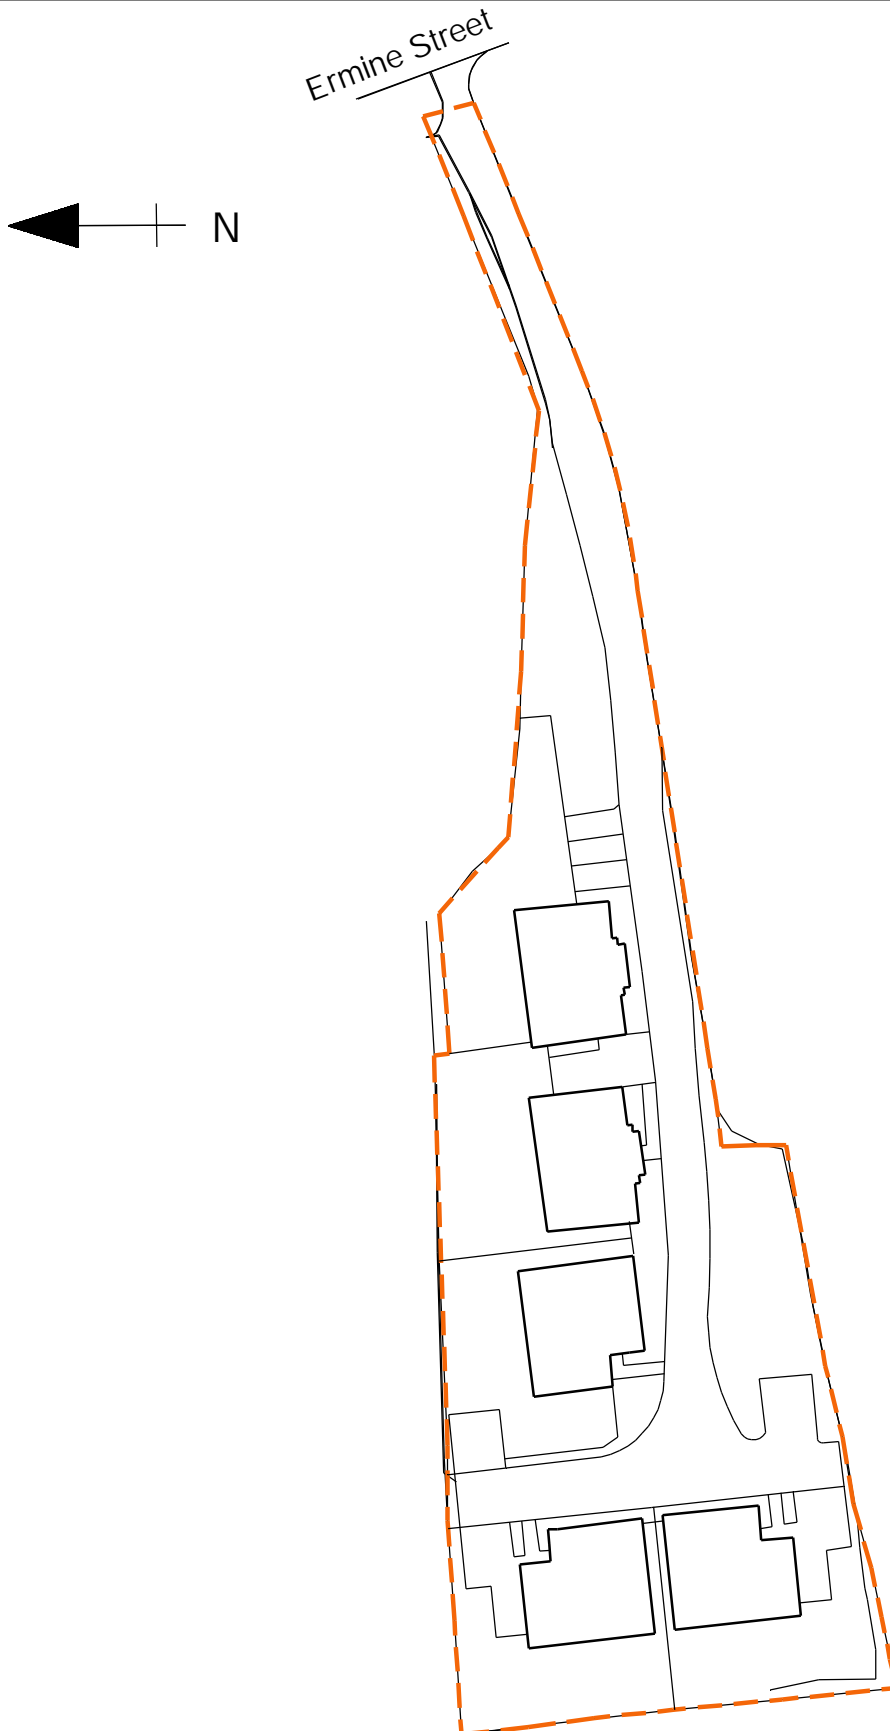
Not to Scale
Sketch No. : DTS / 18610 / 02 / 03

Proposed Site Plan
