**Updating Bat Survey Report for  
Tallet Yard,  
Duntisbourne Leer,  
Cirencester, GL7 7AS**

**14<sup>th</sup> August 2023**

Tallet Yard, Duntisbourne Leer – Updating Bat Survey Report

Report Number: 40323-01 NKM Assoc

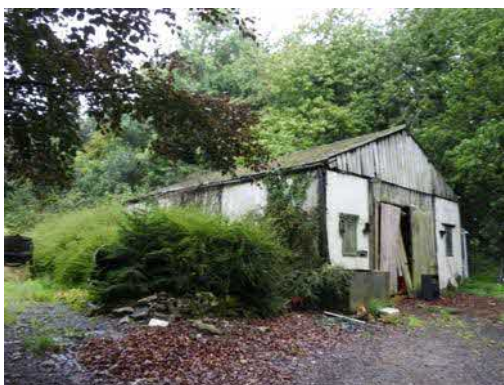
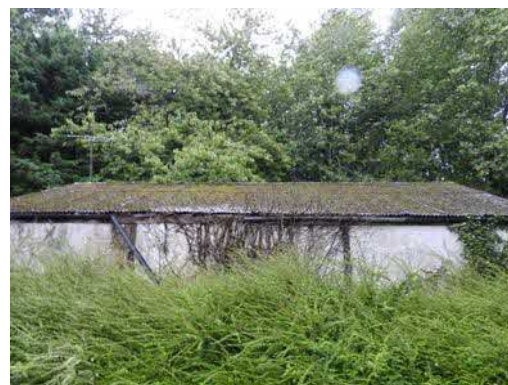
**Figs. 1 & 2 Aspects to the northeast and south**

The survey site comprised a detached pitch roof building (Figs. 1 and 2).

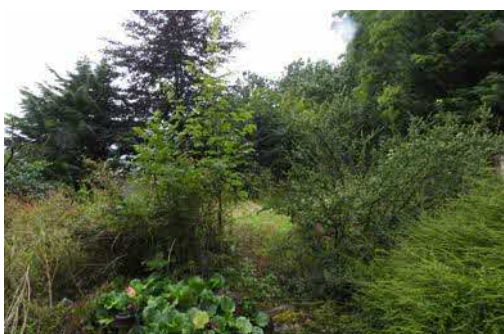
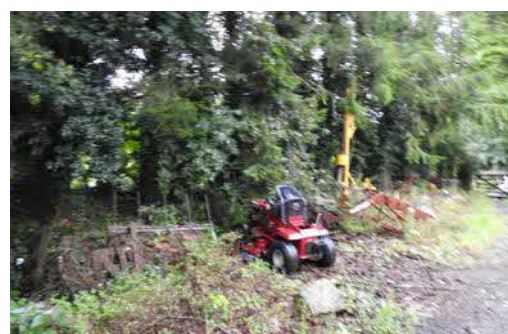
**Figs. 3 & 4 Views to the west (L) and northeast (R)**

The building was surrounded by mixed vegetation and mature trees (Figs. 3 and 4).

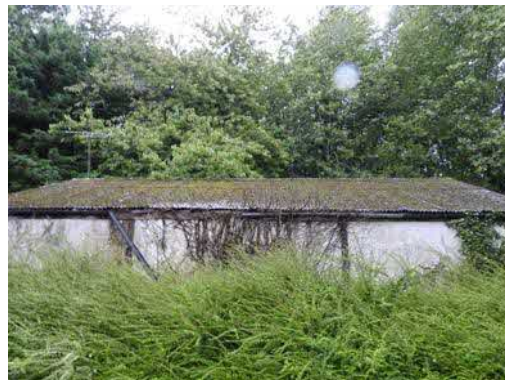
**Fig. 5 Ridge and roof panels**

The ridge was fully intact and sealed, whilst the corrugated roof panels were all tightly fitting with no broken, dislodged or missing (Fig. 5).

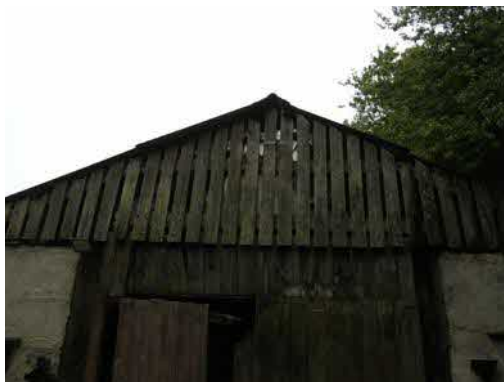
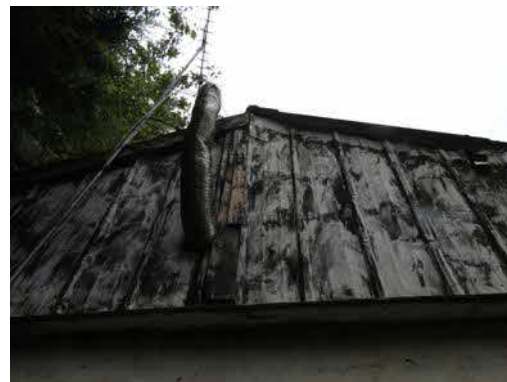
**Figs. 6 & 7 Sealed gables**

The gables were finished with the roof ends secured to the gable wall plates (Figs. 6 and 7).

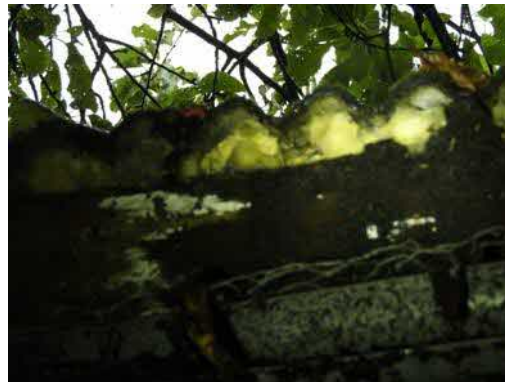
**Fig. 8 Secured roof panels to wall plates**

The eaves were finished with the corrugated panels secured to the wall plates all round (Figs. 8).

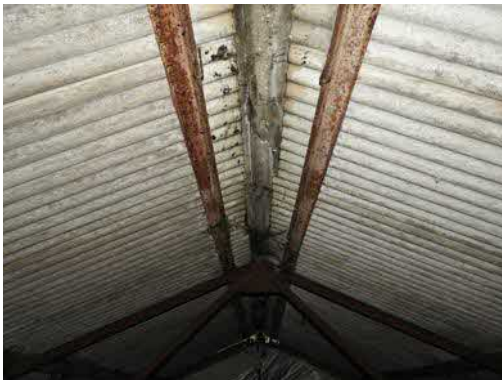
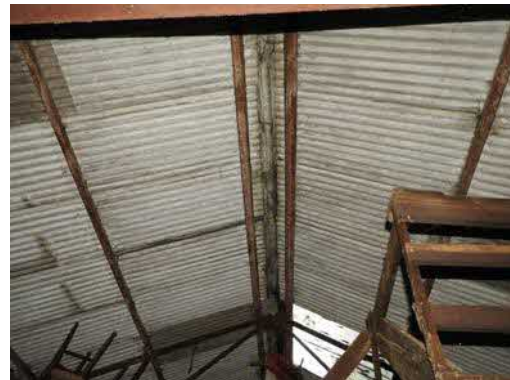
**Figs. 9 & 10 Cobwebbed ridge**

Internally little had changed since the original survey. The building was open to the unlined roof which was cobwebbed on its ridge and at the gable ends (Figs. 9 – 12).

A small amount of light penetrated the building through the Perspex roof panels, and no evidence of bat occupation was discovered inside the building.
