Heritage Impact Assessment
The Bell House
Little Tew
Oxfordshire.

Job reference. 101-22: dated June – October 2022. 128-23: edited May 2023.
Victoria Hubbard MSc.
Tel. 07775598317. Email. victoria@hubbardconservation.co.uk

Part One: Statement of Significance.

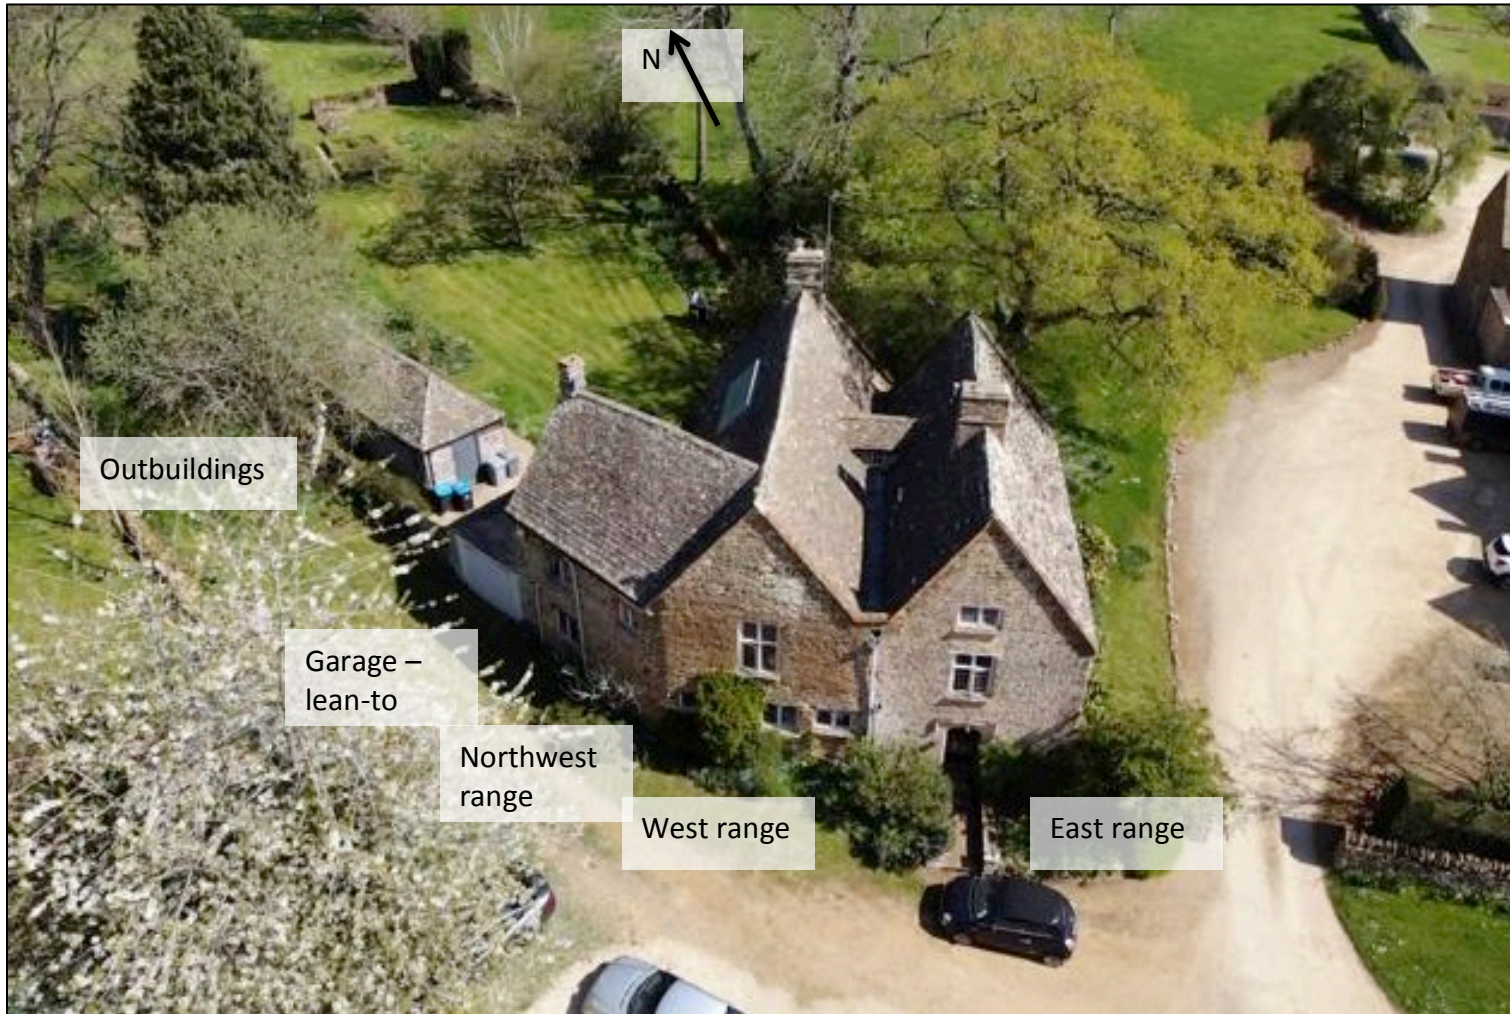
Figure 2: Aerial photograph of The Bell House. Source: Advanced Surveys.
Front page: Front (southwest) elevation of The Bell House.

South west elevation: East and west ranges, northwest range and garage/lean to (**Fig. 2 & 14**).

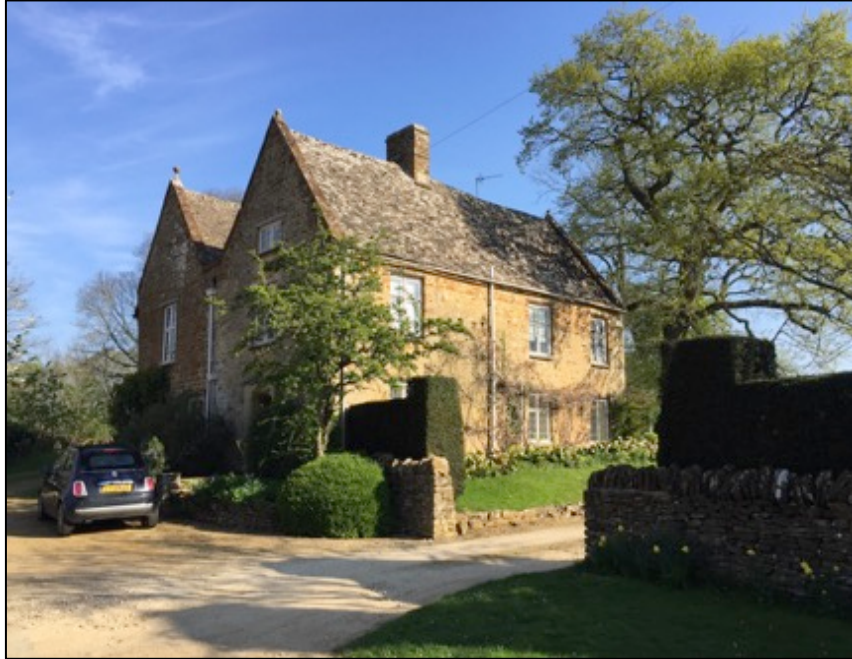
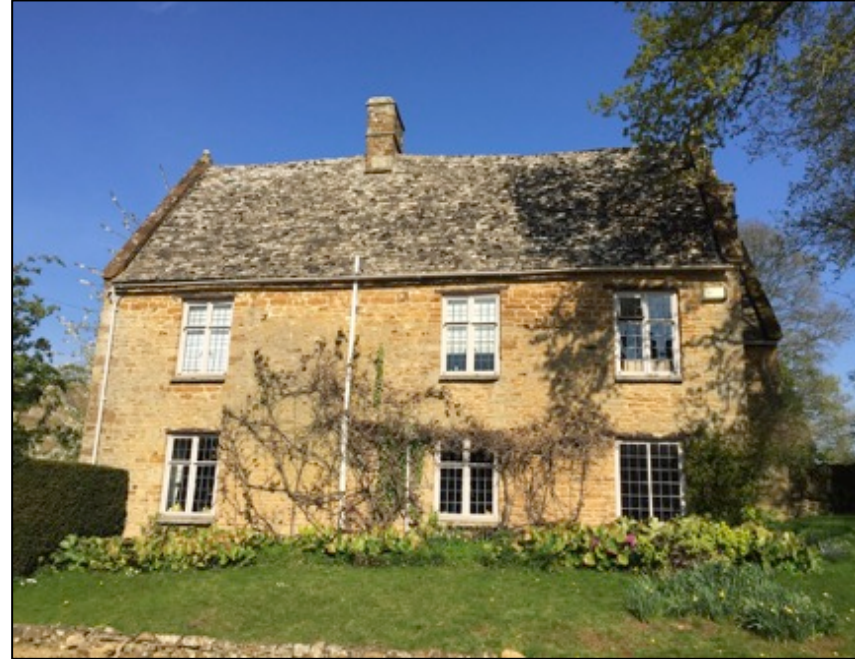
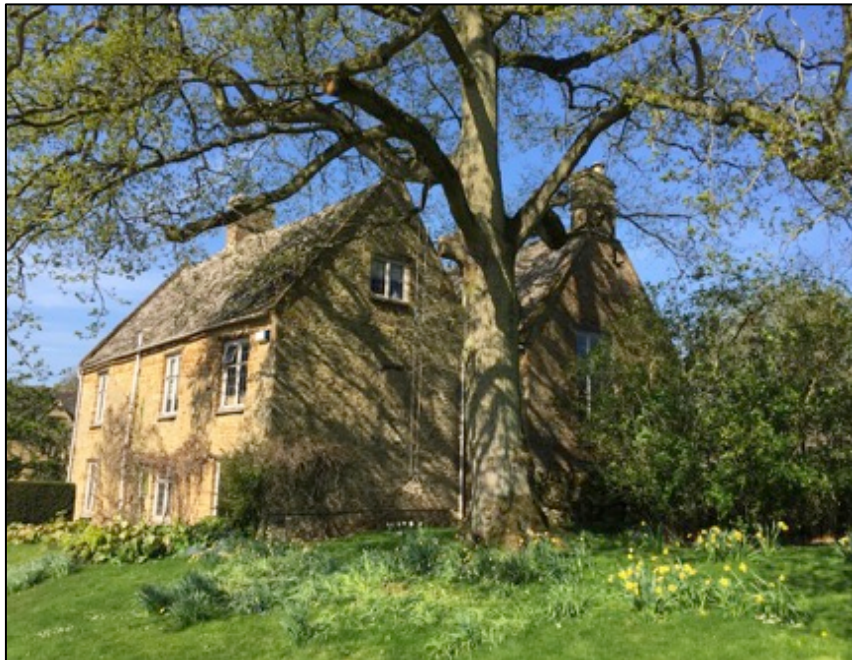
Figure 3: Top left - south corner showing both the east and west ranges.

Top right - southeast façade of the east range.

Below left - northeast gable of the east range, and the northwest gable (behind the tree) of the west range.

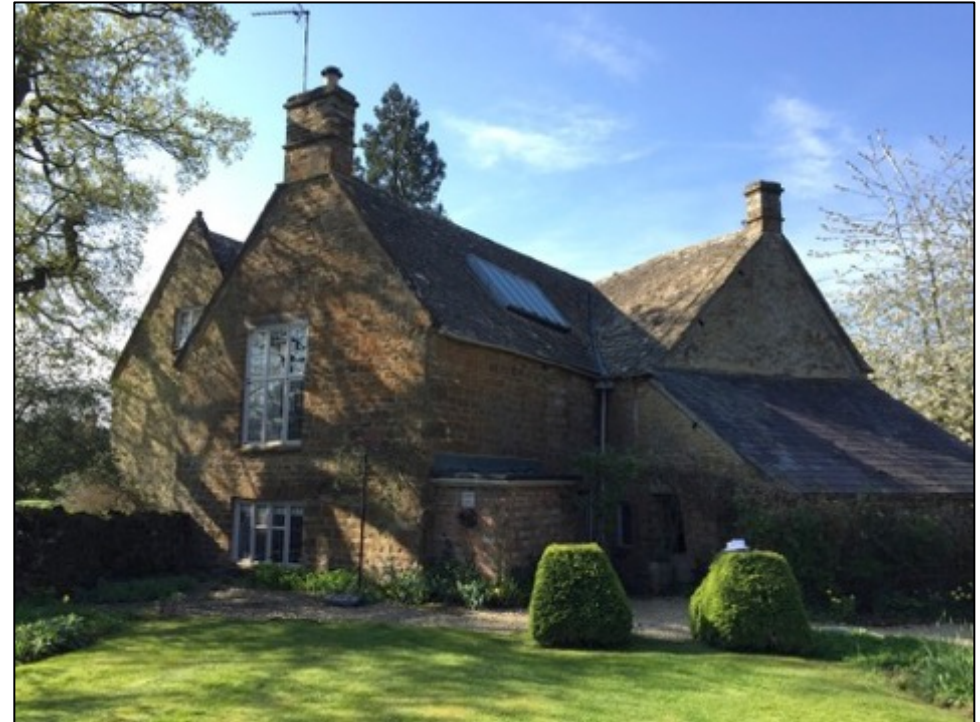
Figure 4: Northwest corner of the west range, garage/lean-to and roof of the northwest range.

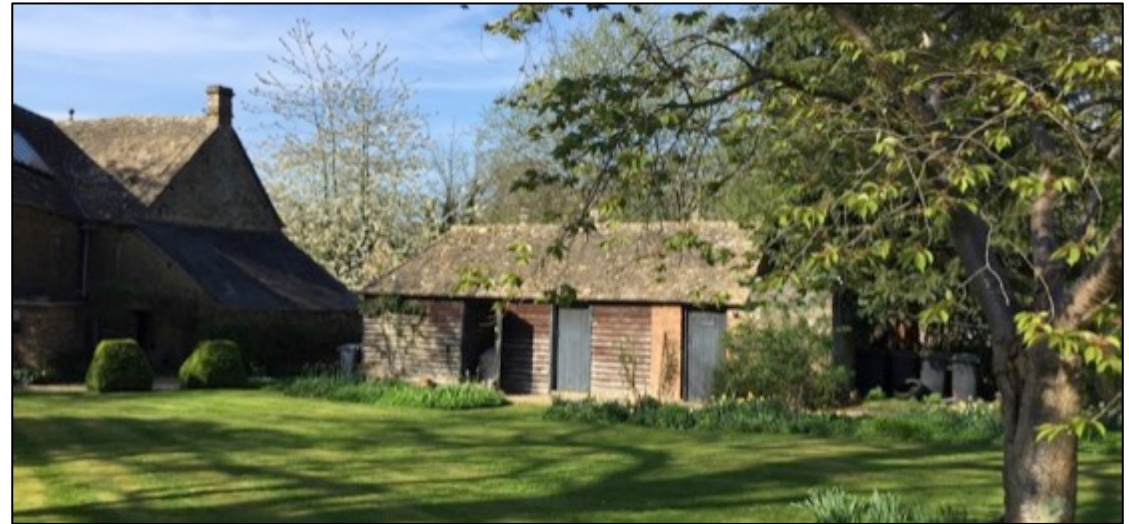
Figure 5: garden side elevation – (northeast) of outbuildings

comprising engineering brick; rendered below. (Figs, 2, 5 and 19). The outbuilding is divided into 4 rooms. The map evidence seems to suggest this structure was constructed sometime between 1919 and 1970 (Figs. 9 & 10).

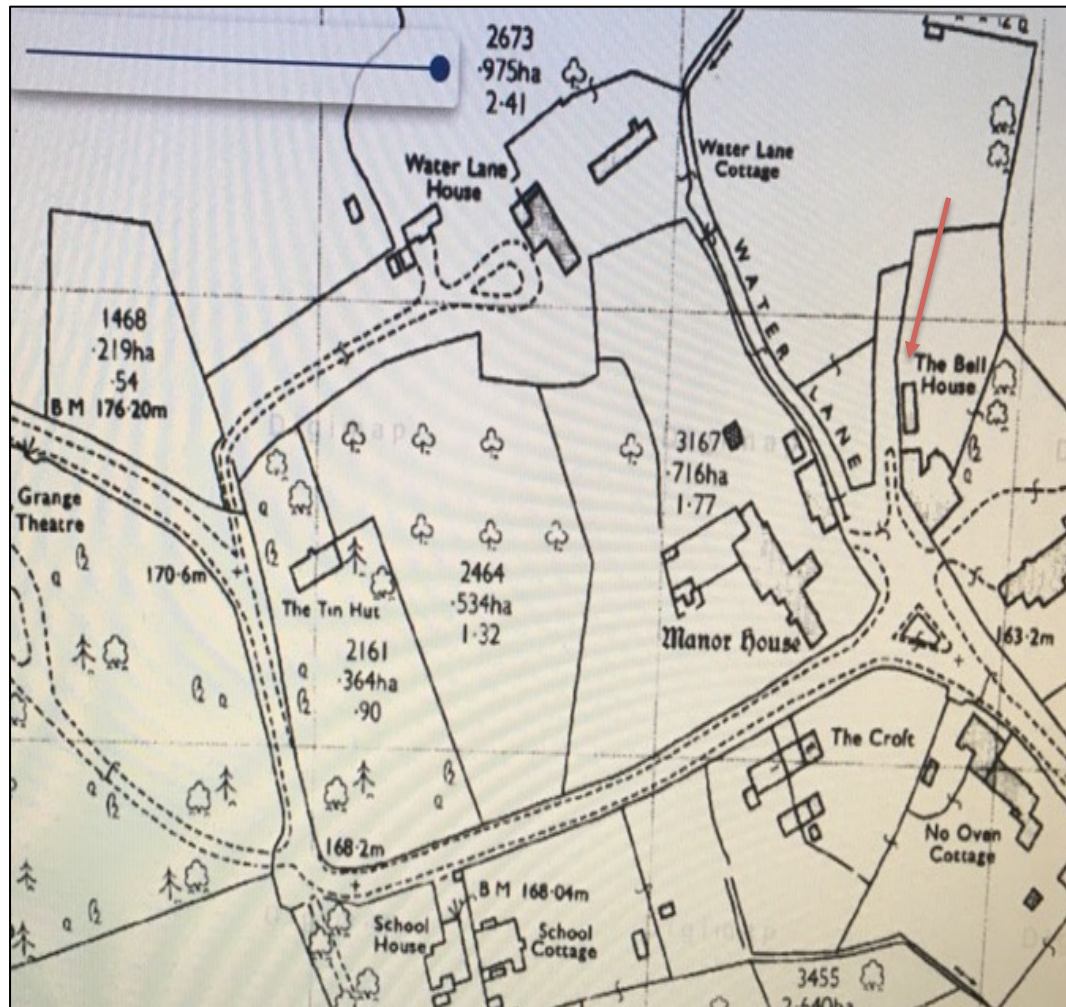
Figure 10: Historic map c1970, kindly supplied by Tyack Architects. The outbuilding is shown as it exists today, detached and positioned away from the boundary wall (red arrow).

By the 1970s, (based on the map evidence), it appears the outbuilding has been rebuilt as a detached structure, away from the boundary wall. Again based on the map evidence, it would appear this change took place sometime between 1919 and the 1970s (**Fig. 10**). The fabric evidence will be discussed later.

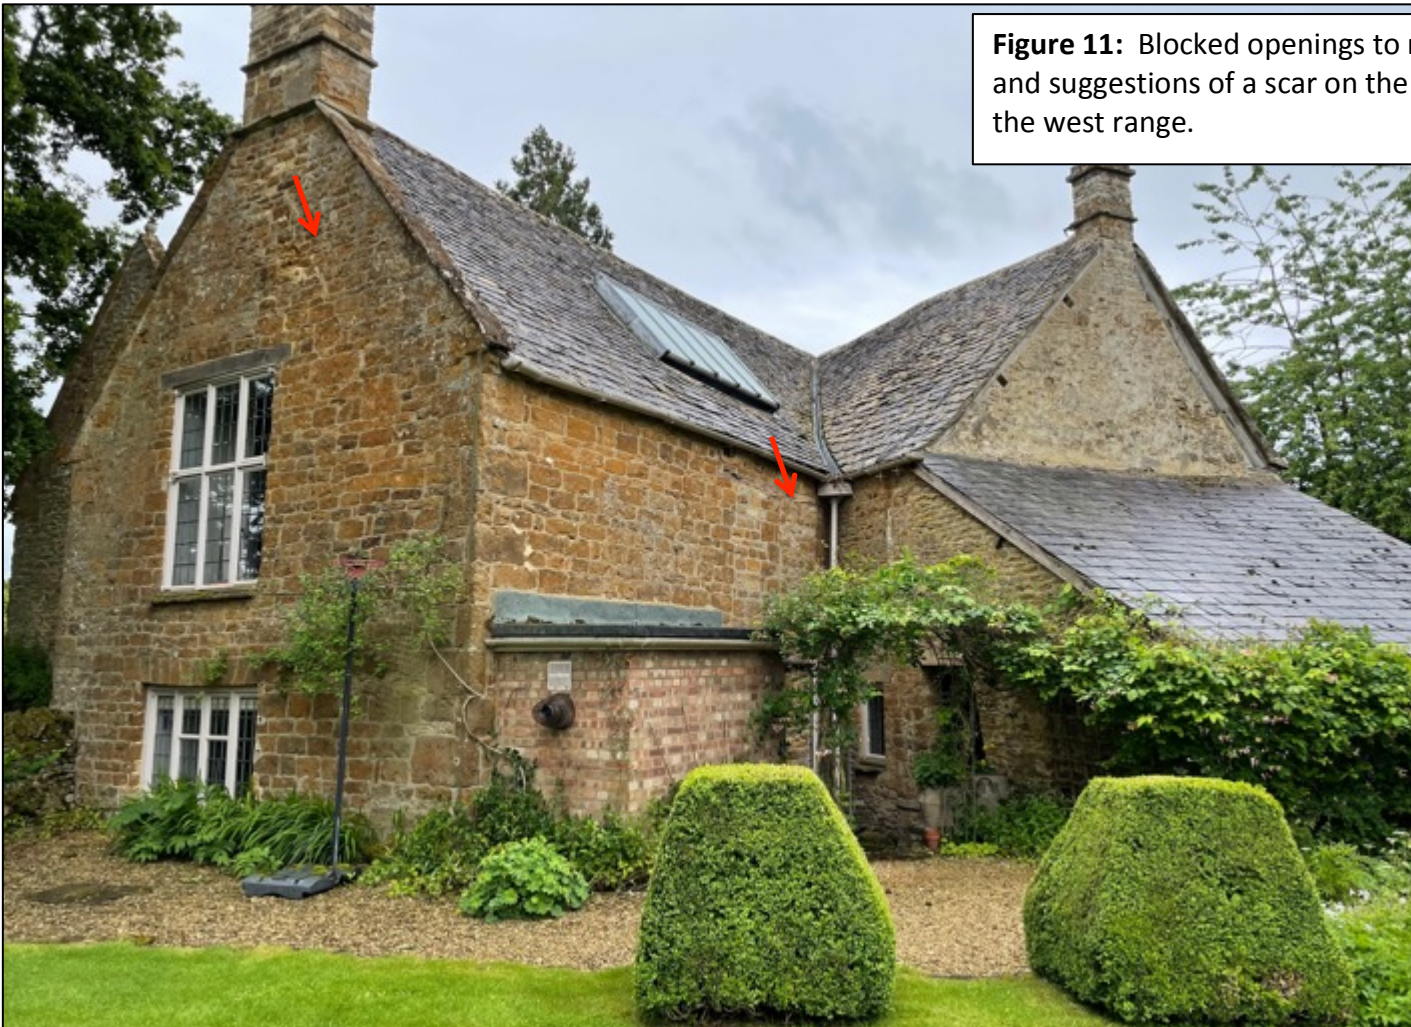
Figure 11: Blocked openings to northwest elevations and suggestions of a scar on the northeast gable of the west range.

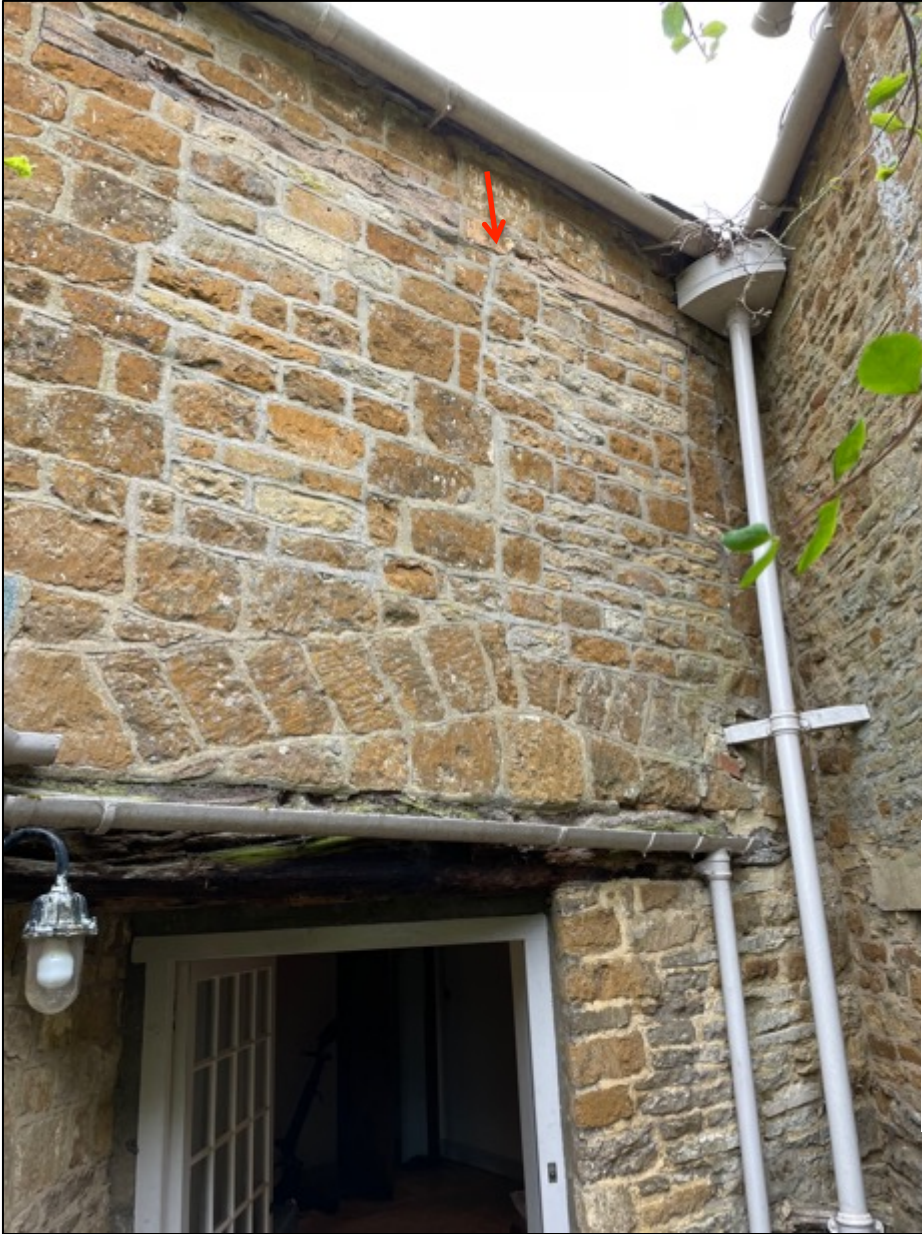
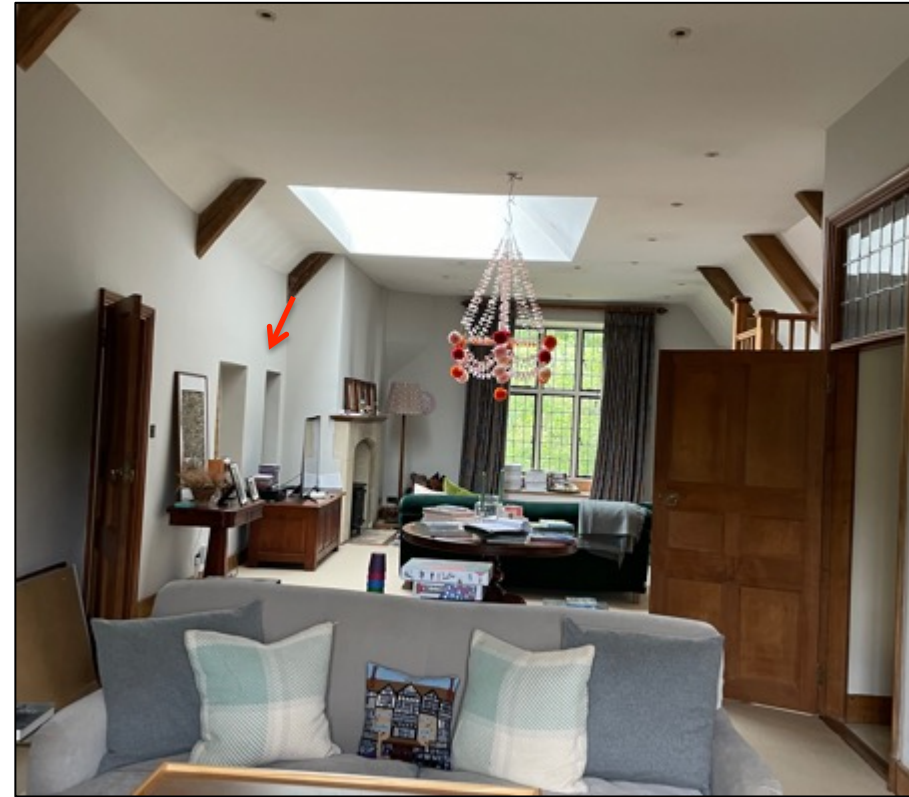
Figure 12: Left, blocked opening of what appears to be possibly a single opening externally, but as two openings internally (right).

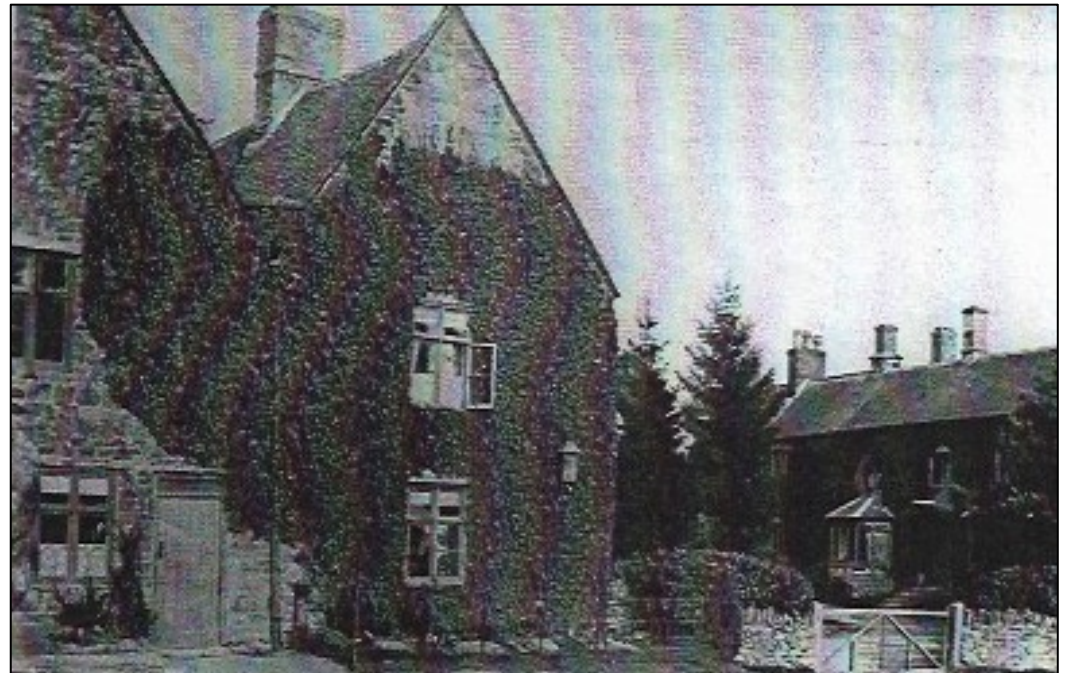
Figure 14: Top – historic photograph, date unknown, presumably pre-1900 before the stairs were inserted into G1 and the front door moved to G1: east range from west range. Right – photograph shows moved door and the window of the former door.

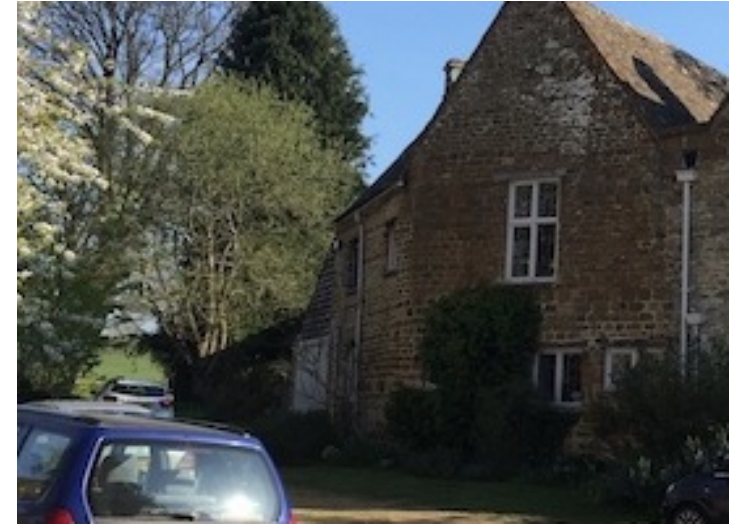
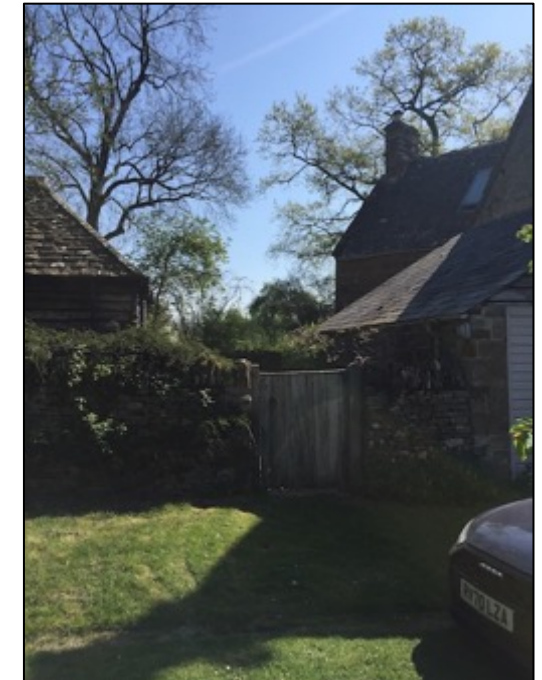
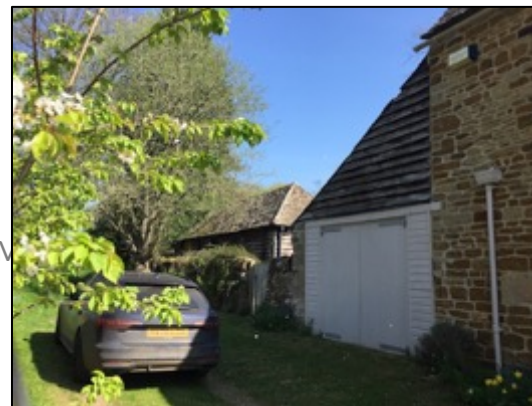
Figure 15: Top – junction between the west and northeast range.

Below right – roof of the garage/lean to.

The northwest range comprises ironstone, randomly coursed, and of random sized stone (**Fig. 15**). There is a single timber casement to the ground floor and two to the first floor. There is a chimney to the northwest gable. The listing description suggests this was a single unit cottage. Presently, access to this range is internal only, however, if this were a cottage there would have been an external entrance. The ground floor window has a straight joint below to the left-hand side, (although not as obvious to the right-hand side), likely the former door. The first floor room (F4) is current used to enter the first-floor hall from the northwest side. If this were primarily a cottage it seems doubtful that this was an entrance into the hall, as this would have been the only bedroom in the cottage. Considering the southeast entrance into the first-floor hall did not exist until post 1900, the suggestion of an external

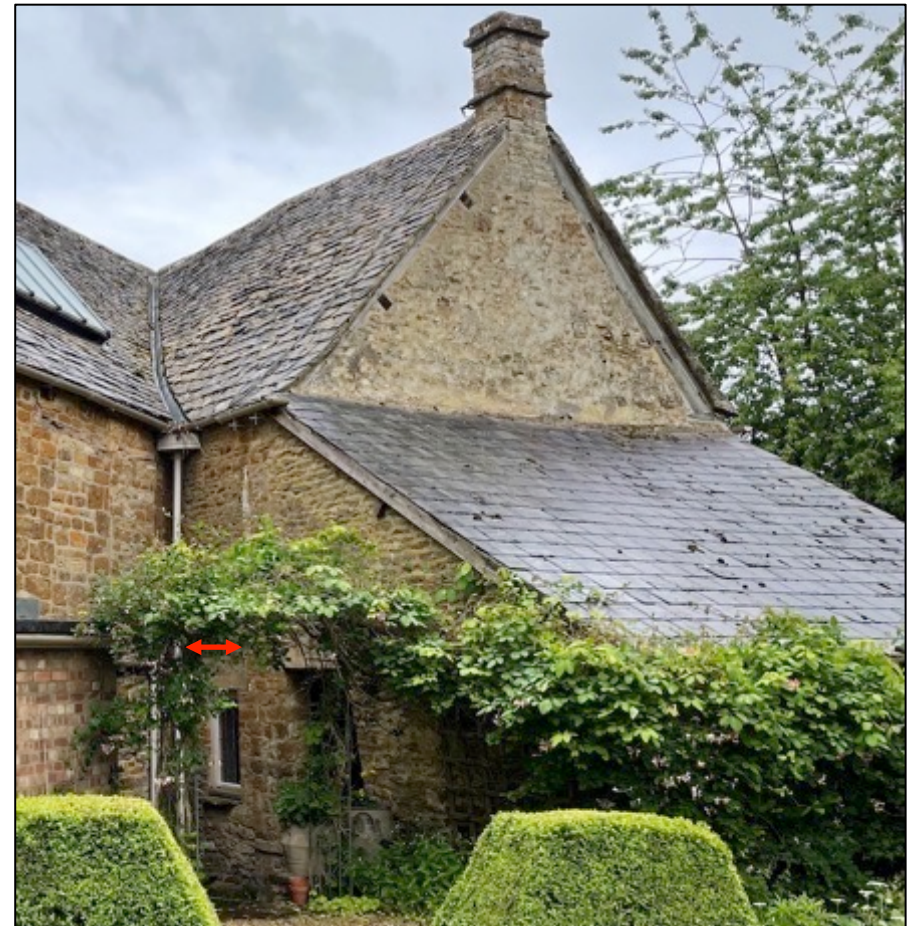
Figure 16: Garage/lean to and northwest range.

The rear of the northwest range comprises a short elevation (**Fig. 16** – red arrow) with a timber casement window to the ground floor under a concrete lintel. The junction joining this range to the main range is awkward; the character of the stone wall (rubble) differs to the character of the main range (coursed and squared ironstone), all of which suggests that the northwest range was built after the west range; likely 19th century. The junction is defined by the two blocked openings (first floor) mentioned on page 12 (**Figs 11 & 12**), and a wide doorway to the ground floor. This door is modern; partially glazed, under

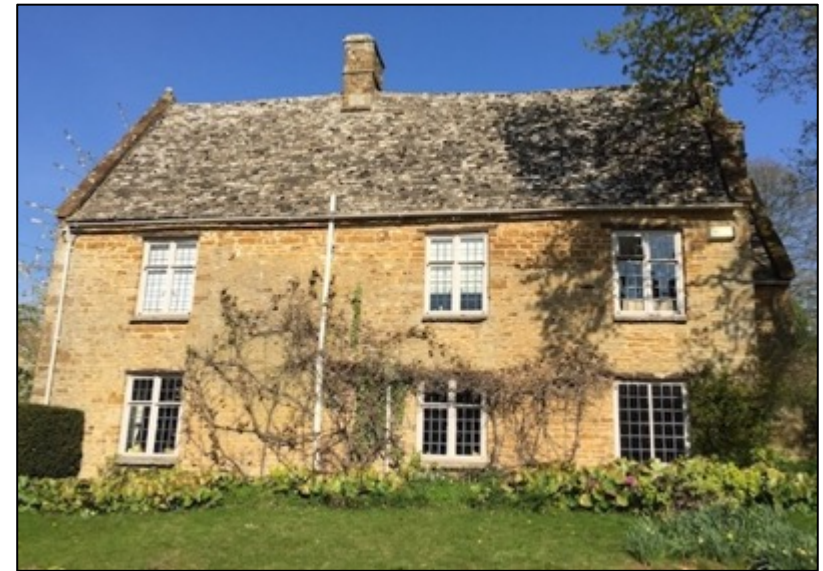
Figure 18: Southeast elevation, east range.

East elevation of west range comprises a short ironstone wall where the west range juts proud of the east range, with a 2-light leaded casement to the ground floor under stone voussoirs. Single timber casement to first floor; under the eaves.

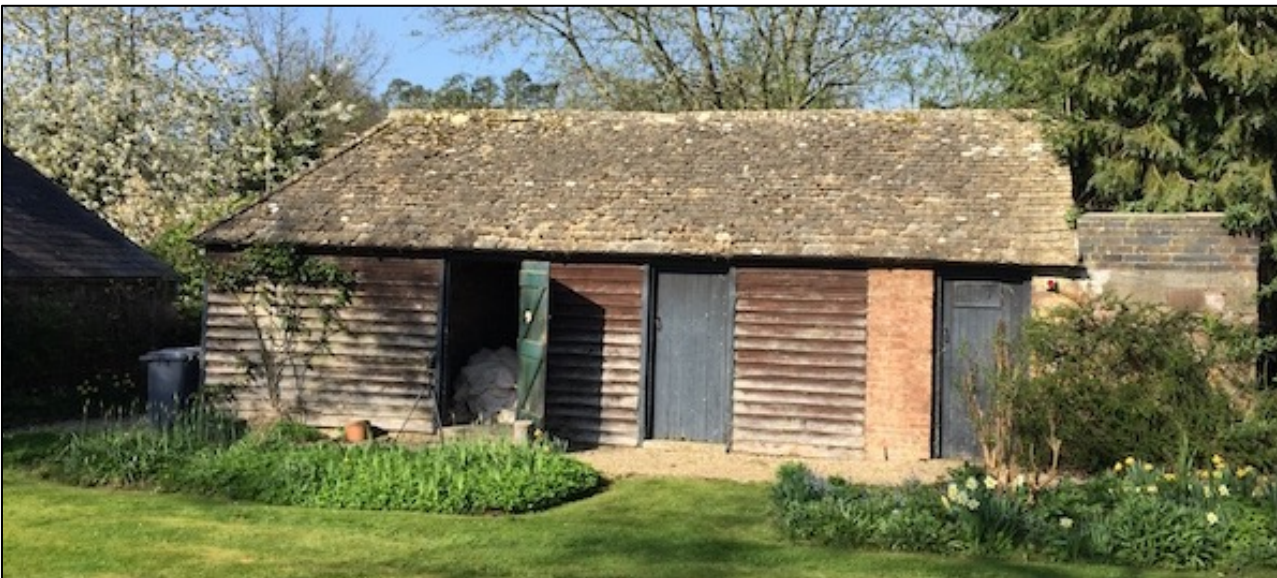
Figure 19: northeast elevation of the outbuilding

This outbuilding comprises brick plinth base with horizontal boarding walls to the majority of the building and brick walls to the far north. Single storey, set away from the boundary wall with Water Lane, with three doorways from the garden and a door from the back into a WC. Hipped roof to the south and gabled to the north covered in stone slate. The northern end has a flat roof and a parapet wall to the northeast side

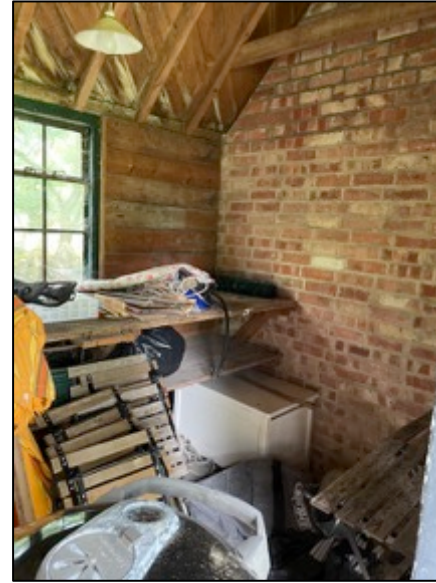
Figure 24: Room 3.

Room 3: The larger of the rooms; southwest corner sectioned off (in brick) for WC, entered from the rear elevation. 2-light metal-framed window comprising 6 panes, with opening left sash and top hung right sash in rear elevation, concrete floor. East and west walls horizontal boards and north wall brick to apex. Plank and braced door with small sliding vent-door (externally) (Fig. 24).

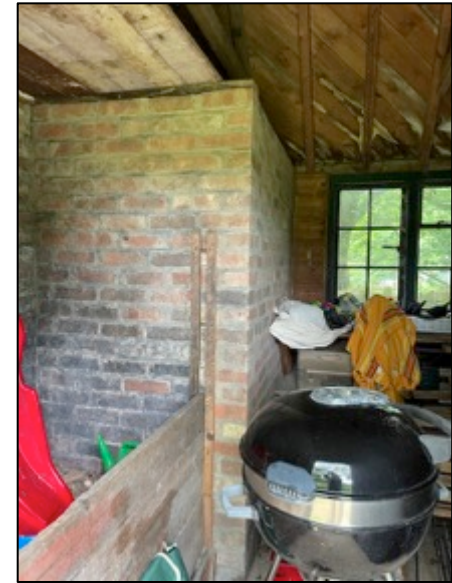
Internally the roof construction is continuous across all of the rooms comprising, (what appears to be), soft wood boarding, with machine cut rafters and machine cut collars - attached to the rafters (Fig 25).

Figure 25: Left – Room 4.
Right – roof construction.

Room 4: South, west and east walls comprise brick; north wall again comprises brick to eaves level and continues to ridge in a paler brick. Concrete floor. Metal frame window to rear in a timber frame, 6 panes, and top hung opening sash (Fig. 25).

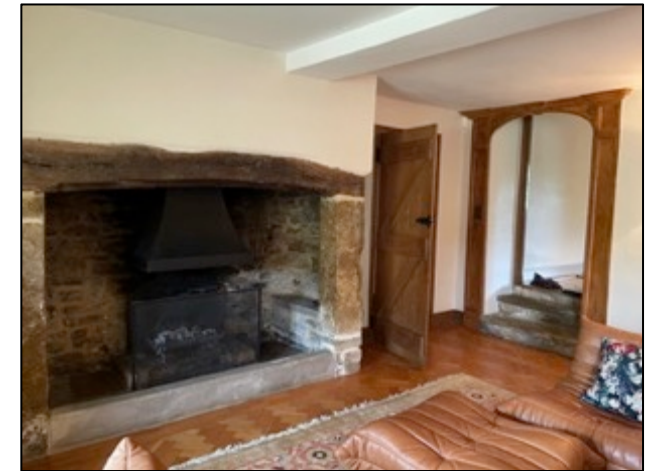
Figure 29: G2 – Inglenook fireplace, and doorways into G1 and G4

G2 (east range): Two windows to the southeast elevation of different characters: one – timber framed cross-mullioned window with leaded lights, and the other – 2-light metal casement with leaded lights; both windows have seats. No obvious signs of early glass in either. Parquet floor and modern skirting boards. Boxed spine beam. Inglenook fireplace with replacement stone seat to the right hand side. Stone jambs with internal chamfers, substantial bressummer with smoke splay and chamfer with lambs tongue stops. Modern hearth and edging. Deep void to the left of the fireplace; curved recess – perhaps the remnants of the winder stair (?). Doorway into G1; door and architrave modern. Doorway into G4 listed as ‘*a late C17/early C18 doorcase with pilasters and segmental arch*’.

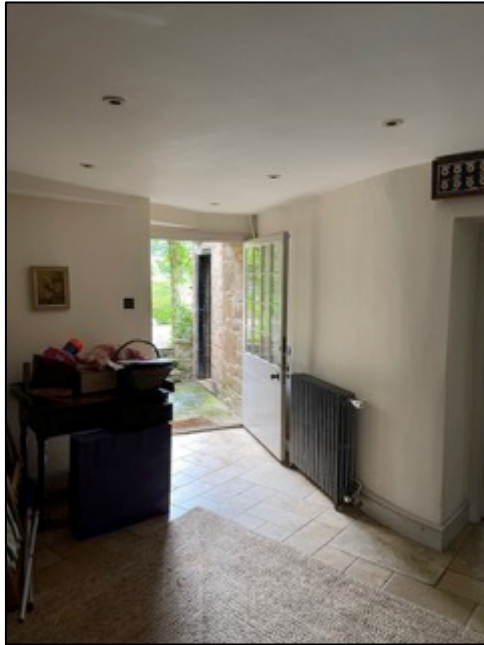
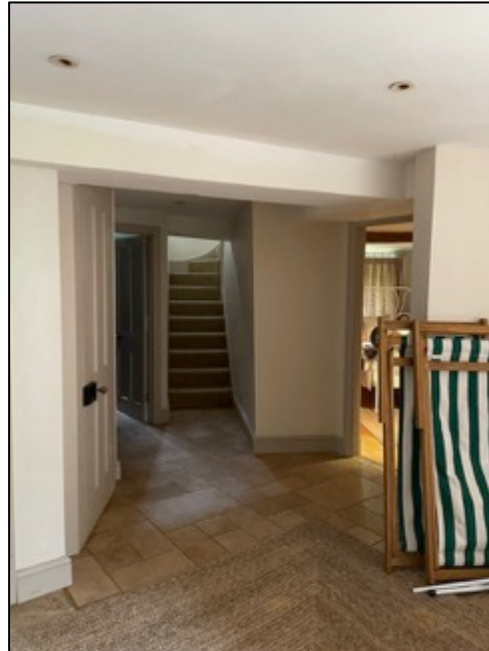
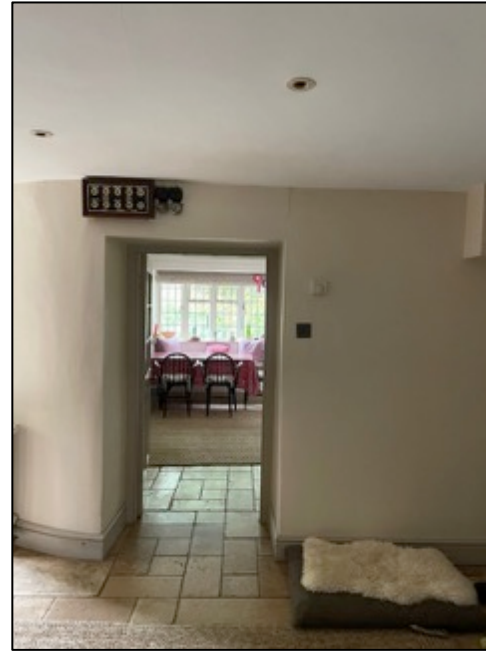
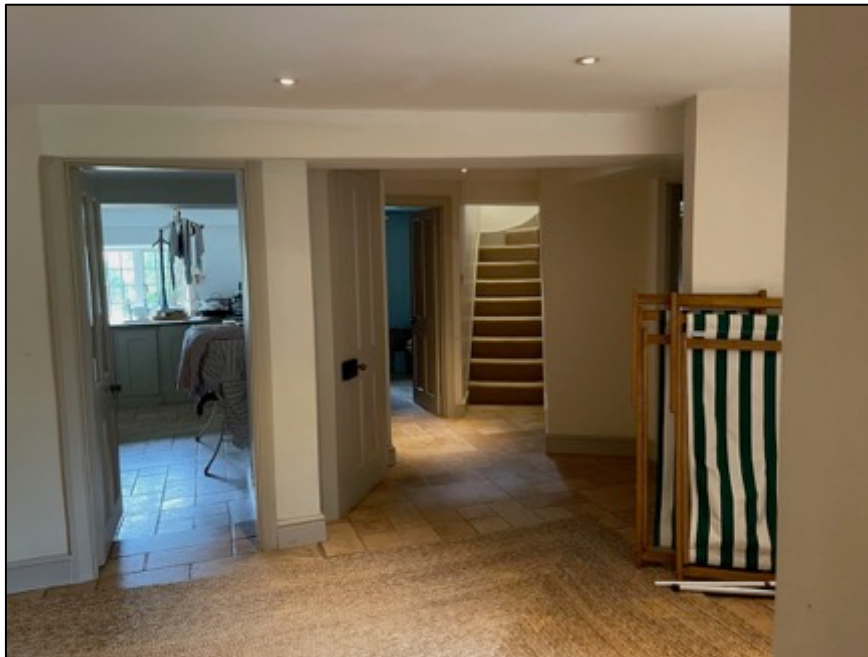
Figure 30:

Left – view towards G3, Stair 2, WC and G6.

Right – WC and Stair 2.

G3 (west range): Based on the historic photographic evidence, it appears the main entrance was adjacent to G3. The documentary evidence suggests this doorway lead into a passage that continued to the rear of the house. c1900 the doorway was converted into a window and the passage was converted into a flight of stairs (stair 1). There is currently a cupboard built underneath stair 1, accessed from G3. There is a boxed transverse beam. All visible fabric is modern, the cupboard walls, and the wall between G3 and G4 appears to be stud partitions (hollow when knocked). Spanning the wall between G3 and G4, and continuously towards G6, there is (what appears to be) a long steel or structural support suggesting primary walls have been removed in this area, around G4. This is conjecture without firm evidence, but there is an awful lot of studwork and boxing-in and an unusual arrangement to the ceiling and door-heads (**Fig.30**).

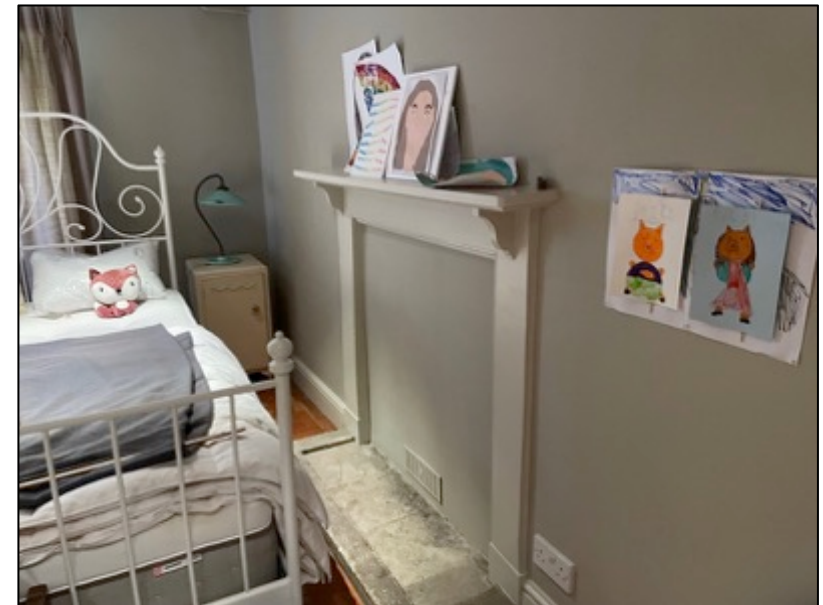
Figure 31: Fireplace on room G6.

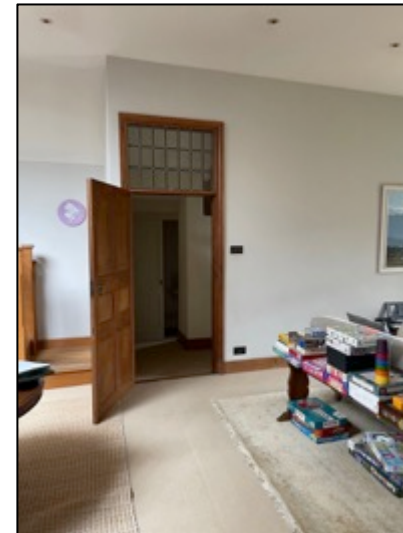
Figure 33: Top left – door at the top of stair 1 c1900, into F3. Top right – double door arrange; rooms F3 and F4. Below – cupboards in F3

There are cupboards to the northwest; presumably making good use of the void provided by the angle in which the northwest range meets the west range. These comprise a floor to ceiling cupboard separated into two cupboards with panelled doors and matching architrave. The same detail can be found on the adjacent smaller cupboard (**Fig.33**).

F4 (northwest range): This room almost provides a thoroughfare between the ground floor and room F3 (hall). As mentioned above, there is are 2-sets of doors between this and F3 (**Fig. 33**) where the doorframe and skirting board details are repeated from F3. There is a floor-to-ceiling cupboard against the short northeast wall, similar in character to those found in F3. There is a 2-light leaded mullioned window in northwest elevation.

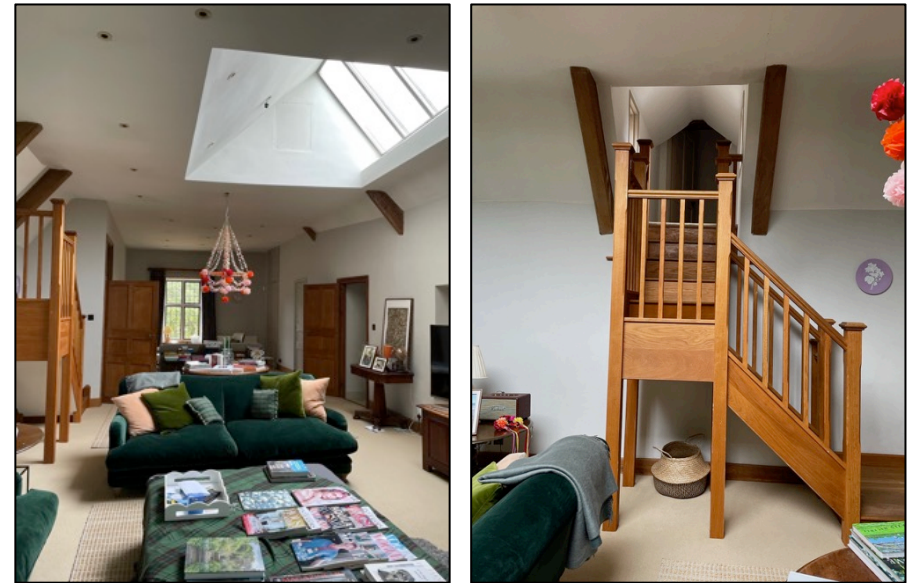
Figure 34: Left – room F3. Right stairs to the east range.

After the pub closed the property was owned by the Taylor family (carpenters by trade). There is a 42-foot room on the first floor (F3) of the west range (**Figs. 12, 33 & 34**) that was used as a workshop and referred to as the 'top room'. This is said to have been accessed via an external staircase. It is reported that there was an 'alley way' from the front door to a deep-well⁷. Any fabric evidence of the 'alley way' or passage way from the former front door (G3) has long since disappeared. This would have been situated where Stair 1 now exists, and likely to have continued through G3 into G4. There is some debate as to
