CDC SKEGNESS

GEO-ENVIRONMENTAL APPRASIAL

UNITED LINCOLNSHIRE HOSPITALS NHS
TRUST

NOVEMBER 2023

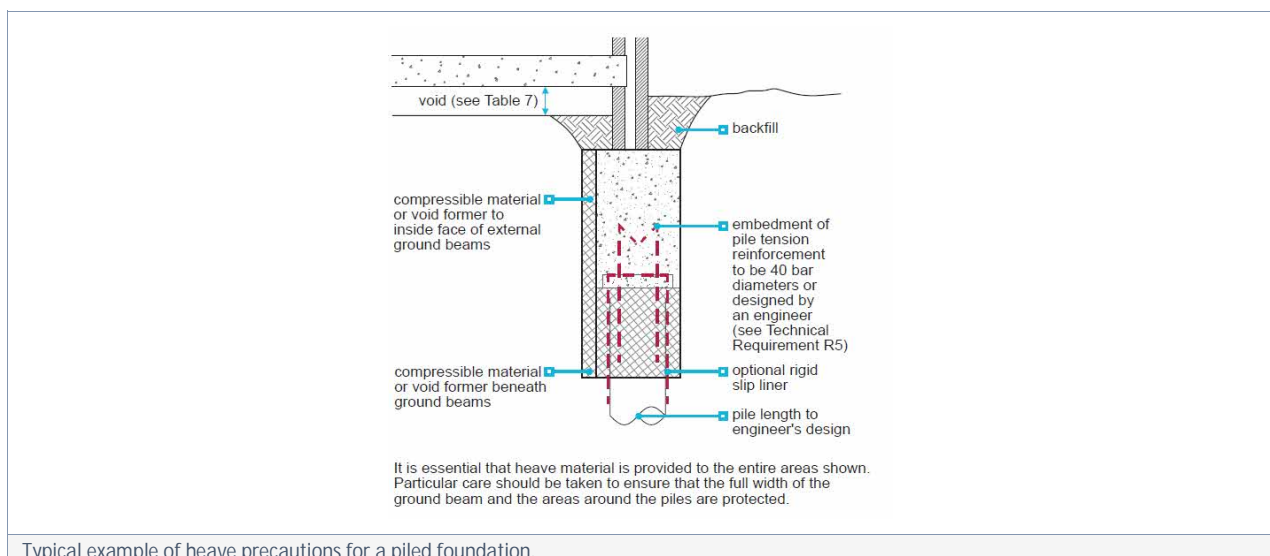
A typical example of heave precautions for piled foundations has been taken from appropriate guidance is displayed below:

Typical example of heave precautions for a piled foundation.

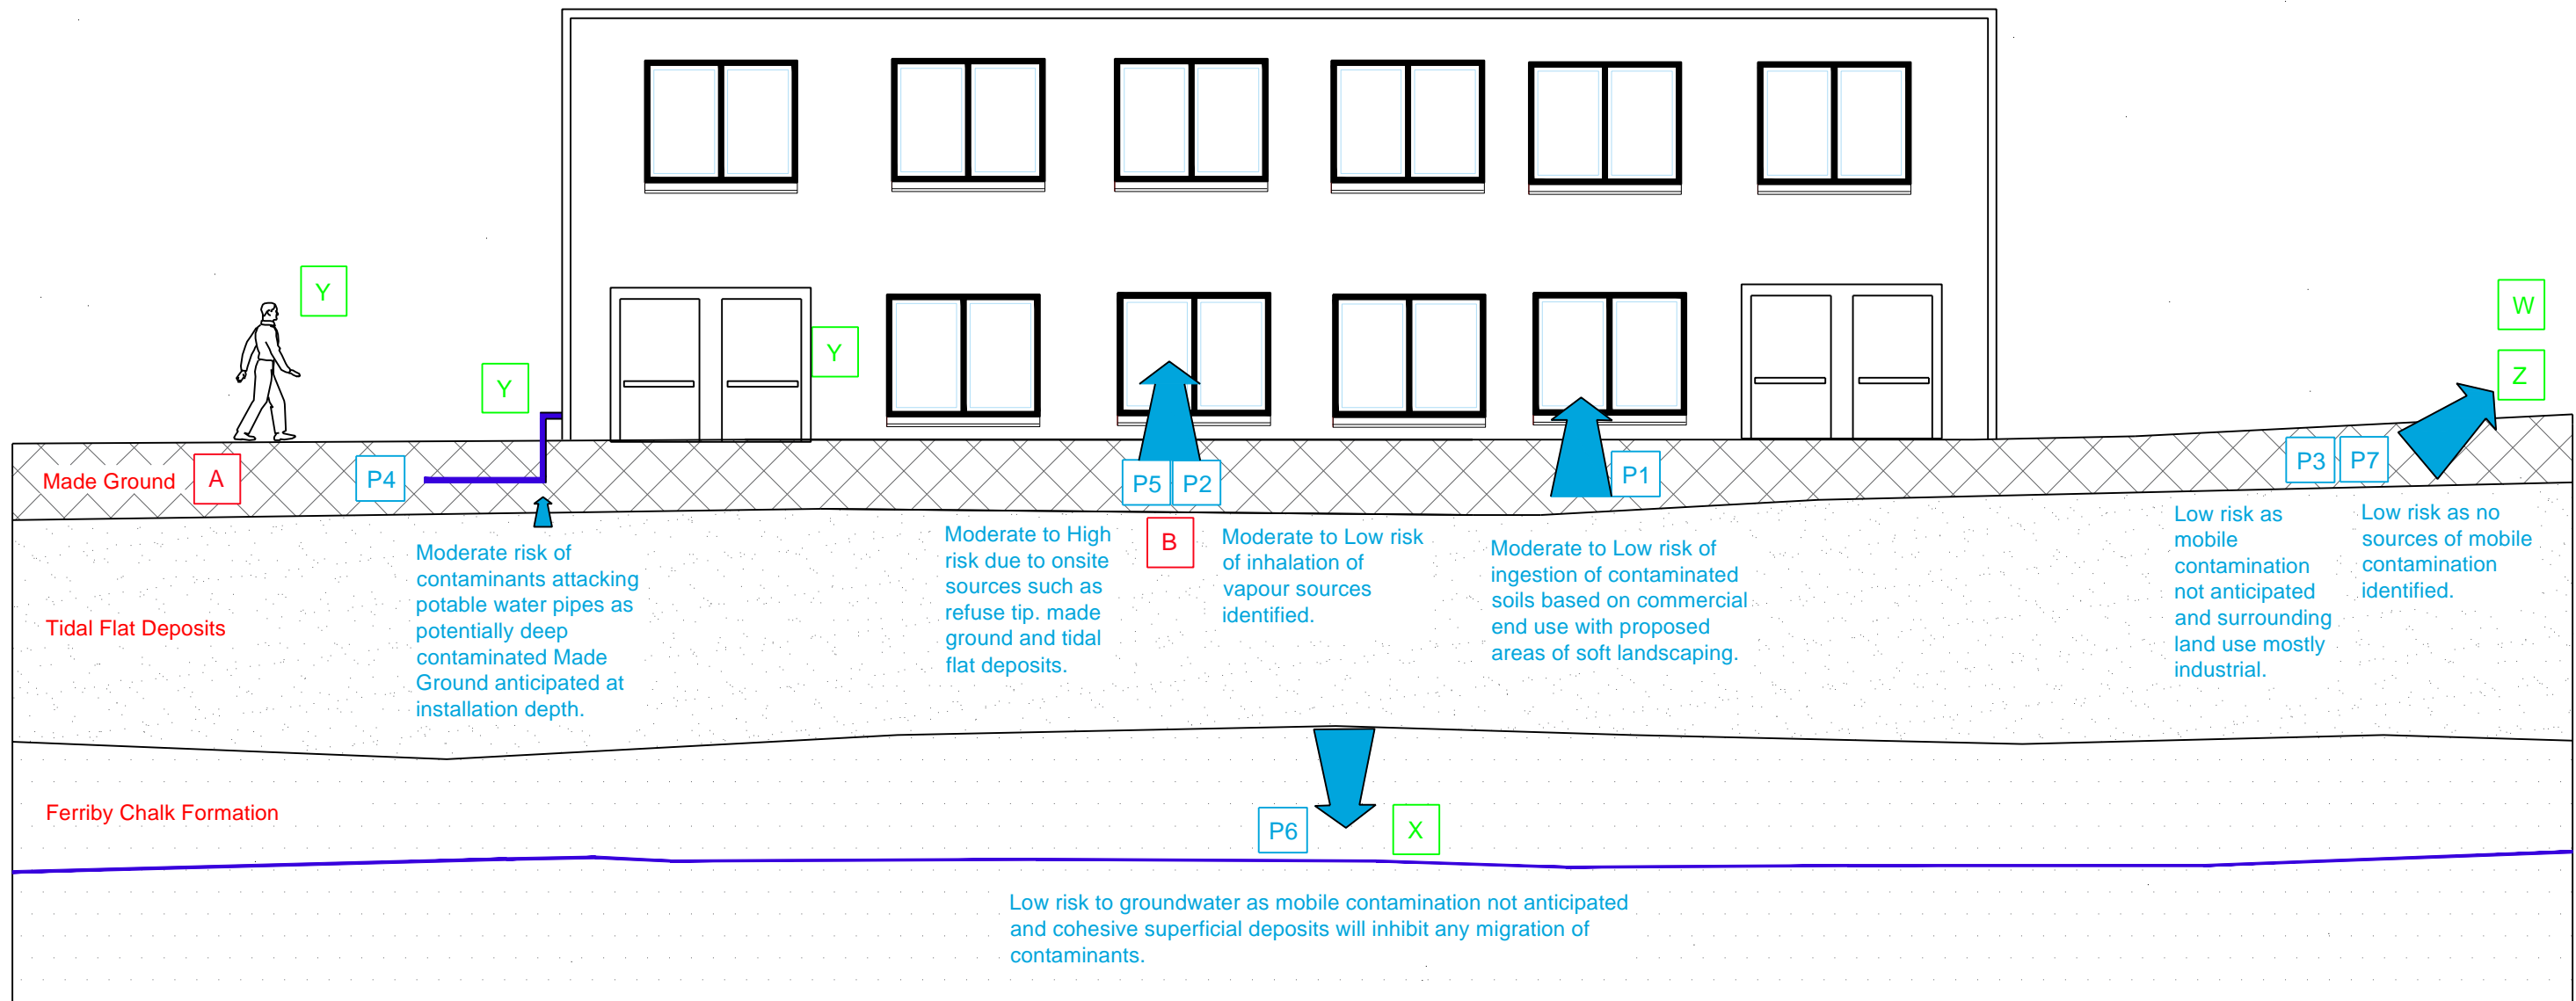
CLIENT UNITED LINCOLNSHIRE HOSPITALS NHS TRUST	DATE SEPTEMBER 2023			Status Preliminary Draft Issued ● For Comment Approved	Notes
	PROJECT TITLE CDC SKEGNESS	SCALE NTS				
	PLAN TITLE ILLUSTRATIVE PRELIMINARY CSM	PLAN NUMBER GRO-23133-P03	Rev. Details Date

SOURCES
A. Contaminated soils / Made Ground. B. Ground gas.

POLLUTION LINKAGES
P1. Ingestion of soil and dust. P2. Inhalation of vapour. P3. Inhalation of soil dust by adjacent site users. P4. Attacking of potable water supply pipe. P5. Migration and accumulation of ground gas in internal places. P6. Impaction of groundwater from soil contamination. P7. Migration of soil and groundwater contamination impacting surface waters.

RECEPTORS
W. Main Drain River X. Groundwater within the Principal bedrock Aquifer. Y. Site end users. Z. Adjacent site users.

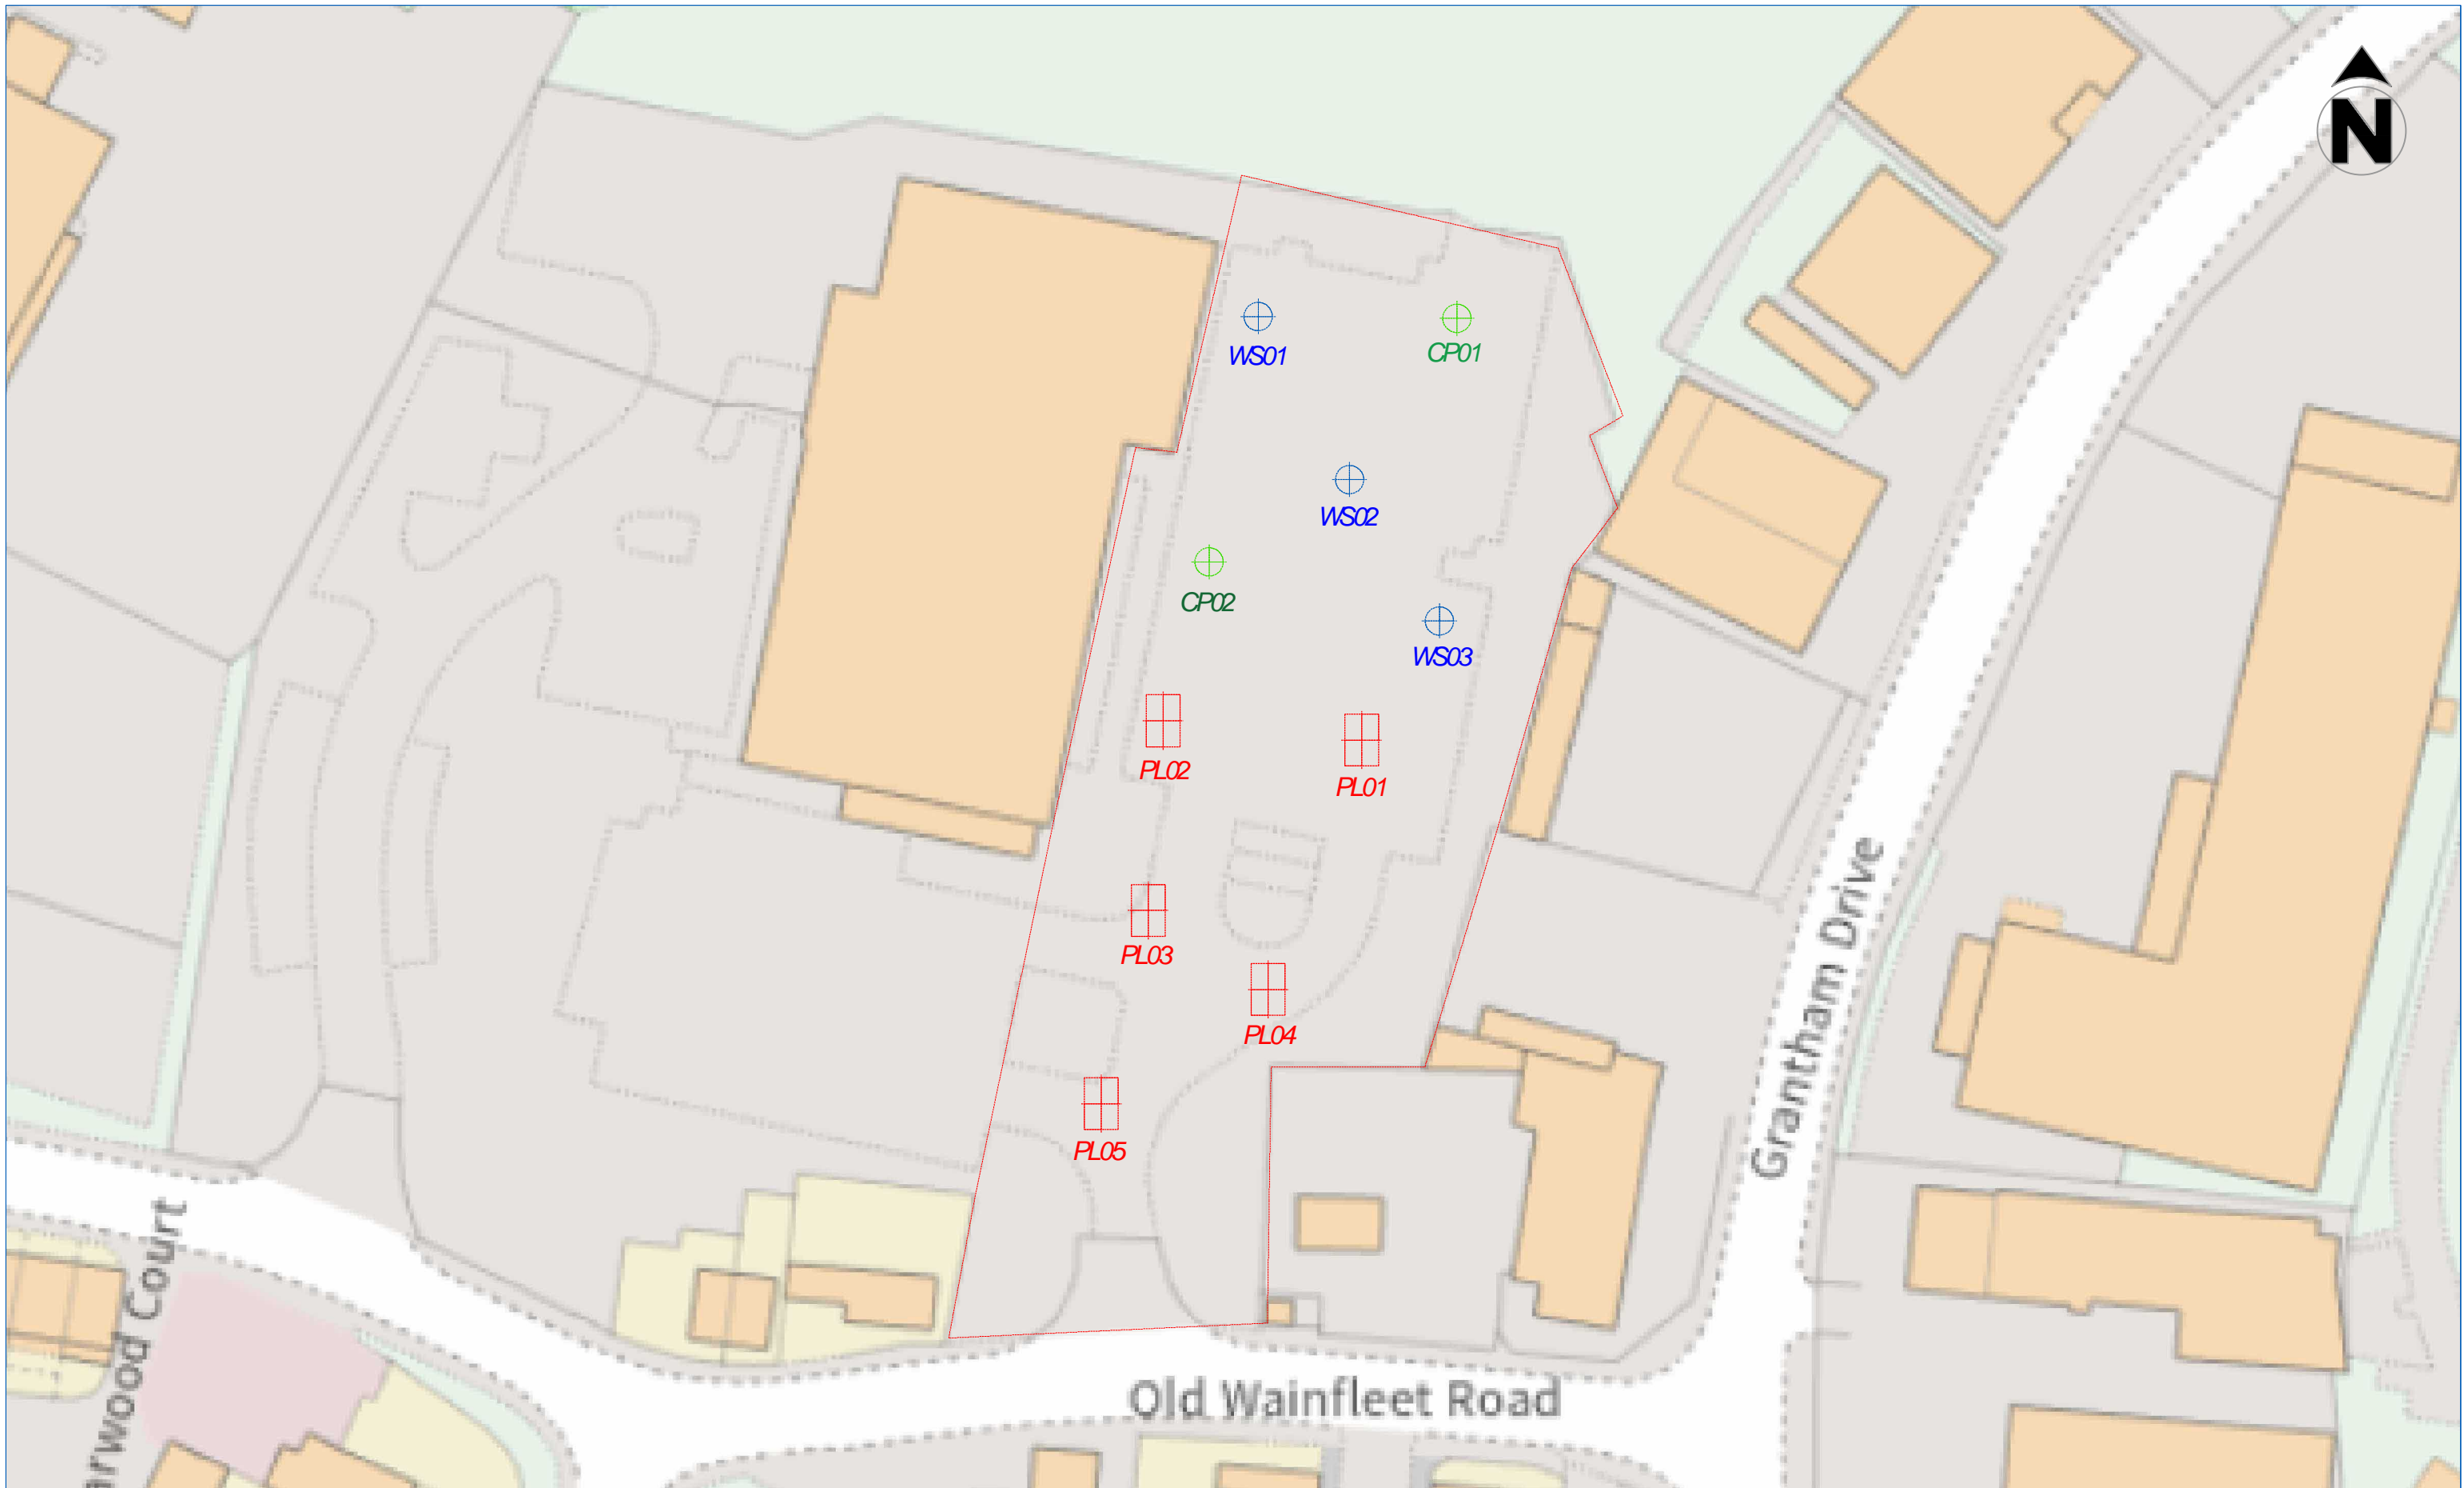
DATE	SEPTEMBER 2023
SCALE	NTS
PLAN NUMBER	GRO-23133-P04

CLIENT	UNITED LINCOLNSHIRE HOSPITALS NHS TRUST
PROJECT TITLE	CDC SKEGNESS
PLAN TITLE	PROPOSED EXPLORATORY HOLES PLAN

Notes	
	Site Location
	Windowless sample borehole location
	Cable percussion borehole location
	Plate load test location

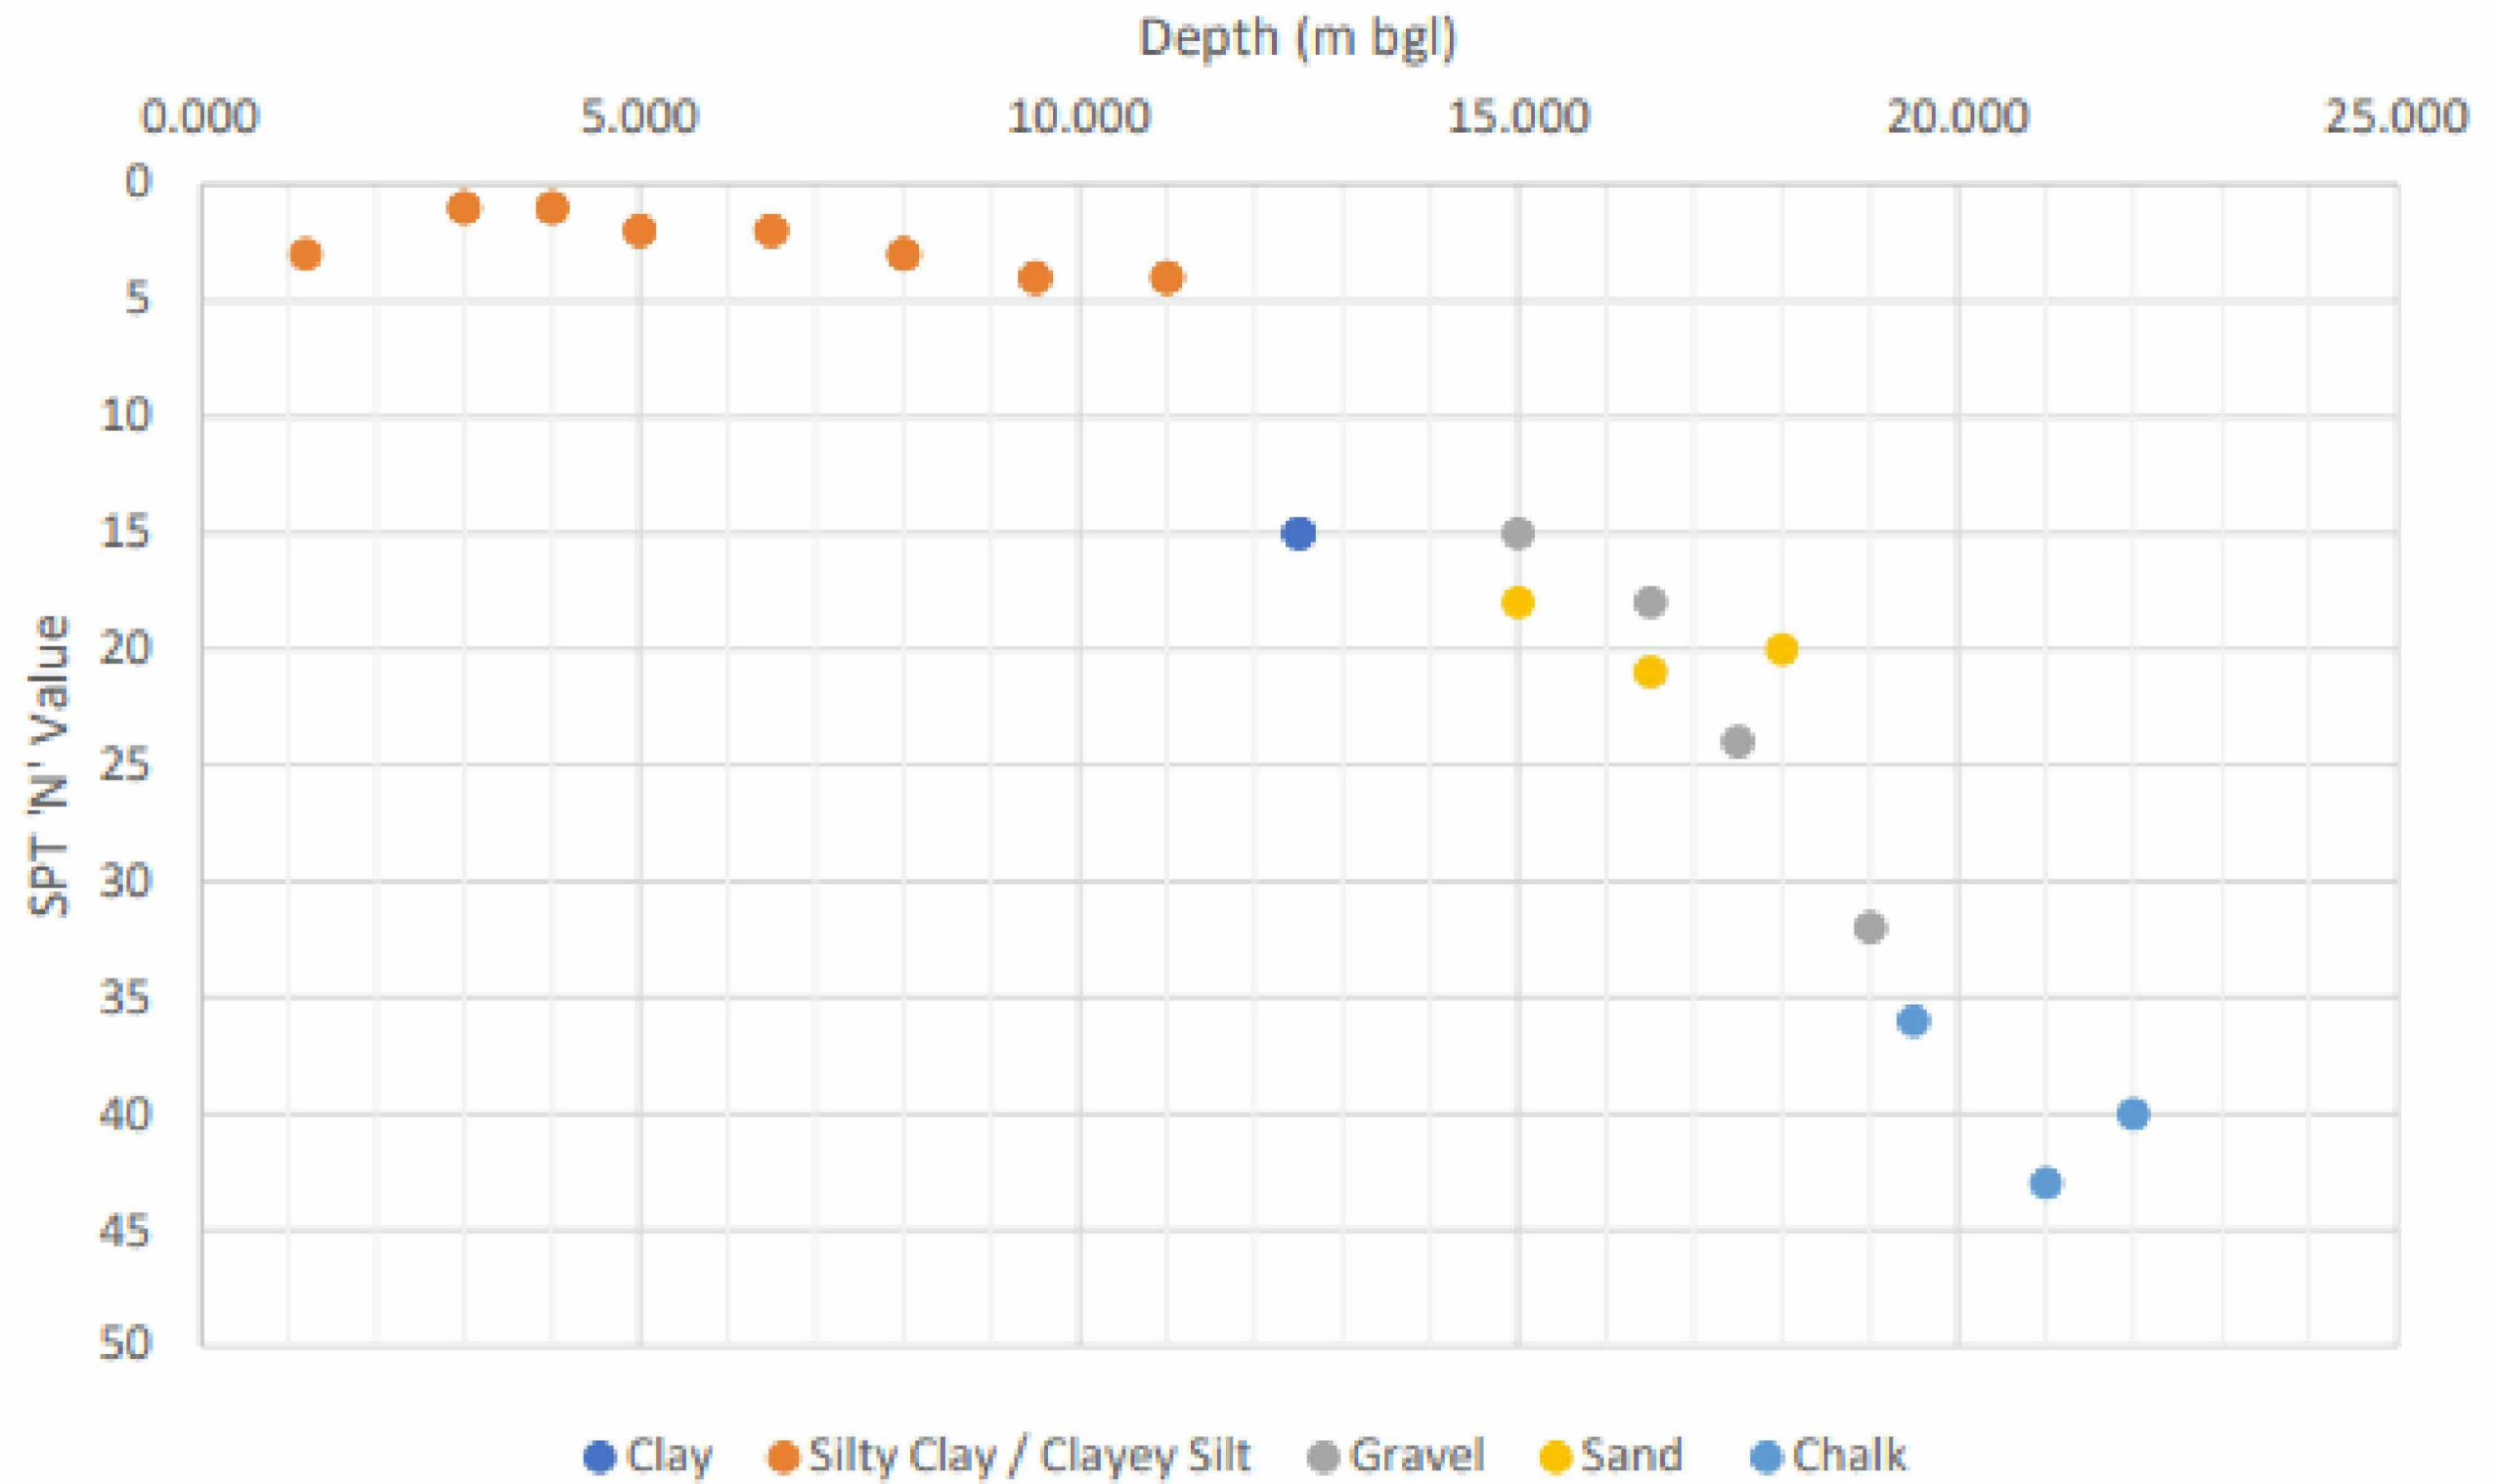
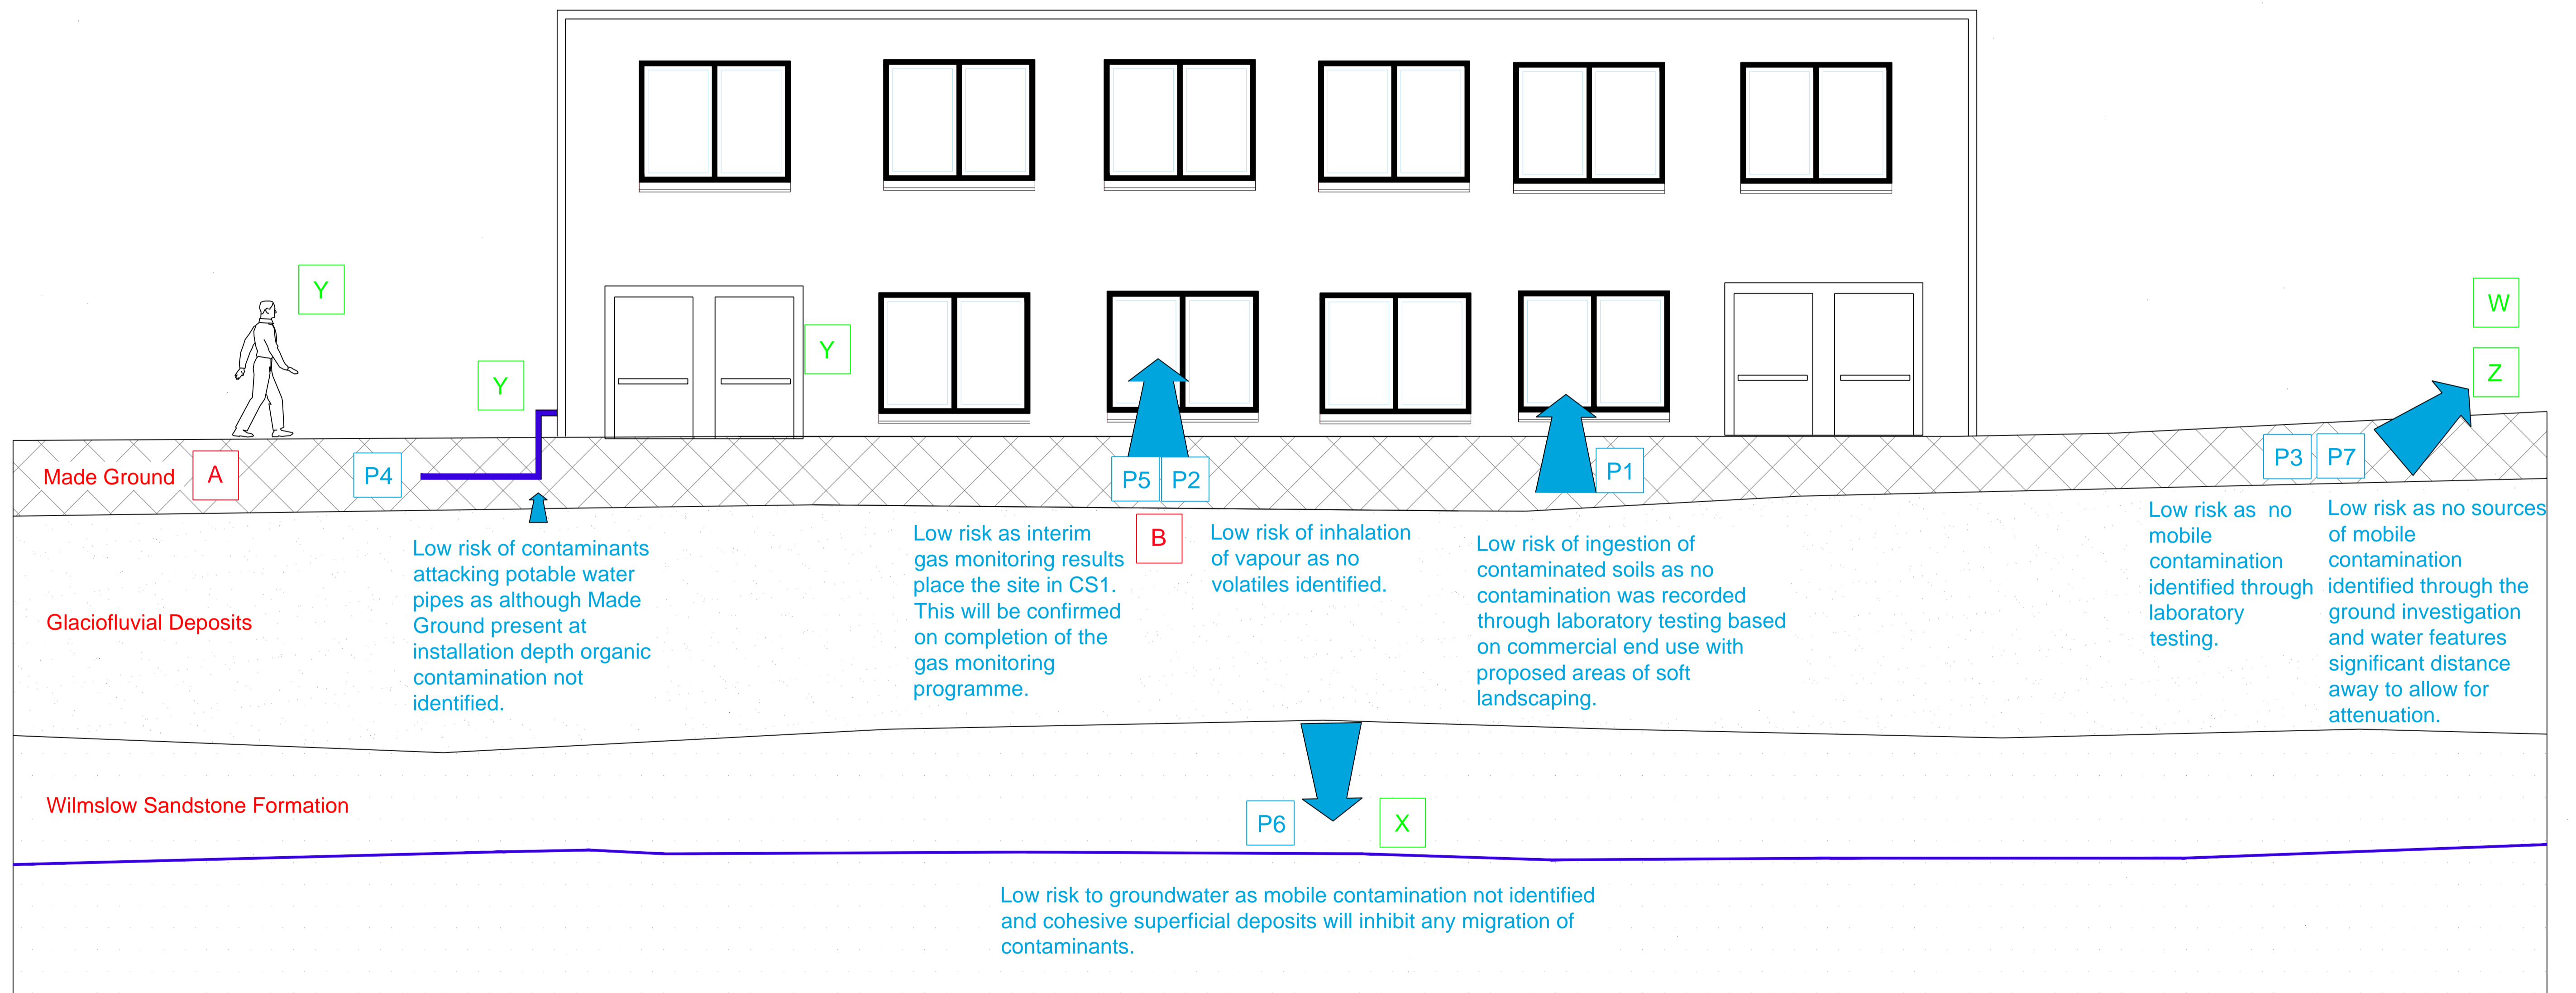
CLIENT CCS CONSULTING	DATE OCTOBER 2023			Status Preliminary	Notes
	PROJECT TITLE CDC SKEGNESS	SCALE NTS			Draft	
	PLAN TITLE ILLUSTRATIVE REVISED CSM	PLAN NUMBER GRO-23133-P06			Issued ●	
			Rev. Details	Date	For Comment Approved

W. Main Drain River
 X. Groundwater within the Principal bedrock Aquifer.
 Y. Site end users.
 Z. Adjacent site users.

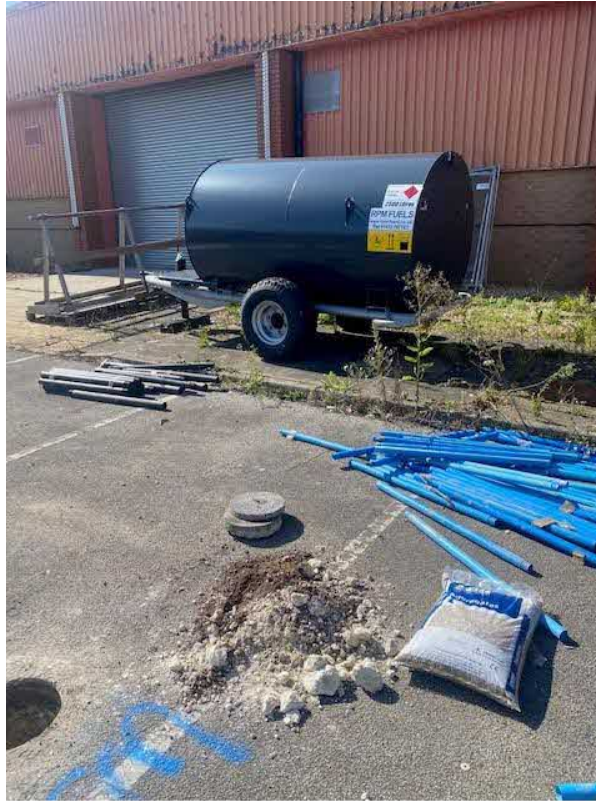
Photograph 1 – AST on western site boundary.

The current presence of a fuel tank on site could cause hydrocarbon contamination to the site.

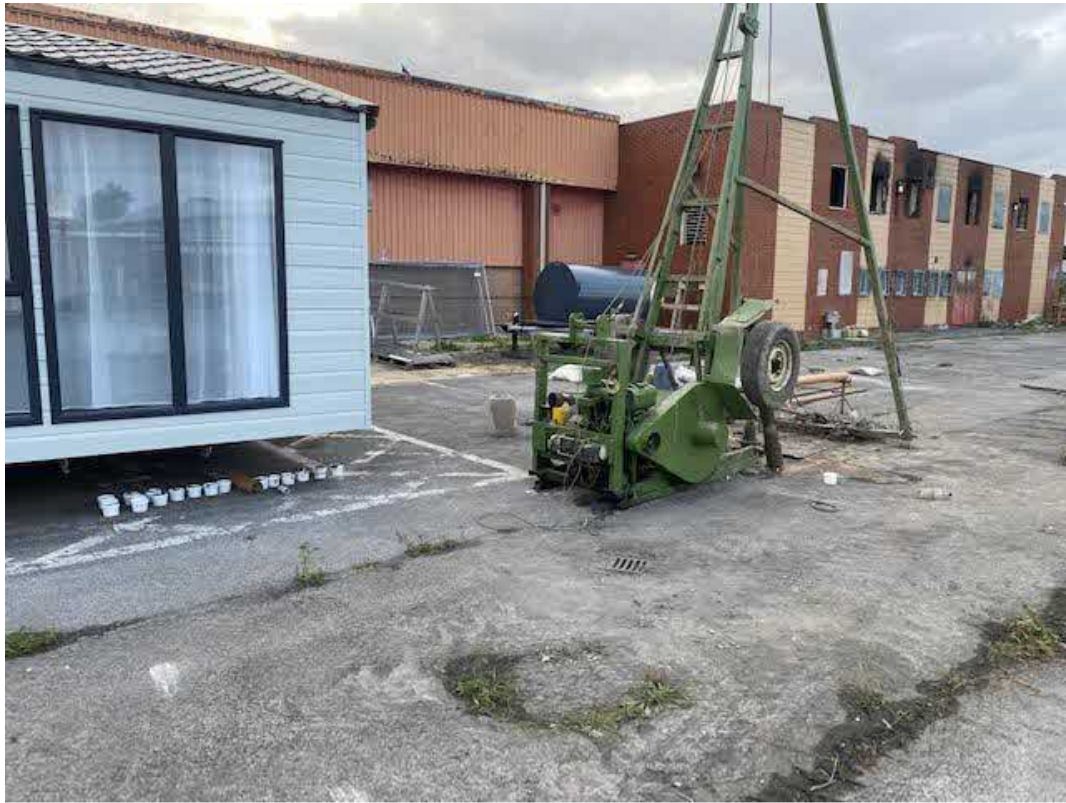
Photograph 3 – CP02 Location.

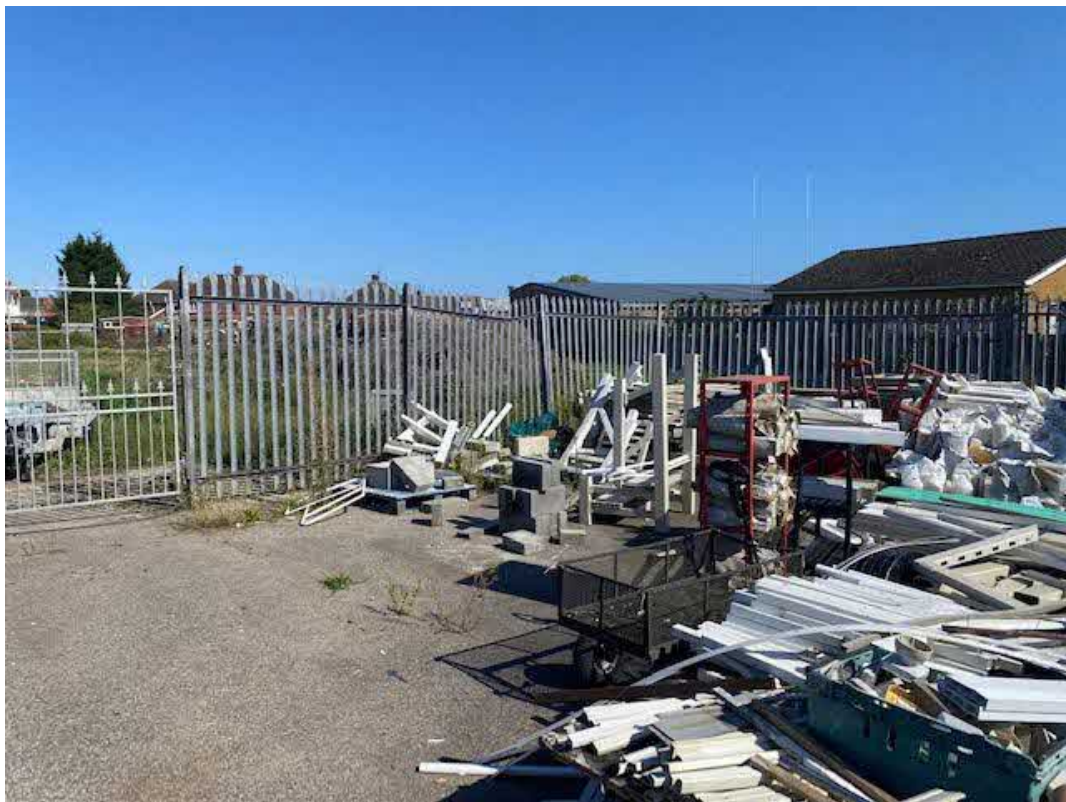
Photograph 4 – North east corner of site obstruction.

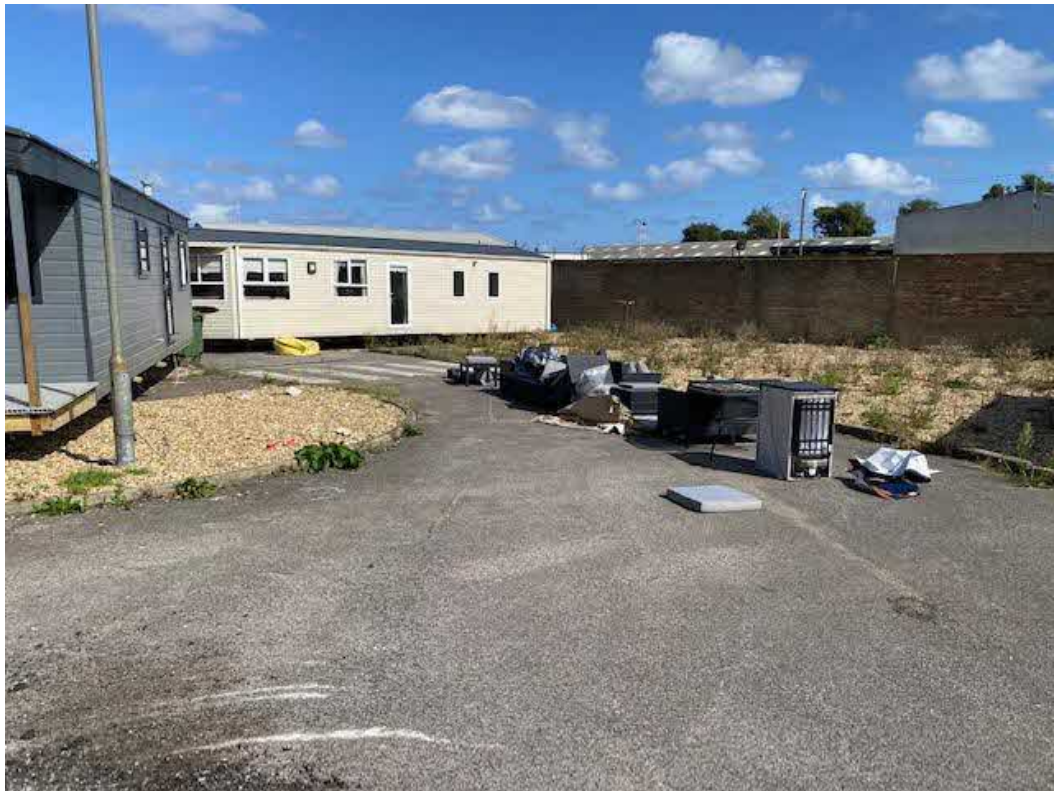
Photograph 6 – Mobile housing units stored in eastern section of site.

At the time of the investigation, the site was being utilised as a storage area for mobile housing units with several mobile homes stored across the site. HGVs were noted to be frequently accessing the site through the southern entrance from Old Wainfleet Road to collect and deposit the mobile units.
