### Monitoring Details:

Address: Ely St Mary's Junior School, High Barns, Ely, CB7 4RB

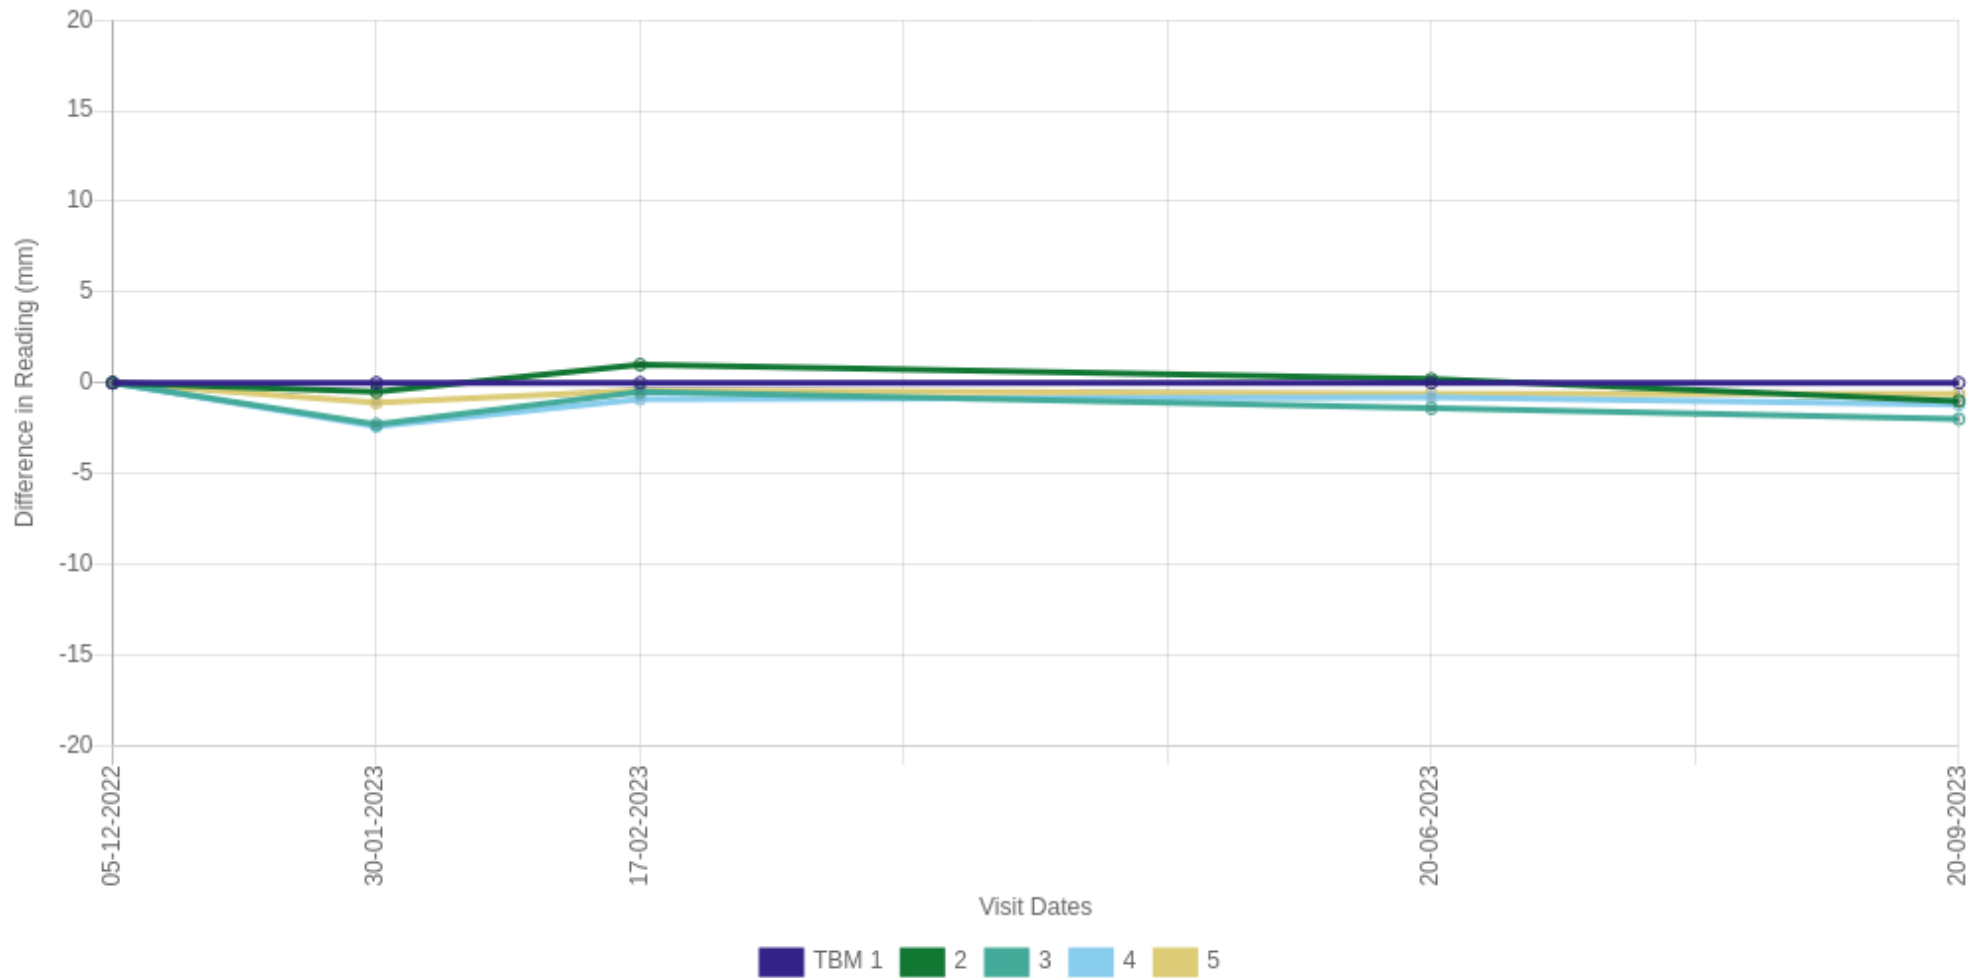
### Level Readings Chart (Points TBM 1 - 5)

Visit 1	Visit 2	Visit 3	Visit 4	Visit 5	Visit 6	Visit 7	Visit 8	Visit 9	Visit 10
	05/12/22	30/01/23	17/02/23	20/06/23	20/09/23					
TBM1	0	0	0	0	0					
2	0	-0.5	+1	+0.2	-1					
3	0	-2.3	-0.5	-1.4	-2					
4	0	-2.4	-0.9	-0.8	-1.2					
5	0	-1.1	-0.4	-0.6	-0.6					
6	0	-3.2	-1.3	-2.3	-1.6					
7	0	-0.6	+0.5	+0.7	-0.4					
8			0	+0.8	-18.4					
9			0	+0.4	-6.9

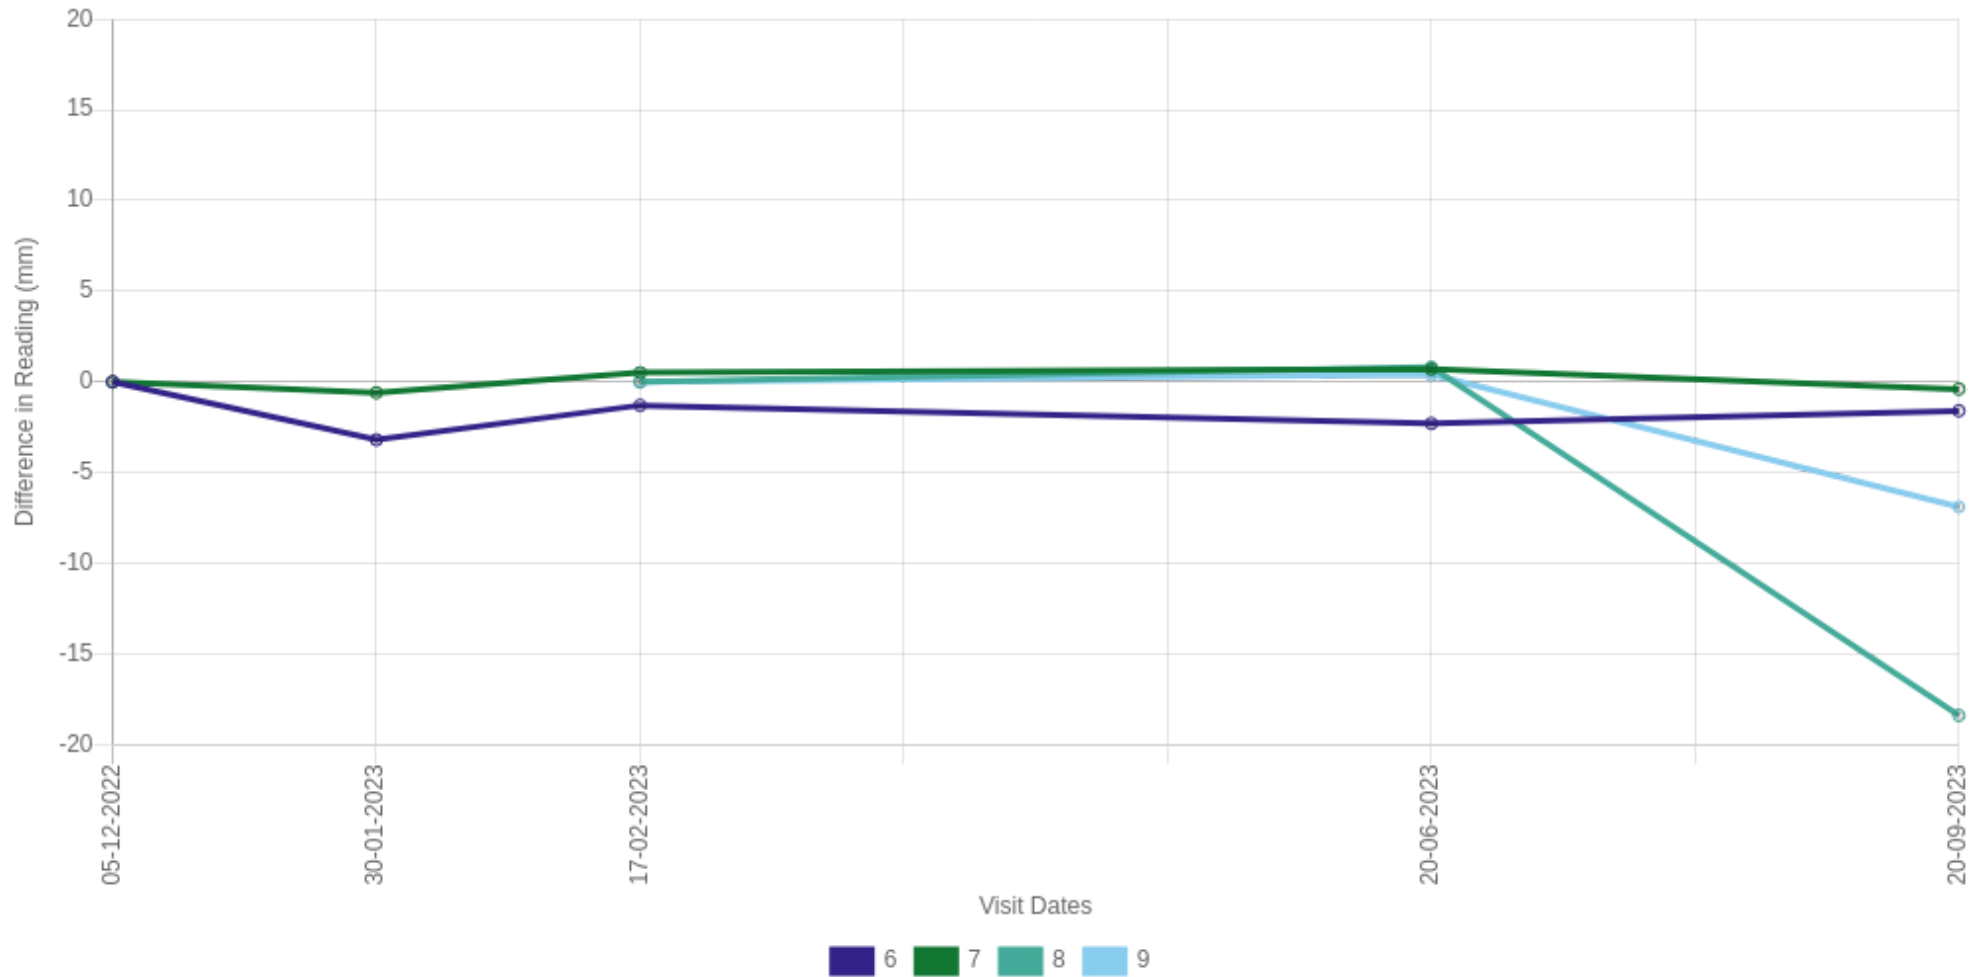
### Level Readings Chart (Points 6 - 9)

Visit	Surveyors Note
Visit 4	Ph reported concrete from roof coming away.

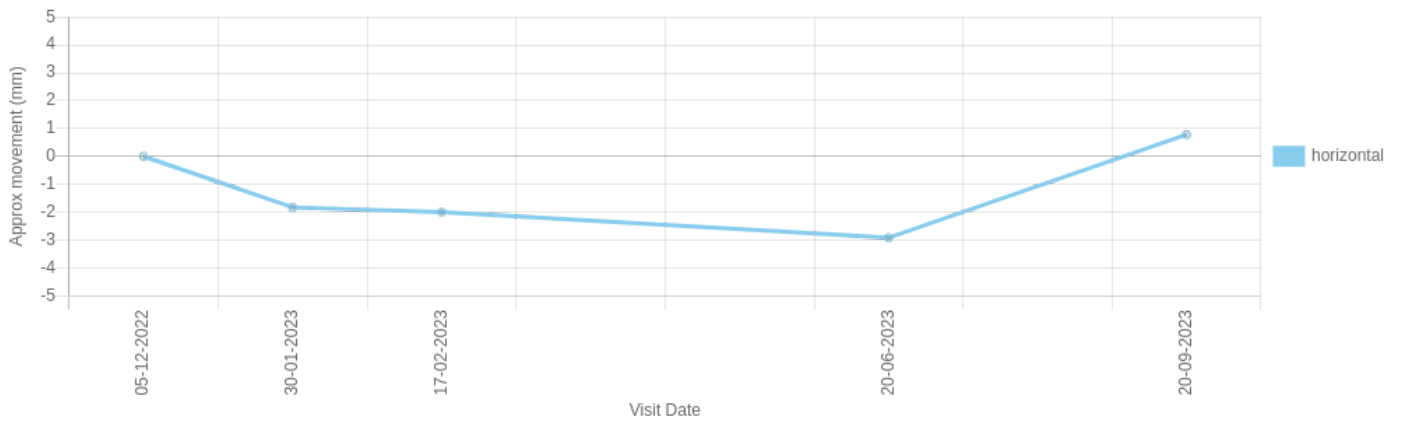
## EXT Conjunction of main house and utility

Visit 1	Visit 2	Visit 3	Visit 4	Visit 5	Visit 6	Visit 7	Visit 8	Visit 9	Visit 10
	05/12/22	30/01/23	17/02/23	20/06/23	20/09/23					
H	0	-1.83	-2	-2.92	0.78

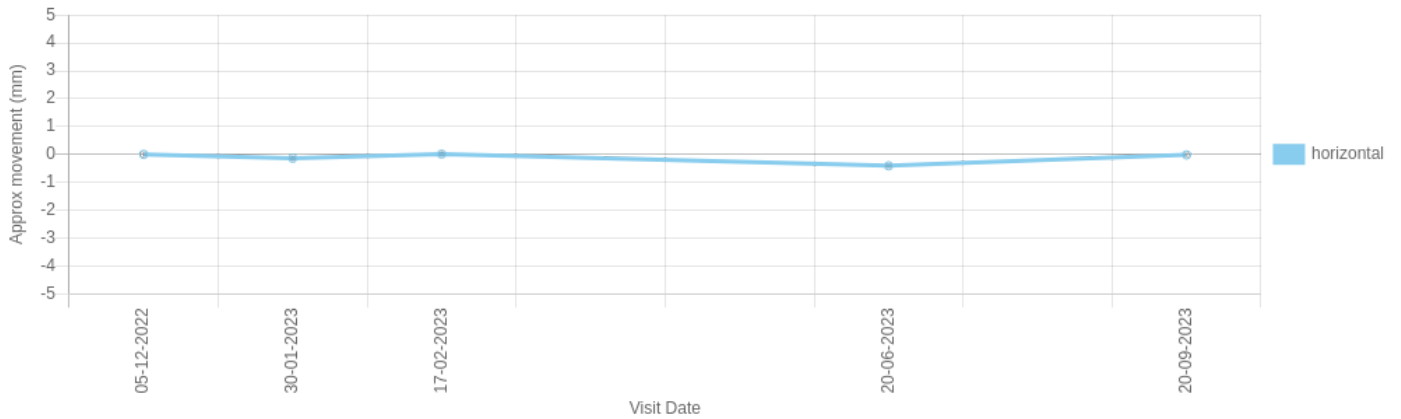
INT above rear utility door

Visit 1	Visit 2	Visit 3	Visit 4	Visit 5	Visit 6	Visit 7	Visit 8	Visit 9	Visit 10
	05/12/22	30/01/23	17/02/23	20/06/23	20/09/23					
H	0	-0.14	0.01	-0.41	-0.02

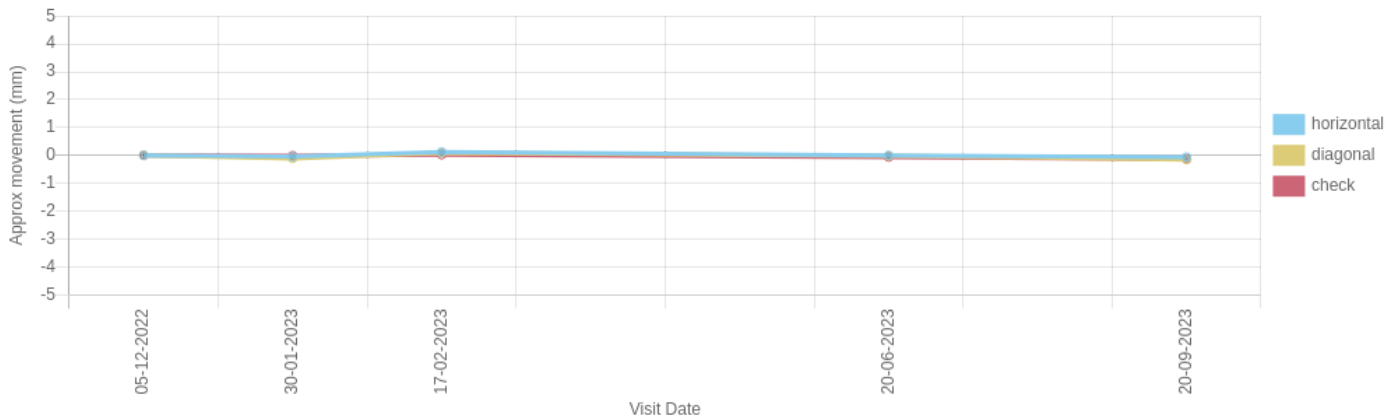
## INT crack above WC window

Visit 1	Visit 2	Visit 3	Visit 4	Visit 5	Visit 6	Visit 7	Visit 8	Visit 9	Visit 10
	05/12/22	30/01/23	17/02/23	20/06/23	20/09/23					
H	0	-0.04	0.12	0	-0.06					
D	0	-0.11	0.09	-0.02	-0.15					
C	0	-0.01	0.02	-0.06	-0.13

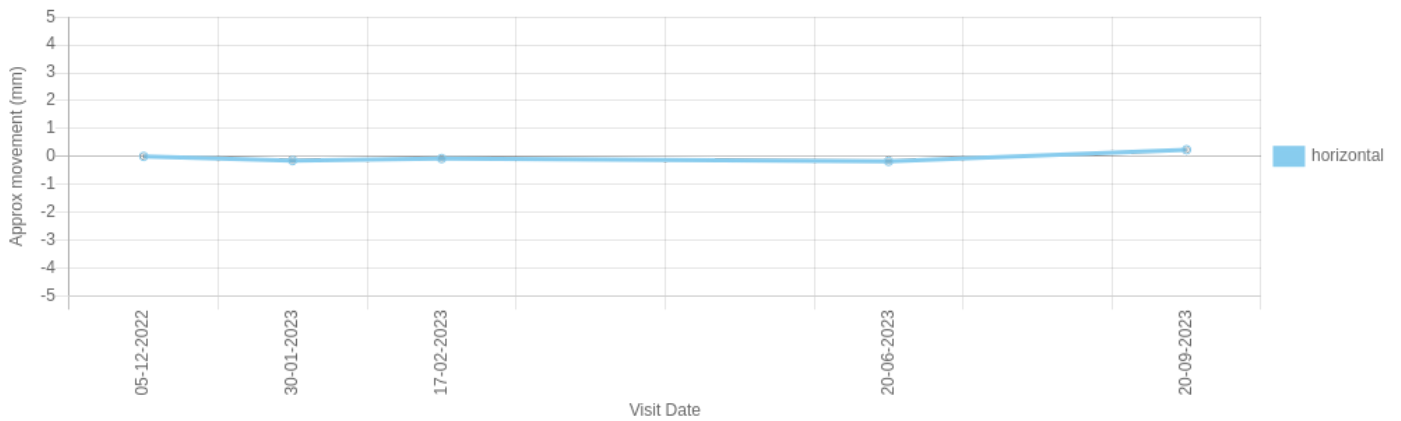
## INT crack above living room door

Visit 1	Visit 2	Visit 3	Visit 4	Visit 5	Visit 6	Visit 7	Visit 8	Visit 9	Visit 10
	05/12/22	30/01/23	17/02/23	20/06/23	20/09/23					
H	0	-0.15	-0.08	-0.18	0.24
