Report : Bat and Nesting Bird Assessment:  
House at The Brooches,  
Craven Arms SY7 9AG

Reference : IL/2998/22.1

Date : 2 January 2024

Proposed development : Extension of the House

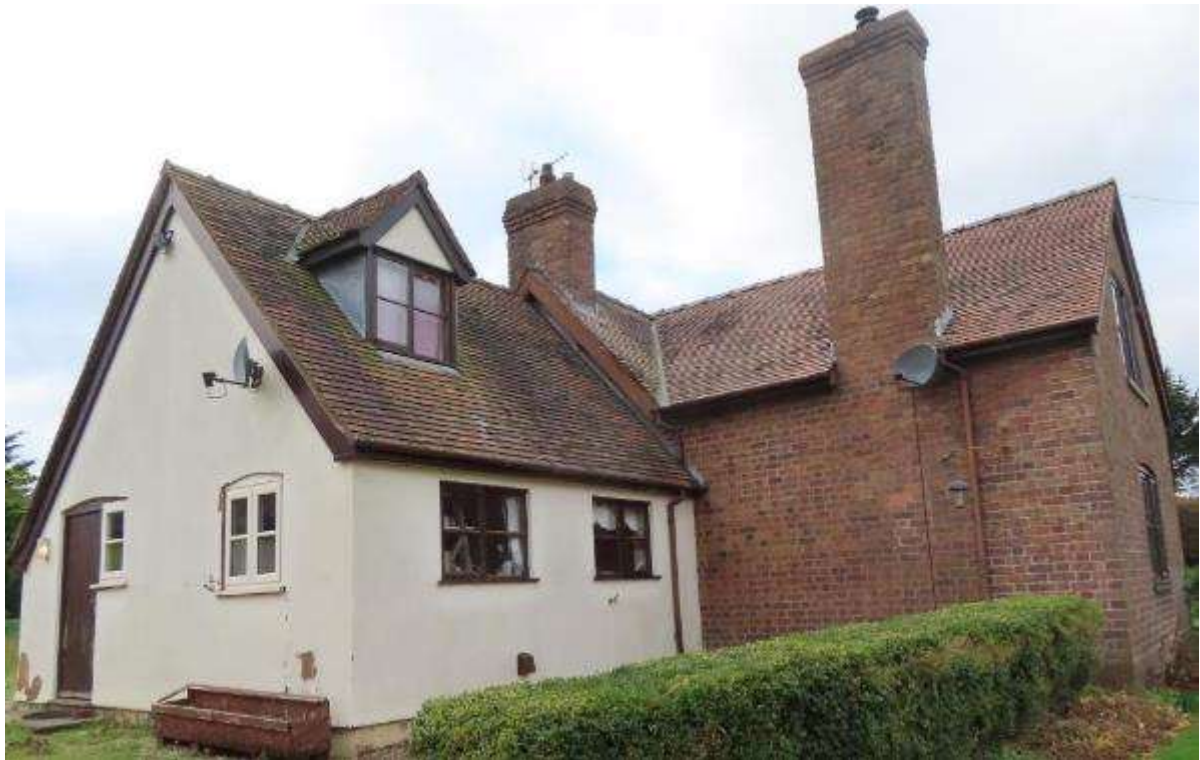
**Photograph 1. Exterior.**

Left: Southeast elevation of Section B.  
Left-of-centre: Northeast elevation of Section B.  
Right: Southeast elevation of Section A.  
Far right: Northeast elevation of Section A.

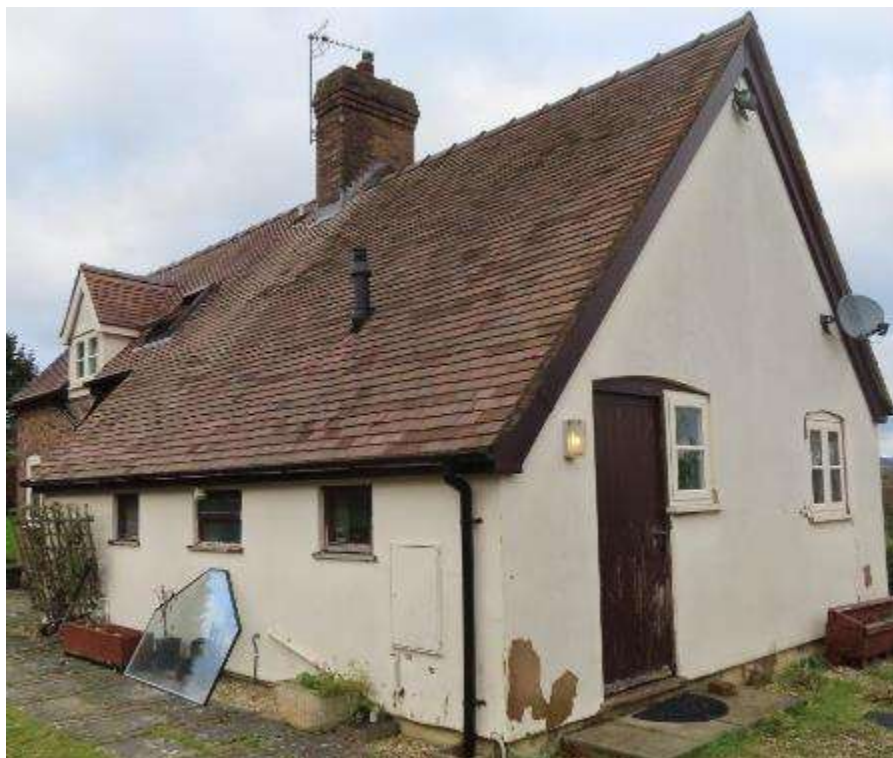
**Photograph 2. Exterior.**

Upper far left: part of the Southwest elevation of Section A.  
Left: Southwest elevation of Section B.  
Right: Southeast elevation of Section B.

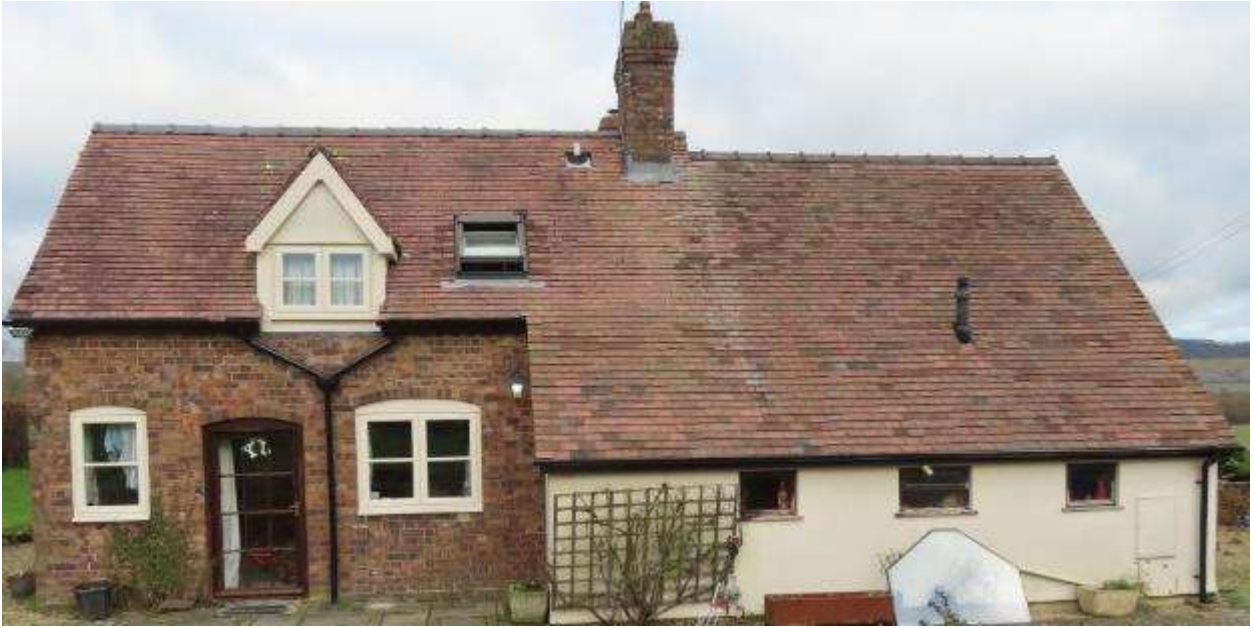
**Photograph 3. Exterior.**  
Left: Southwest elevation of Section A.  
Right: Southwest elevation of Section B.

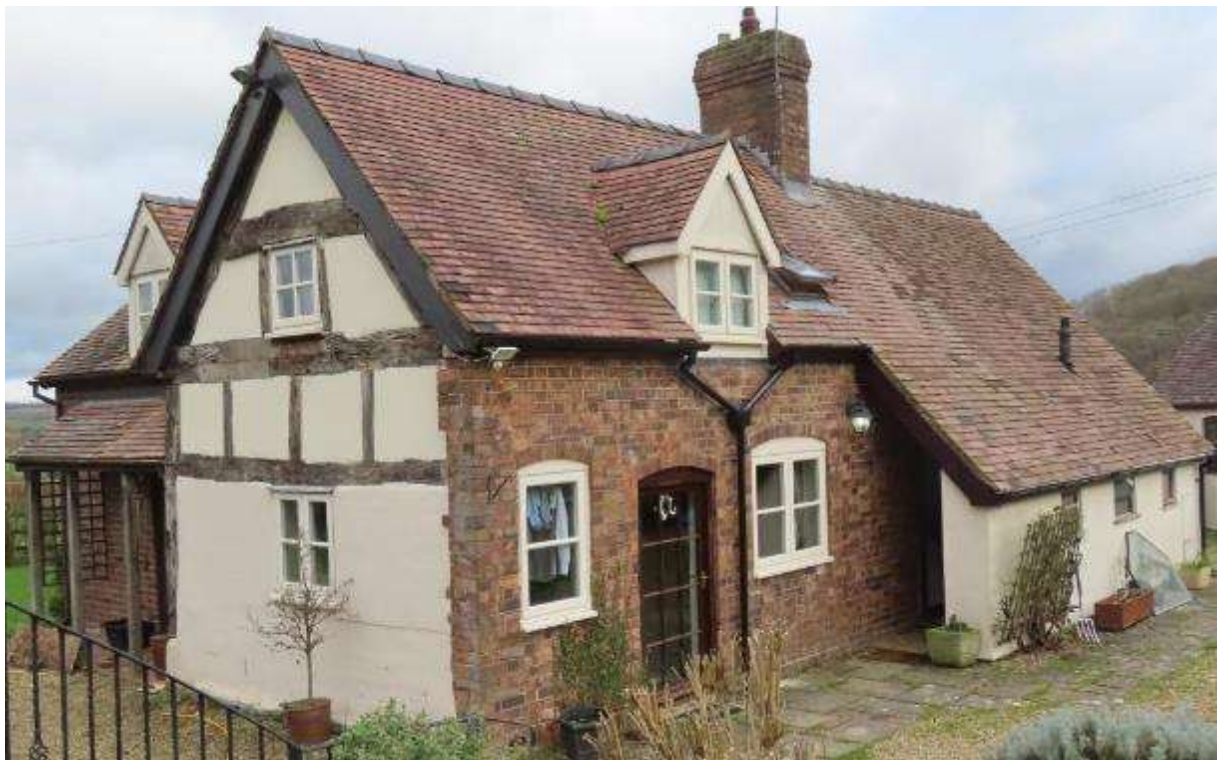
**Photograph 4. Exterior.**  
Left: parts of the Northwest elevation of Section A.  
Centre and right: Southwest elevation of Section A.  
Right: Southwest elevation of Section B.

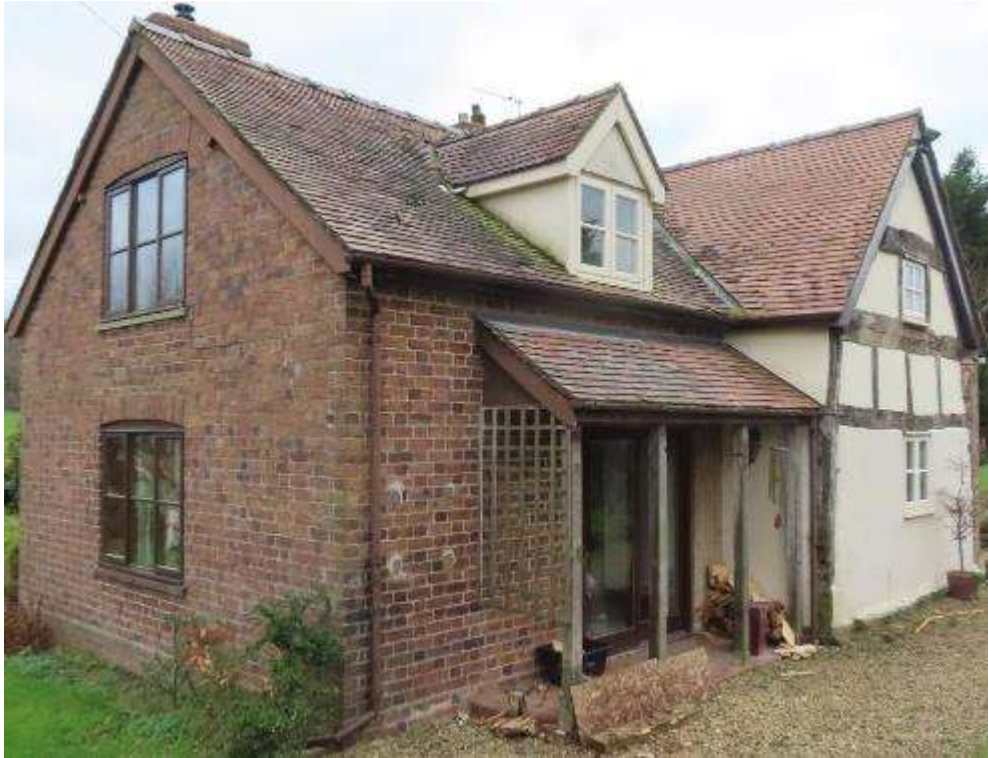
**Photograph 5. Exterior.**  
Left: Northeast elevation of Section A.  
Centre and right: Northwest elevation of Section A.

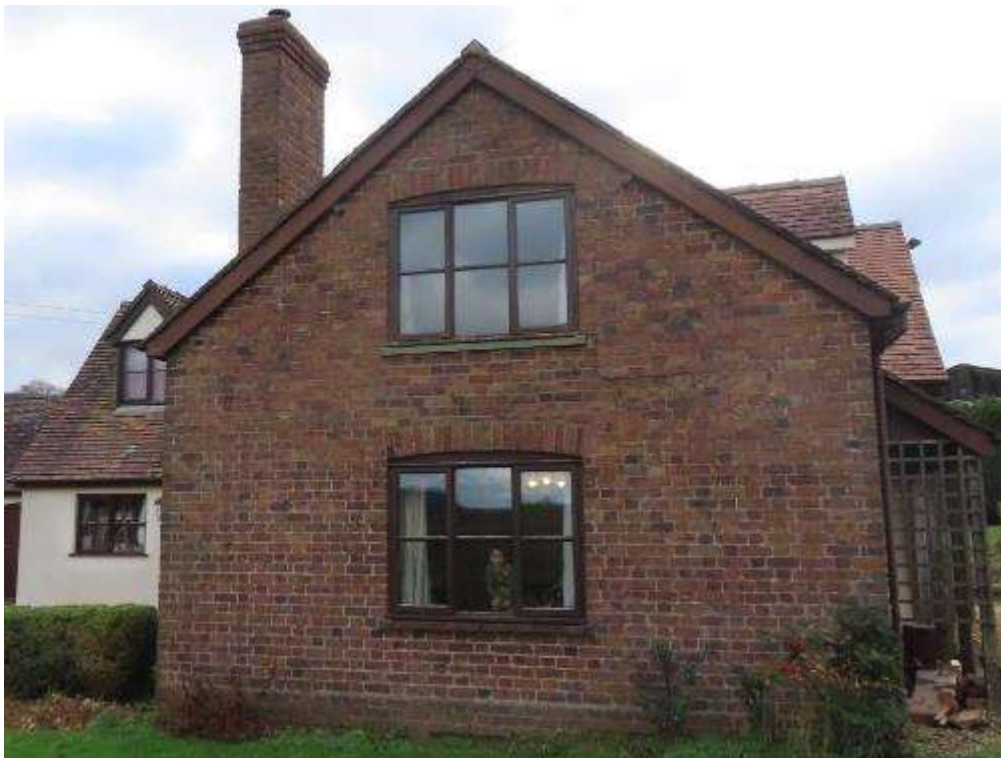
**Photograph 6. Exterior.**  
Far left: part of the Northeast elevation of Section B.  
Centre and right: Northeast elevation of Section A.

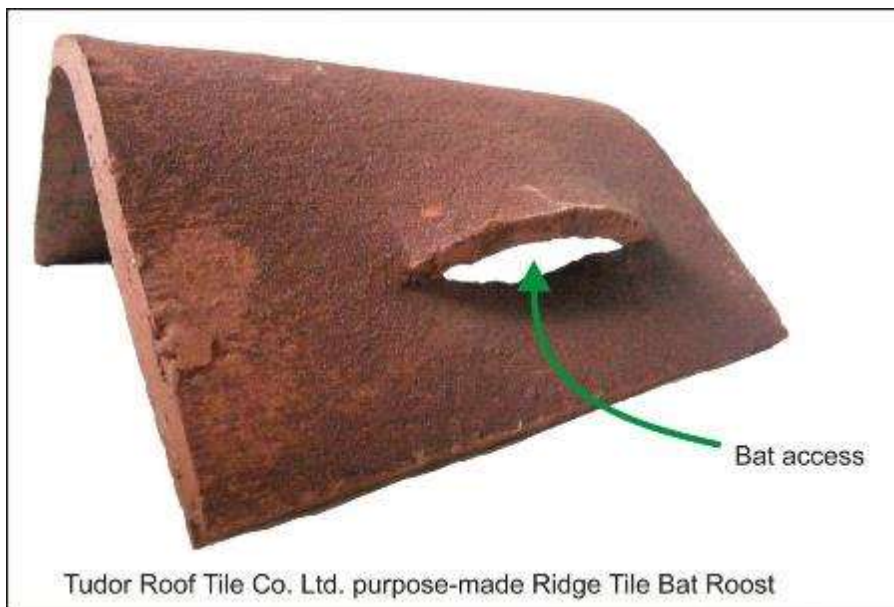
Purpose-made ridge tiles with bat-access openings are available commercially. For example, the handmade 'bat access ridge tile' produced Tudor Roof Tile Co. Limited, Dengemarsh Road, Lydd, Kent, TN29 9JH.

A picture of the Tudor Roof Co. Limited purpose-made ridge tile bat roost is shown below:
