COLLINS ARMS, 18 THE COLLINS ARMS, HIGHER FORE STREET, REDRUTH, TR15 2AP

**Client Ref:** 23528  
**Report Ref:** GCL-O9A-CIJ-P4L-PIG  
**Grid Ref:** 170235, 42164

# Appendix D

## GeoRisk Report

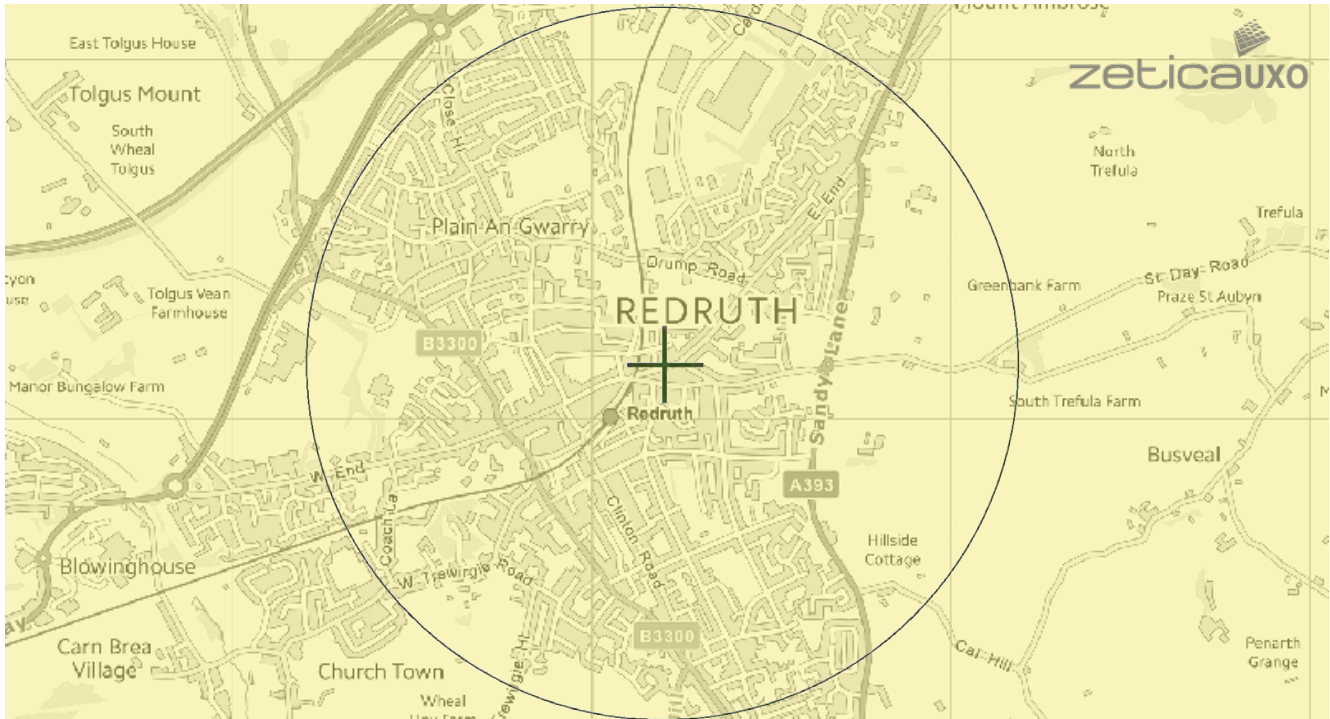
# UNEXPLODED BOMB RISK MAP

Location: TR15 2AP,  
Map Centre: 170209,42156

- High:** Areas indicated as having a bombing density of 50 bombs per 1000acre or higher.
- Moderate:** Areas indicated as having a bombing density of 15 to 49 bombs per 1000acre.
- Low:** Areas indicated as having 15 bombs per 1000acre or less.

Generally, we recommend that a detailed UXO desk study and risk assessment is undertaken for sites in a moderate or high UXB risk area.

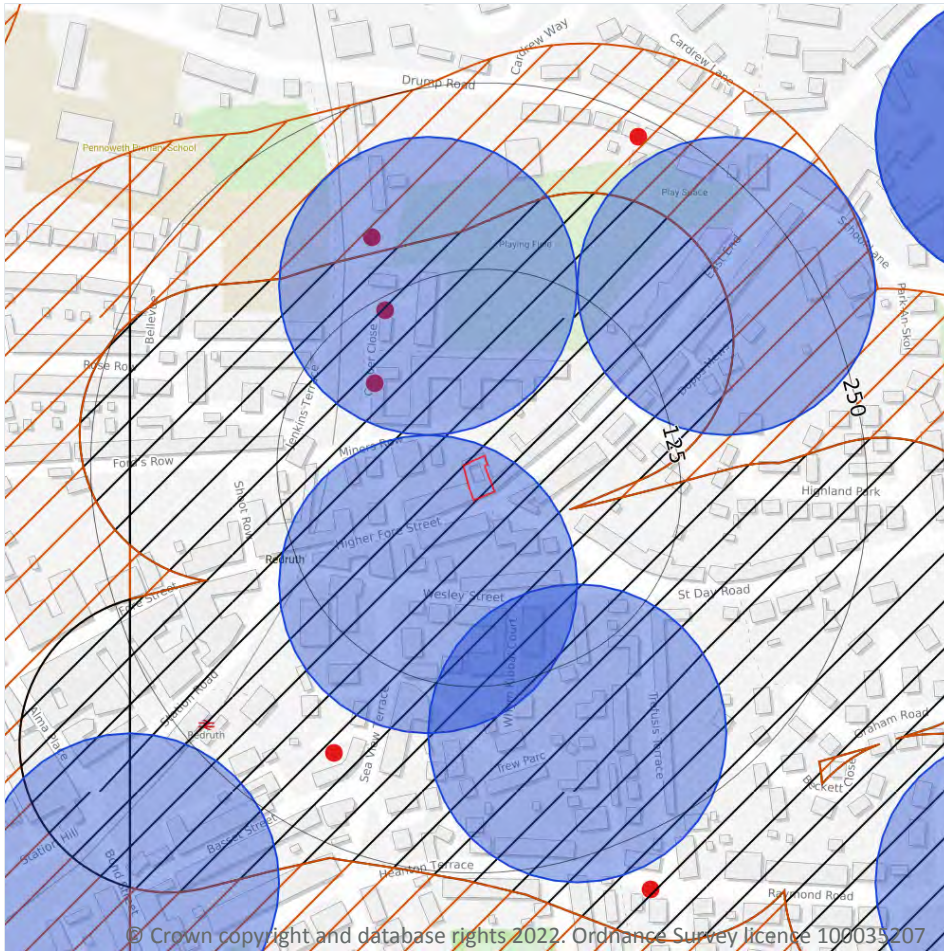
## Non-coal mining / Mining records

Location	Name	Commodity	Class	Likelihood
On site	Not available	Vein Mineral	E	Underground mining is known to have occurred within or very close to the area. Potential for difficult ground conditions should be investigated. Potential for localised subsidence is at a level where it should be considered

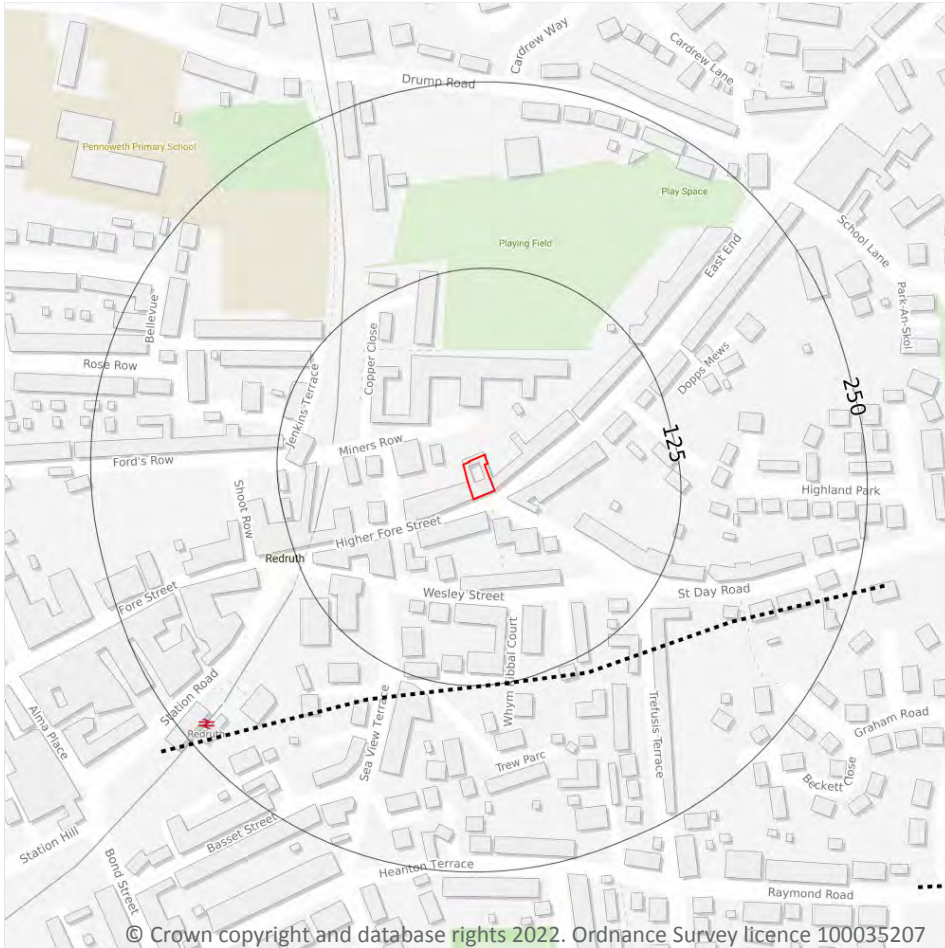
## Non-coal mining / Geological features 50k

### Linear features - mineral veins (50k)

Detail of linear features such as mineral veins identified from geological maps at 1:50,000 scale. The presence of mineral veins in the area is an indicator that mining operations may have occurred in the area.

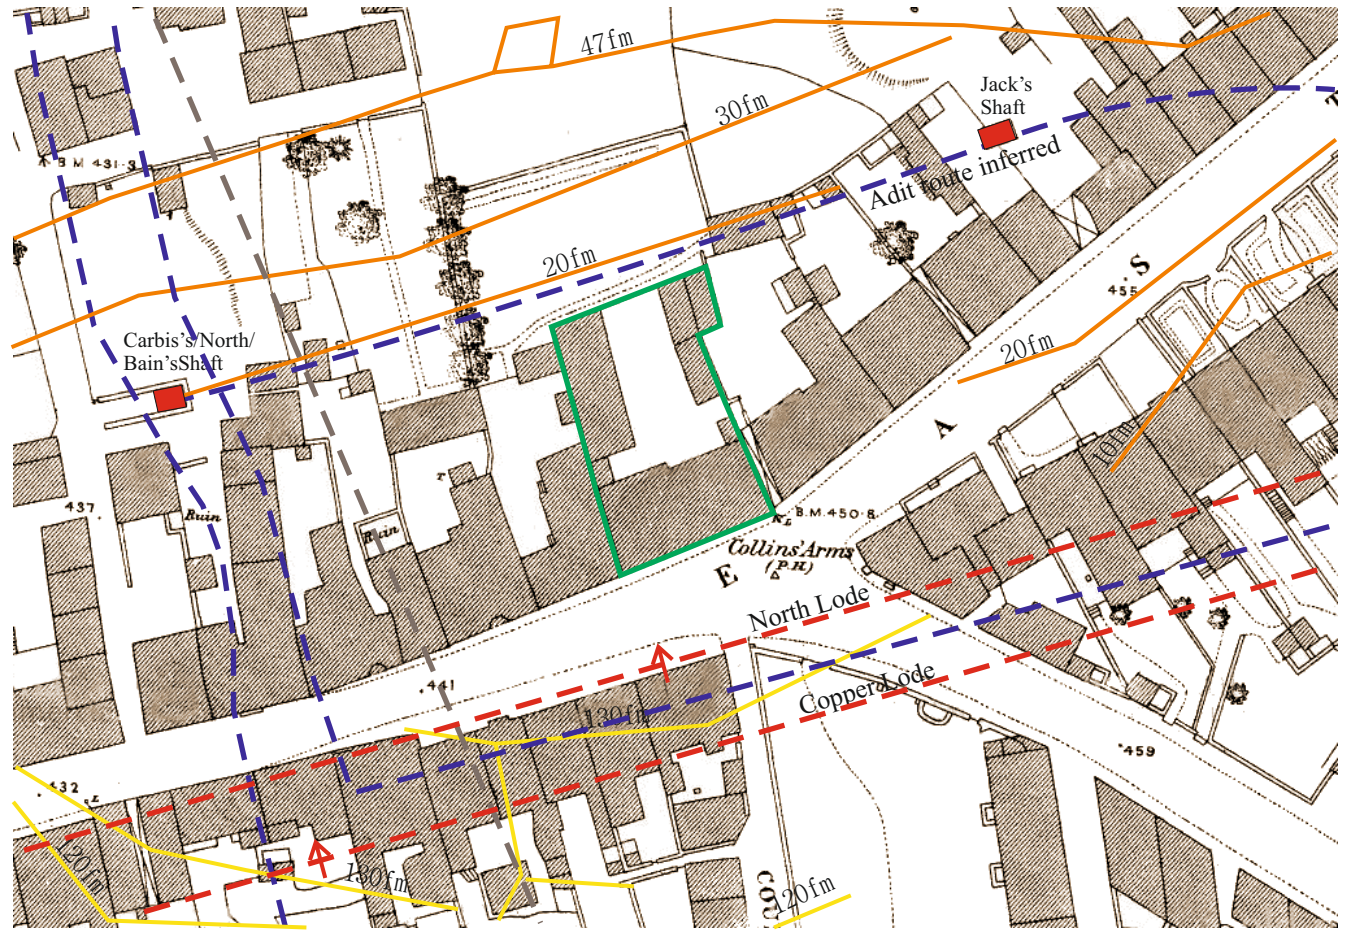
KEY	
	Site Boundary (as provided)
	Lode
	Workings below adit level
	Shaft/Well
	Minewaste
	Crosscourse
