**RESULTS OF A PRELIMINARY ROOST ASSESSMENT ON THE  
FORMER COLLIN'S ARMS PUB, HIGHER FORE STREET, REDRUTH,  
CORNWALL.**

November 2023

**Report No:** 22-197\_BBO\_Collin's Arms, Redruth

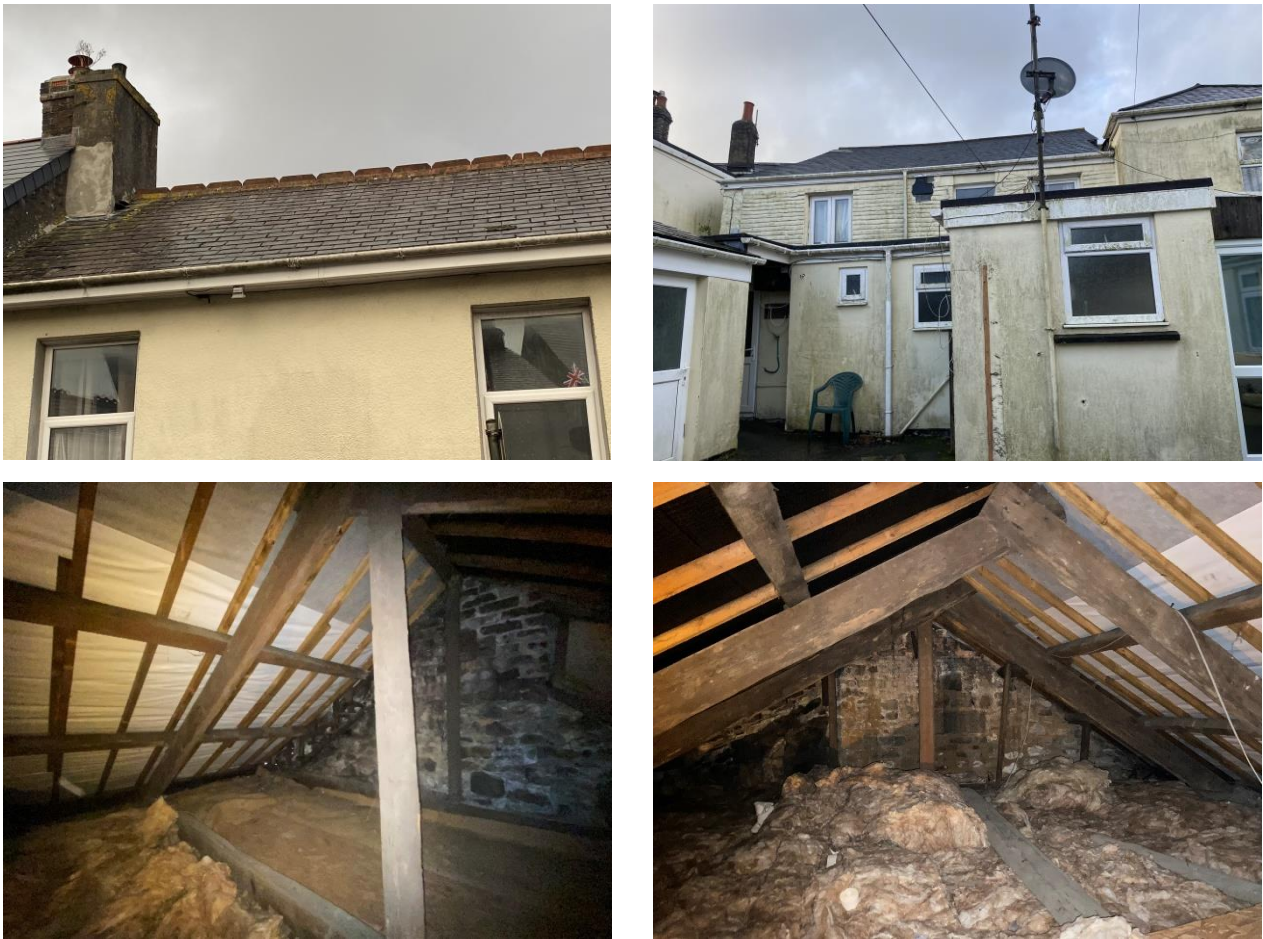
The building surveyed is the former pub with rear attached extension. The pub is now closed to the public and the rear extension and rear of the pub is used as a dwelling. The pub comprises of a traditional stone building with rendered external walls. The roof is lined with slates and there are layers of wall slates which have also been rendered. The rear extension is a single-storey flat roof lined with bitumen felting. The fascias are mainly plastic and the windows are double glazed plastic.

Internally the roof void is a large open space which covers the eastern length of the roof of the pub. The space contains a layer of thick insulation on the floor. The roof is lined with bitumen felting which is torn in some places on the northern slope of the roof and a breathable membrane on the southern slope. The gable ends are mainly stone mixed with some brick replacement.

**Figure 2: The roof on the front of the pub (top left), the rear aspect (top right) and the internals of the roof void to the west (bottom left) and east (bottom right).**

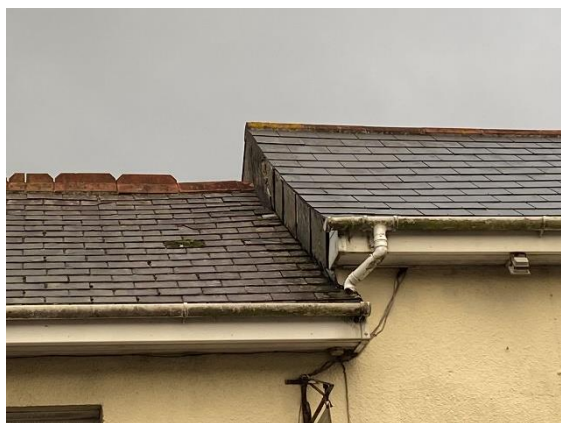
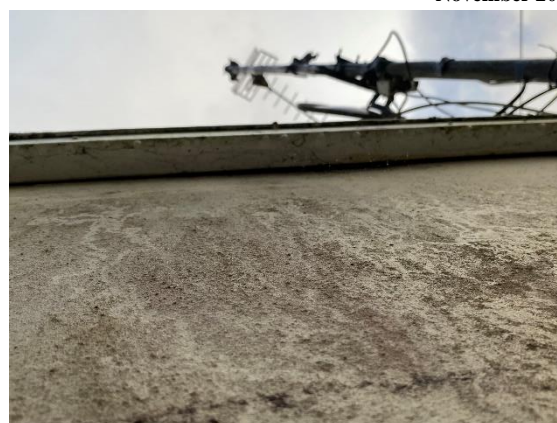
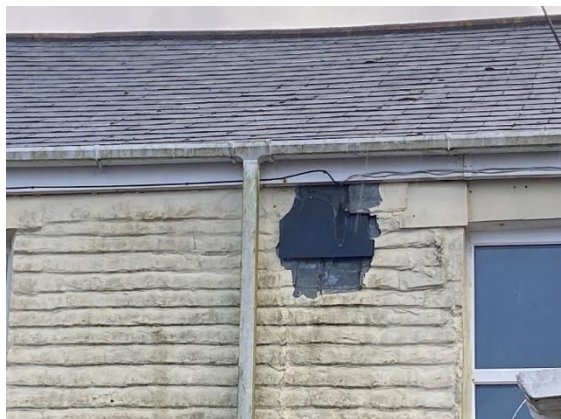
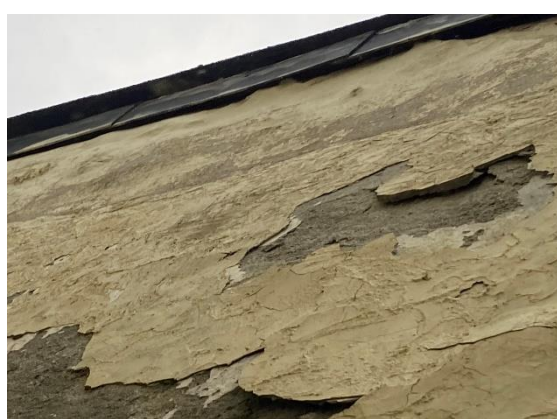
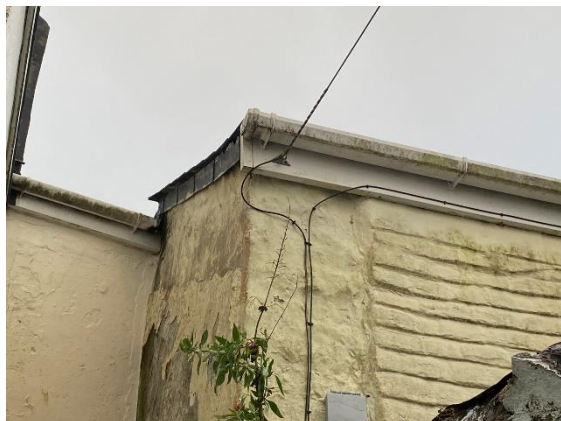
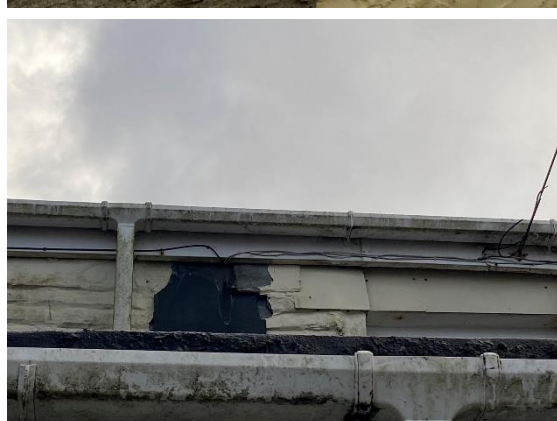
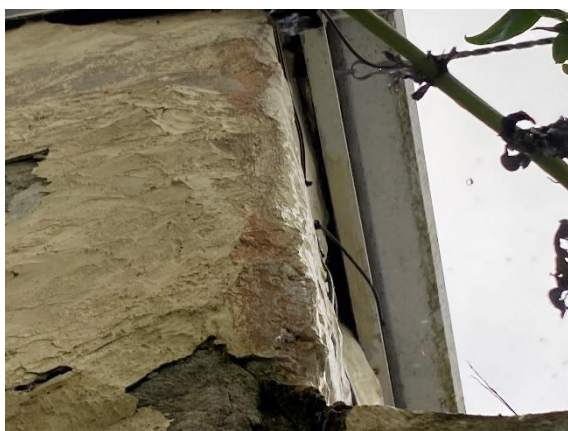
No evidence of bats was discovered within the roof void of the former pub. Externally there were areas which hold the potential to be used by roosting bats. These include gaps underneath lifted/missing slates on the main roof, gaps under the hanging wall top slates on the eastern side, gaps underneath fascia boarding on the flat roof extension and on the main pub wall tops on the rear side (Figure 5). Within the roof void there are gaps through the western wall which lead to outside and allow light into the void.

**Figure 5: The external gaps present on the former pub including gaps under roof and hanging slates, gaps into the wall and underneath fascias.**

No evidence of the use of the building by bats was discovered however, several external features which could be used by bats were highlighted on the building. As the proposals stand, it is not thought that further surveys are required due to the works being carried out on the elevations away from the roof and the internals of the building, It is recommended however, that if the proposals were to include replacing the roof, hanging slates and fascias of the pub at the wall tops which were highlighted as potentially sensitive areas, then further surveys in the form of two emergence surveys are recommended using 3 surveyors within the active bat season (May-September), with one survey being undertaken within a peak activity month for bats (June-August).
