# 2203 BFSG Bramling Court Farm

Heritage Statement for a Full Planning  
Application at Bramling Court Farm, Bramling,  
Canterbury, Kent, CT3 1NA.

RIBA Stage 3

December 2023

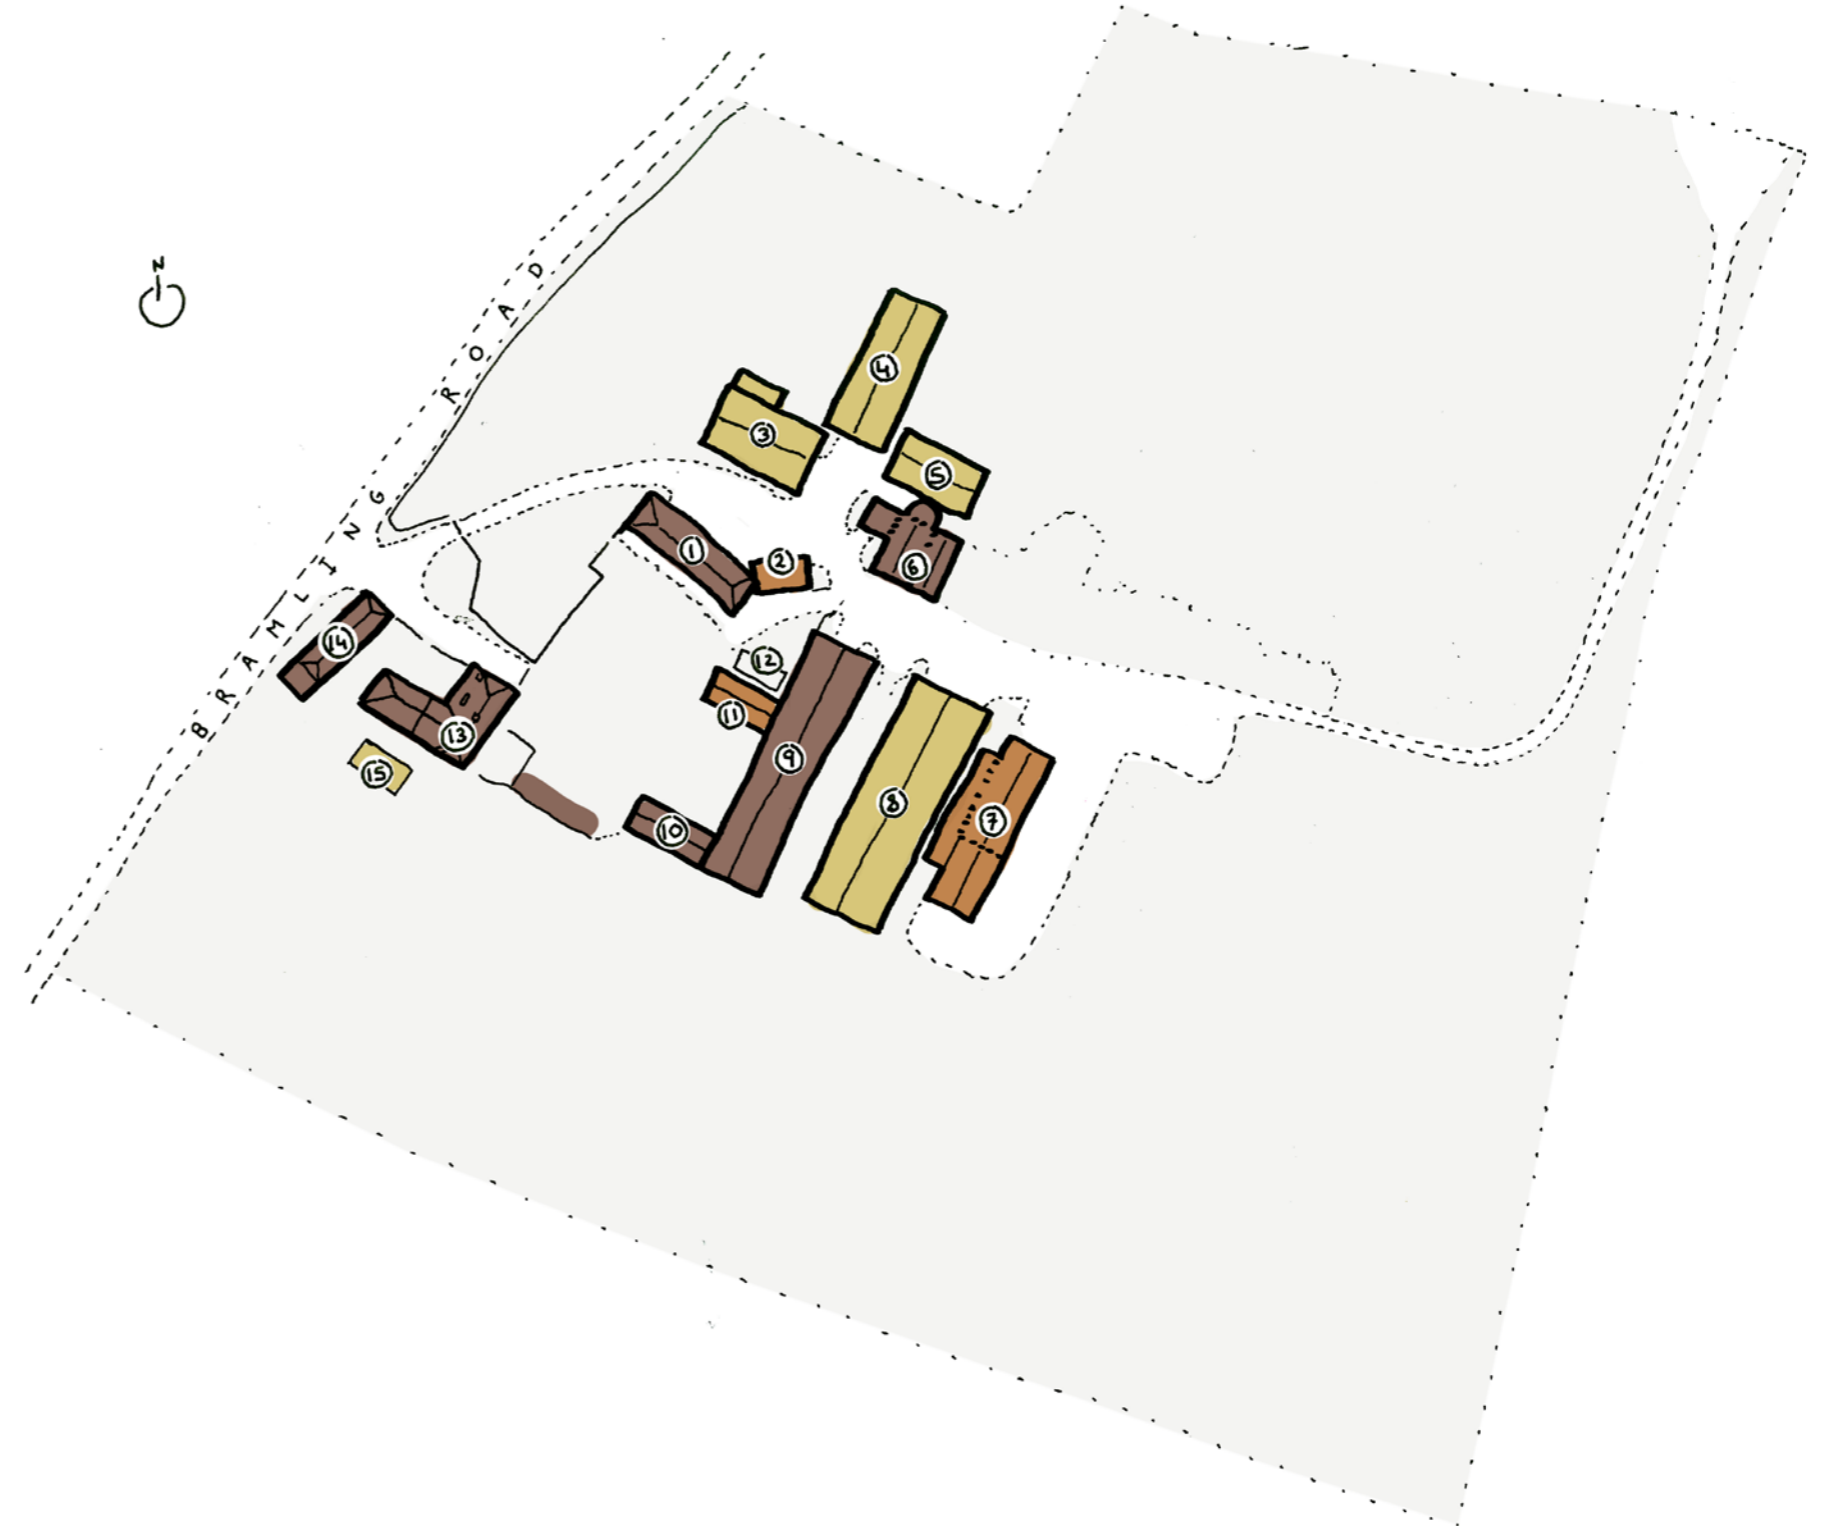
Above: Site Plan (NTS)

The site plan to the right hand side gives a fundamental overview of the site as it appears today, with colour coding denoting key periods in the farm's modern history.

- 1 Shoot School / Stables
- 2 Garage
- 3 Combine Shed / Grain Store
- 4 Grain Store
- 5 Grain Drier
- 6 Oast / Cart Shed
- 7 Cow Shed / Dairy
- 8 Hay Barn / Grain
- 9 Potato Store / Former Threshing Barn
- 10 Byre
- 11 Pigery / Stables
- 12 Static Caravan
- 13 Bramling Court Farmhouse - Grade II Listed
- 14 Stables at Bramling Court - Locally Listed
- 15 Swimming Pool

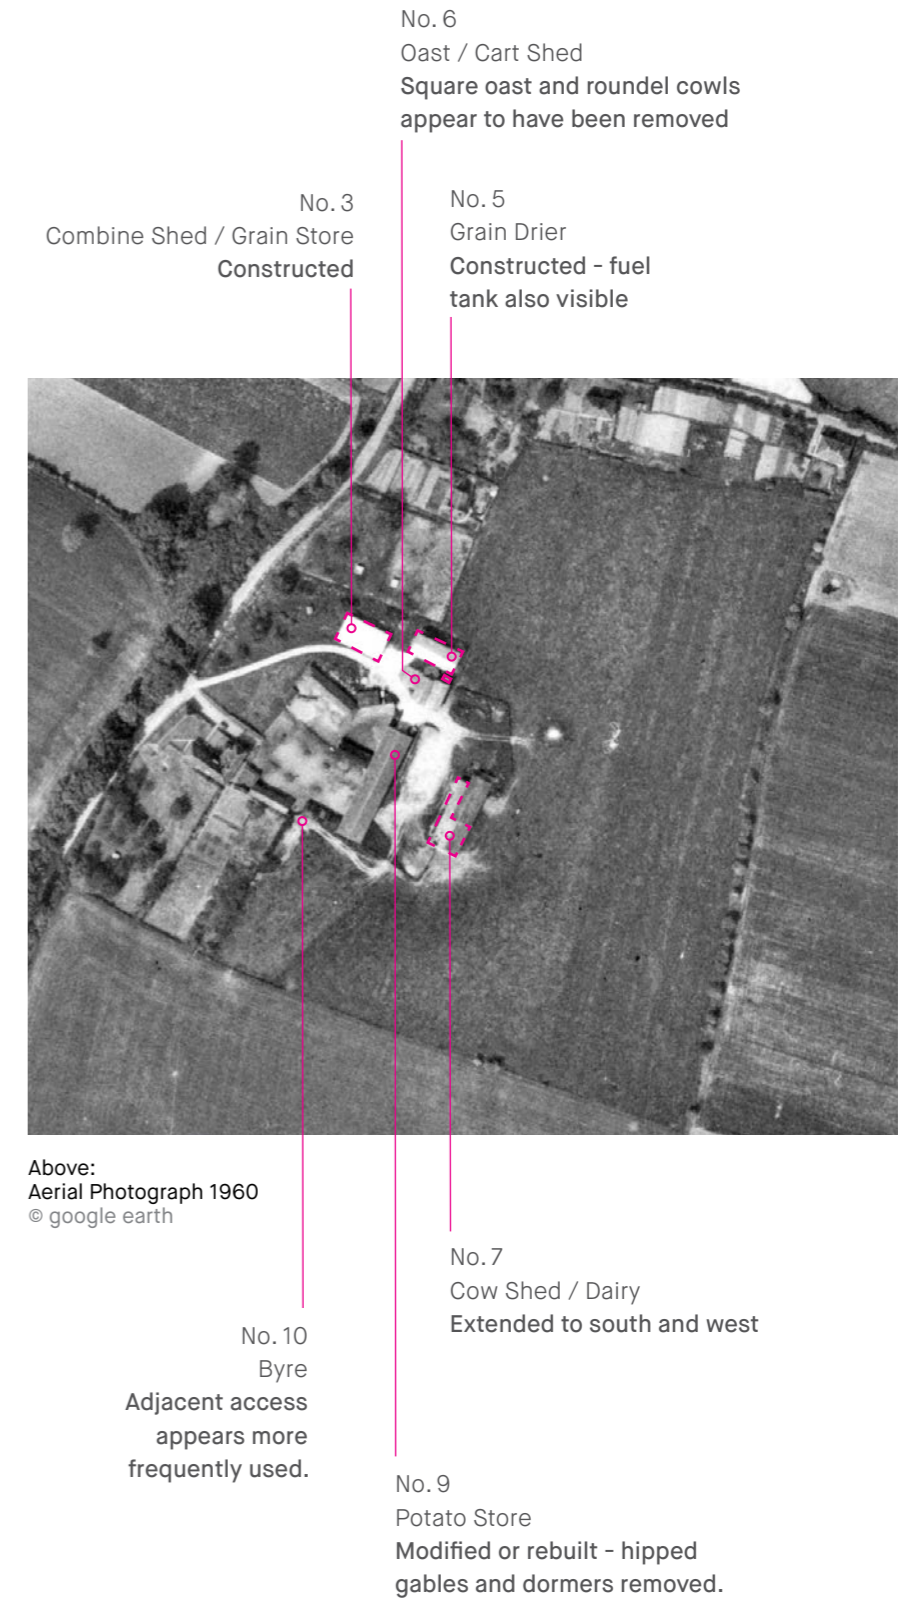
Above:  
Aerial Photograph 1960  
© google earth

No. 7  
Cow Shed / Dairy  
Moderately extended to  
south-west

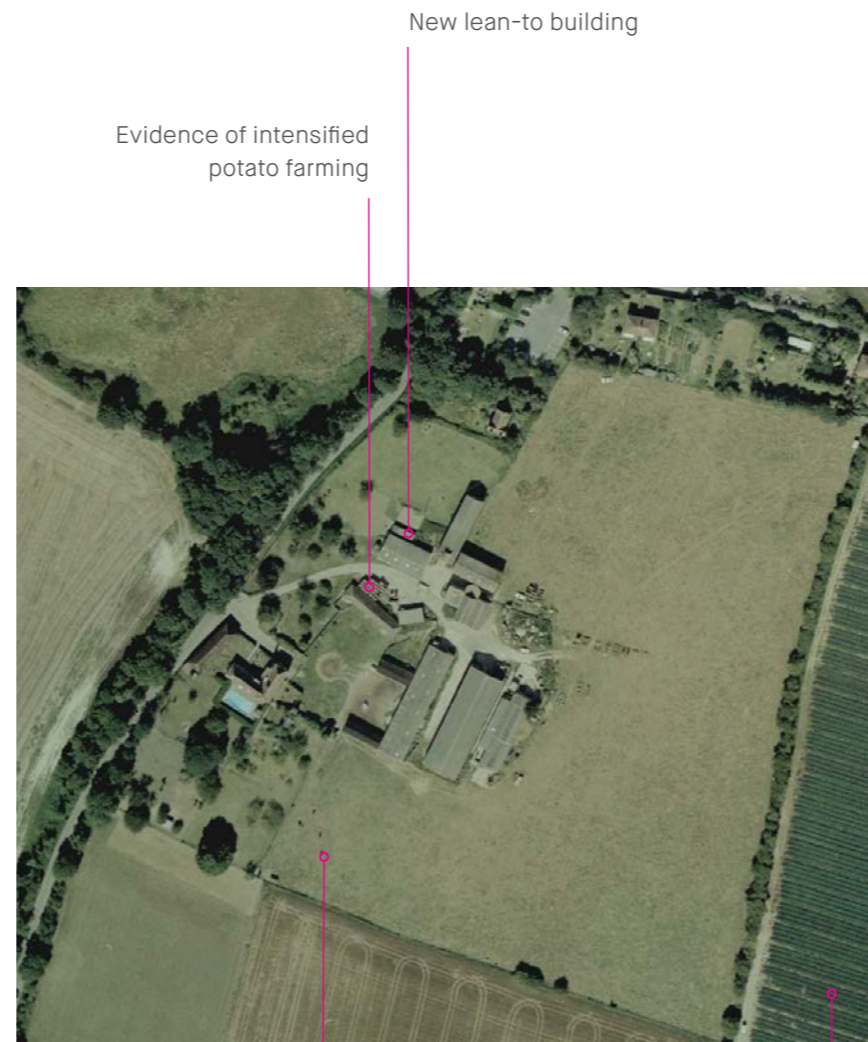
Above:  
Aerial Photograph 2003  
© google earth

No. 1  
Shoot School / Stables  
Grazing area no longer  
segregated, shooting school  
use approved (1990)

Pool added to  
Bramling Court  
Farmhouse

No. 8  
Hay Barn / Grain  
Store Approved &  
Constructed

No. 4  
Grain Store  
Constructed

No. 7  
Cow Shed / Dairy  
Hardstanding to southern end

No. 12  
Pigs  
Roof covering removed

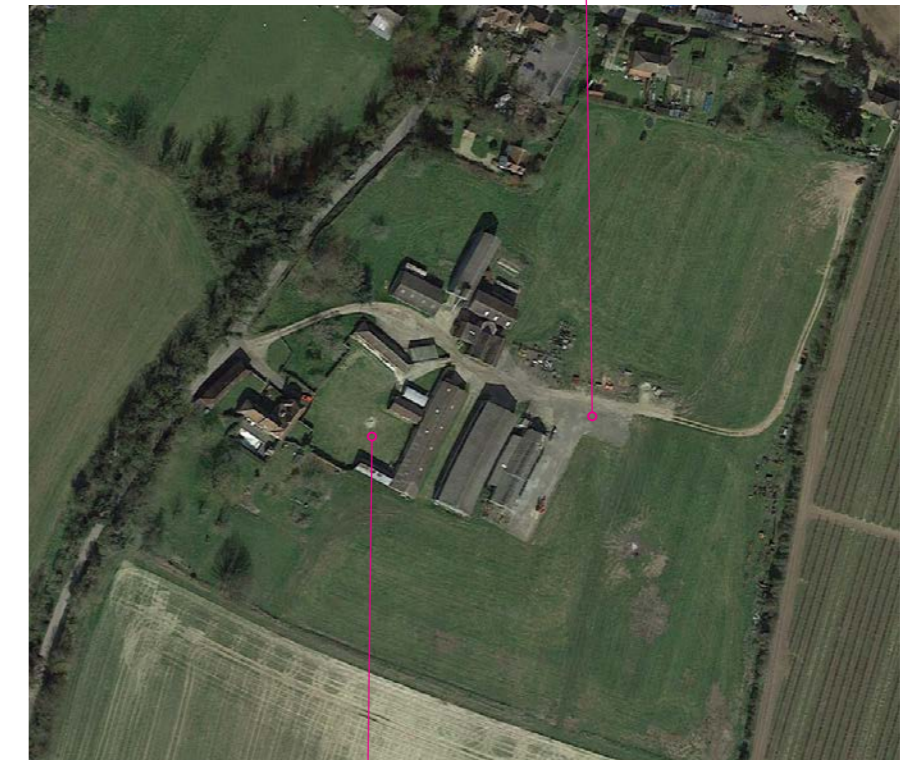
Above:  
Aerial Photograph 2021  
© google earth

New lean-to building

Evidence of intensified  
potato farming

Potato crop

Livestock

New hardstanding /  
gravel

Courtyard less heavily  
trafficked, suggesting  
discontinued livestock  
use

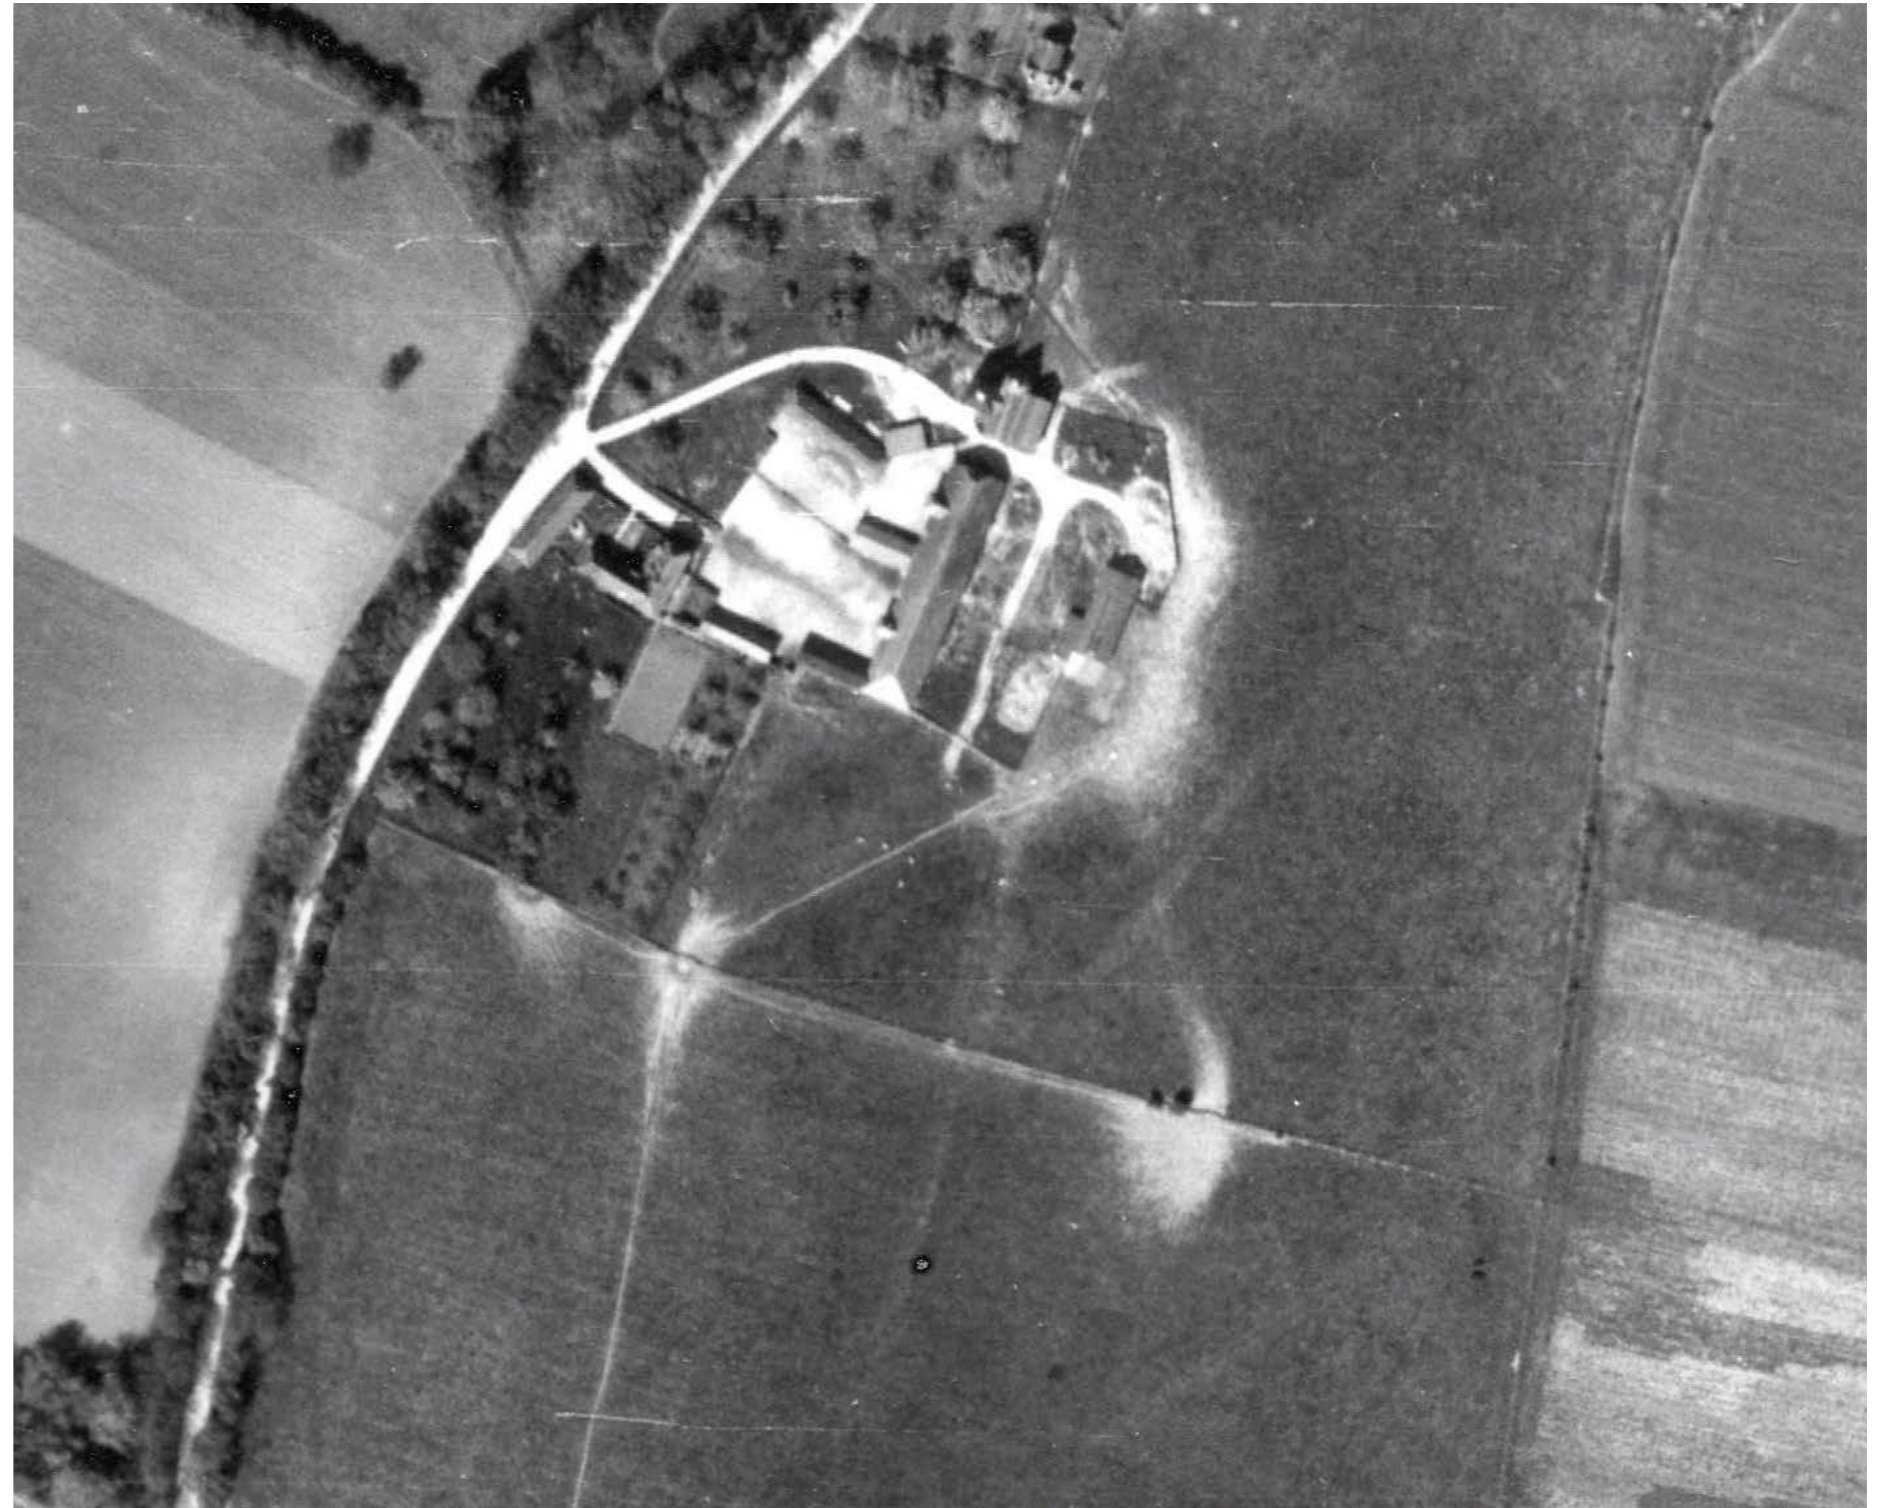
Above:  
Aerial Photograph 1940  
© google earth

The earliest available aerial photography of Bramling Court Farm shows the oasts in their full splendour, sat alongside the threshing barn.

The oast's full agricultural splendour is evidenced in aerial photographs from 1940 - when square and round oasts are both clearly visible, with cowls atop and the large pointed shadows indicating their scale relative to the other gables.

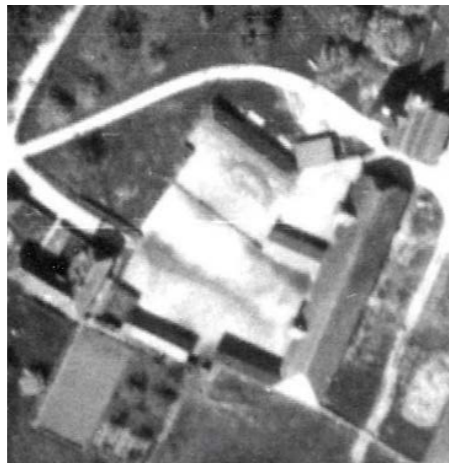
Above:  
Aerial Photograph 1940  
© google earth

The image from 1940 shows a hipped roof to the southern end, and a half hipped roof to the north end. Two dormer roofs appear across the length of the building, suggesting large openings onto the farmyard. The eave line appears to sit well below the ridge of the byre to the southern end.

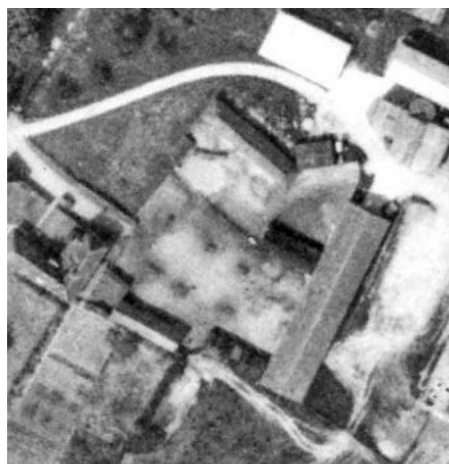
Above:  
Aerial Photograph 1960  
© google earth

In the 1960 image, a large gabled roof stands clear of the byre, and appears to be the very same construction present on the site today. The existing building has a large sloping concrete floor, with single skin blockwork walls and a series of clear span steel trusses. This is all relatively modern construction. No physical evidence of the barn structure photographed in 1940 remains.

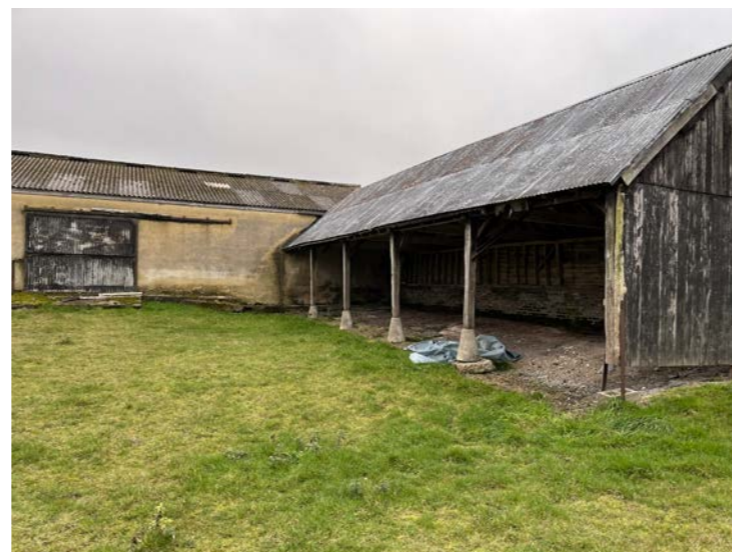
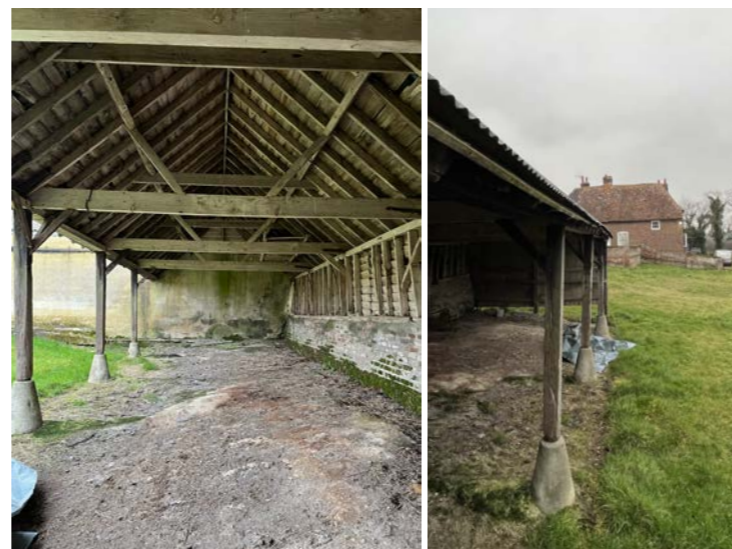
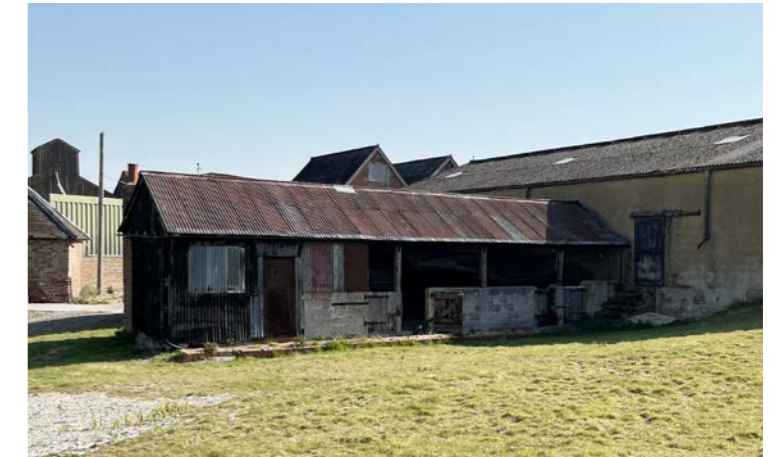
The open sided building is constructed off of a masonry base, which consists of flemish bond brickwork to the southern elevation, and a series of five concrete bases to the open northern side. Atop these bases are a series of solid timber posts, supporting roof trusses, and in turn the perkins then rafters. This structure appears to be original and suggests the building was used as a byre (cowshed).

The windowless timber clad end gable of the building is directly opposite to the original frontage of the farmhouse and is perhaps the most significant elevation of this building with respect to the listed farmhouse. Keeping this gable looking simple and utilitarian will help preserve its open sided character.

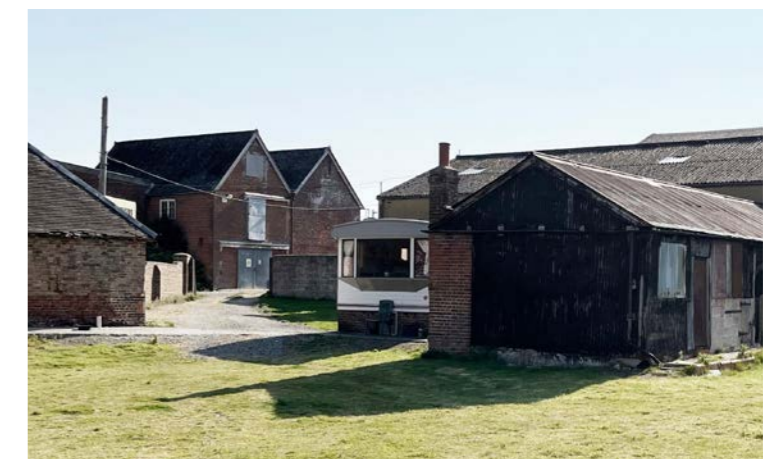
The chimney to the gable end is arguably a defining feature of this building, framing views out of the farmyard to the oast (pictured below).

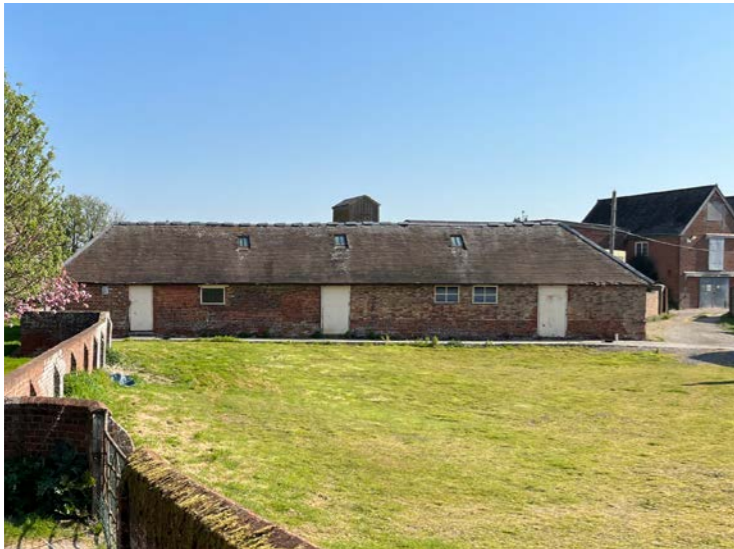
The elevation above appears to show signs of this former life, particularly notable in the change in brick tone to the right hand (eastern) end of the building, from around 11 courses above external floor level.

The brickwork obviously changes in colour, but also from Flemish bond to English garden wall bond, further highlighting this modification.

This construction method creates solid 1 brick thick walls, a construction approach consistent with the building appearing on historic maps at least as early as 1871.

It is assumed that the roof structure is likely to be a series of timber trusses, with perkins spanning between to support rafters, altogether supporting a tiled roof which is in a poor state of repair.

Modifications along the ridge suggest some further ad hoc repair has been undertaken.

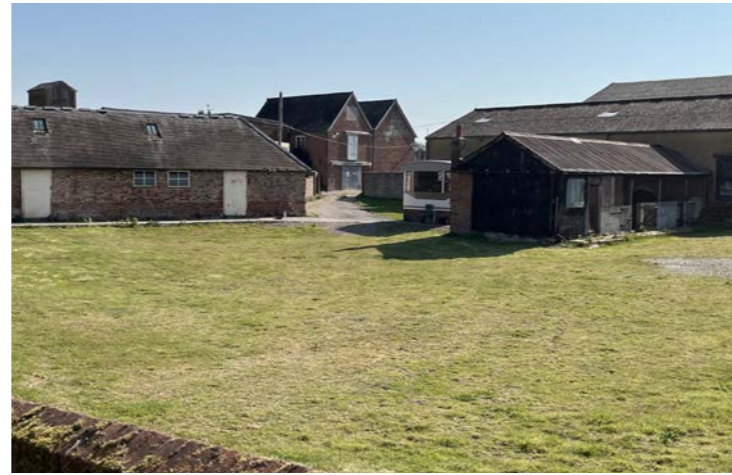
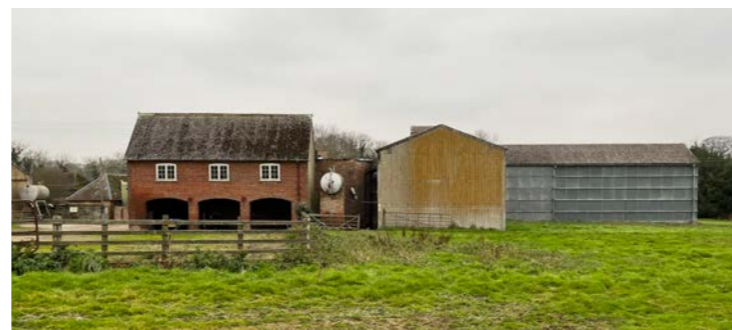
The oast is close to three stories in height, similar in scale to the main farmhouse with which it shares a strong visual connection (pictured top). Despite being stunted by C20 demolitions, its scale and brick gables makes it a key focal point on the site.

At ground floor level, the building has two primary rectangular spaces, one of which is open sided (picture above) likely forming a cart shed originally. From the main ground floor space, the square and round oasts can be accessed.

The construction appears to be solid brickwork - 1 brick thick in most places. The double pitched roof structure then bears onto these exterior walls, visible at first floor level.

The building features an ordered elevation to the east, whilst the south elevation features solid metal sliding doors at ground and first floor levels, with clear evidence of adjacent openings which have been blocked up with a mixture of timber sheets or brickwork.

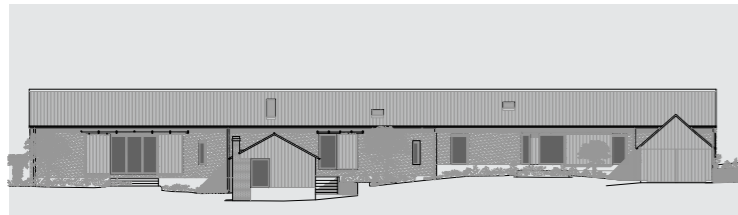
Above:  
Proposed Elevation

Given the historic imagery of this large building's footprint previously being inhabited by a threshing barn, a clear reference to the Kentish vernacular of blackened timber cladding has been introduced to the modern construction.

This also softens the appearance of the existing blockwork structure, while modern construction details, such as vertical board orientation and a matching metal roof prevent the proposed finishes from becoming trite or pastiche.

Given the large scale of the building, it is proposed to clean up and re-render a lower plinth of the blockwork to reference traditional building plinths in a way that is authentic to the age of the building.

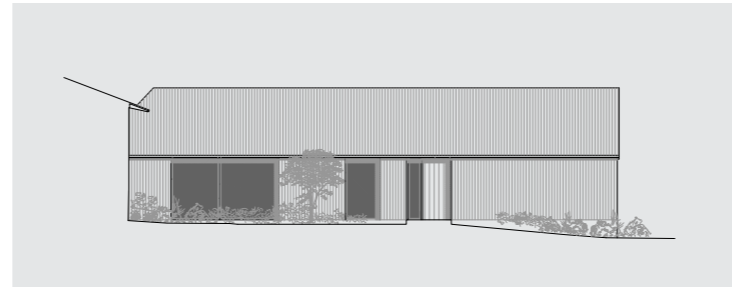
Above:  
Proposed Elevations

The byre is currently open sided with a character largely defined by its bayed construction and therefore elevations. Preserving the legibility of the building bays and large openings is central to retaining its agricultural character.

Smaller openings are very limited, retaining a relatively simple elevational composition, also referencing its agricultural origins.

The west gables faces onto the farmhouse and is proposed to be retained as a simple clad gable, in much the same way as it is as existing.

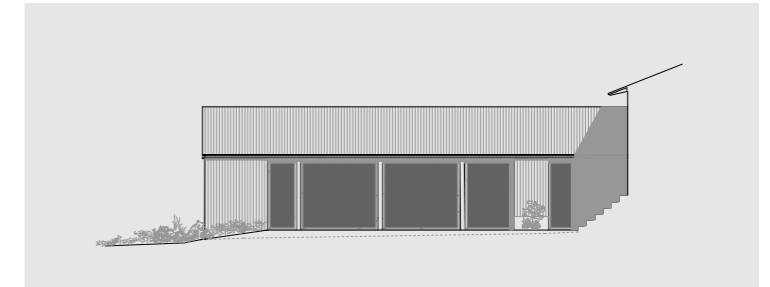
Above:  
Proposed Elevations

Similarly to the Byre, the Pigery is a bayed structure, however this gives way to a brick gable and chimney to its west end. As a defining feature of the building, a new picture window is proposed to emphasise the form of the chimney and proportions of the gable.

To the north side, the current structure is relatively solid, with minimal openings - this is reflected in the proposal which retains a relatively solid north elevation.

To the south is where the building bays are more overt, a feature which the proposal seeks to express in the elevation. This is carried forward to the adjacent landscaping, where the rhythm of the bays is reflected in the floor finish.

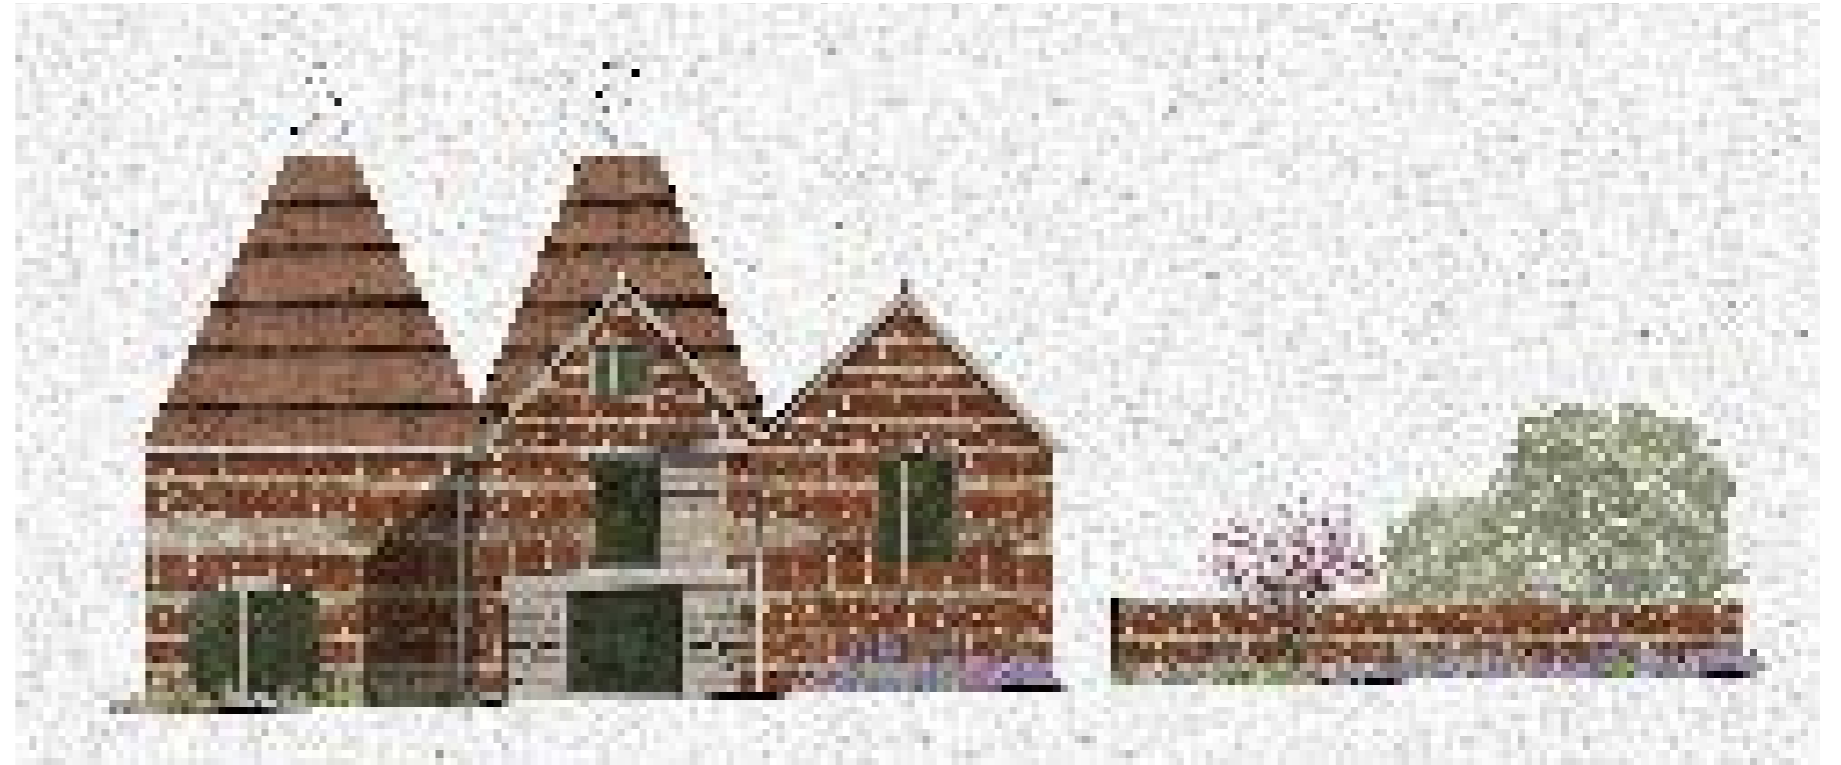
Proposals for the oast have been developed around existing openings in the building, and through re-opening bricked up openings in the facade. By using this approach to define the layout, this allows the proportions and brickwork on the building to remain the same, preserving its overall character.

Historic imagery reveals the scale and splendour of this building with operational oast roundals, which have since been removed, presumably to facilitate modern agricultural practices which currently project into the building (proposed to be removed).

The proposal seeks to re-introduce the oast roofs alongside general enhancements to the brickwork, mortar, windows and finishes. These enhancements would allow the building to stand proudly as a core element of the re-juvenated masterplan scheme, with a visual connection directly between the farmhouse and oast.

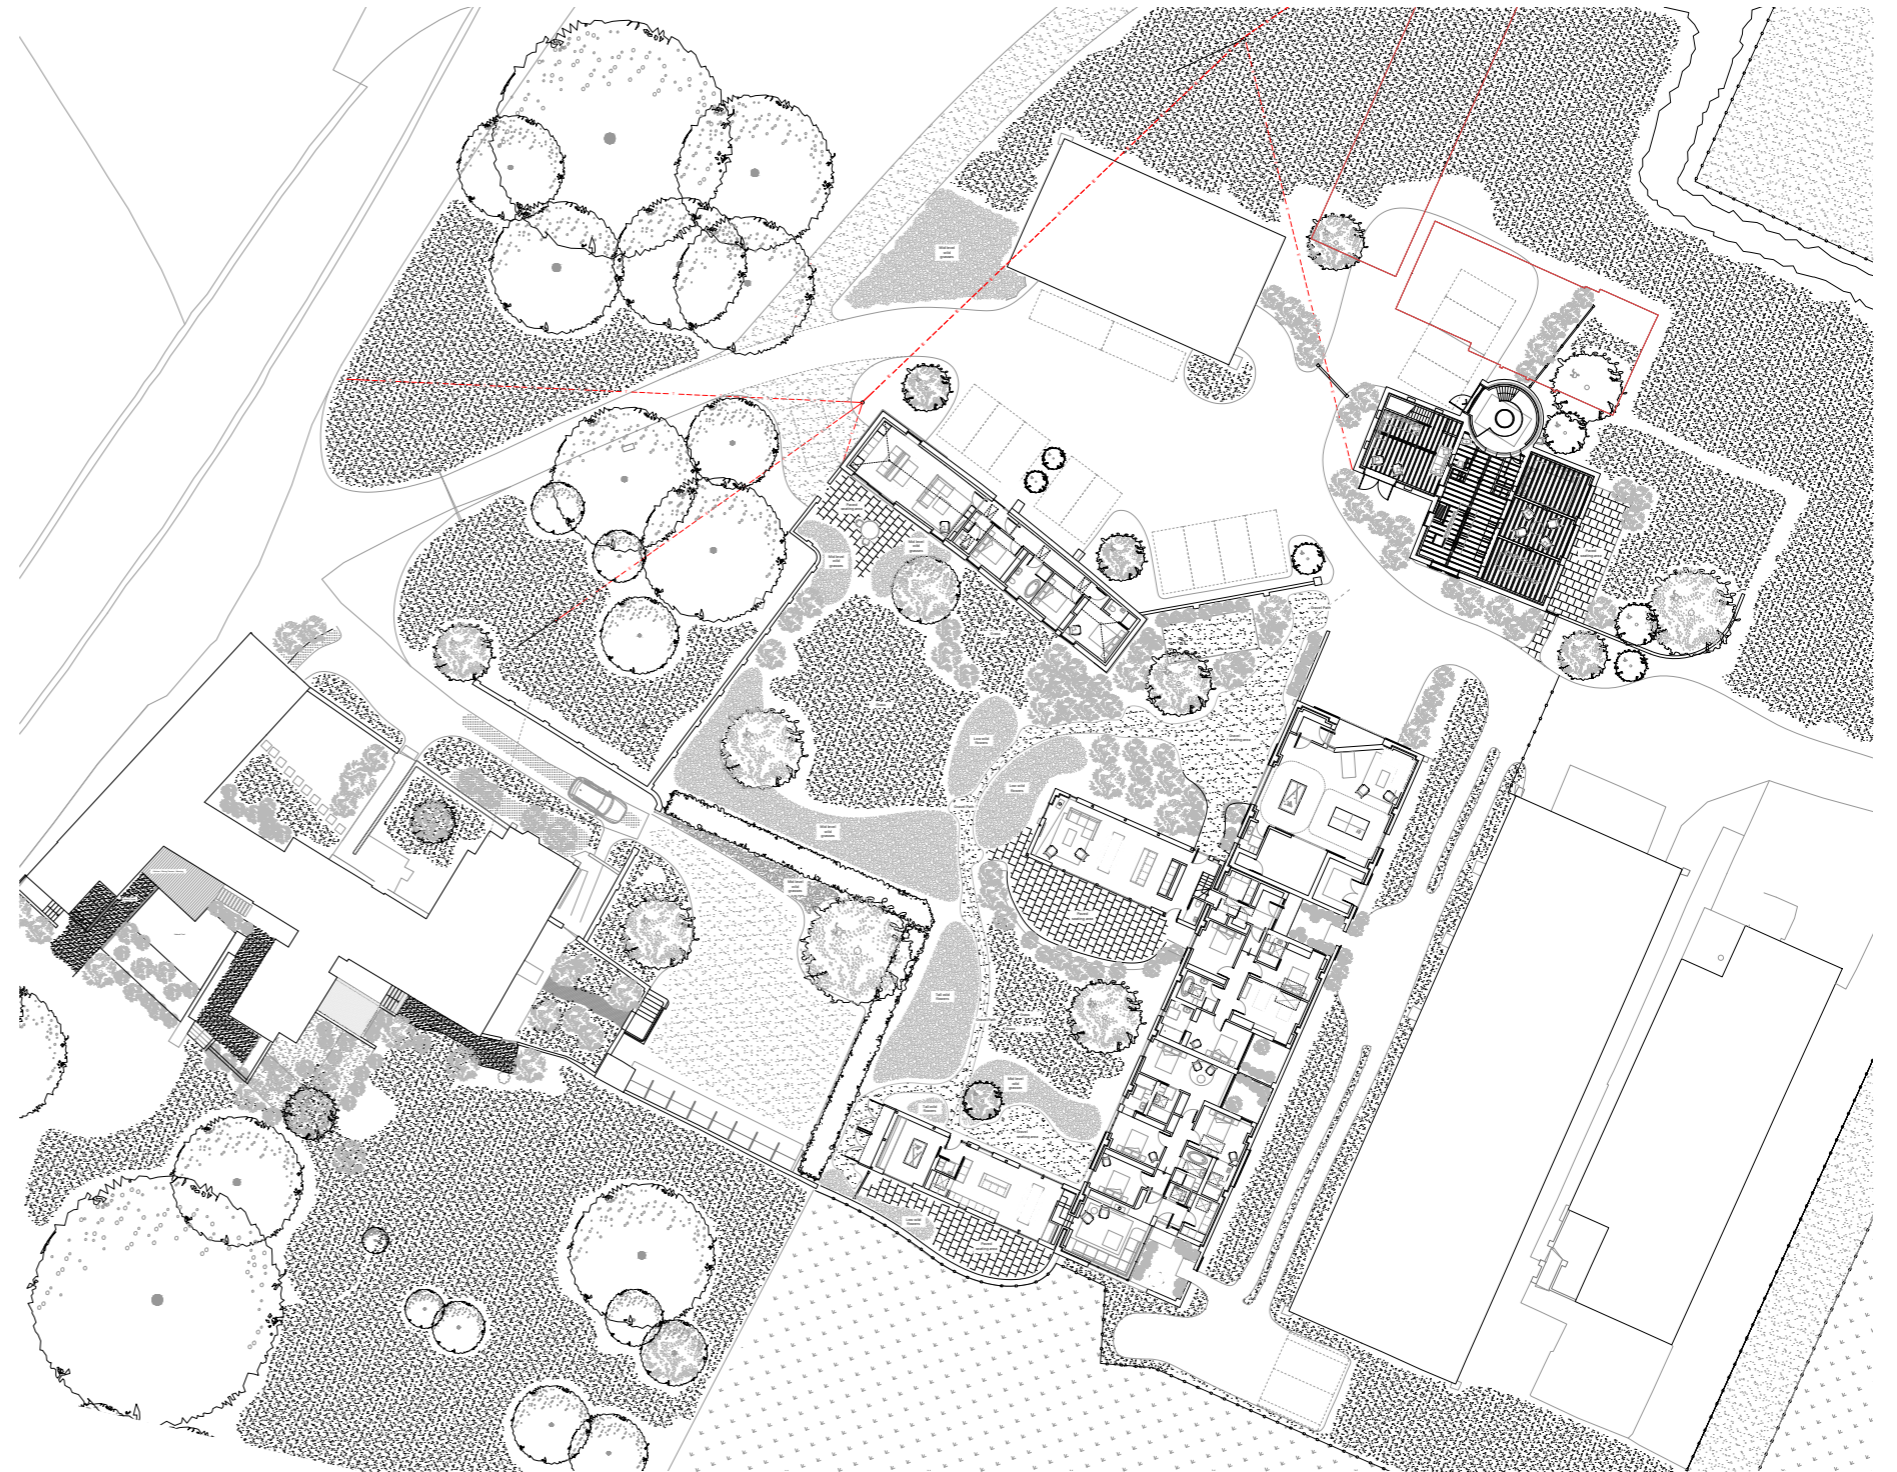
Above: Proposed Masterplan Landscaping Strategy

Landscape enhancements are informal, with planting and soft boundary conditions driven by traditional farmsteads and referencing the local planting.

By focusing on the quality of the farmstead and its historic qualities, the setting of the grade II listed farmhouse is intrinsically improved without the need to create additional substantial visual barriers. Nevertheless, soft planting buffer zones have been created at low level to help enhance the general setting of the farmhouse.
