**12 Harefield
Cottages**

Lympstone

**Bat and Breeding
Bird Survey**

**Client: Mrs Hindle &
Mrs Wootton
Project no. 2324094
Issued: December 2023**

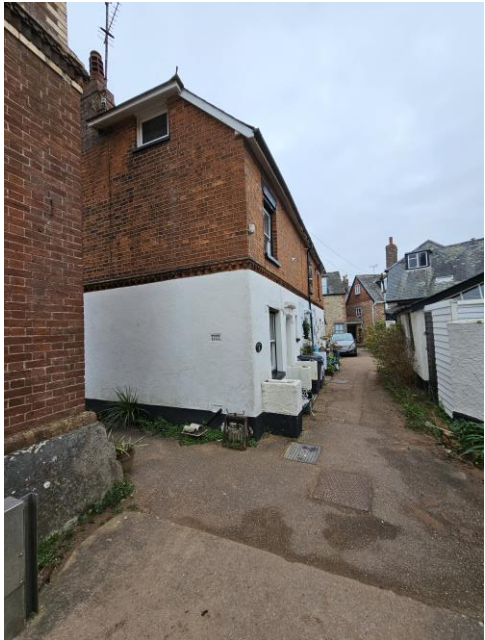
Wall construction	Brick
Roof construction	Timber framework with a covering of slates with a bitumen felt lining.

Photograph 1: 12 Harefield Cottages

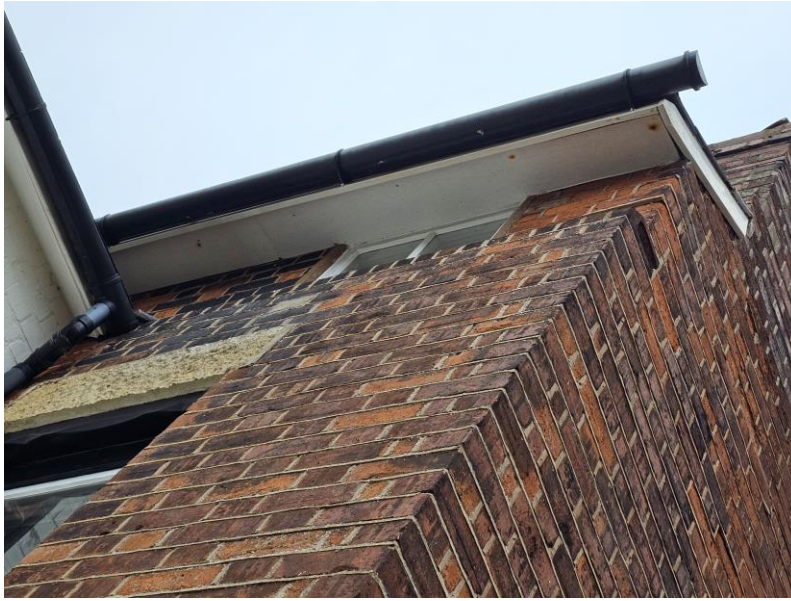
Photograph 3: Close up of the sealed soffit to wall top join where the north elevation dormer will be located

The building had very limited roof spaces as rooms had been built into the roof structure along with roof lights and an existing dormer. The eaves roof spaces were fully inspected with a torch and an endoscope to view behind the bitumen felt. No bat field signs were found. The wall to soffit join was inspected with binoculars from the ground and appeared sealed (refer to Photograph 3 which shows where the proposed northern elevation dormer will be located). The south elevation dormer location had no slipped or missing slates and no wall top gaps that could be exploited by bats to gain access to the roof structure.

In combination the absence of bat field signs within the small roof spaces or behind the felt lining, the limited works to the roof coverings to construct the dormers and their location in areas that appeared in good condition with no potential bat access points enabled the assessment that the areas proposed for the works offered no bat roost potential.
