One Call
Roofing Solutions

Grade II Listed Buildings Roof Repair Image Annotation Guide

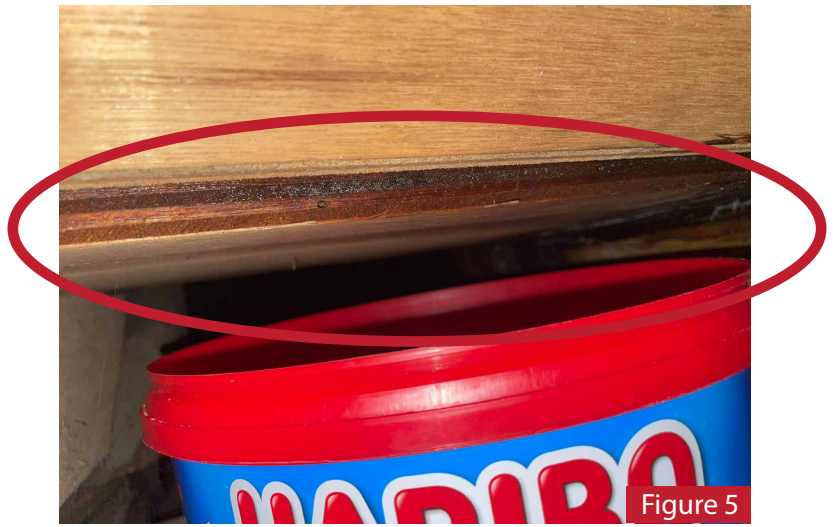
Figure 5

Water ingress onto existing lay-board

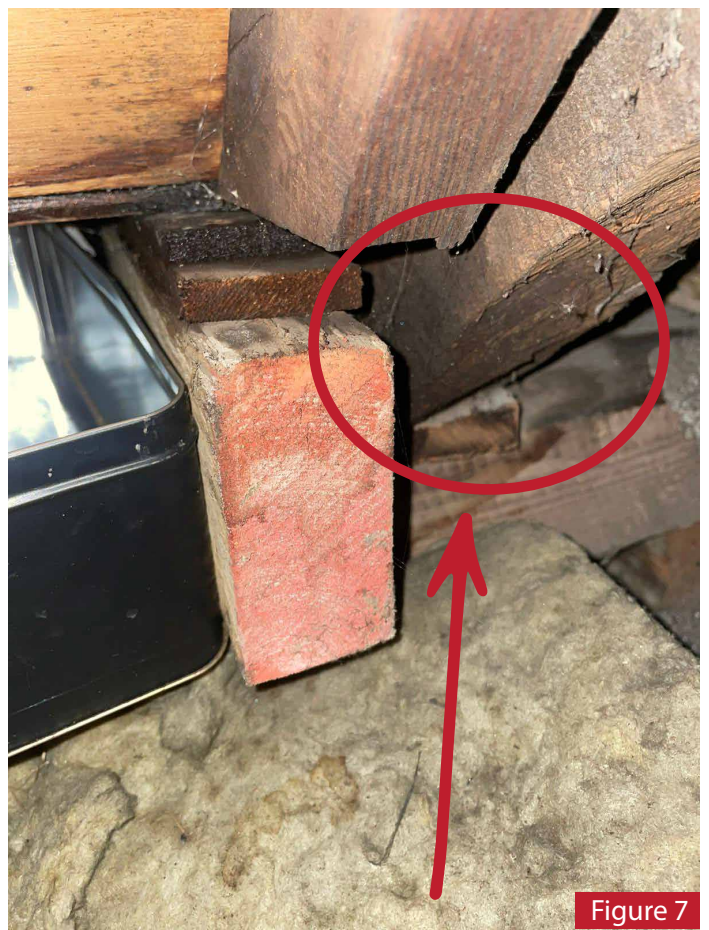
Figure 7

Evidence of water damage resulting from an extended period of leakage.
