57 NIBLETTS HILL, BRISTOL

Report Ref: p46.0.1

Title: Phase 2 Land Contamination Assessment

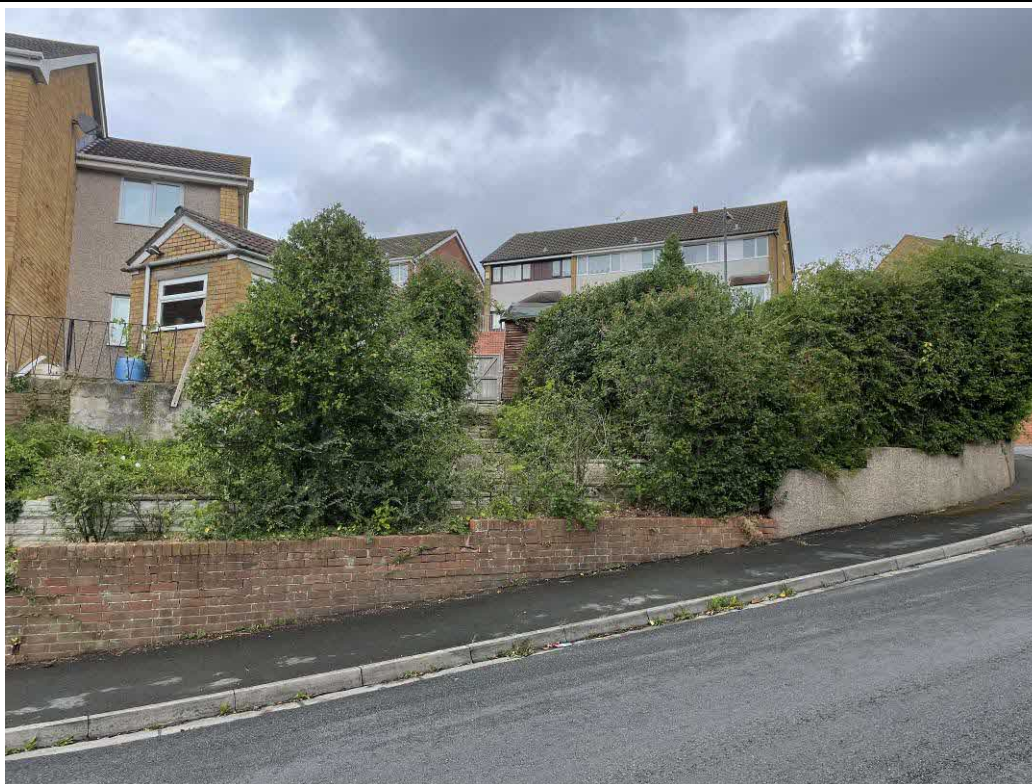
Plate 1

Facing north towards site from Niblett's Hill.

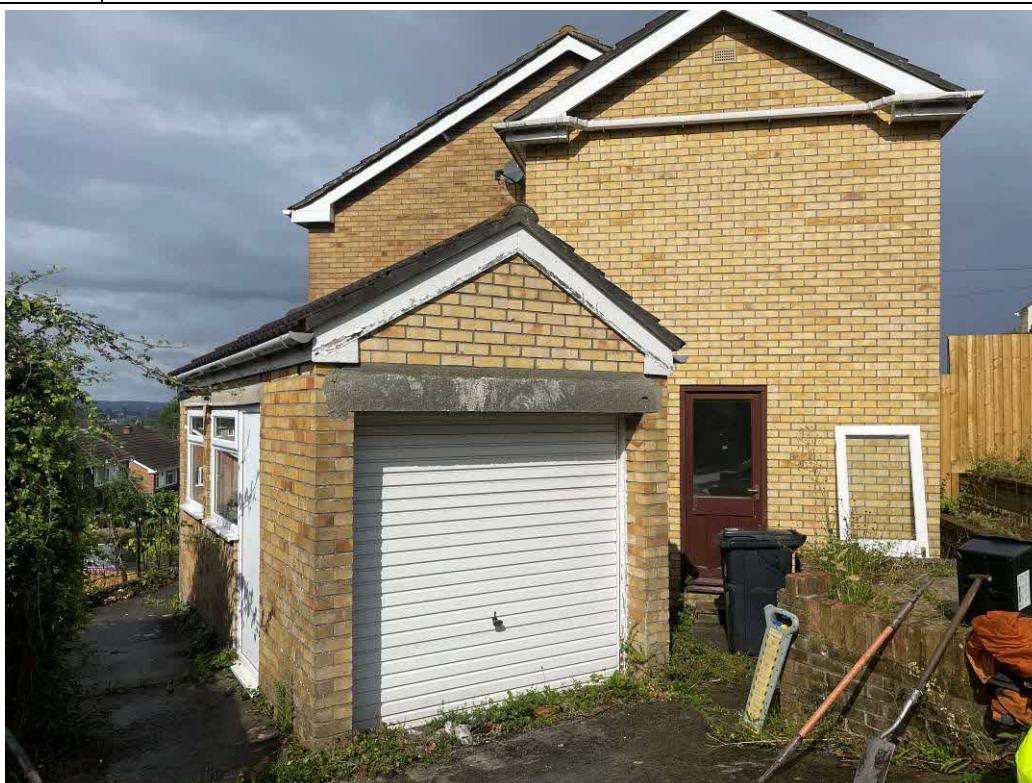
Plate 2

Facing west towards garage and extension.

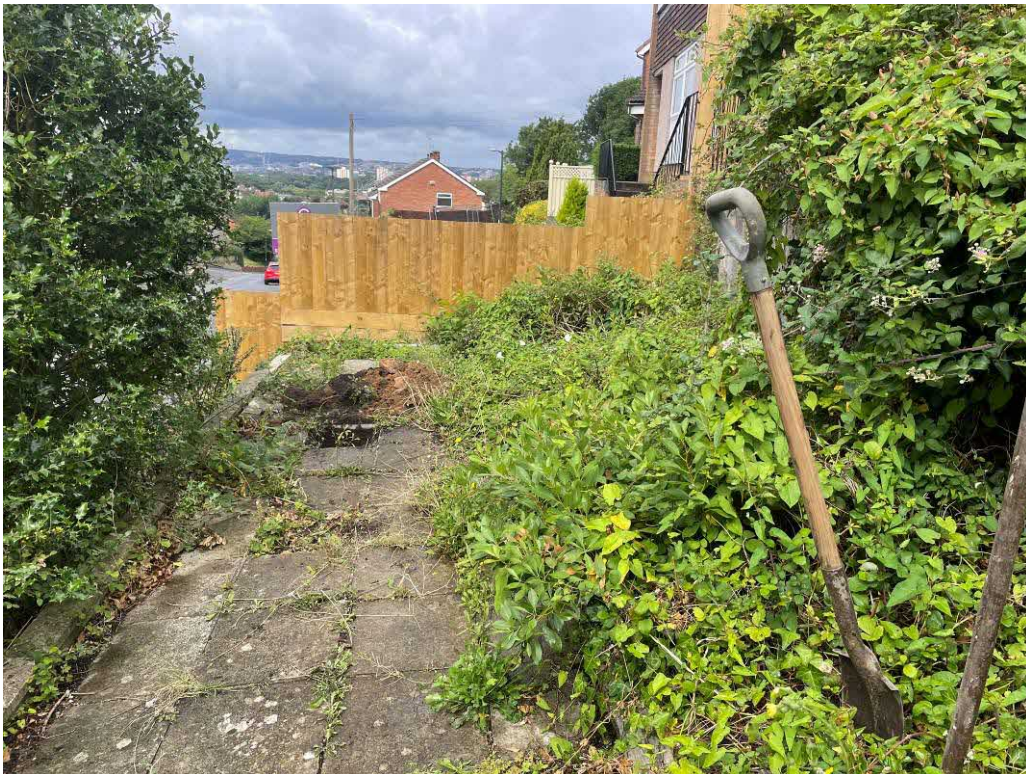
Plate 3

Facing west across paved and garden areas in the south of the site (location of HDP5 (foreground)). Properties along Niblett's Hill beyond.

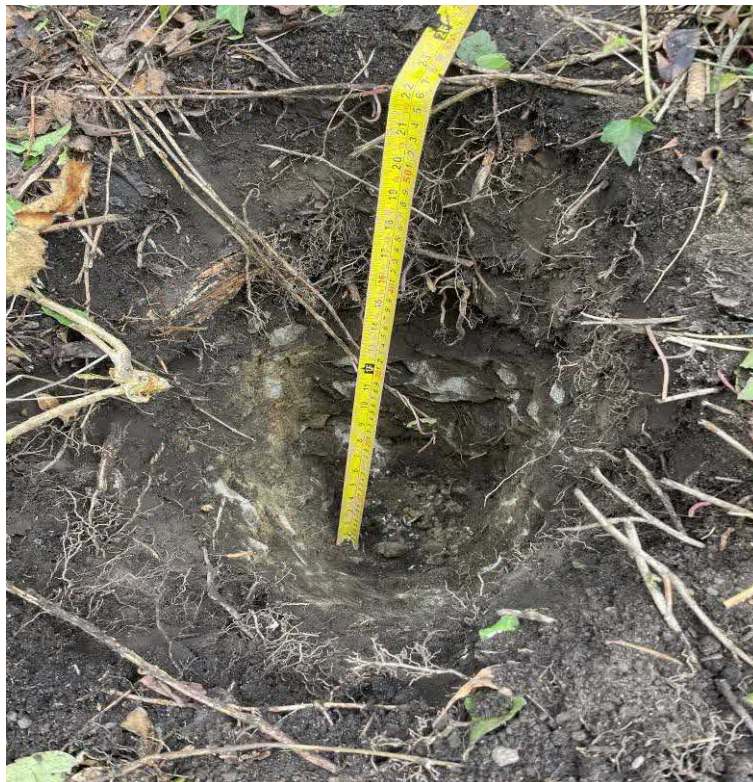
Plate 4

It is noted that the exceedances of arsenic and lead have been recorded in a sample of the made ground (HDP2 at 0.1 – 0.2m) that will be located within an area of hardstanding (driveway) as part of the proposed development. This has been taken into consideration within the risk assessment for the site although the result has not been disregarded given the number of samples and as the made ground encountered in this location was not distinct from that encountered across the remaining site area.

Encountered ground conditions in HDP2.

Given the localised nature of the recorded contaminants of potential concern within the shallow made ground - recorded within an area of proposed hardstanding only - additional testing may be undertaken at final site levels to confirm the requirement for remedial measures at the site.

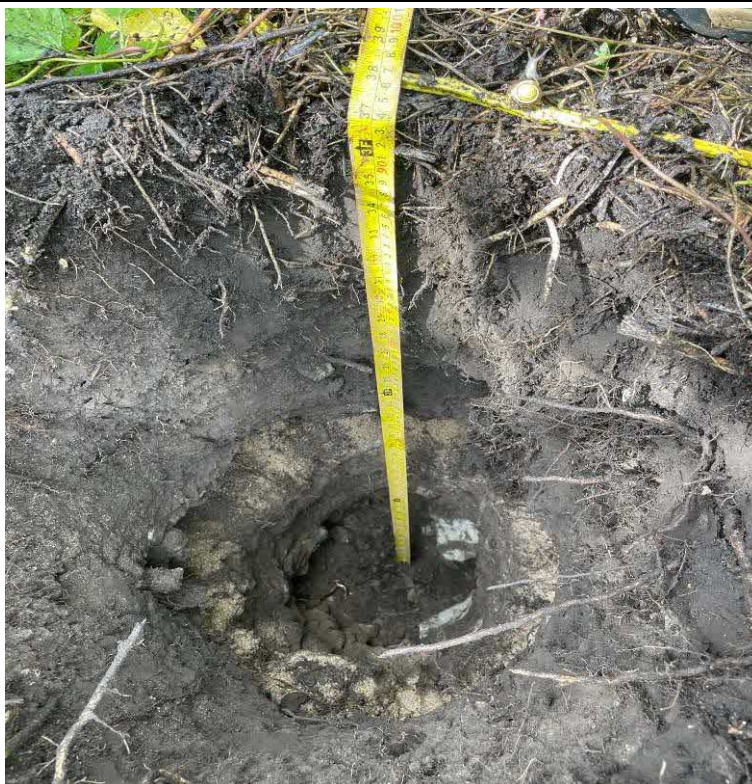
Plate 5

Within HDP3, a band of light brown medium to coarse sand with gravel of fine red brick was recorded between 0.5m and 0.65m below ground level (bgl).

Encountered ground conditions in HDP3.

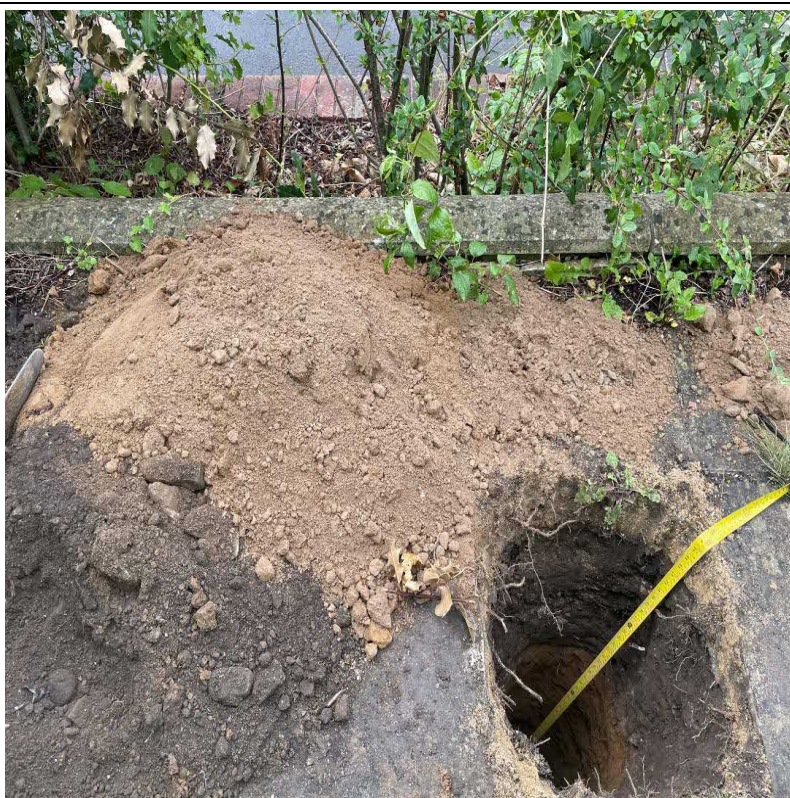
Plate 6

The Downend Member sandstone was encountered in all locations below the made ground. Within HDP5, an upper completely weathered deposit of orangish brown gravelly silt sand (gravel of sandstone) was encountered. Underlying this - and encountered below the made ground in all remaining locations - the Downend Member was recorded as weak to medium strong very thinly bedded, light grey and red or orange stained, fine to medium grained sandstone with some silty sand infill.

Encountered ground conditions in HDP5.
