Bat Survey Report

Kirklands of Cluny steading and house

Date: 15/6/2021

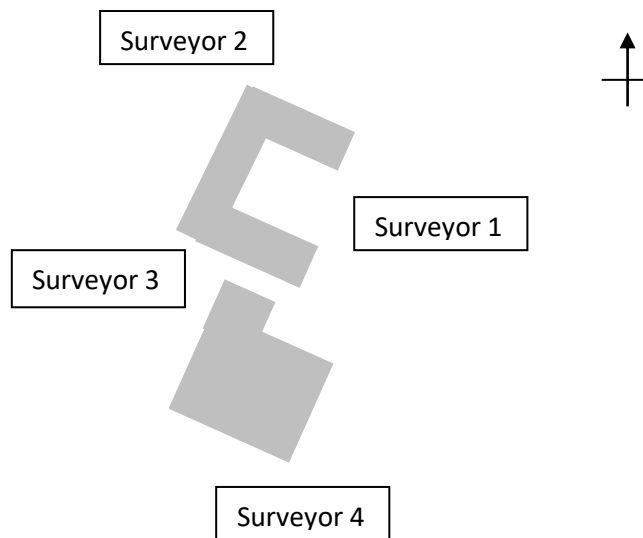
Dusk and dawn surveyor locations

The aim of the study was to establish if bats were present and if so, which species. The buildings were checked for signs of bat use, such as droppings, staining or moth wings with a strong torch. Emergence and dawn surveys were carried out by 4 surveyors using BatBox Duets, and Anabat Express static detectors. The location of the surveyors is shown below. Bat calls were analysed using Anabat Insight.

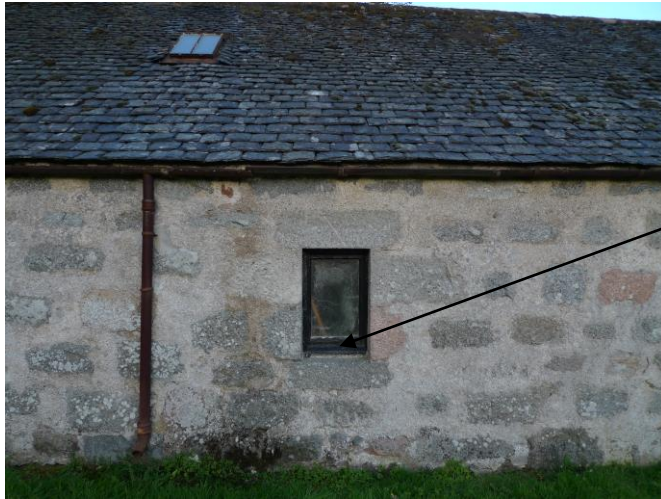
The house had no external evidence of a bat roost. There are no attics, so the house itself was not accessed. The steading was checked internally for signs of bats, including accessing two loft areas, both with high light levels. The only signs of bats were found on the west side of the steading where there were three bat droppings on the exterior of a window ledge with a more extensive scatter of old droppings in the corresponding area inside the steading.

Roost E - droppings on sill below bat accessible gap at top of window. There are droppings in the area inside.

- Converting and re-roofing the steading will lead to the loss of Roosts A, B, D and E.
- Compensatory bat roosts can be erected following bat worker advice
- Roosts C and F will be unaffected by works to the house. No mitigation is required for these roosts.
- **A bat licence from NatureScot will be required to allow the works to proceed, based on an agreed bat species protection plan – see Section 7 on page 9.**

5. **Steading** - Roofing materials to be removed carefully by hand with a bat worker present for the stripping of materials on the vicinity of roosts, at least until such time as they are satisfied that bats are unlikely to be found.

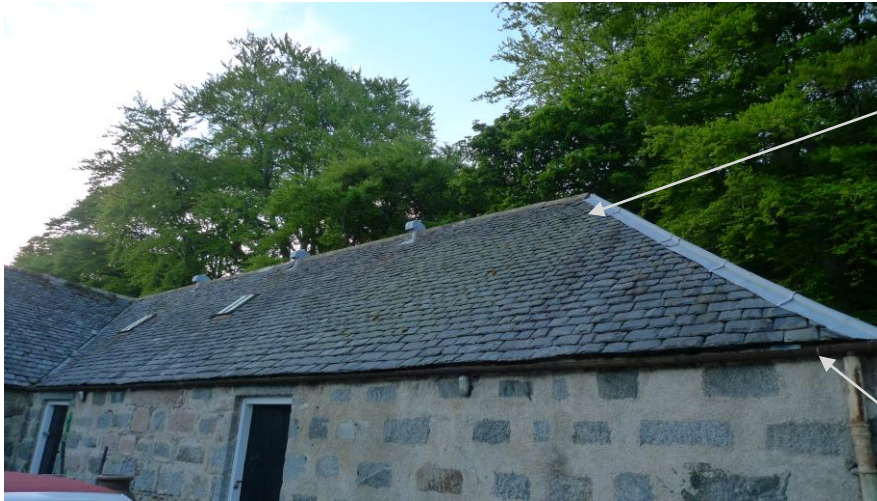
Roost A – non-breeding soprano pipistrelle roost of one bat. Under slate 6 down from top

Roost B – non-breeding soprano pipistrelle roost of one bat. Behind gutter by gutter bracket.

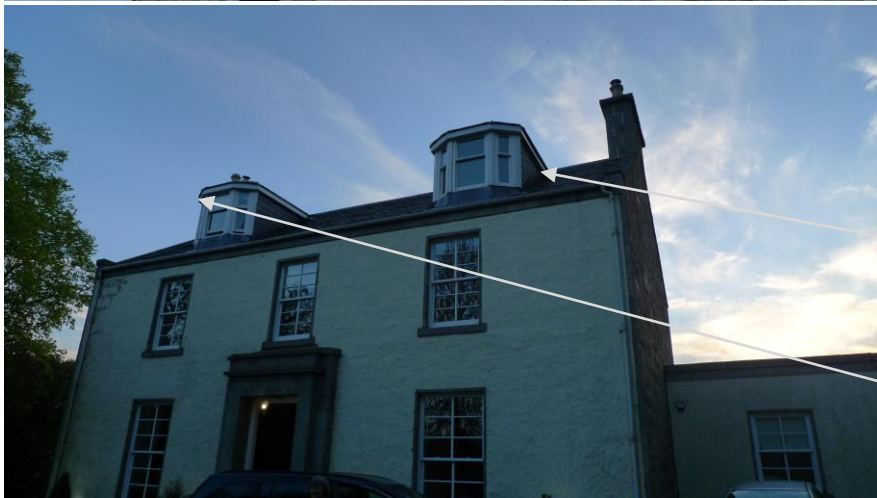
Roost C - non-breeding soprano pipistrelle roost of one bat. Back right of dormer.

Roost F – soprano pipistrelle maternity roost identified in 2011 on left hand side of dormer but not currently active

6. **House** – no works to be carried out on roof without seeking advice from bat worker.
7. Workers to be briefed on what to do if bat is found. Gloves must be worn if handling a bat.

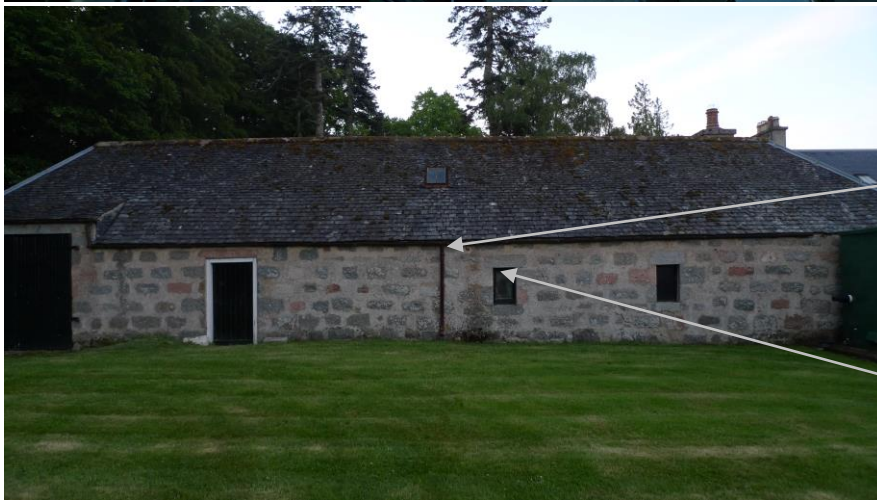
Roost D - non-breeding soprano pipistrelle roost of one bat. At wall head next to downpipe

Roost E - non-breeding pipistrelle roost accessing top of window and interior – not active during surveys
