Re: PRELIMINARY ROOST ASSESSMENT at POULNER FARM HOUSE, 5 BUTLERS LANE, RINGWOOD, BH24 1UB

ANNEX I: SITE PHOTOGRAPHS

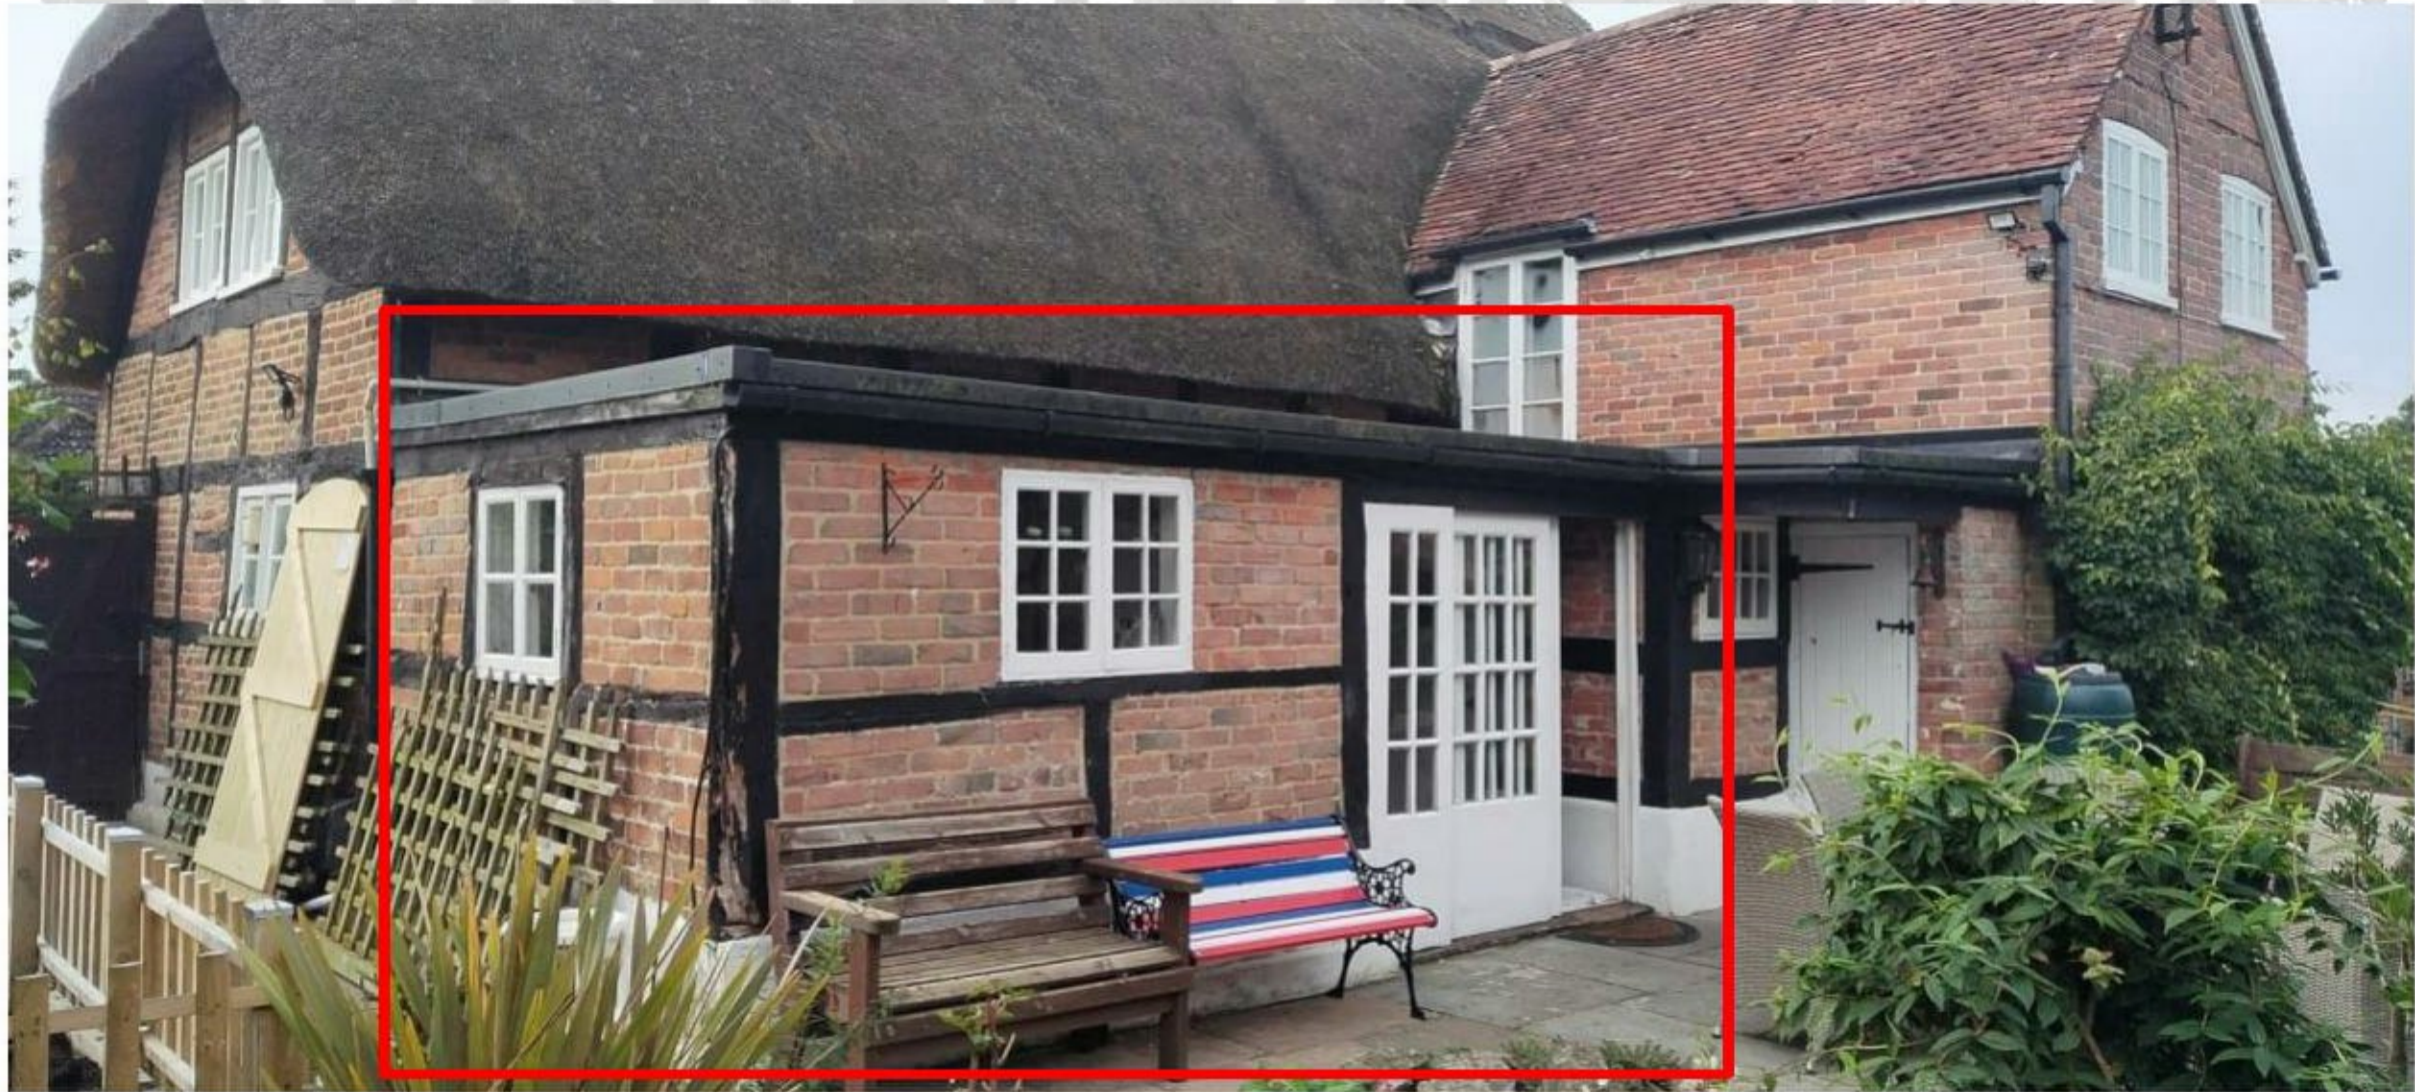
The flat roofed extension (**Photograph 1**) that is proposed for demolition & rebuild is a single-storey flat roofed structure with no internal roof void. It is constructed from a mix of brick infill around wooden beams and supports wooden doors, windows and fascia boards. The bricks within the walls are well sealed with no areas of missing mortar or other crevices that could be utilised by roosting bats. Similarly, the fascia boards are tightly sealed to the walls and do not provide sufficient gaps that could provide bat roosting habitat.

Photograph 1: Flat roofed extension scheduled for demolition & rebuild

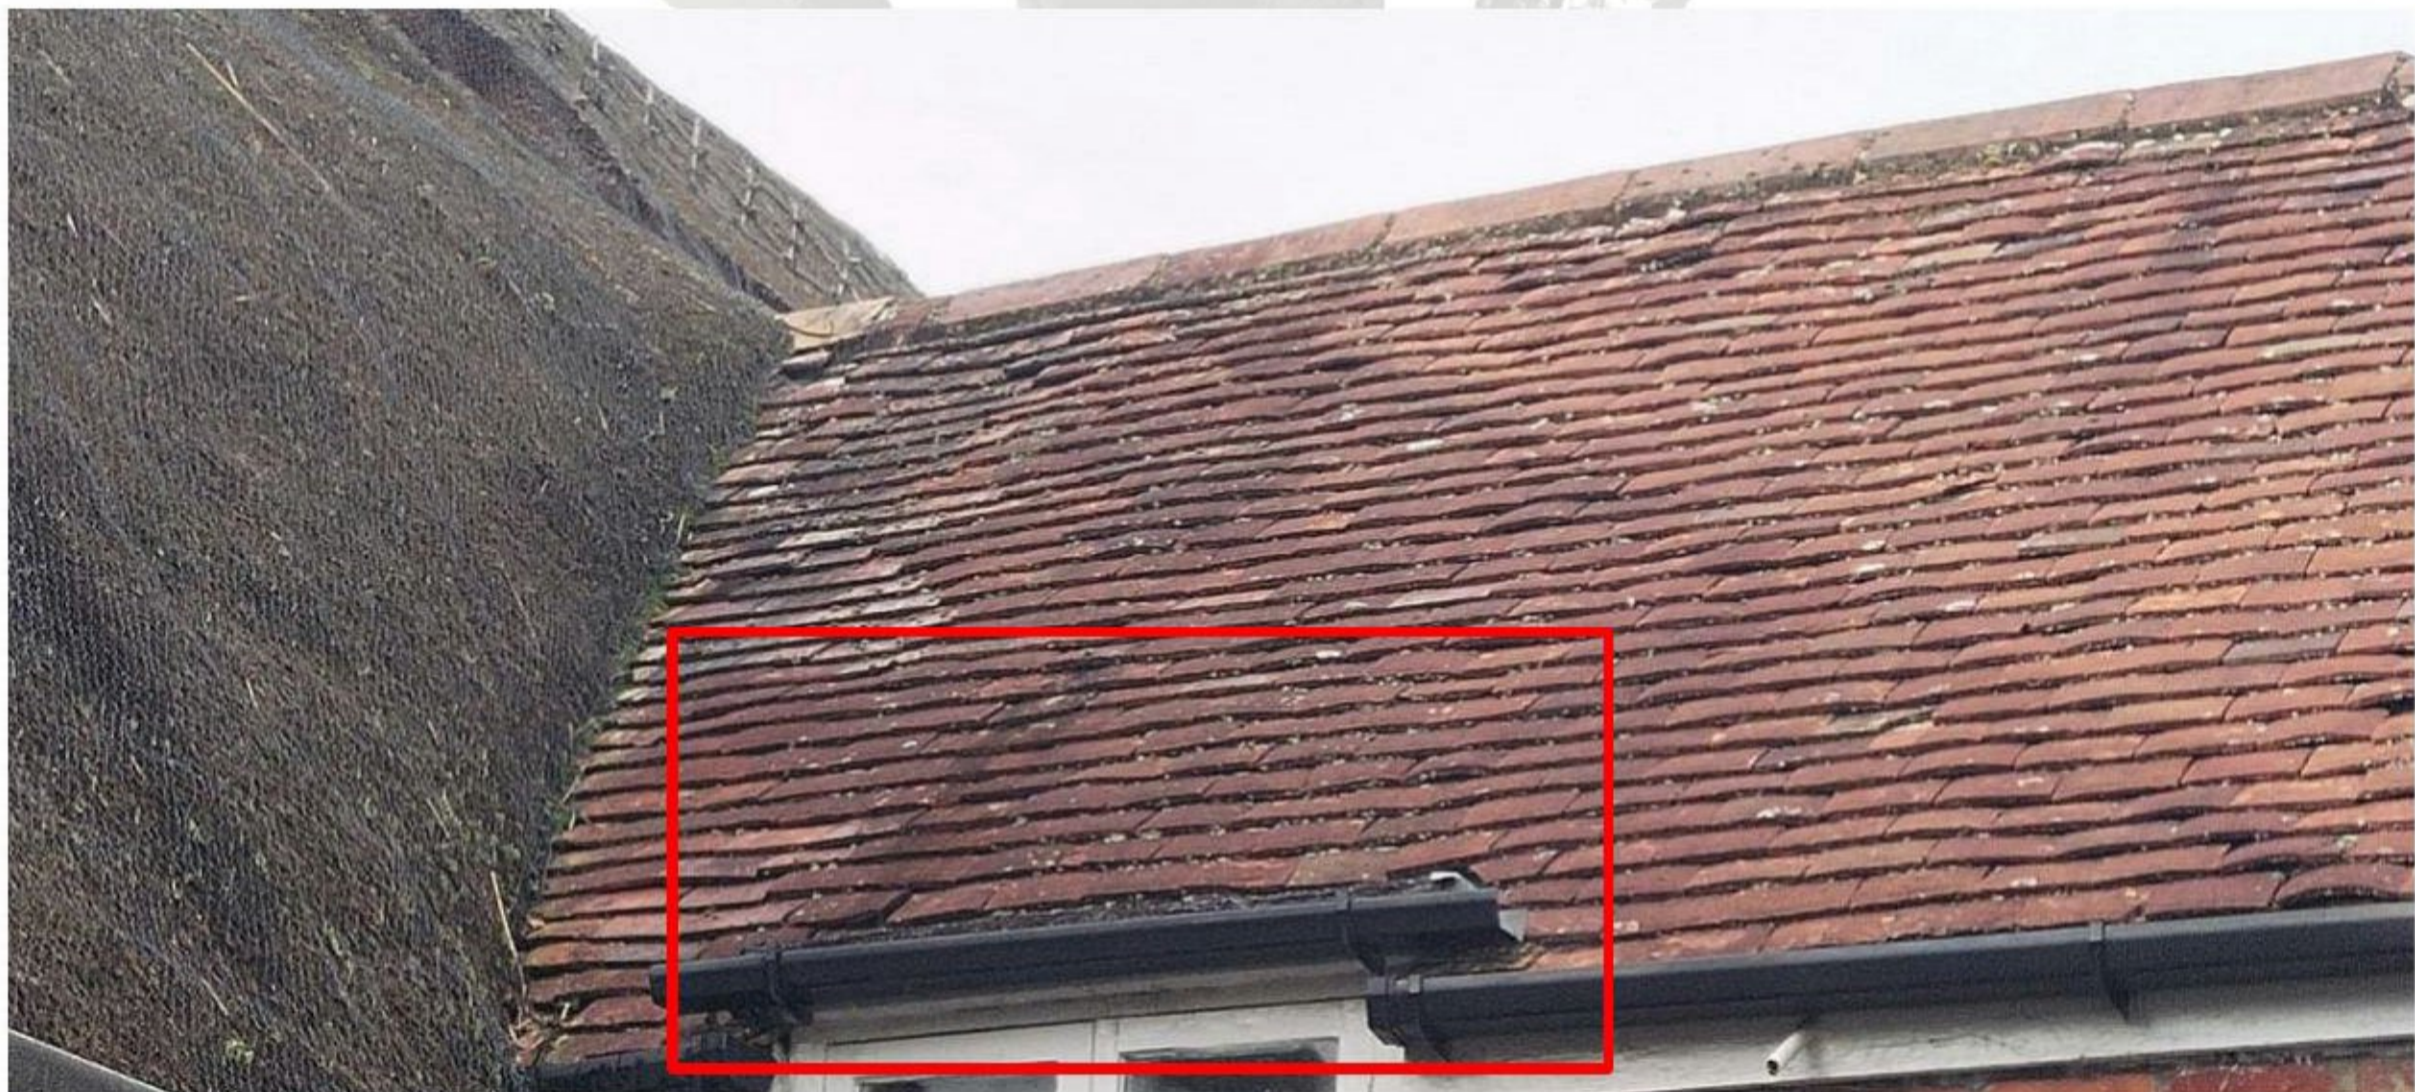
The first-floor window on the main dwelling (that is proposed to be converted to a door on to the new balcony) is tightly sealed to the walls. The roofing tiles in the affected area are also well-fitted (**Photograph 2**) and no evidence of bat presence was recorded within the internal roof void. No evidence of bat presence (bats, droppings, feeding remains, etc) was recorded anywhere within the main farm house.

Photograph 2: Tightly fitted roof tiles in location of proposed door

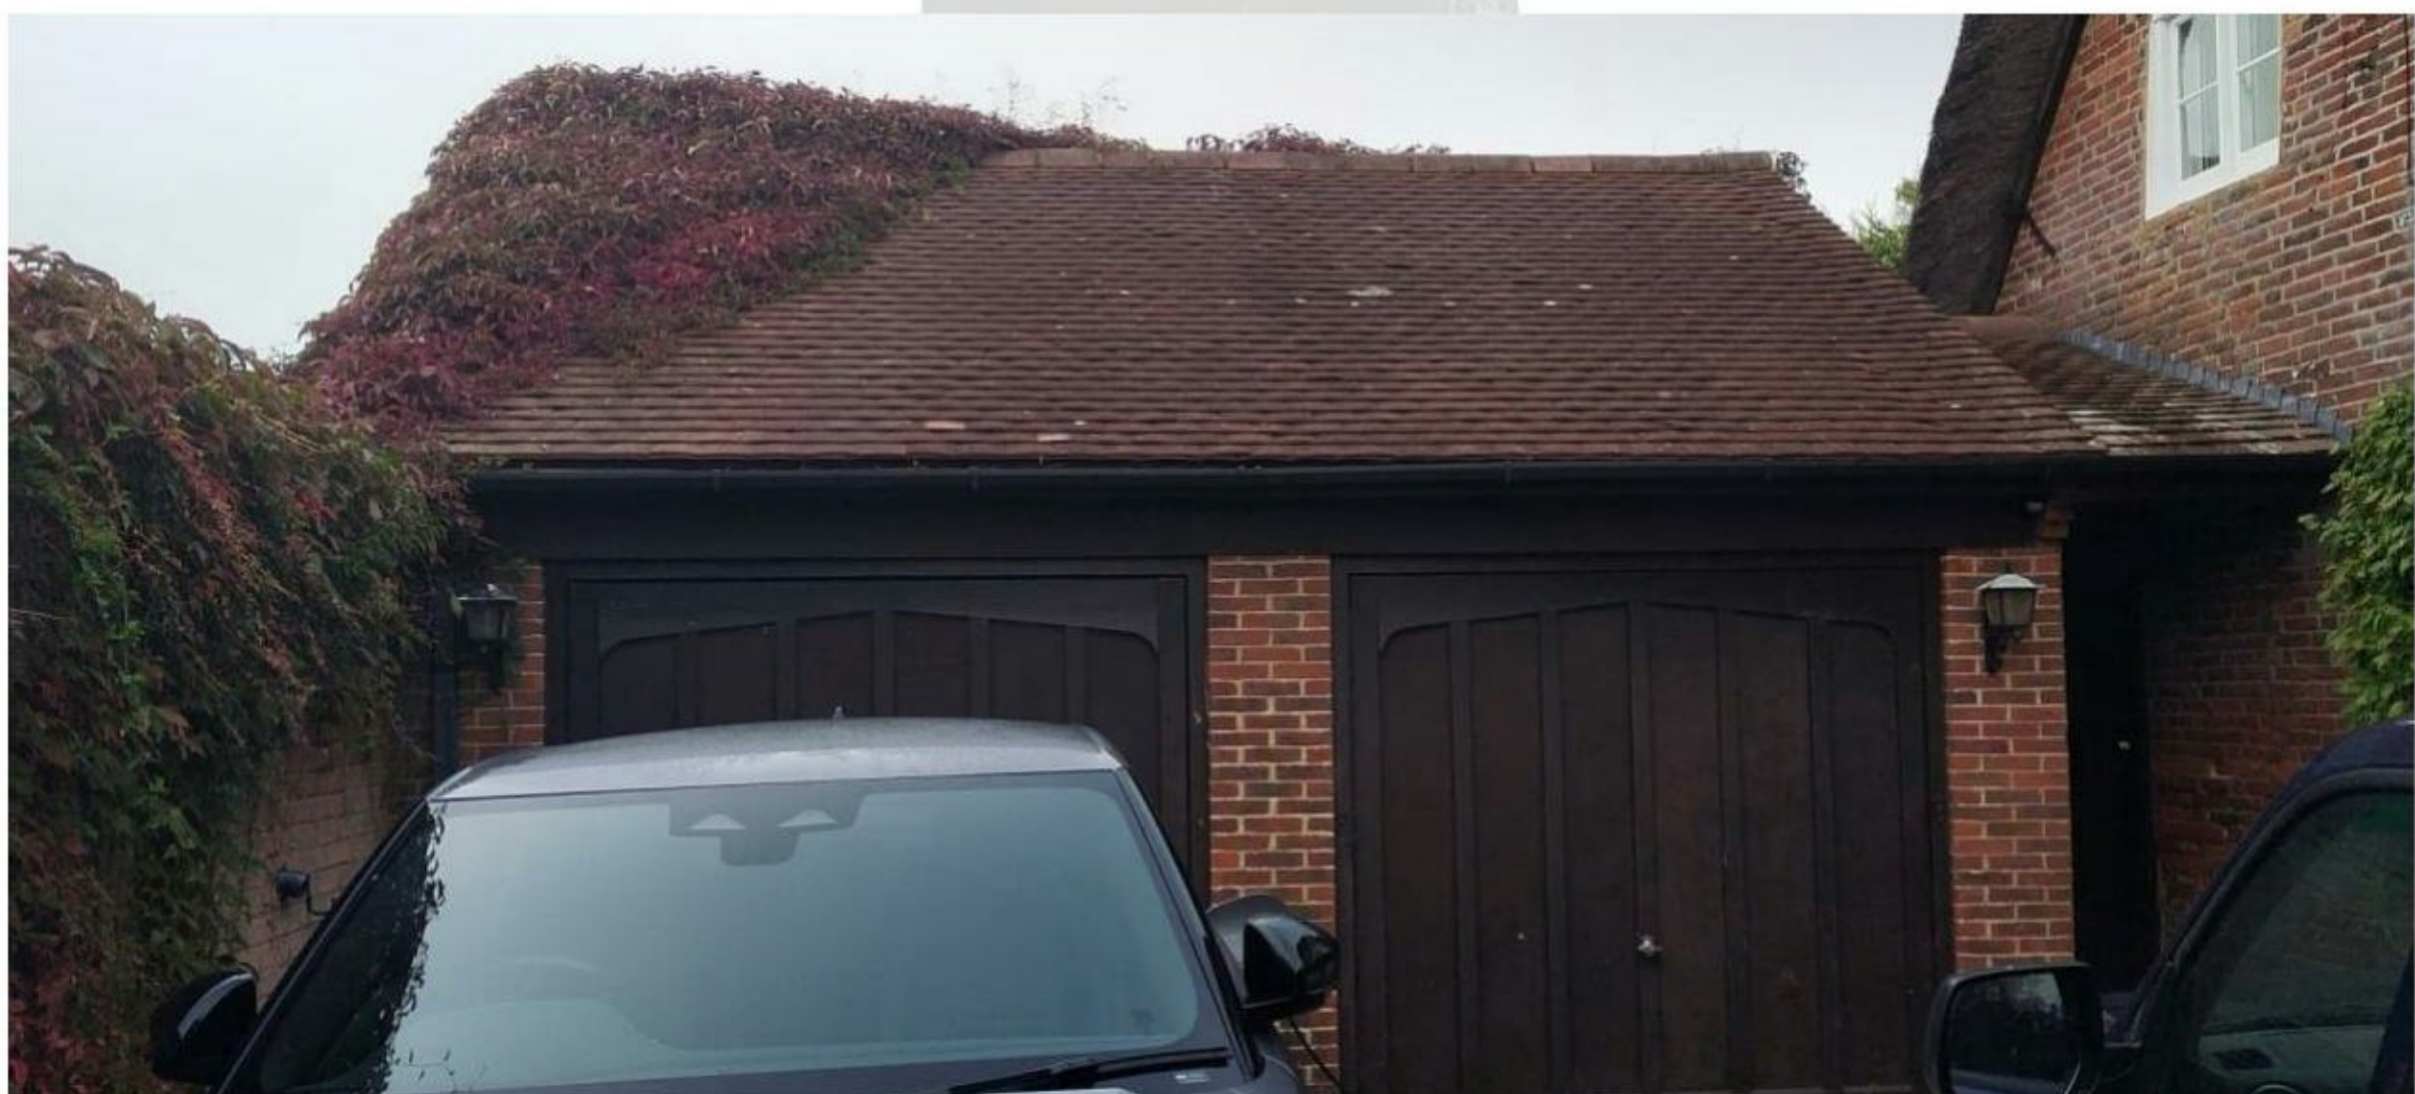
The existing garage (**Photograph 3**) is constructed from single-skin brickwork and supports a single pitched roof covered in flat clay roofing tiles. It supports a wooden boxed soffit that is tightly sealed to the walls (**Photograph 4**) and contains double-garage doors to the front and a large door to the rear. The roof void (**Photograph 5**) contains struts & perkins, is lit at one end by a window and is lined with a bitumen style roofing membrane. It is largely un-boarded with some areas of fibreglass fleece insulation. No evidence of bat presence was recorded within the roof void and no light gaps to the outside were visible (that would indicate bat access points).

Photograph 3: Detached garage

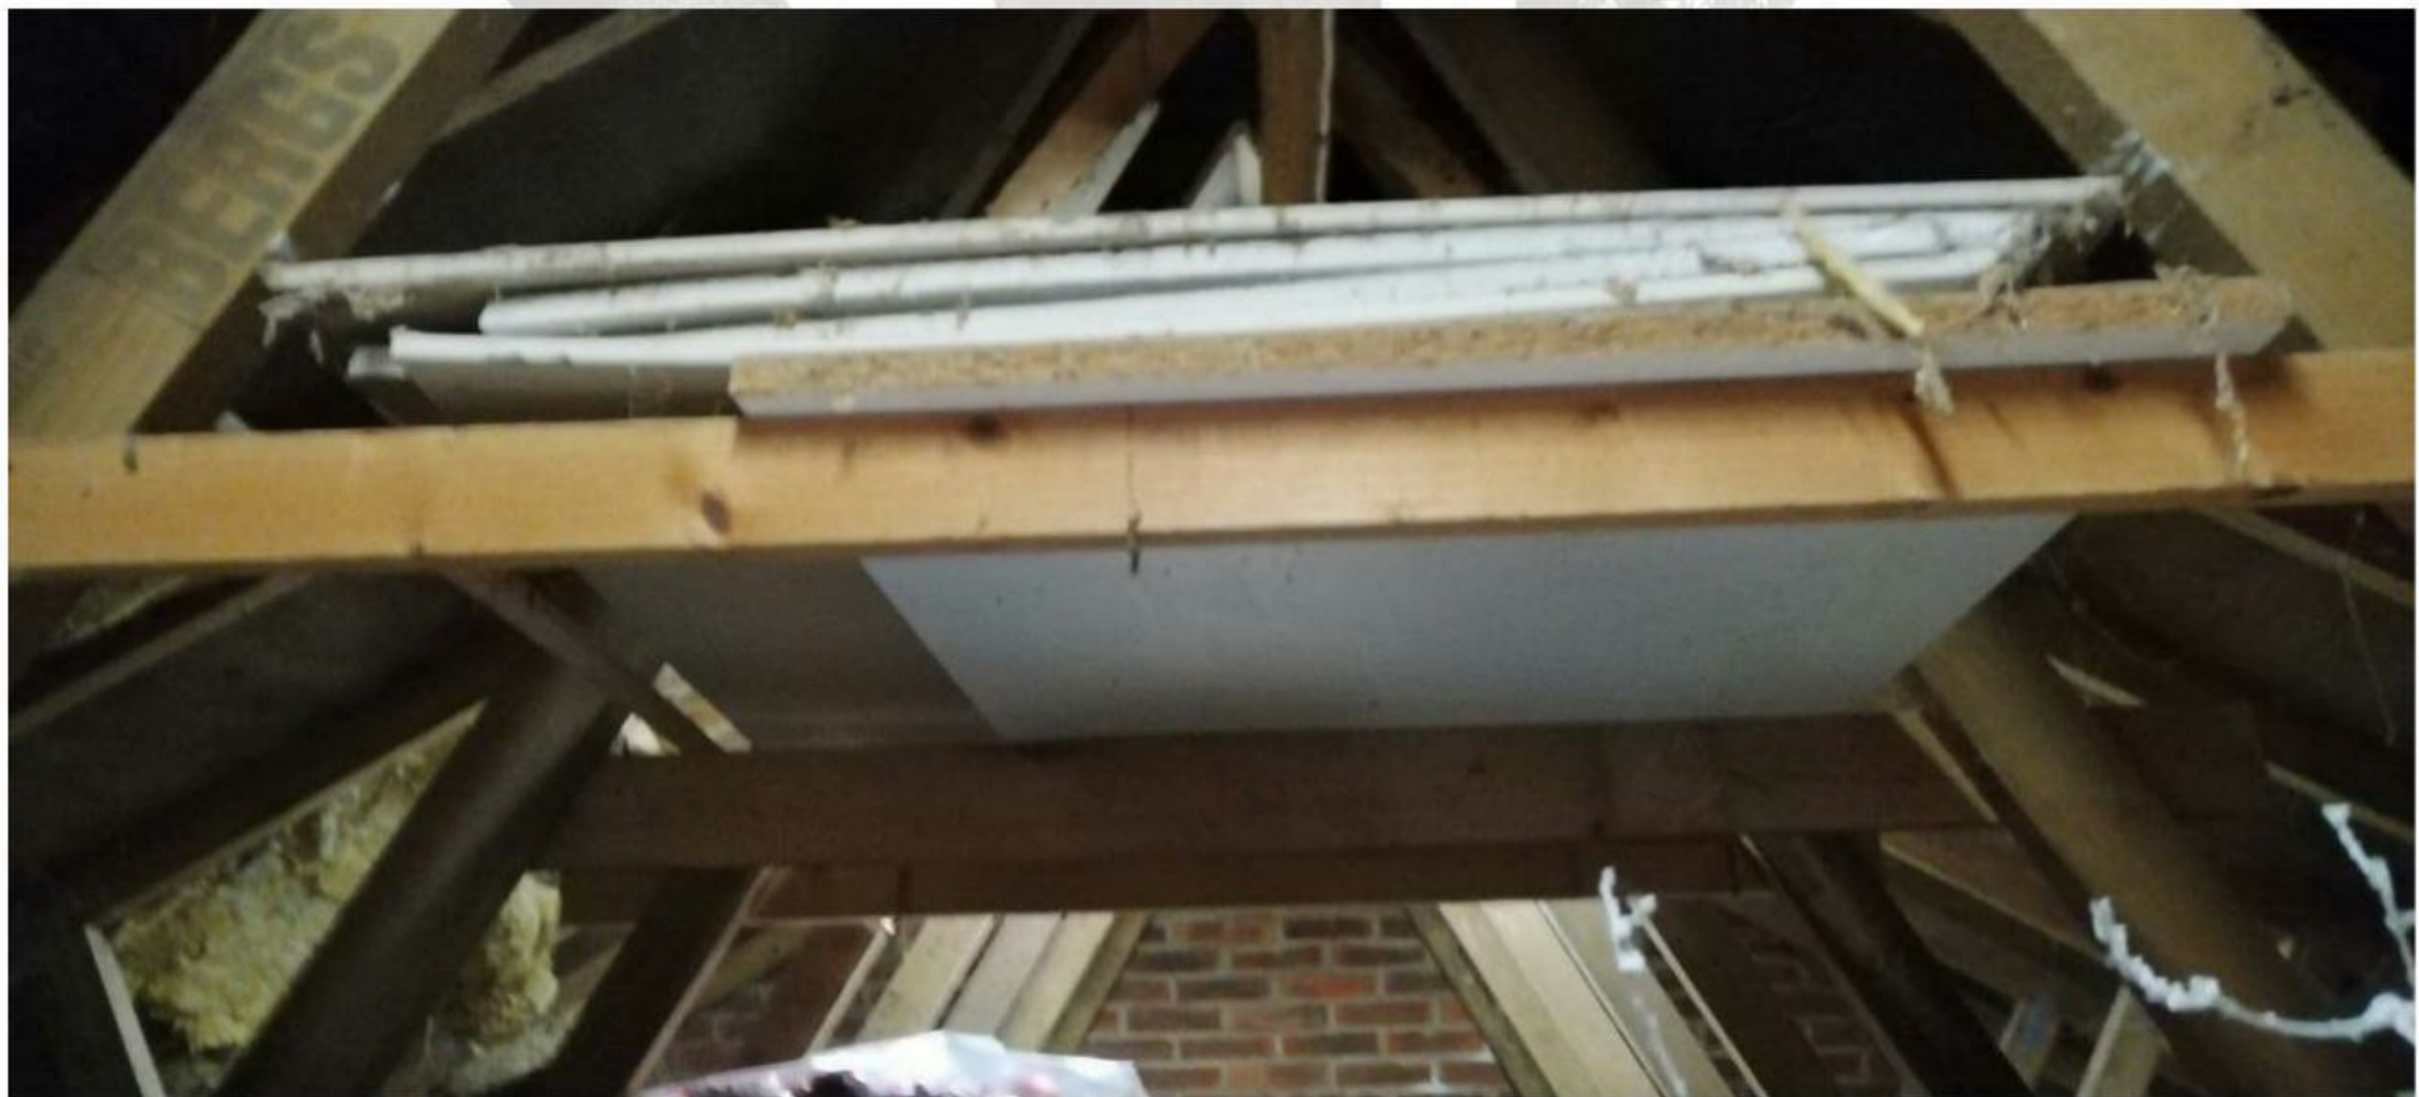
Photograph 5: Garage roof void

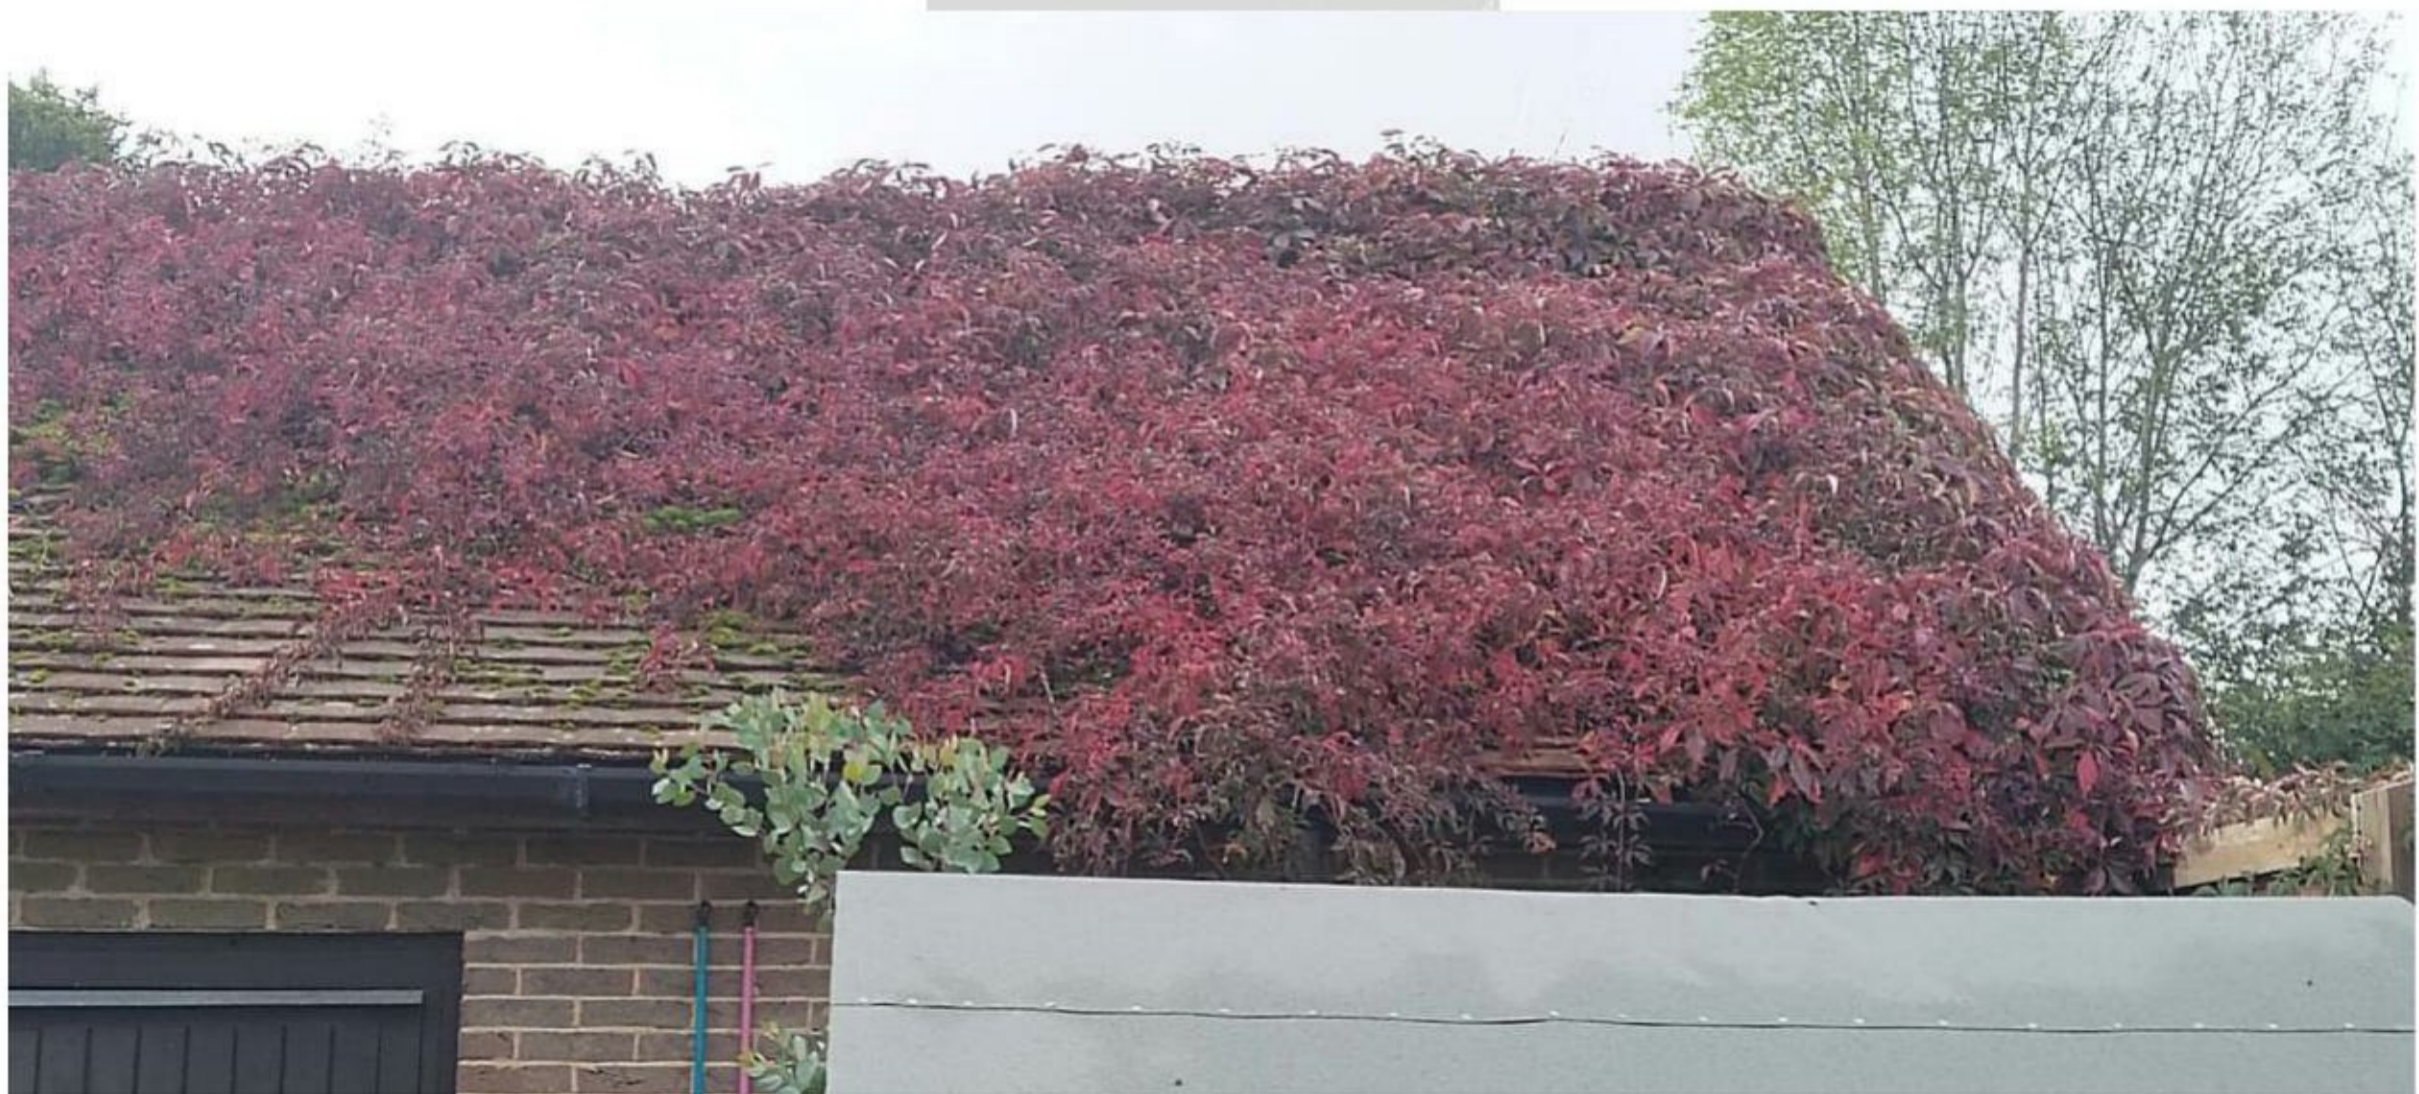
Externally, the part of the garage that will be affected by the proposals is heavily covered in Virginia creeper (*Parthenocissus quinquefolia*) (**Photograph 6**). The density of this vegetation precluded a full external inspection but equally precludes bat access due to the density of the foliage.

Photograph 6: Virginia creeper on garage that precludes bat access

It is recommended that the Virginia creeper on the garage is removed outside of the nesting bird season (which runs from March – August inclusive) to avoid any impacts on nesting birds.

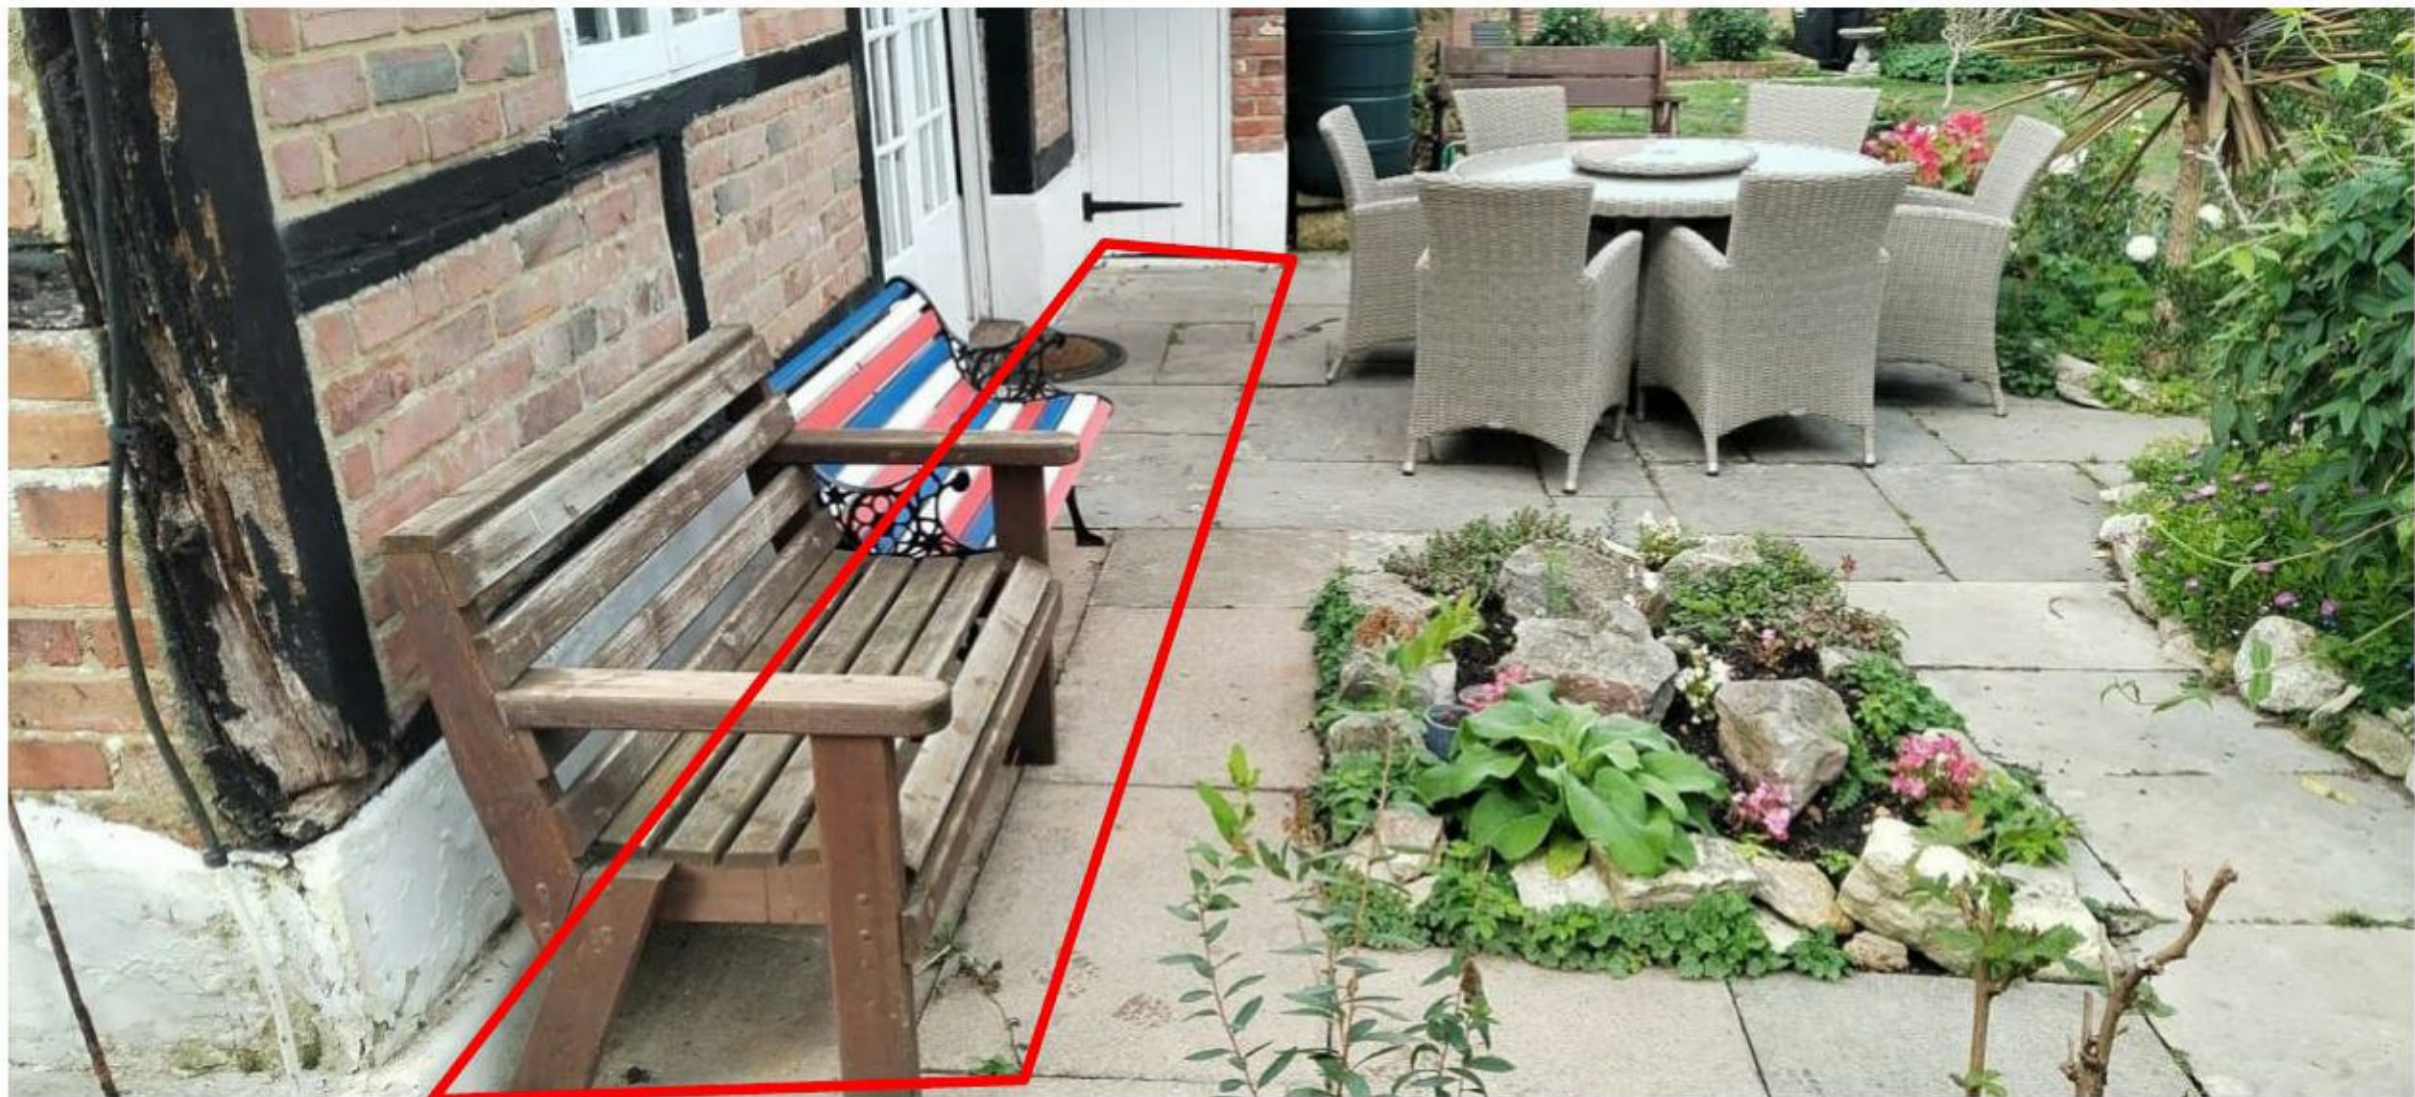
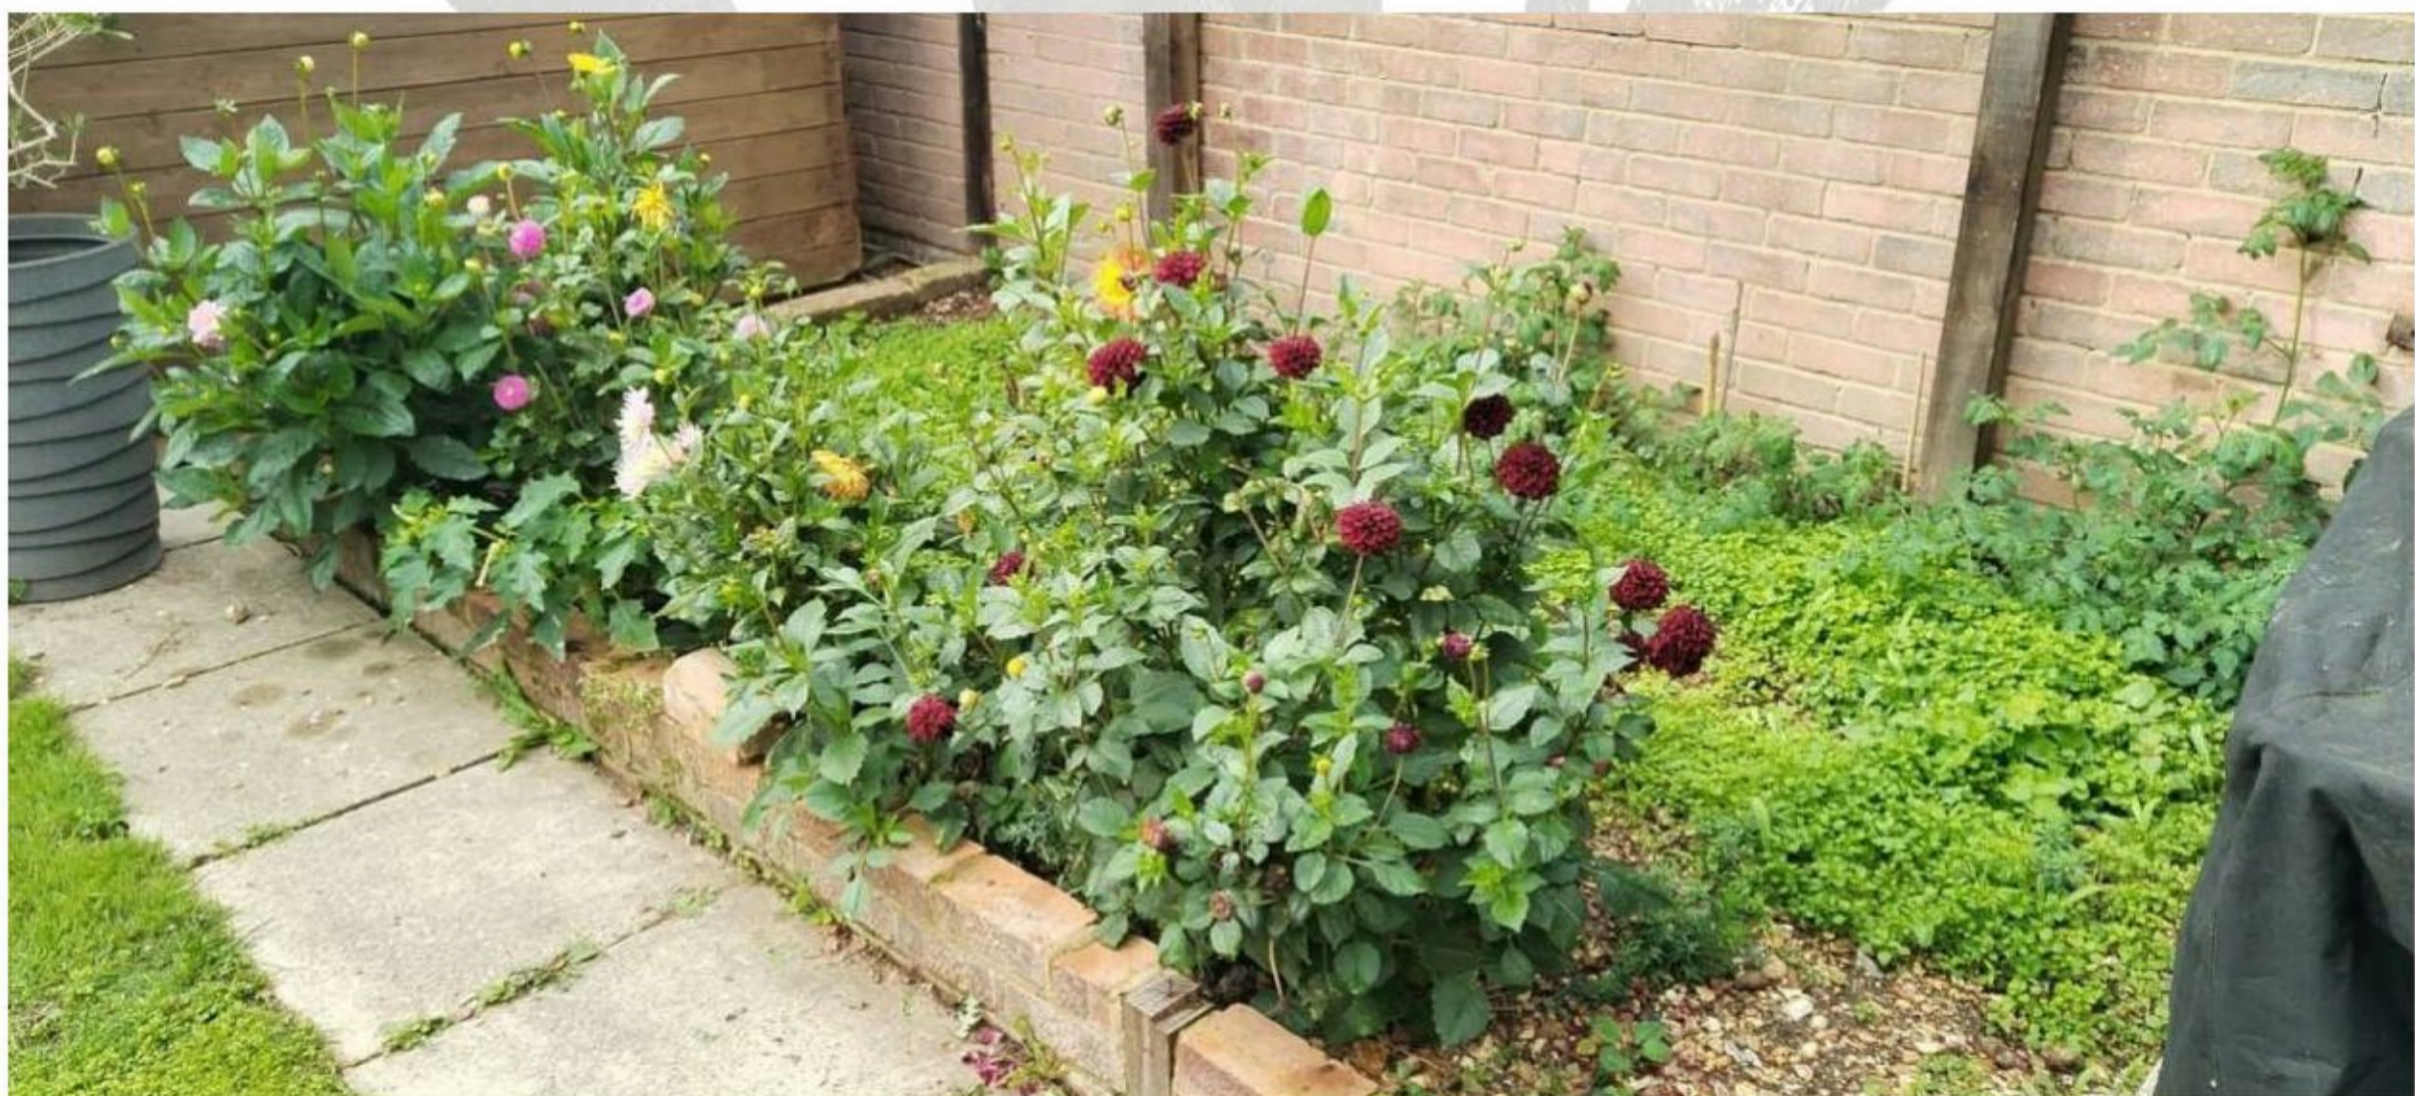
No nesting birds were recorded within either the farm house or garage. It is possible that the Virginia creeper on the garage may provide suitable nesting bird habitat, so measures to address this are presented below. The footprints of the proposed development (**Photographs 7a & 7b**) comprise existing paving slabs and/or ornamental flowerbeds. Being regularly disturbed and with no semi-natural habitats, the development footprint does not provide suitable habitat to support protected species.

Photographs 7a & 7b: Footprints of proposed extensions
