REPORT NO: D30056

**GEOENVIRONMENTAL APPRAISAL FOR LAND AT
TATHAM STREET, SUNDERLAND**

SUNDERLAND BANGLADESHI INTERNATIONAL CENTRE

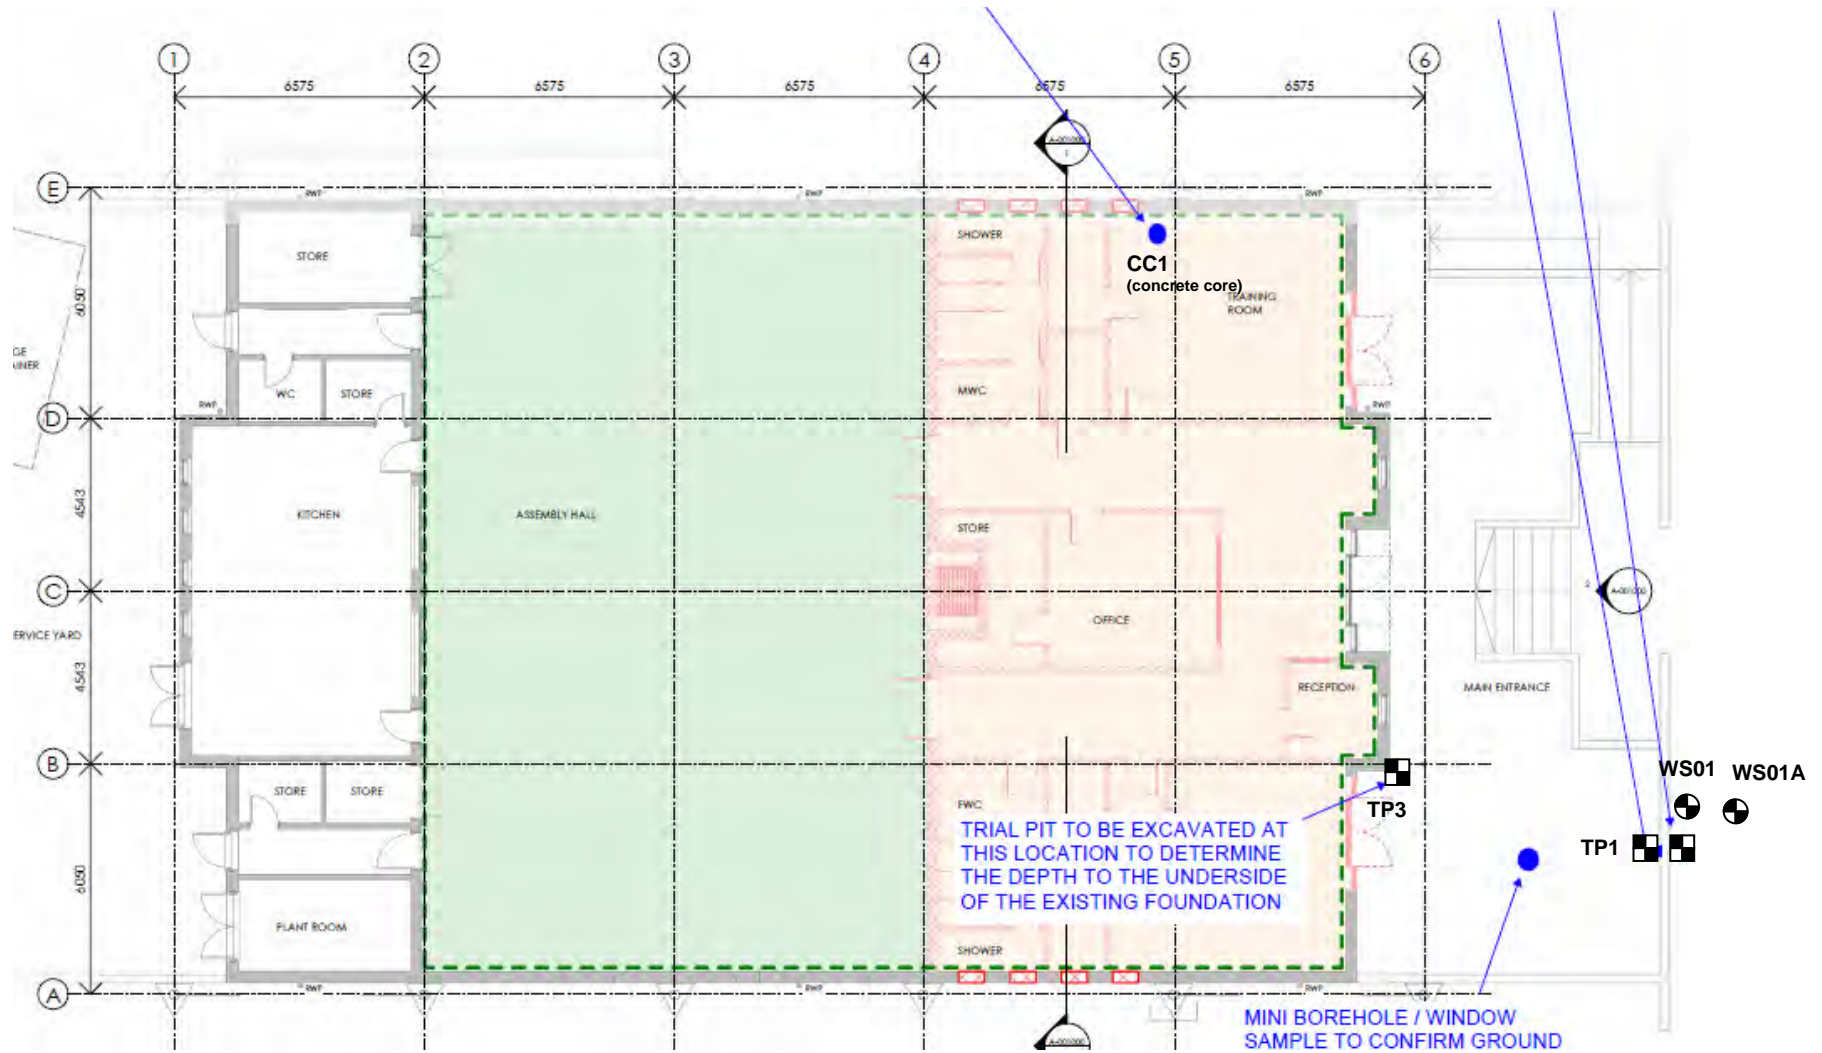
Contract: Tatham Street, Sunderland	Contract No.: D30056	
TEL: 0191 378 3151	Drawing Title: Exploratory Hole Location Plan		Client: Sunderland Bangladesh International Centre
Drawing & Revision No: DUN_D30056_02_00	Date: September 2023	Scale: NTS	Drawn by: KD

The exploratory holes listed below were advanced on the 28th July 2023. Records for each of the exploratory holes noted are included in Appendix B to this report and the locations are shown on Drawing No. D30056_02_00 presented in Appendix A.

- Trial pits: TP1 to 3 to maximum 1.05m bgl
- Mini percussion boreholes: WS1 and WS1A to maximum 3.95m bgl
- Concrete core CC1

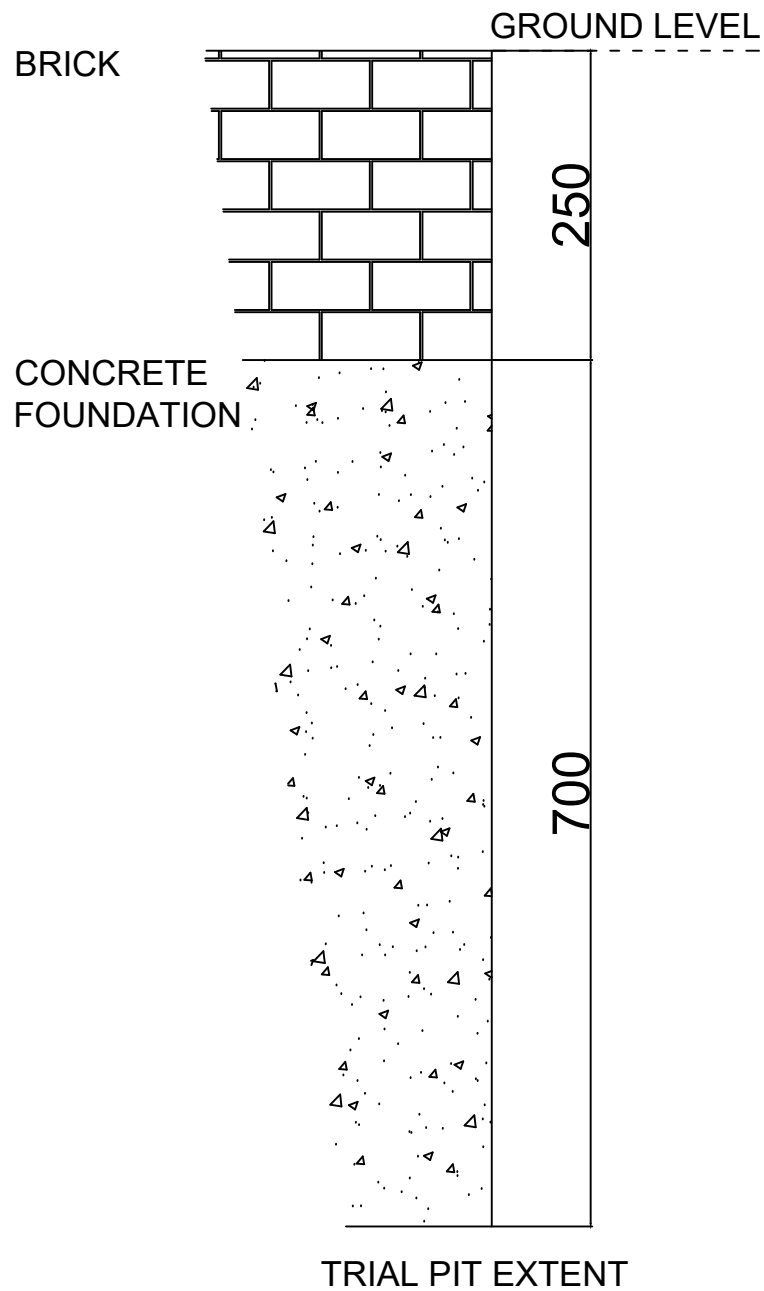
TP3 recorded a foundation from 0.25m bgl with no projection extending to a depth of 0.95m bgl a thickness of 0.70m.

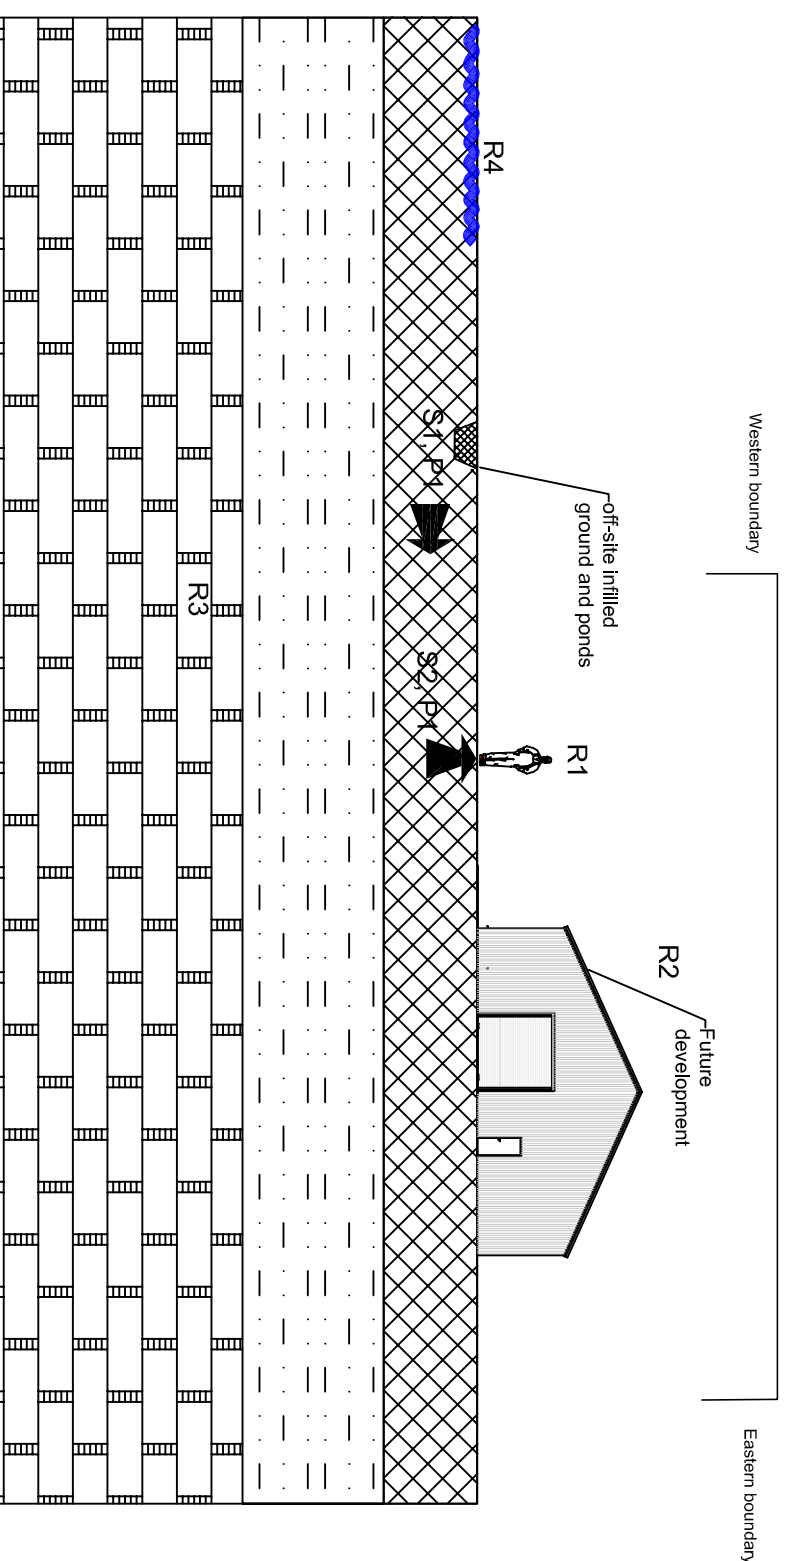
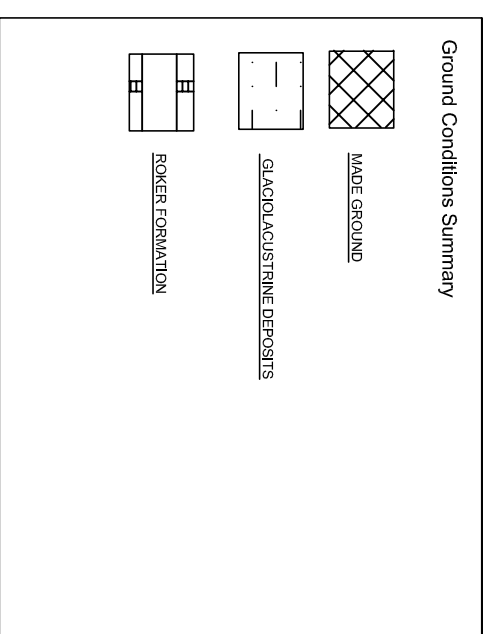
Cross Section Through the Site (Approximately West to East)

Pollutant Linkages

SOURCE	PATHWAY	RECEPTOR
<ol style="list-style-type: none"> Potential ground gas from off site sources Potential ground gas from made ground on site 	<ol style="list-style-type: none"> Potential migration and inhalation of gas through underlying soil 	<ol style="list-style-type: none"> Human Health (Future occupants, workers) Future development Principal Aquifer Wear Lower Estuary

A preliminary conceptual site model, including an assessment of potential pollutant linkages, has been determined based on the desk study information presented in report ref D10648_01_00.

The main receptors include future site building occupiers and the underlying Principal Aquifer.

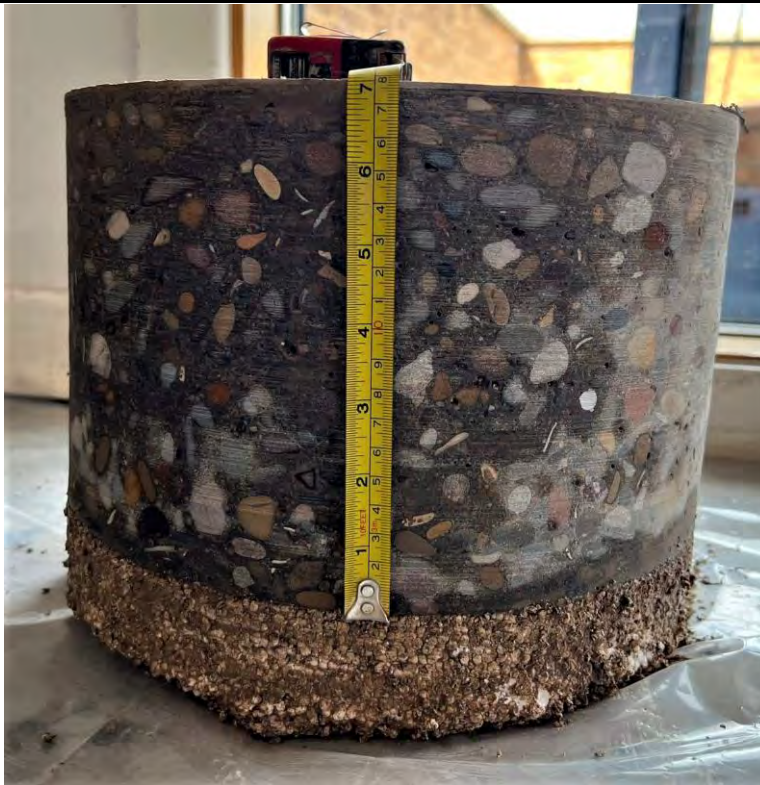
A concrete core was obtained as shown on the exploratory hole location plan in Appendix A. The concrete core details and photograph are included within Appendix D. The core was recorded as 300mm diameter and 205mm thick including a polystyrene base. The maximum aggregate size was recorded as 20mm. A damp proof membrane was also noted to be present.

Core dimensions	Length (mm)	205 including 25mm polystyrene base
	Diameter (mm)	300
Aggregate	Maximum Size (mm)	20-Section 1
	Petrological Description	Gravel
	Particle Shape	Sub Angular- Angular
	Distribution	Even
Compaction and Cracks	Mean Excess Voids (%)	0%
	Small Voids (0.5-3mm)	0%
	Medium Voids (3-6mm)	0%
	Large Voids (>6mm)	0%
	Honeycombing	None
	Cracks	None
Reinforcement	Number of Bars	None
	Diameter of bars (mm)	N/A
Other details	Top	Smooth
	Bottom	Smooth - Damproof Membrane Present
