Daytime Bat Survey Report

Site: Bungalow at The Laurels, Main Street, Syerston NG23 5NF

Ref: 232021 / E1

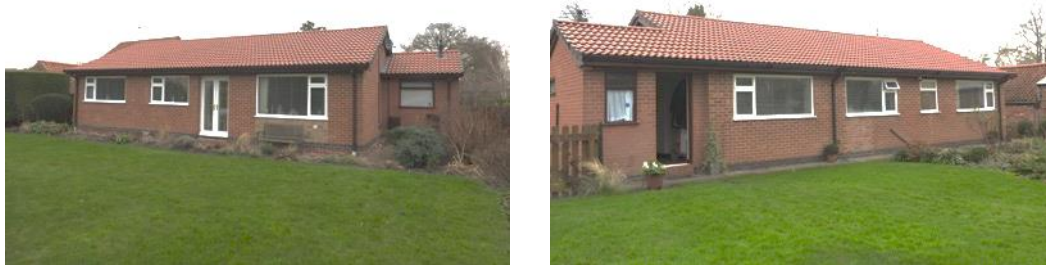
Figs. 1 & 2 Aspects to the southwest and northeast

The survey site comprised a detached pitched roofed bungalow (Figs. 1 and 2).

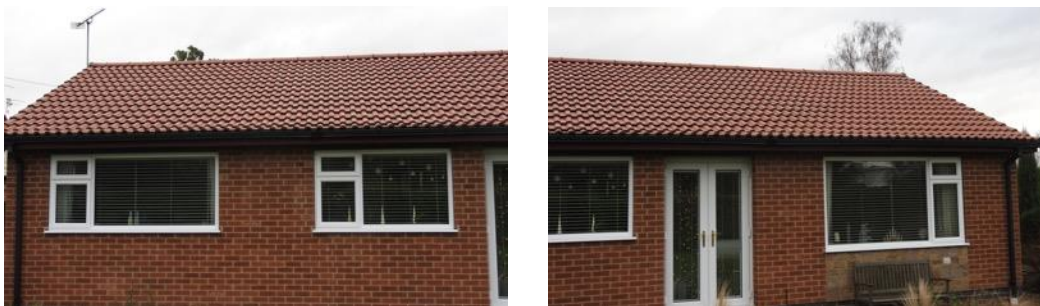
Figs. 6 & 7 Ridge and roof tiles to the southwest

All the ridges were intact and sealed, whilst all the roof tiles were tightly overlapping with none broken, dislodged or missing (Figs. 6 – 10).

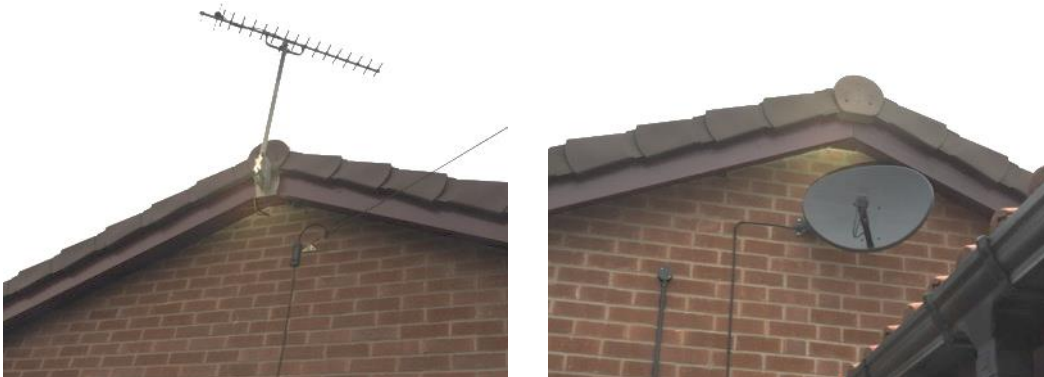
Figs. 11 & 12 Sealed gables

The gables were sealed with the roof tiles sealed with tile end caps tightly fitting against boxed soffits (Figs. 11 – 13).

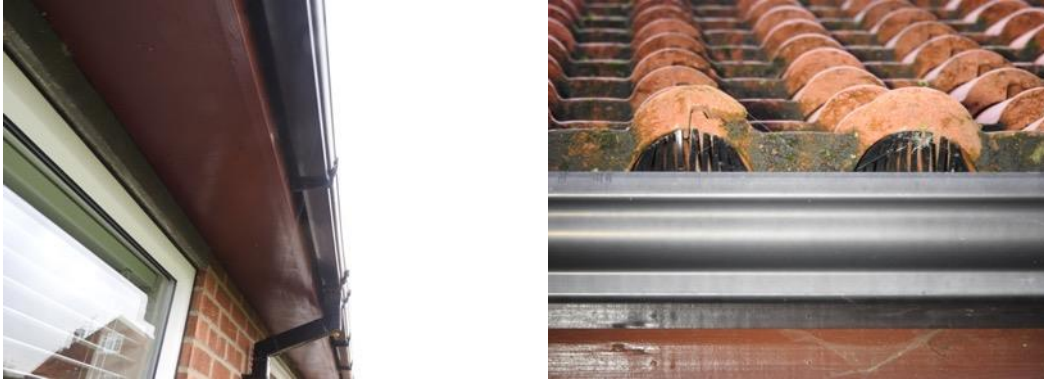
Figs. 14 & 15 Tightly fitting boxed soffits (L) and eaves filler combs (R)

The eaves were finished with tightly fitting boxed soffits against the walls all round and the end of the roof tiles were all fitted with eaves filler combs (Figs. 14 and 15).

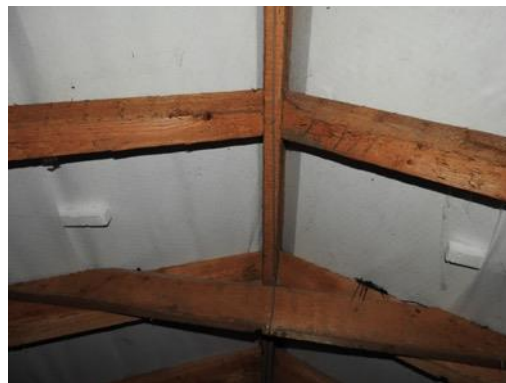
Fig. 16 Cobwebbed ridge of the main roof void

Internally the bungalow had two roof voids, both lined and both lightly cobwebbed on their ridges and gable ends (Figs. 16 – 20).

No light penetrated either roof void, and no evidence of bats was found inside the bungalow.
