**Bat Survey Report for
proposed staff car park and path,
Greenway Hotel & Spa, Shurdington,
Cheltenham, GL51 4UG**

Proposed staff car park and path, Greenway Hotel, Shurdington – Bat Survey Report

Report Number: 4515-CWS-01

Date: 6th September 2023

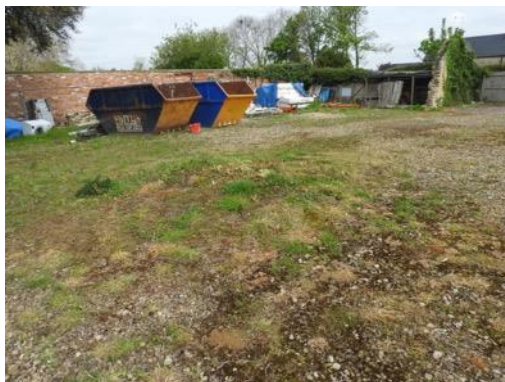
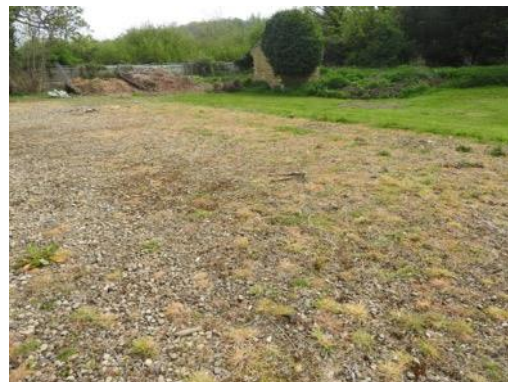
The survey site comprised a gravelled area with brick and stone walls to the west and north, timber fencing to the north, and close mown lawn to the east and south. A small open-fronted timber lean-to was also present (Figs. 1-4).

Figs. 1 & 2 View to the west (L) and east (R)

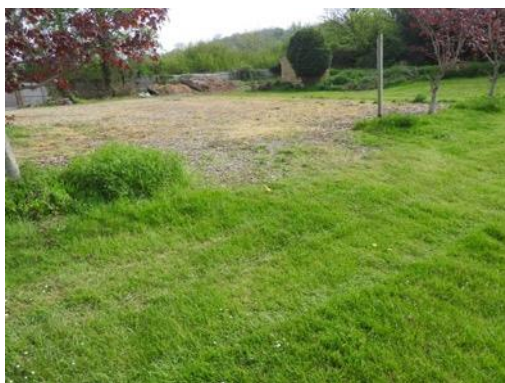
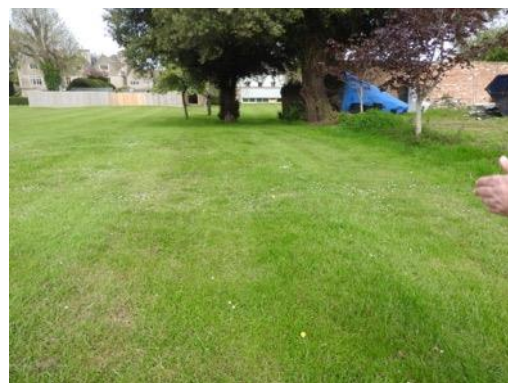
Figs. 3 & 4 Views of the proposed path to the east (L) and west (R)

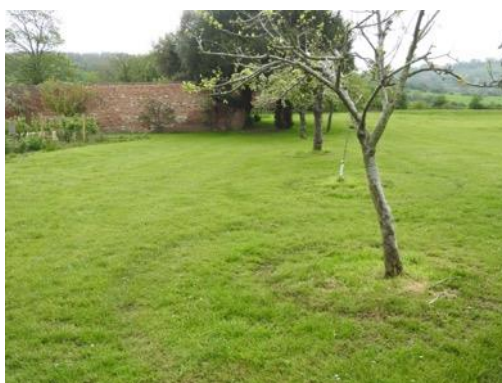
The route of the proposed path from the car park ran across the close mown of the garden, alongside a row of young fruit trees and two mature broadleaves where the row joined the brick wall (Fig. 5). None of these contained any features suitable for bat roosting.

Fig. 5 Looking east from the hotel – route of proposed path

It is therefore recommended that any illumination should be bollard or low level lighting, preferably low lux LED, with light directed towards the floor, i.e. not a general spill of light. Cowls may be necessary to ensure lighting is deflected downwards.

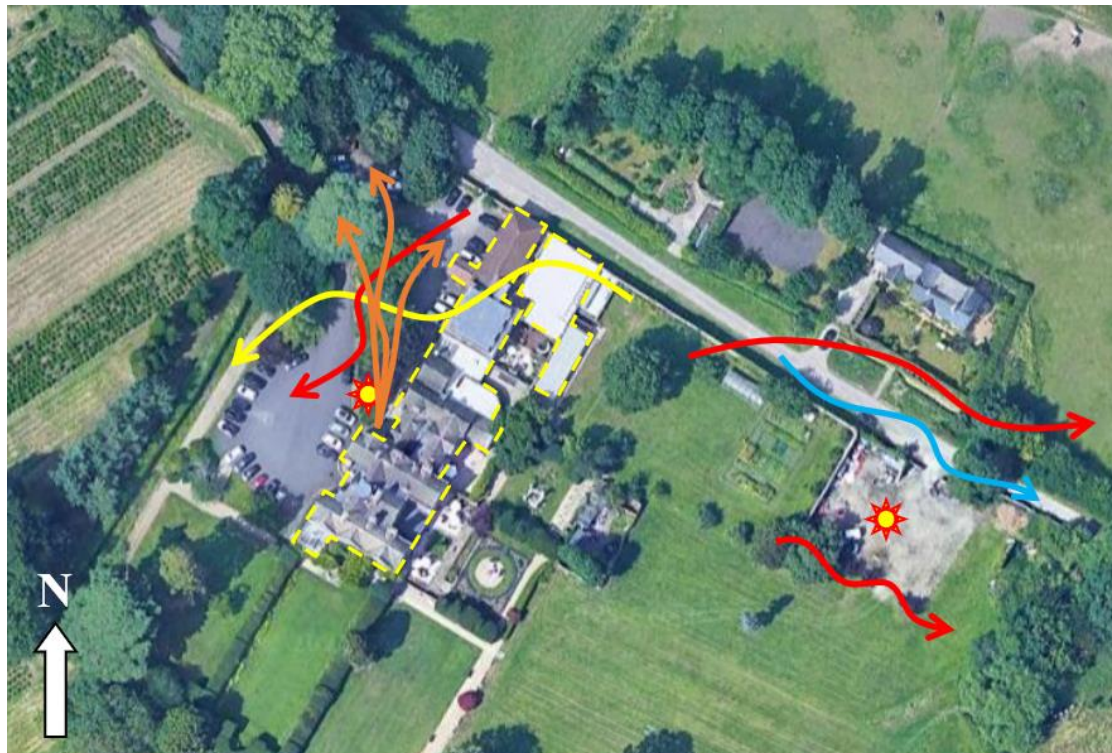
Plan 1 Bat flight paths on 12th June 2023

A total of 82 individuals were subsequently counted out of the roost, these all flying off north across the car park of the spa and away north and northwest. No Lesser Horseshoes were noted in the location for the proposed staff car park, but one of two Common Pipistrelles were noted flying back and forth in the gardens, and a Natterer's Bat was detected as it flew along the lane. A Soprano Pipistrelle was also recorded.

The bat flight paths on 12th June 2023 are shown on Plan 1 overleaf

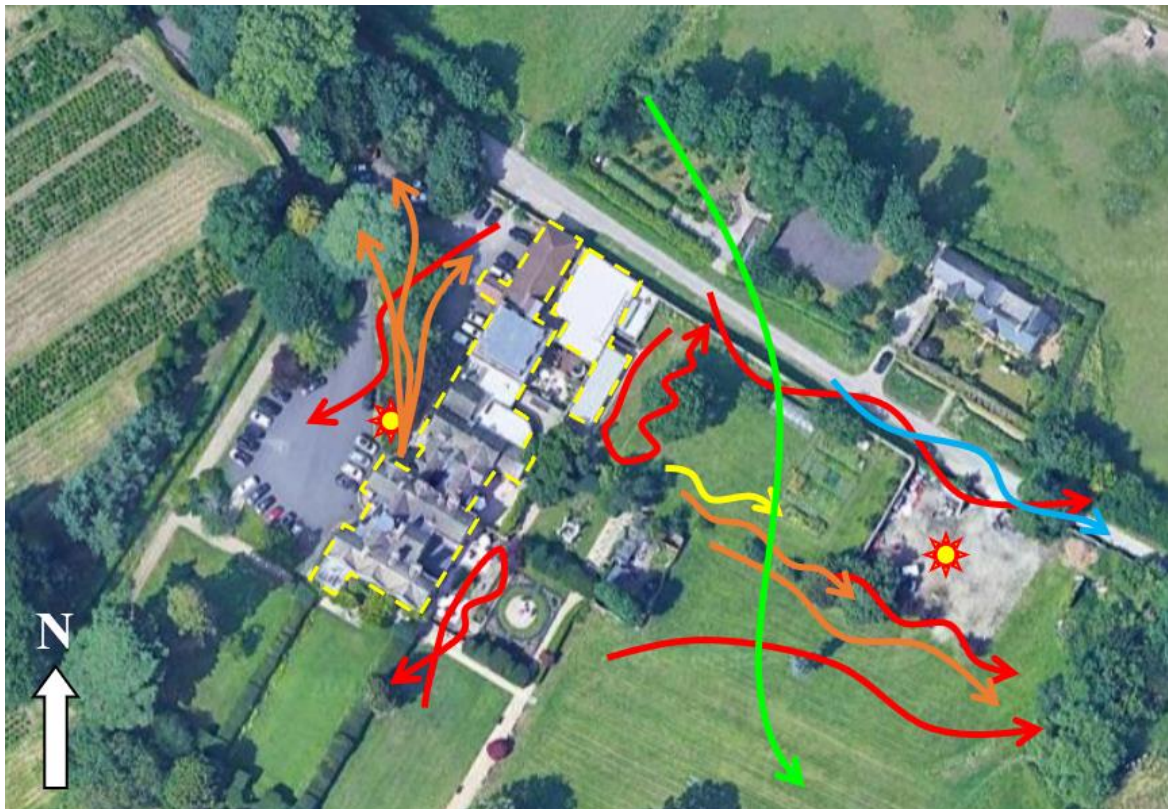
Plan 2 Bat flight paths on 26th June 2023

Although all the Lesser Horseshoes flew off north as before, at least one or two animals were subsequently detected as they foraged around the garden, including along the route of the proposed path from the staff car park.

Again Common and Soprano Pipistrelles were recorded, along with Natterer's Bat along the lane, and an overflying Noctule.

The bat flight paths at emergence on 26th June 2023 are shown on Plan 2 overleaf.

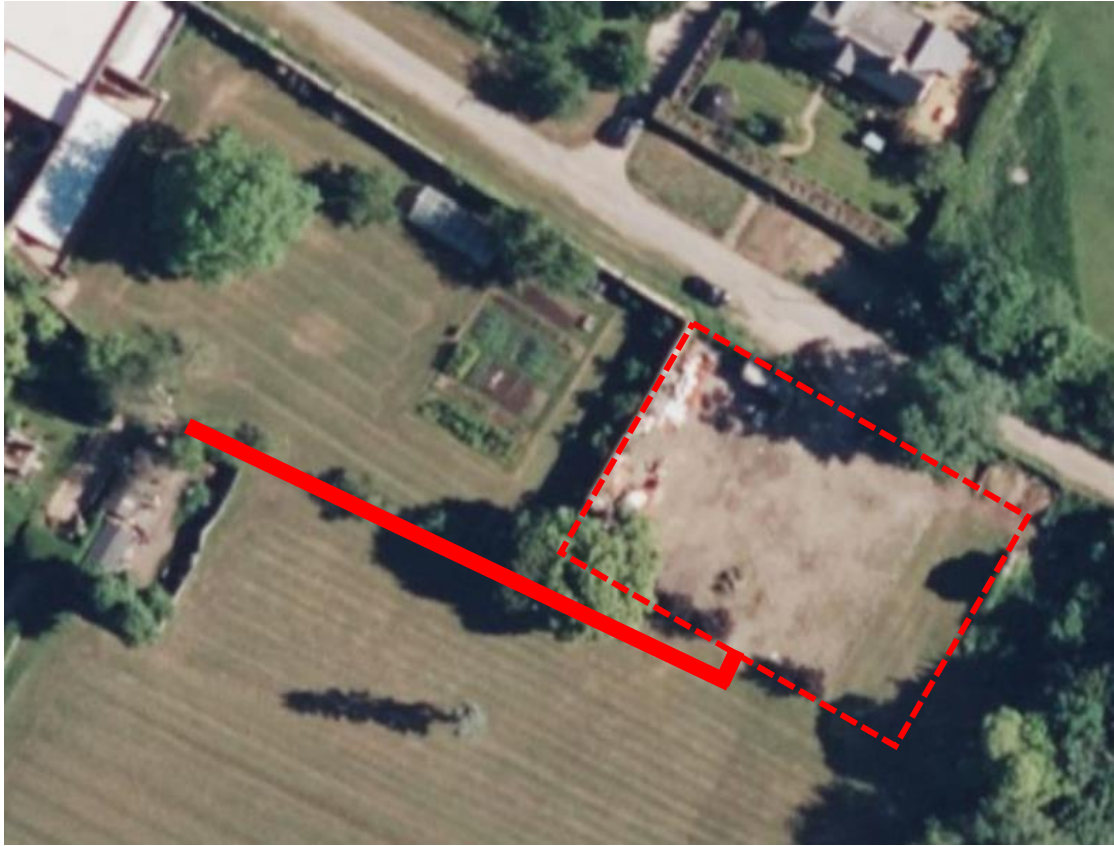
Appendix 2: Site layout

The layout of the site is shown in the aerial photograph in Appendix 2.

Proposed staff car park and path
