Stocksbridge Towns Fund Community Hub

Geotechnical and Geoenvironmental Desk Study

Reference: PC01676-ARUP-XX-XX-RP-CG-00701

P01 | 15 December 2023

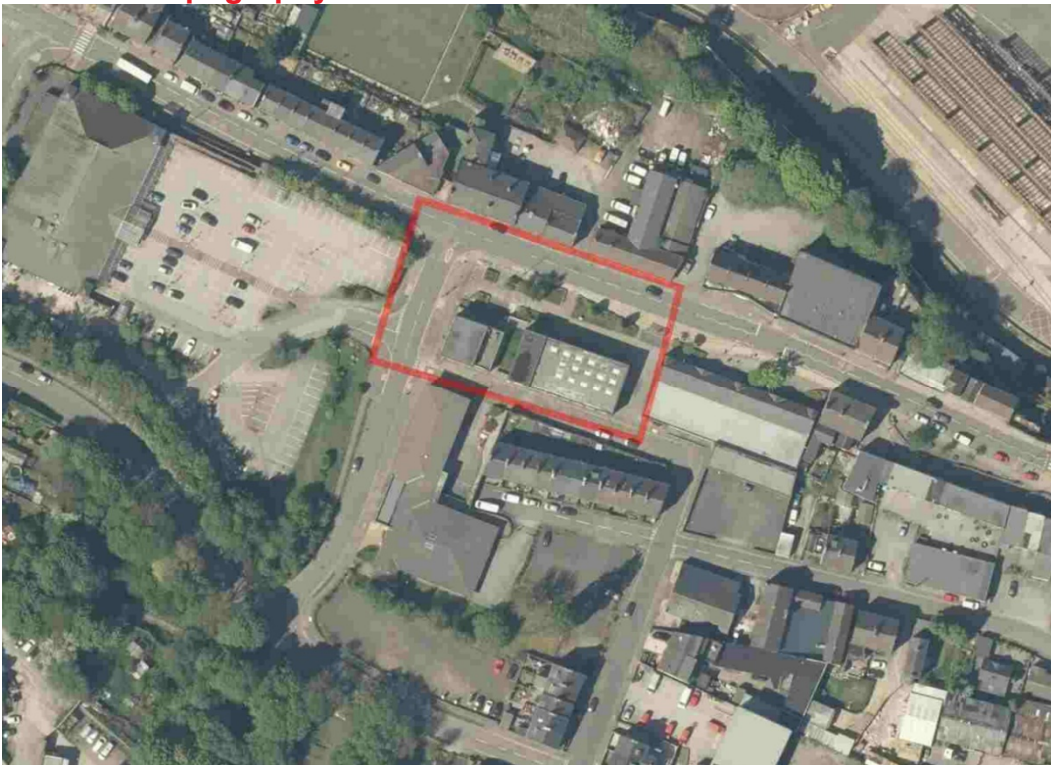
Figure 1: Site Location

The current site consists of Stocksbridge Library and St Luke's Hospice charity shop, with a paved area and flowerbeds between the buildings and Manchester Road. The site is bound by Manchester Road to the north, Button Row to the south and Johnson Street to the west, with a pharmacy building on the east site boundary. The approximate site boundary is presented in **Figure 1**.

The topography of the site has been interpreted from 1m resolution government LiDAR data [1]. The site is located in the centre of Stocksbridge town. The site slopes from the Library's Button Row entrance down to Manchester Road, with the south west of the site lying at approximately 166m OD, sloping down to 164m

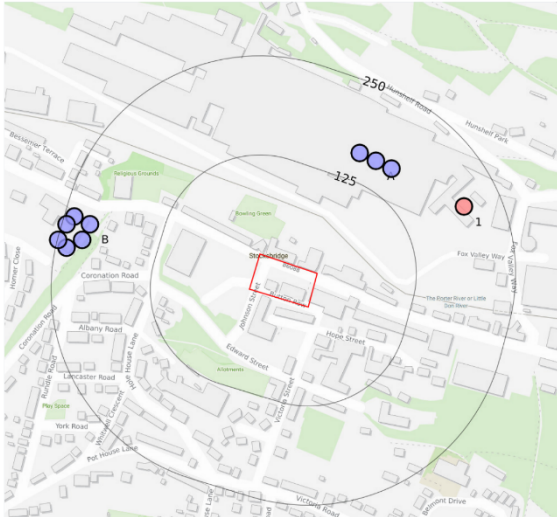
Figure 2: Location of BGS boreholes

The BGS holds no records of historical boreholes within the site boundary. Several shallow boreholes exist within the steelworks boundary to the north, with one borehole at a depth of 274.34m situated around 200m to the northeast of the site. However, this is situated at a lower elevation than the site boundary. This borehole encountered coal at 132 ft and 269 ft. Similarly, a cluster of shallow boreholes have been drilled approximately 200m to the west of the site, but at a lower elevation to the site.
