BAT EMERGENCE SURVEY REPORT

Old Brickyard, Lodsworth, West Sussex

Client:	Mr & Mrs J Adams			
Project:	Old Brickyard, Lodsworth, West Sussex			
Reference:	LLD3002-ECO-REP-002-01-BES			
Revision:	Date:	Author	Proof	Approved
01	30/10/22	Sam Hall MSc BSc (Hons)	Catherine O'Reilly MCIEEM	Catherine O'Reilly MCIEEM

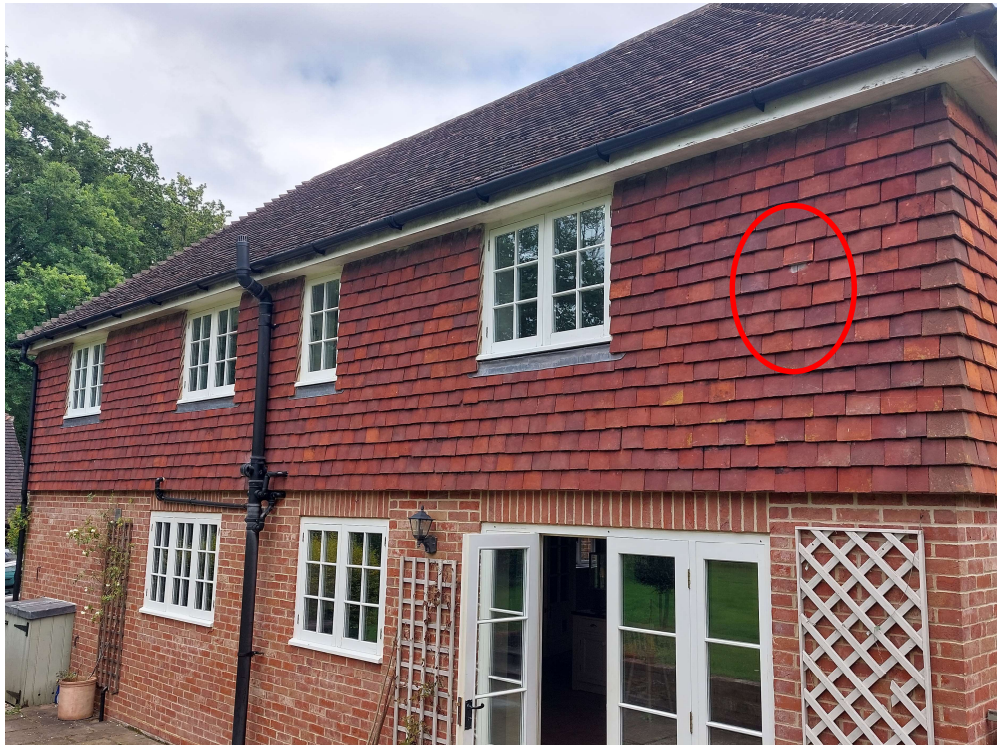
Image No. 01 – B01, western aspect. Pipistrelle access points circled in red.

Survey Point	Species	Notes
Southwest	S. PIP x 1 C. PIP x 8 PIP x 6	2 x emerge from hanging tile (HT) on the western aspect. 7 x emerge from HT on the south aspect. Approx. 6x emerge from SW corner before survey start
Southeast	C. PIP x 2	1 x emerge from HT between left windows. 1 x emerge from HT below middle window.

Survey Point	Species	Notes
Southwest	S. PIP x 3 C. PIP x 5	3 x emerge from corner hanging tile (HT) 5 x emerge from HT on south aspect to left of window.
Southeast	C. PIP	9 x emerge from 6 separate HTs next to the 3 windows and between left and middle windows.

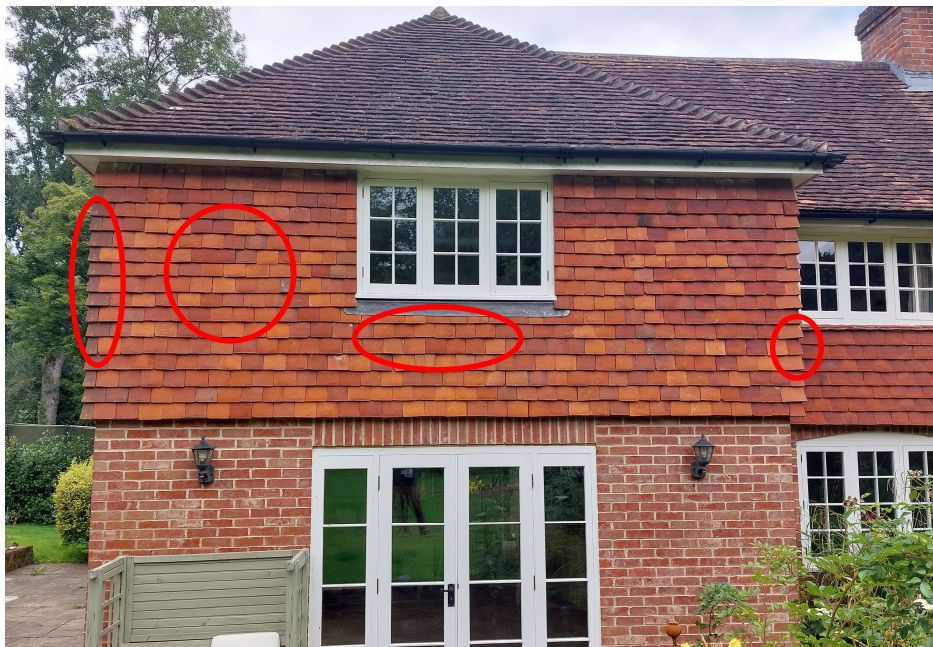
Image No. 02 – B01, western portion of southern aspect. Pipistrelle access points circled in red.

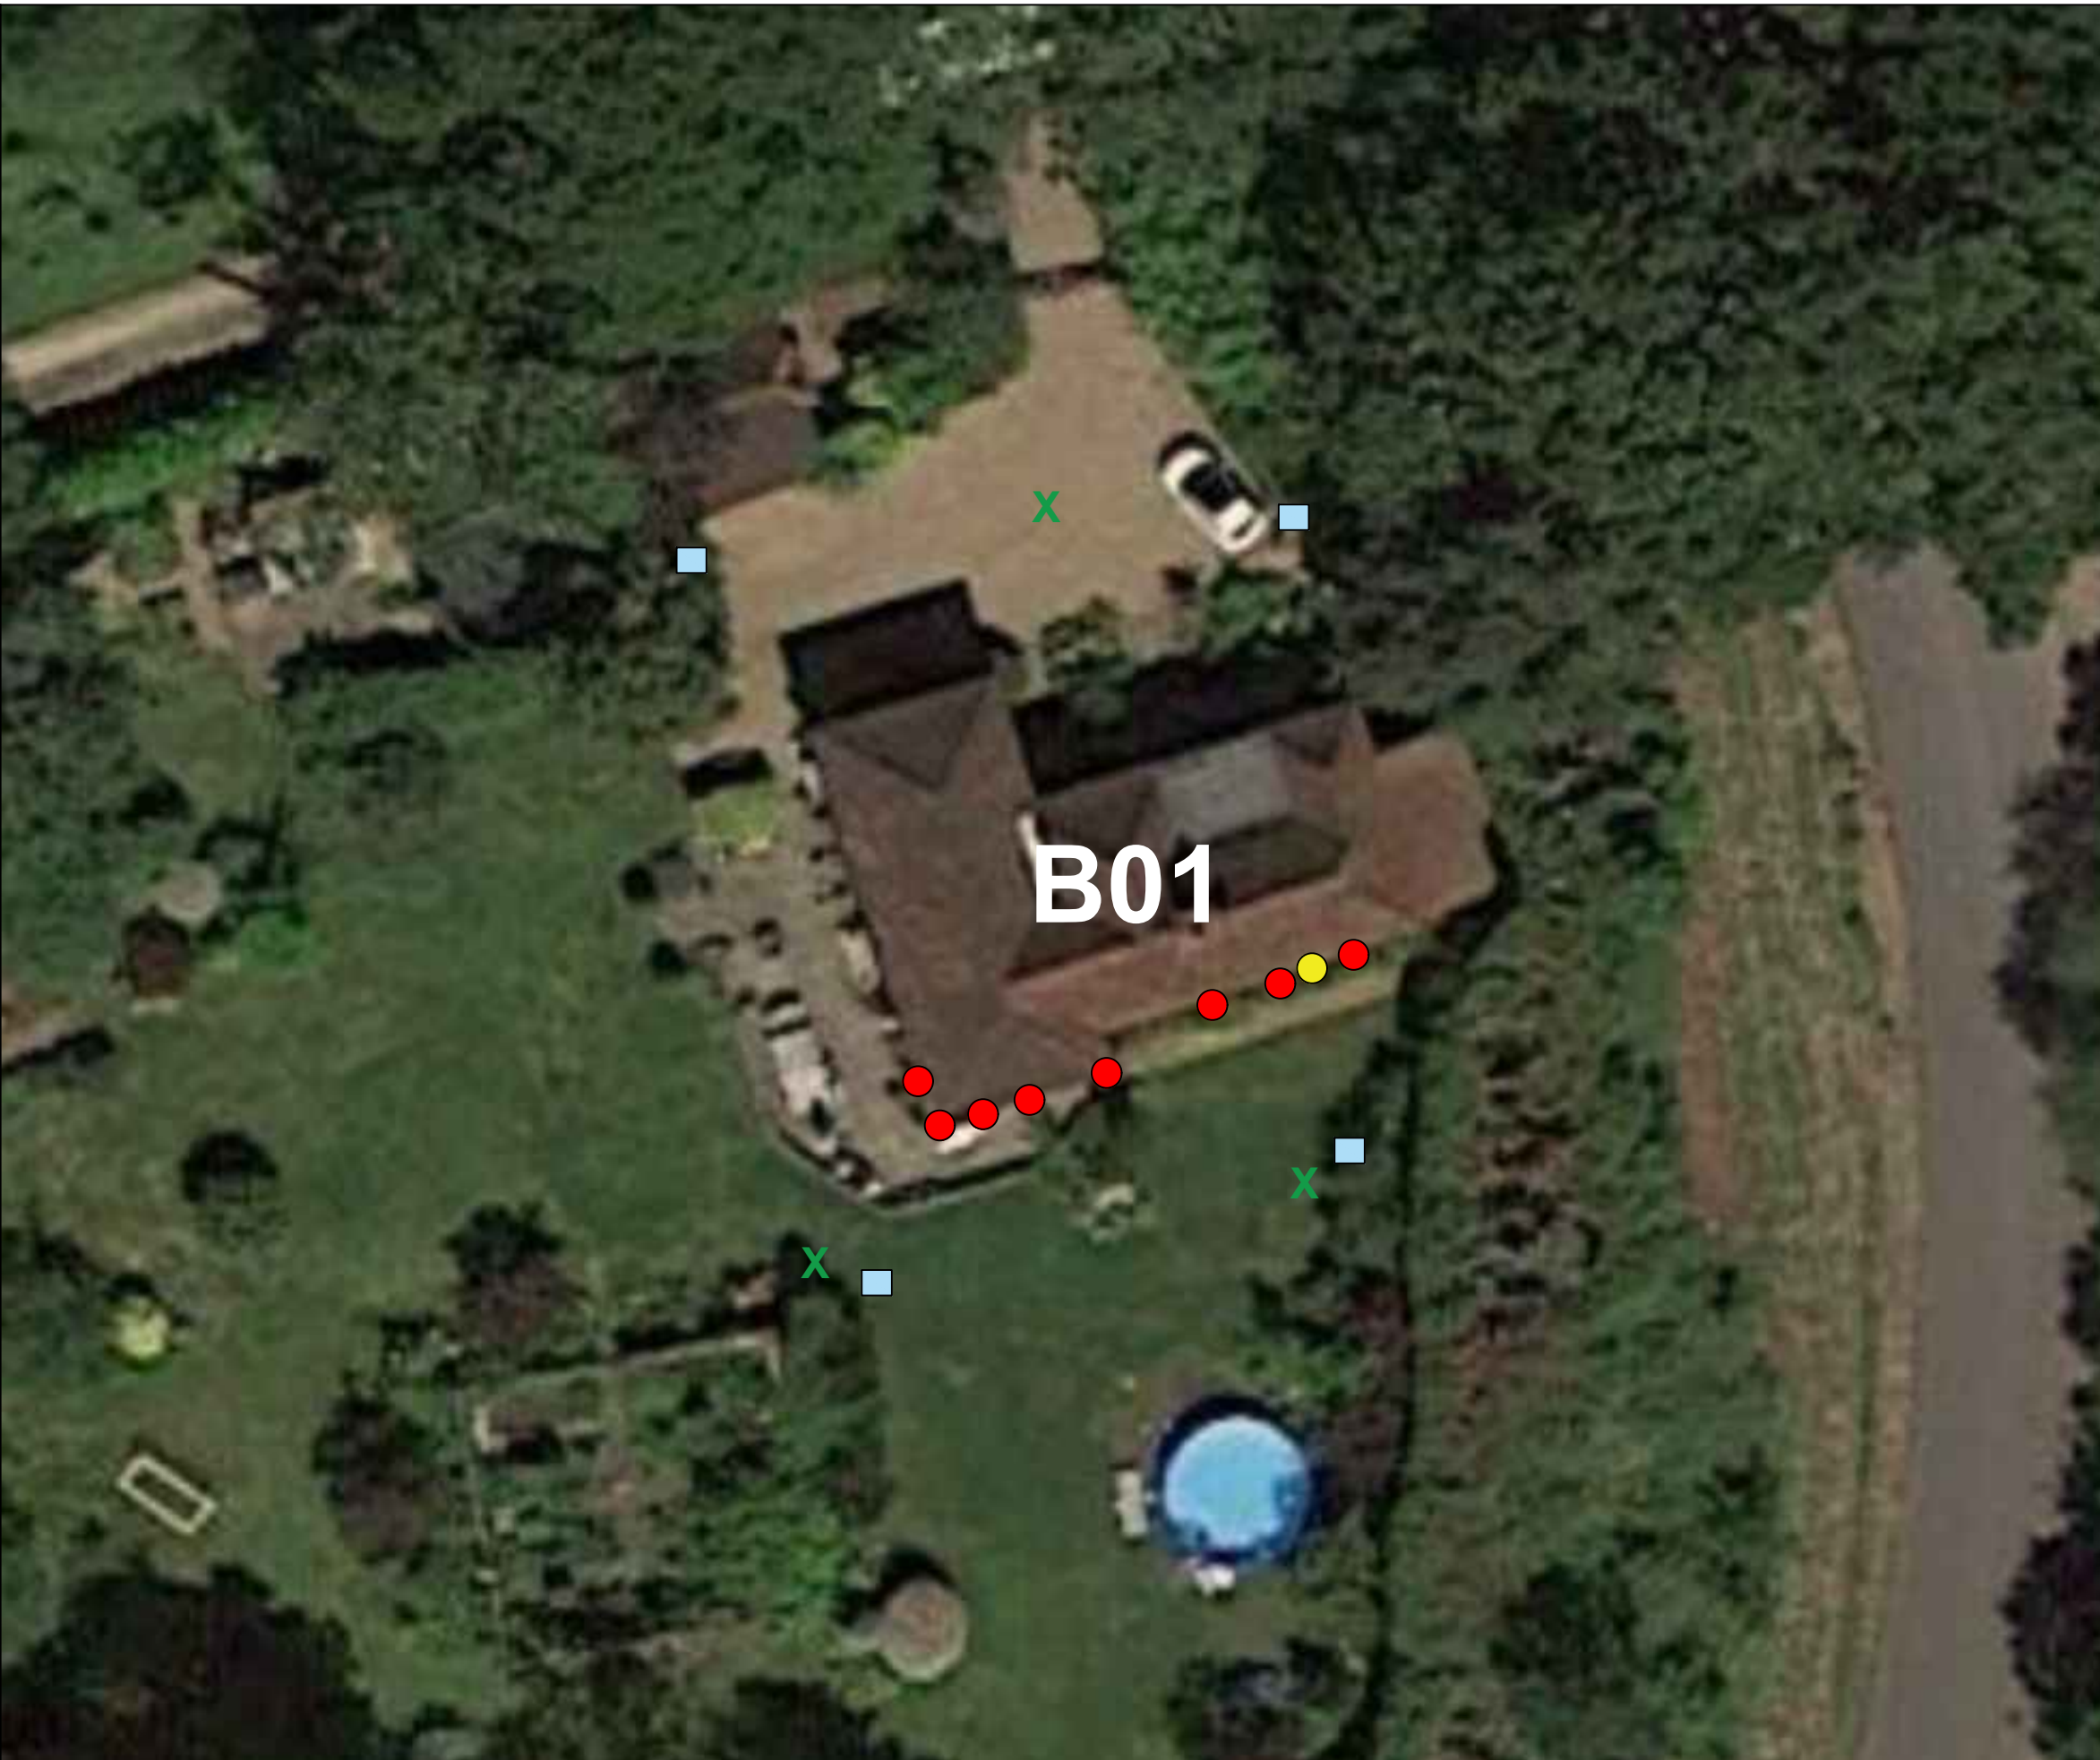
Figure No. 01 - Bat Survey Plan Old Brickyard, Lodsworth, West Sussex

3.1.4 Bats were identified using Echo Meter Touch Pro 2 and Peersonic RPA3 bat detectors. Up to 4no. Sannce CCTV infra-red cameras with additional illuminators were also used to aid the surveys (see *Figure No. 02 - Bat Survey Plan*) in line with interim guidance (BCT, 2022).

Drawing Title
Bat Survey Plan
