UPDATE BAT, BIRD & NEWT ASSESSMENT 2023

**STABLES AT PUMP LANE
LONG NEWNTON, GLOUCESTERSHIRE**

STABLES AT PUMP LANE LONG NEWNTON, GLOUCESTERSHIRE

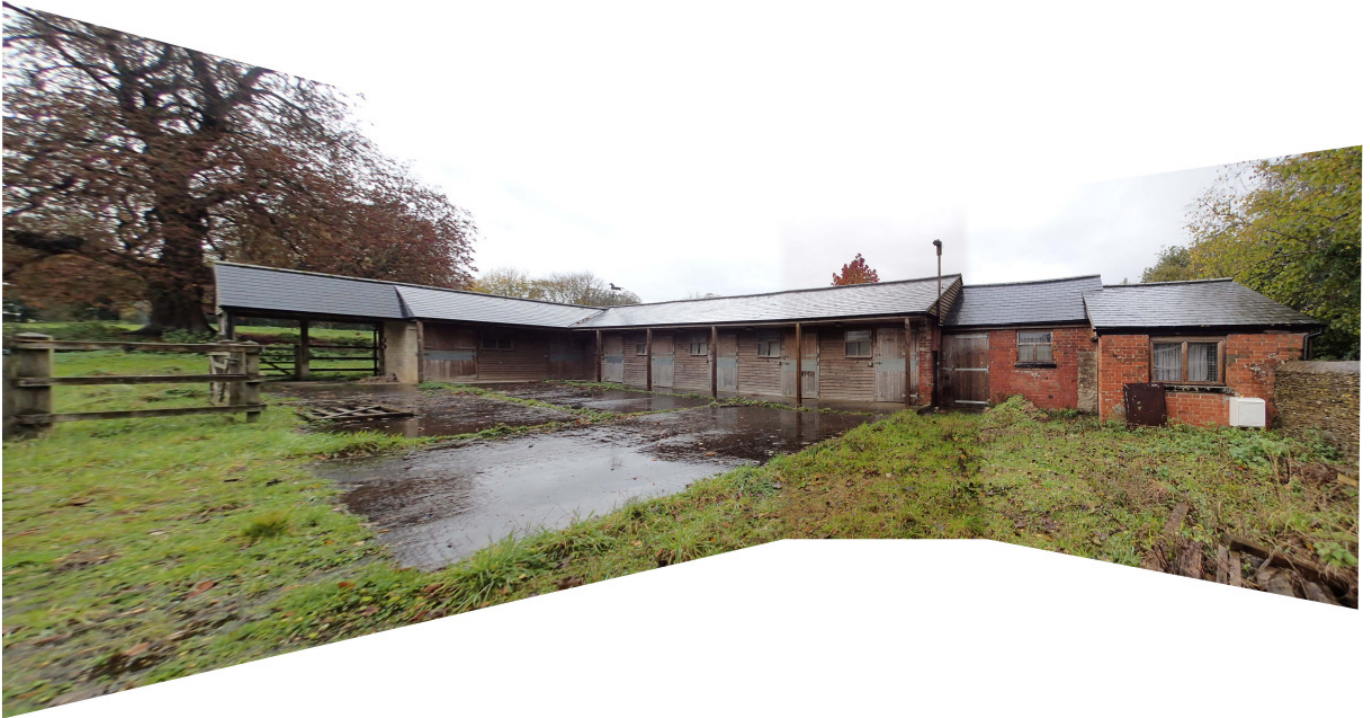
Photo 3 Stables (Nov 2023)

The stables are an L-shaped row of single-storey stalls and storerooms with an open lean-to at one end. The walls are a mix of brick, blockwork, stone and horizontal weatherboards. The roofs are twin-pitched and capped with slates over sarking boards with a narrow gap between. The building is described in detail in the original 2019 report – refer to that report for more information.

The building looked unchanged since 2019 except the gravel had started to vegetate. The building was in relatively good condition, doors and windows closed, and the interior disused and empty.

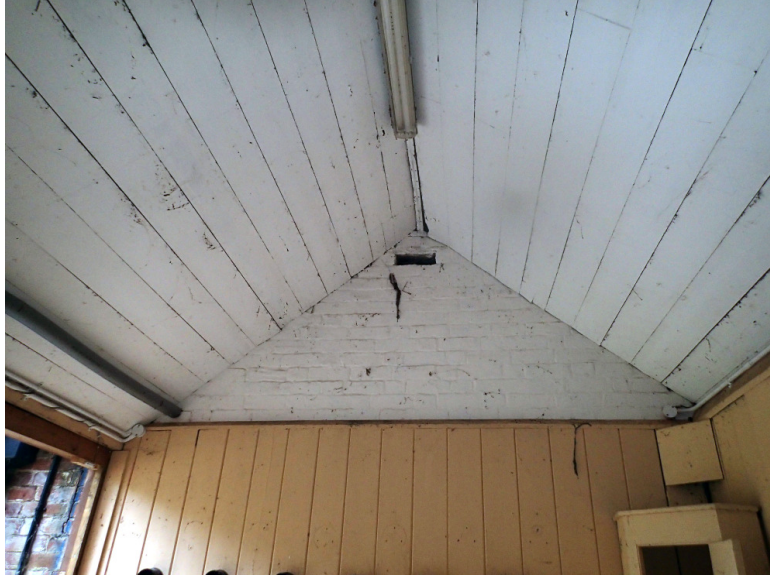
Photo 5 Interior (Nov 2023)

The following **former / old bird nests were found inside the building**: (1) a medium-sized twig nest, (2) a medium-sized grass nest, (3) grass nesting material within the underside of the roof ridge (typical of house sparrows) & (4) a swallow nest. There was a rotten dead bird on the floor (blackbird?).

- As a standard precaution – **if the start of the proposed work is during the nesting season (which is typically March – August) – check for nests first and delay / change the work if an occupied nest is found.**
- **Provision of nest boxes for house sparrows and garden birds is suggested** as compensation / enhancement. Vivara Pro WoodStone House Sparrow Nest Box and Vivara Pro Build-In Half Open Nest Box or Build-in Open Nest Box for example. Fit out-of-the-sun
