Revised Remedial Strategy & Verification Report (Topsoil Cover System)

Land South of 17 Main Street
Woodnewton
Peterborough
PE8 5EB

EPS Project Reference:	UK22.5787
Date Issued:	15 th June 2023
Report Status:	Issue 1

LAND SOUTH OF 17 MAIN STREET, WOODNEWTON

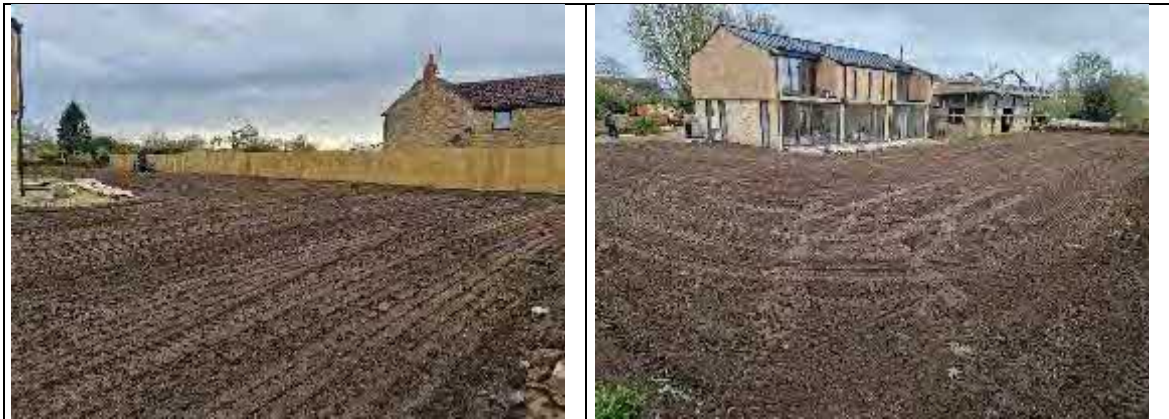
<p>Photo 5: Image showing the topsoil in the gardens of the converted barns being suitably compacted –provided by client</p>	<p>Photo 6: Image showing the topsoil in the gardens of the converted barns after being suitably compacted and ready to be turfed / seeded – provided by client</p>

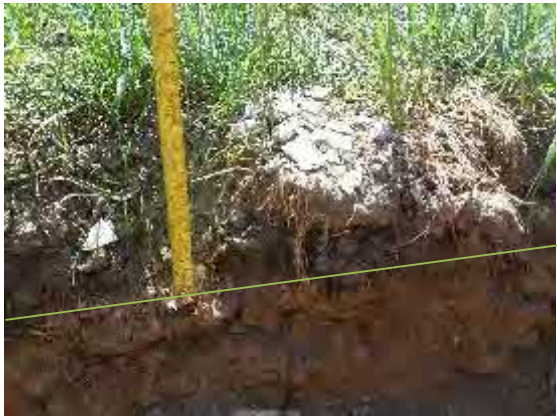
<p>Photo 7: Image showing the profile of the topsoil imported by the client in May 2023 (above green line) photo taken by EPS, 14/06/23</p>	<p>Photo 8: Image showing the location of HA01 –photo taken by EPS, 14/06/23</p>

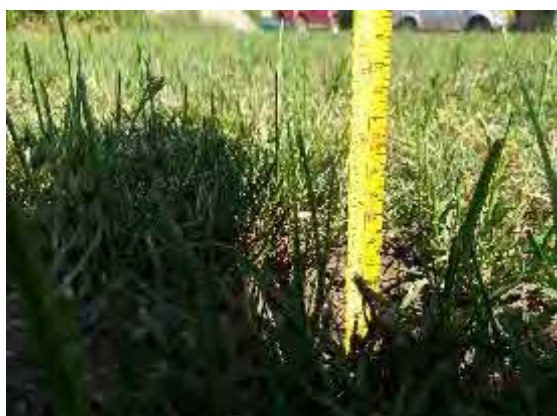
Location ID	Depth of Topsoil (mm)
HA01	> 120
HA02	> 140
HA03	130
HA04	> 130
HA05	> 120

<p>Photo 9: Image showing the depth of topsoil at hand auger borehole location HA01 –photo taken by EPS, 14/06/23</p>	<p>Photo 10: Image showing the depth of topsoil at hand auger borehole location HA02 –photo taken by EPS, 14/06/23</p>

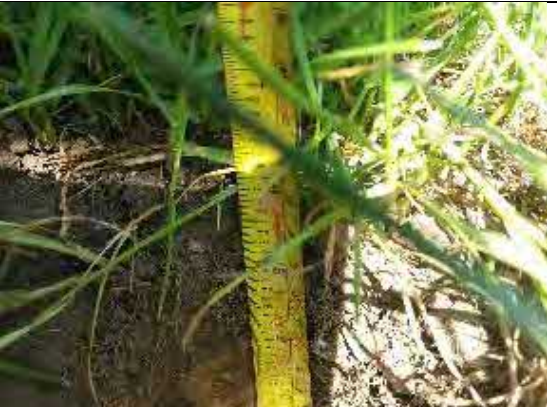
<p>Photo 11: Image showing the depth of topsoil at hand auger borehole location HA04 –photo taken by EPS, 14/ 06/ 23</p>	<p>Photo 12: Image looking north across the rear garden areas of the converted barns –photo taken by EPS, 14/06/23</p>

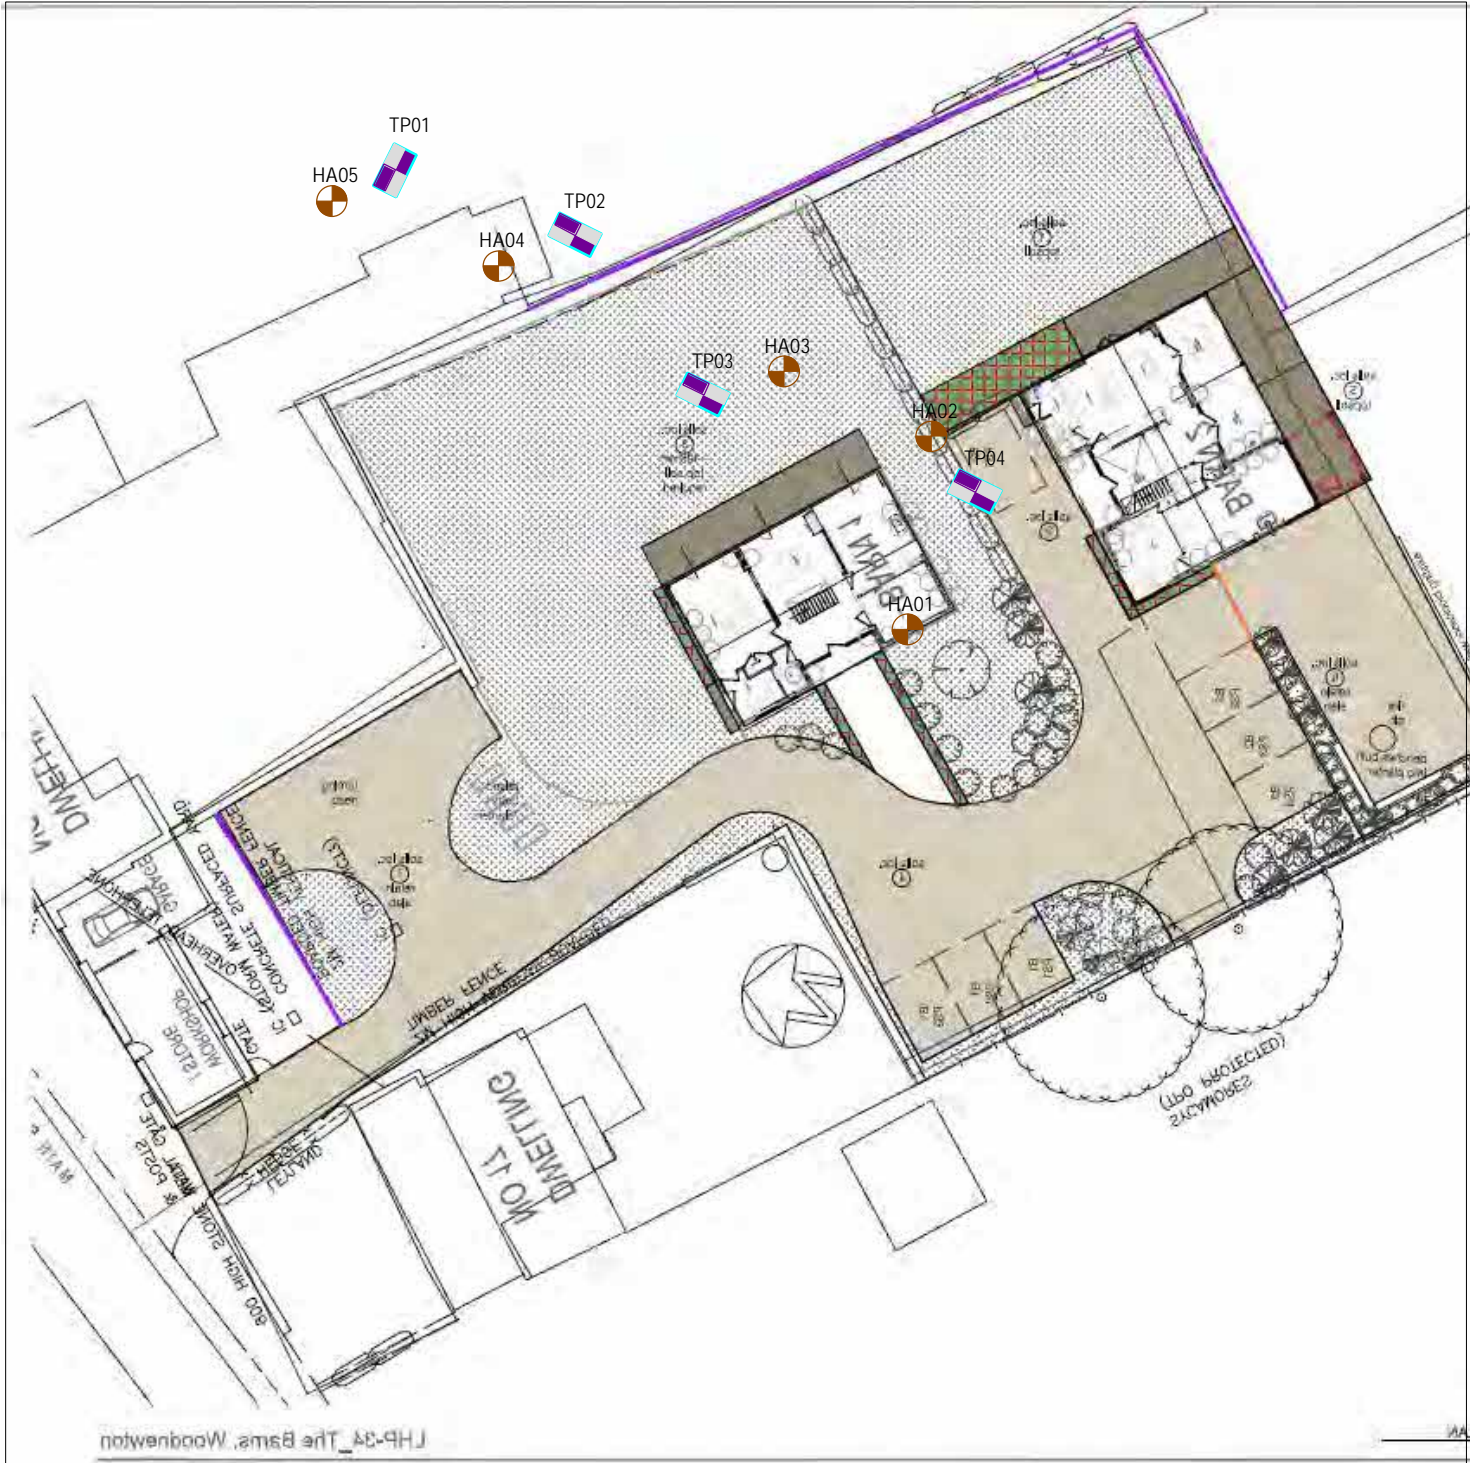
Dwg No: UK22.5787/0623/01

Supplementary site-specific trial pit logs are included as Appendix B and give descriptions and depths of strata encountered and descriptions of the encountered soil types are presented in the following sub sections. A supplementary exploratory hole location plan is included as Figure 2.
