LAND AT TREWENNACK

HELSTON

CORNWALL

Results of a Heritage Assessment

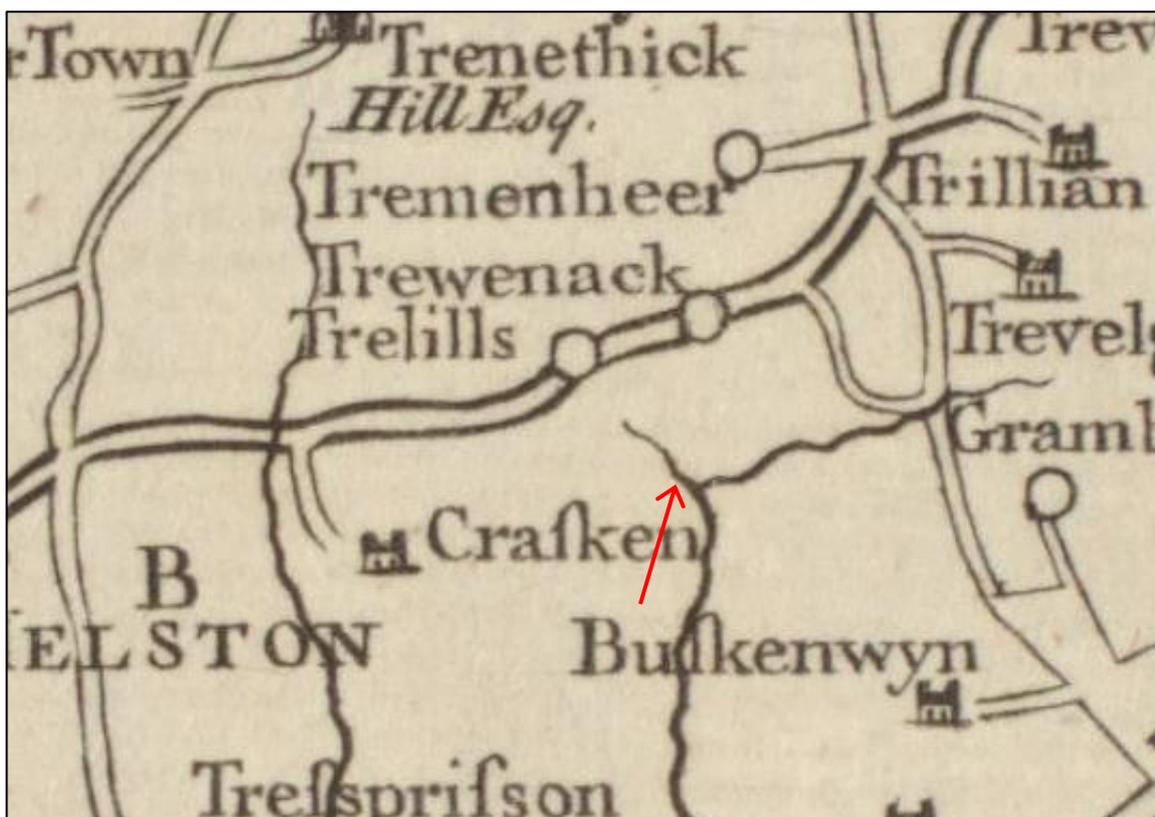
Martyn's Map of 1748 (Figure 3) indicates Trewennack, as well as Tremeheer and Trelill, although no specific buildings are represented and there is no detail of the land pattern.

FIGURE 2: EXTRACT OF THE 1748 MARTYN MAP OF CORNWALL. THE APPROXIMATE SITE LOCATION IS INDICATED (HARVARD UNIVERSITY MAP COLLECTION).

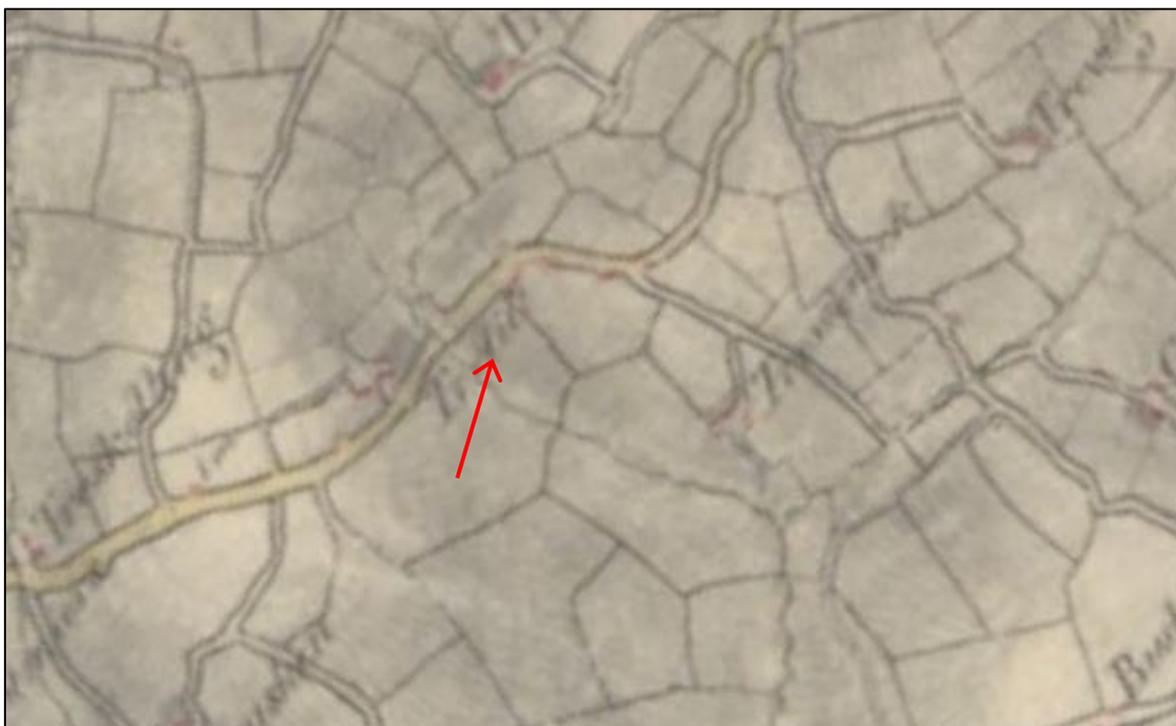
The Ordnance Survey Surveyor's Draft of 1805 shows the very small settlement at Trewenack, a similar sized cluster at Trelill. There is an attempt at representing field enclosures, although it is not clear how accurate this is.

FIGURE 3: EXTRACT FROM THE 1805 OS SURVEYOR'S DRAFT MAP FOR HELSTON (BL). THE APPROXIMATE SITE IS INDICATED.

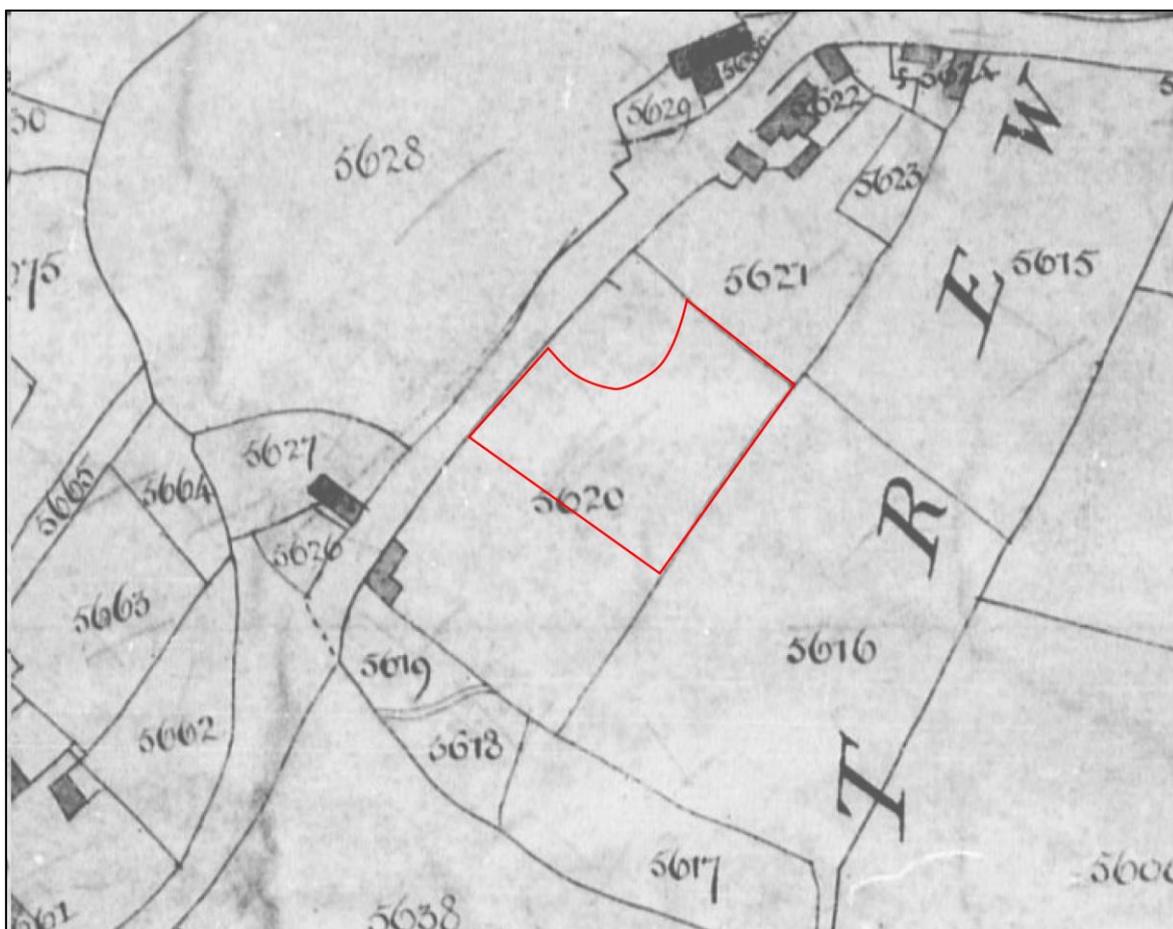
The Wendron tithe map of c.1840 shows the area in greater detail. The site forms part of a larger

field, plot 5620. There is a house (Tregilly Cottage) to the south-west of the plot, but this is associated with Plot 5619, which is described as house and garden and is in different tenancy. The plot which the Site is in forms part of a group owned and occupied as a smallholding by Thomas Goldsworthy. The name of the farm is not recorded. The fields all have prosaic, descriptive names. Plot 5620 is called Lower Field and was in use as an arable field at the time of the Tithe. The field-pattern around the site is clearly post-medieval in nature, but likely has origins in medieval strip fields.

FIGURE 4: EXTRACT OF THE WENDRON TITHE MAP, c.1840. THE APPROXIMATE SITE LOCATION IS INDICATED (GENEALOGIST).

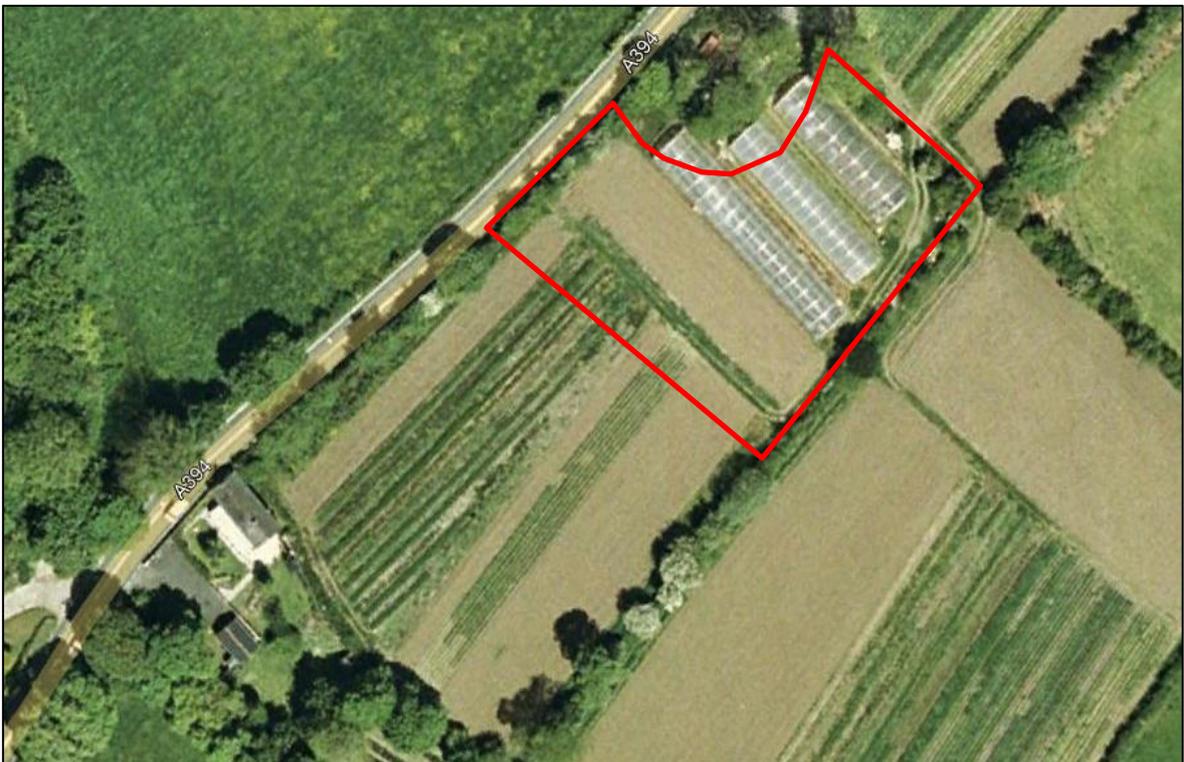
Aerial photography for the site from 2001 shows the row of houses at the northern end of the site has been lost, with only a small, possible agricultural store visible. The site is divided into separate areas, largely apparently agricultural but with polytunnels at the northern end. There are no obvious earthworks, cropmarks, or indications of archaeological features. The 2021 aerial photography appears to indicate that the site has fallen into disuse. The land is scrubby, divisions have disappeared and the larger polytunnel removed. The small building in the northern corner has also apparently been removed.

FIGURE 7: AERIAL PHOTOGRAPHY FOR THE SITE IN 2001 (©INFOTERRA LTD. & BLUESKY). THE SITE IS INDICATED.

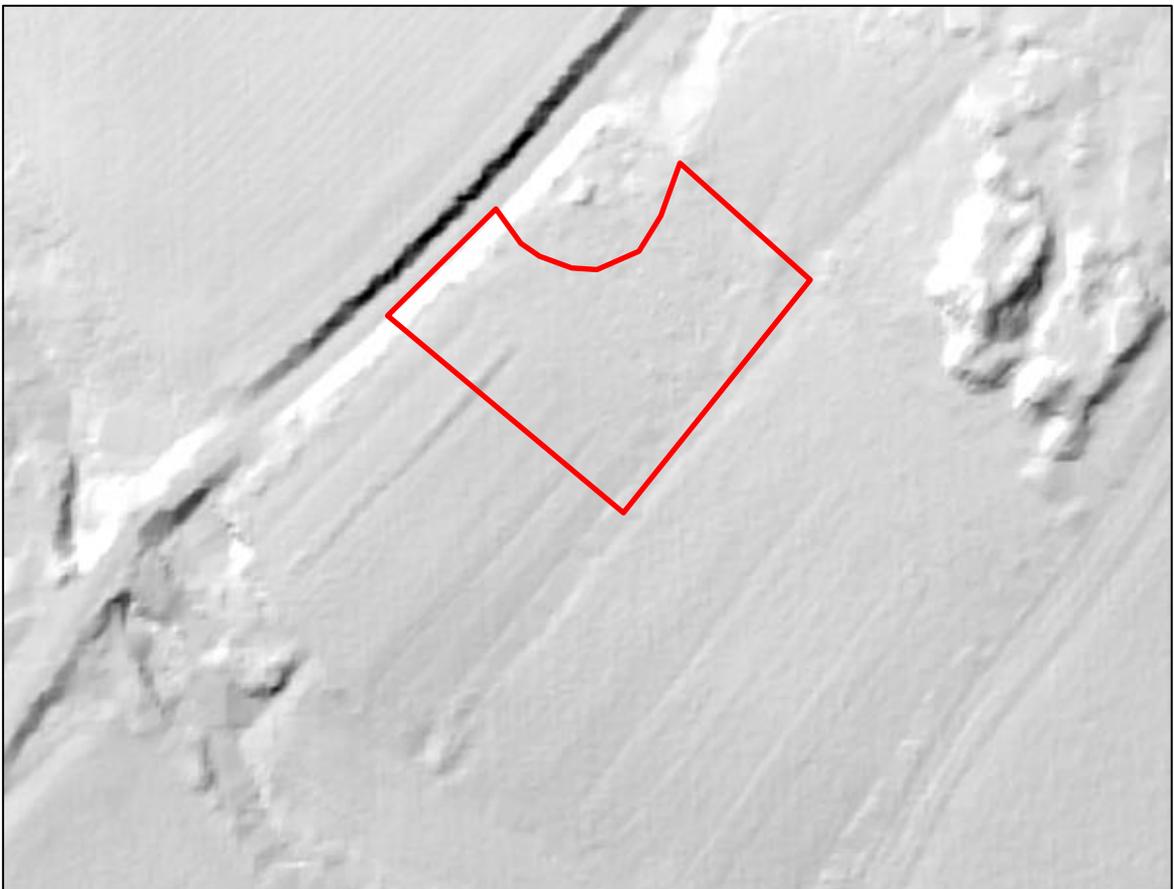
FIGURE 9: LIDAR FOR THE SITE; LIDARFINDER.COM. THE SITE IS INDICATED.

The LiDAR for the site shows the disturbance of the ground at the northern end that likely relates to the polytunnels, as well as the construction in the northern corner and the adjacent field to the north. The site shows linear features consistent with its arable use or possible historic divisions, but there are no indications of archaeological features.

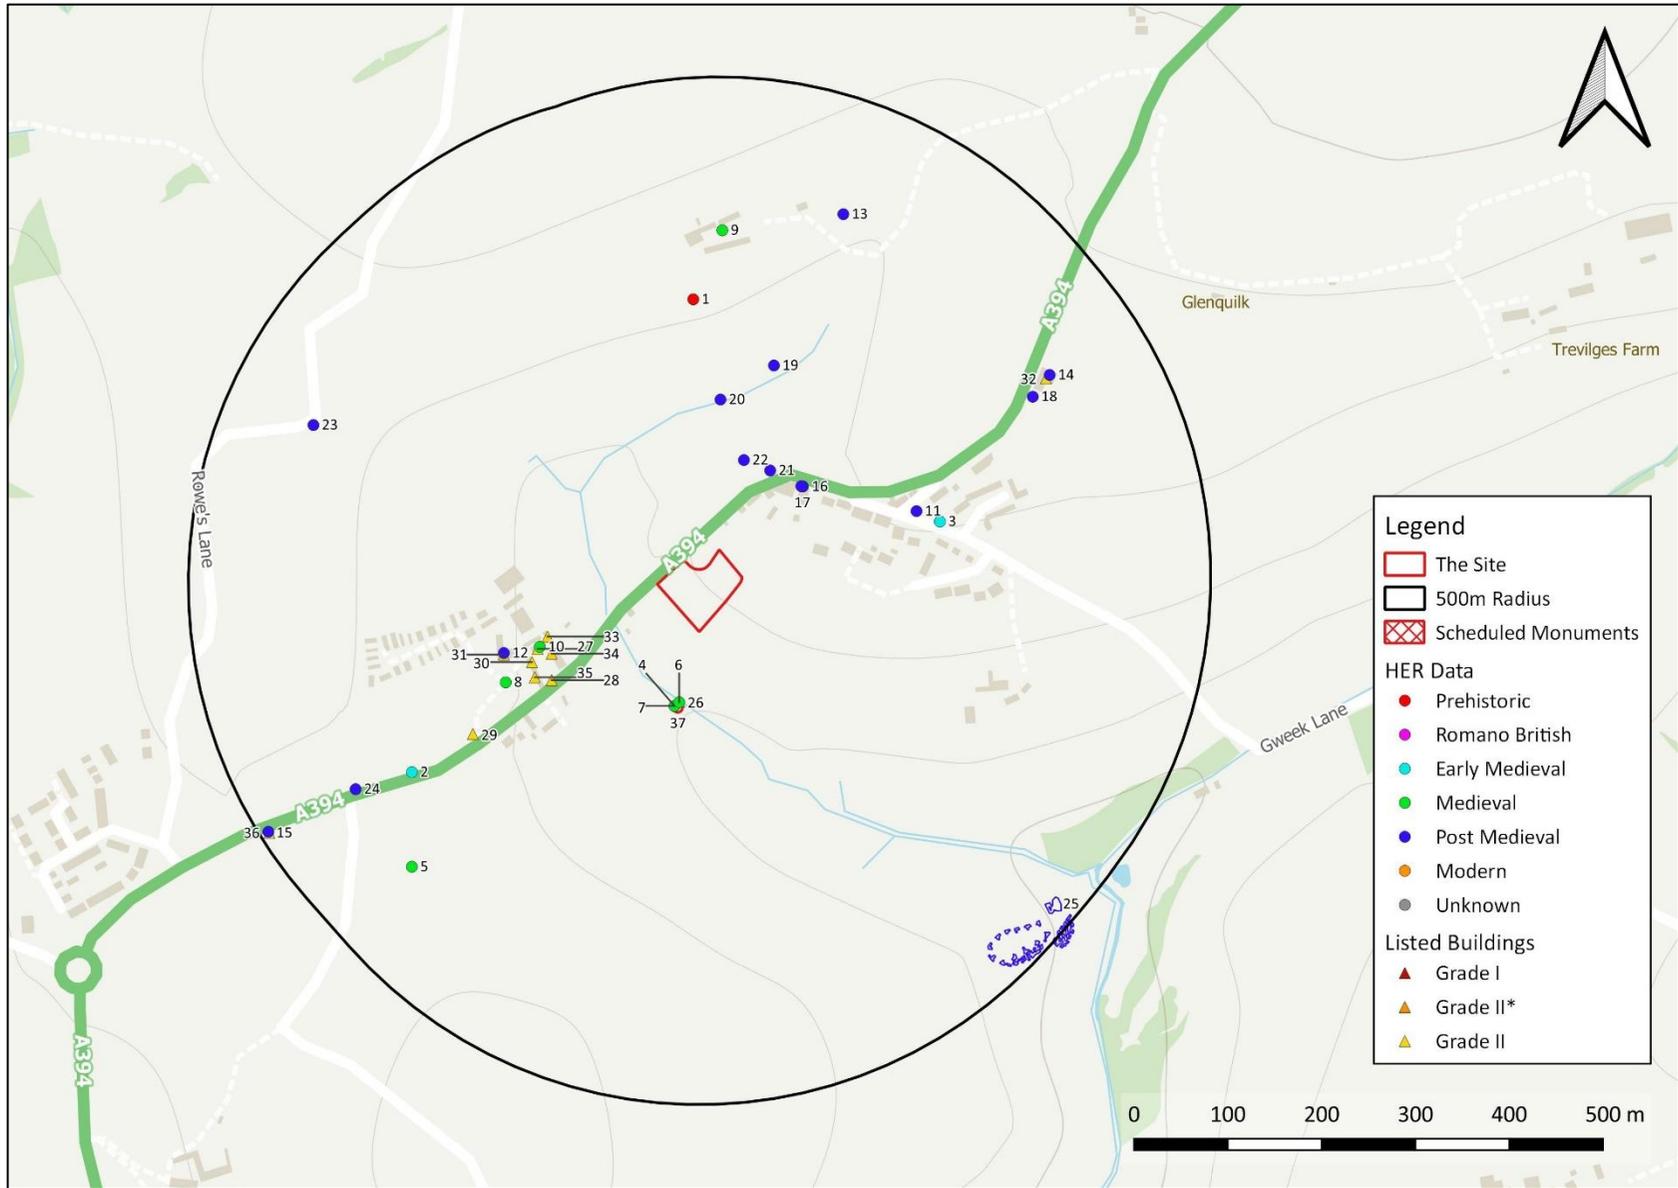
FIGURE 10: HERITAGE ASSETS WITHIN 500M OF THE PROPOSAL AREA RECORDED IN THE CORNWALL HER. CONTAINS ORDNANCE SURVEY DATA © CROWN COPYRIGHT AND DATABASE RIGHT 2023.

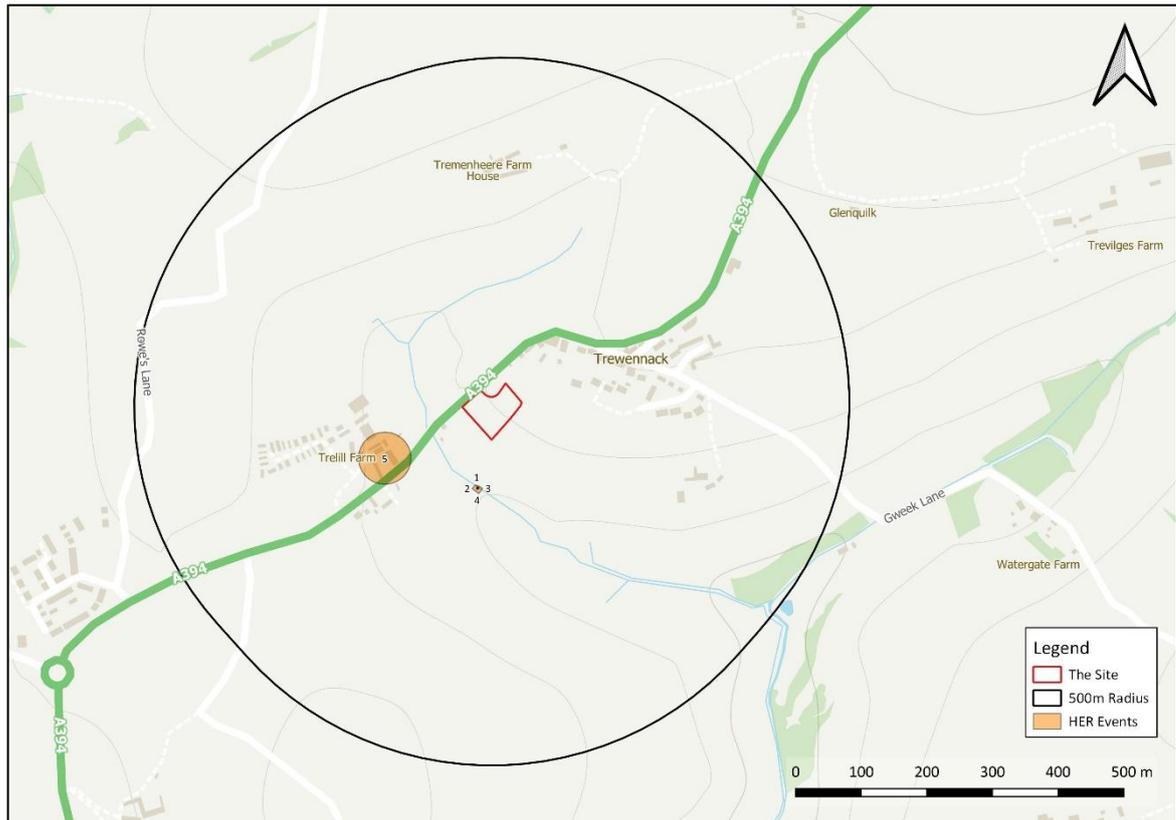
FIGURE 11: ARCHAEOLOGICAL INTERVENTIONS WITHIN 500M OF THE PROPOSAL AREA RECORDED IN THE CORNWALL AND SCILLY HER (CSHER). CONTAINS ORDNANCE SURVEY DATA © CROWN COPYRIGHT AND DATABASE RIGHT 2023.

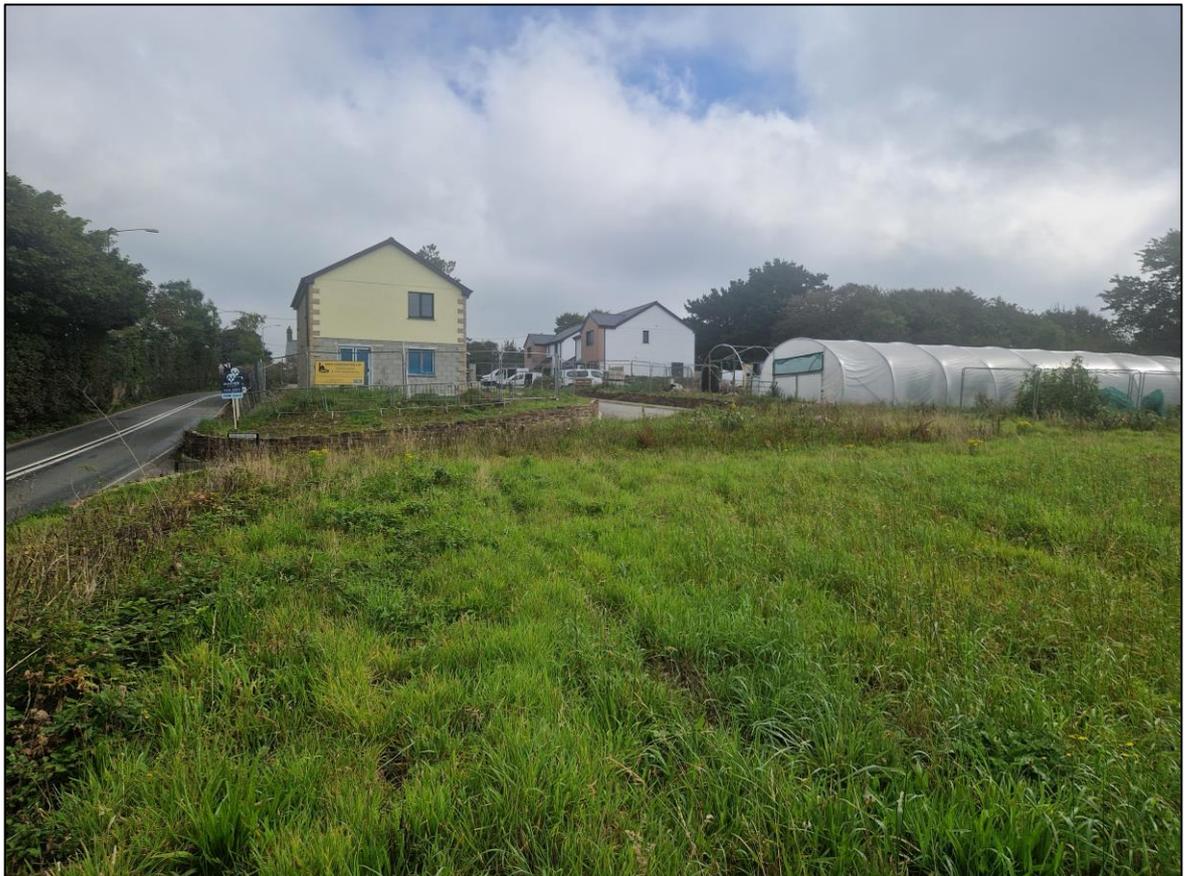
North boundary is open to the new access road and modern stone wall of one of the new buildings. The west boundary is open to the road, 1.2m lower than the field. Becomes a tree lined boundary just at site limits, with beech, buddleia, eucalyptus and sycamore.

FIGURE 12: THE SITE WITH MODERN DEVELOPMENT AND ACCESS, VIEWED FROM THE SOUTH-WEST.

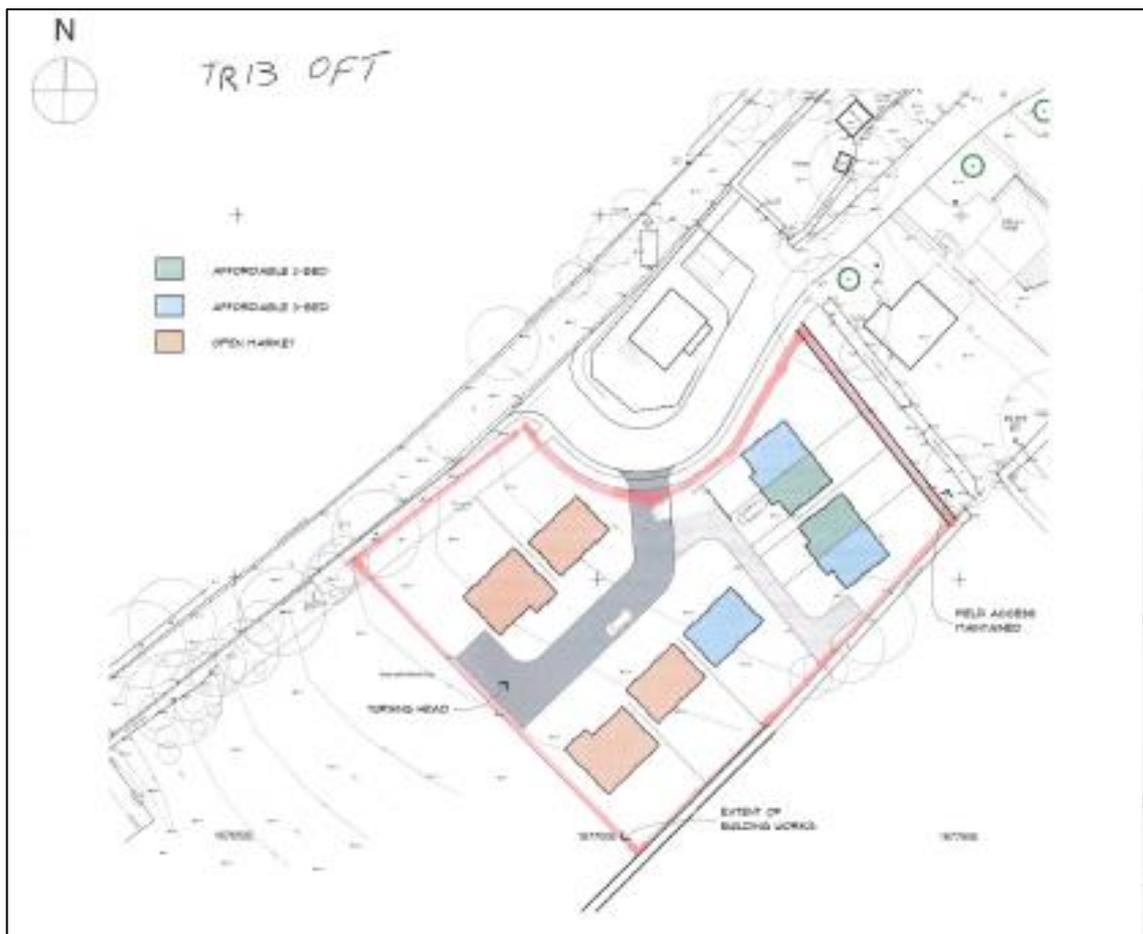
The proposed development would see the construction of 9 dwellings. The land to the north-east has already been developed in recent years. Intervisibility between the proposed development and the Scheduled Monument is and will remain nil, although the mature planting around the proposal site and the holy well should be maintained to reduce and soften and visibility of the new houses. The proposed development would not compete with the holy well in views nor affect the experience of the visitor. The holy well was the only asset considered in detail; all other assets are screened by other historic or modern buildings or other features and therefore will experience no real impact.

FIGURE 13: THE PROPOSED DEVELOPMENT; SUPPLIED BY THE CLIENT.

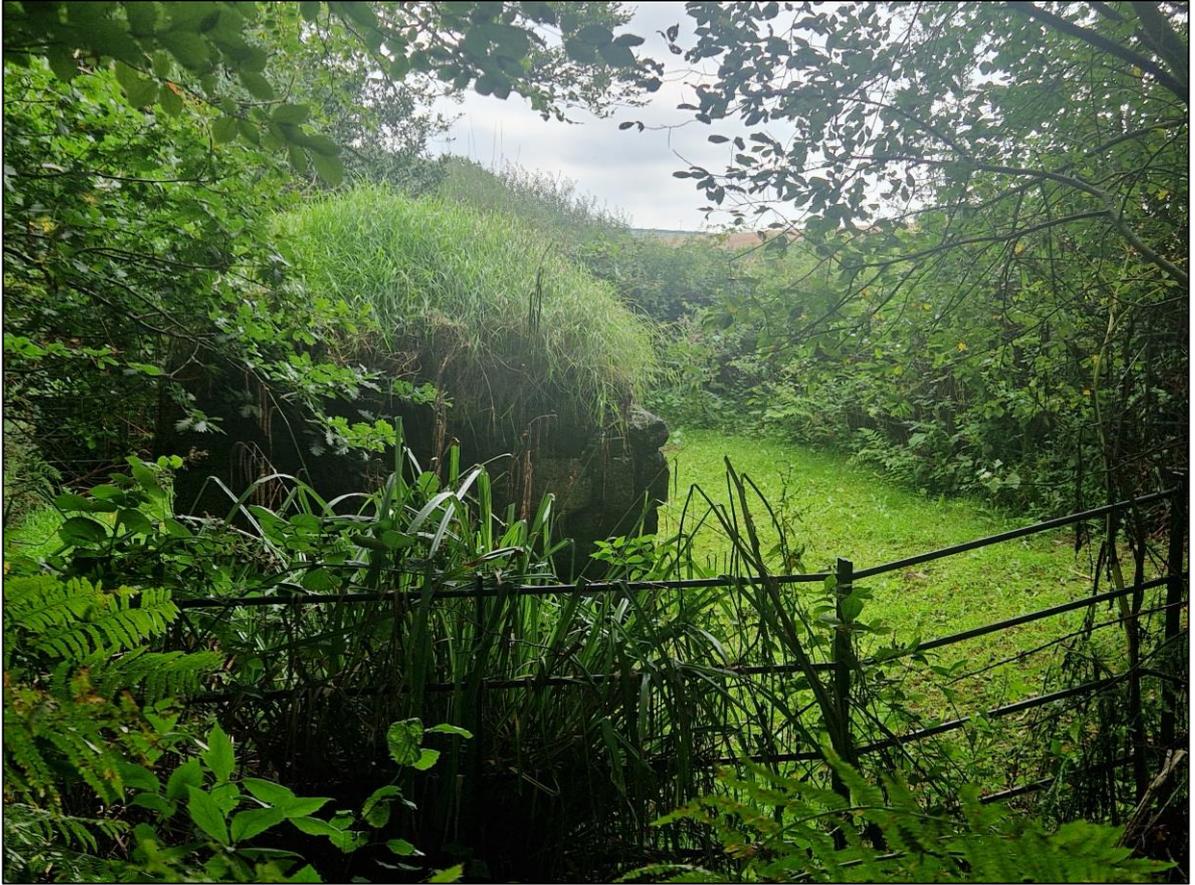
<i>without leaving a pin. A decorated stone cross now at Constantine formerly stood near to the well but was removed at some time prior to 1896. The holy well is Listed Grade II* (66314).</i>
<i>Supplemental Comments:</i> The well house was subject to a programme of restoration and repair in 2013 which restored the structure and created provision for parking and signage for visitors.
<i>Conservation Value:</i> The building has aesthetic value as a vernacular building with a religious purpose. It has historical/illustrative and historical/associative value as the remains of a holy well house, possibly in association with the now lost parish church and a since move cross. It has high evidential value and its archaeological value is unexplored. It has communal value for its local population and visitors to the site.
<i>Authenticity and Integrity:</i> The holy well appears to be in good condition; it remains an authentic place of pilgrimage.

<i>Topographical Location & Landscape Context:</i> The well lies within a field to the south of Trelill and west of Trewennack, enclosed by mature trees and hedges.
<i>Setting:</i> The holy well is sat outside of the settlement in a field that is bounded by mature hedges and trees. It's setting is very limited, to its own enclosure really (see Figure 14).
<i>Principal Views:</i> Very restricted – there are no views to or from the well.
<i>Landscape Presence:</i> Very Limited. The well cannot be seen from outside of its immediate area.
<i>Sensitivity of Asset:</i> A greater part of its significance arises from its historical, evidential, and communal value. Its aesthetic value is the most readily obvious but that is only one component part of its significance.
<i>Contribution of Setting to Significance of Asset:</i> Important. At one stage, one of the most important structures in the village, as part of the religious centre. However, its setting is now much more constrained by the mature specimen trees and hedges of the field, the associated religious structures (chapel) has been lost, and it lacks any landscape presence.

FIGURE 14: HOLY WELL AT TRELILL, VIEWED FROM THE NORTH.

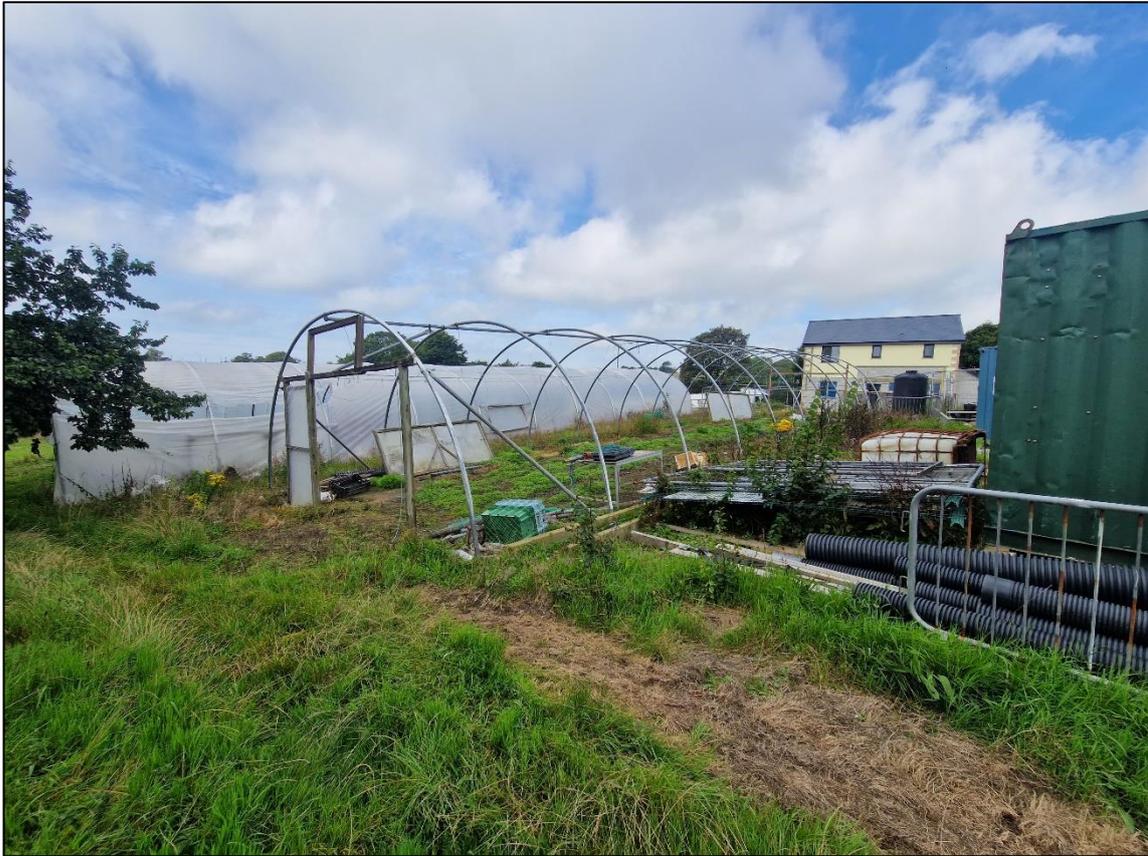
The site was visited by Dr. S. Walls on 17th August 2023. The weather was overcast with occasional showers. Site is currently to pasture, but evidence was market garden/ allotment until recently, with two part-derelict poly-tunnels to the north of the site. There were clear furrows running north-east to south-west (parallel with boundaries) some peonies, surviving in 1 row, with runners beans and others currents bushes netted/fenced to the immediate south of the polytunnels. Evidence of bonfires in this location too.

1. SURVIVING POLYTUNNELS ON THE SITE, VIEWED FROM THE EAST.

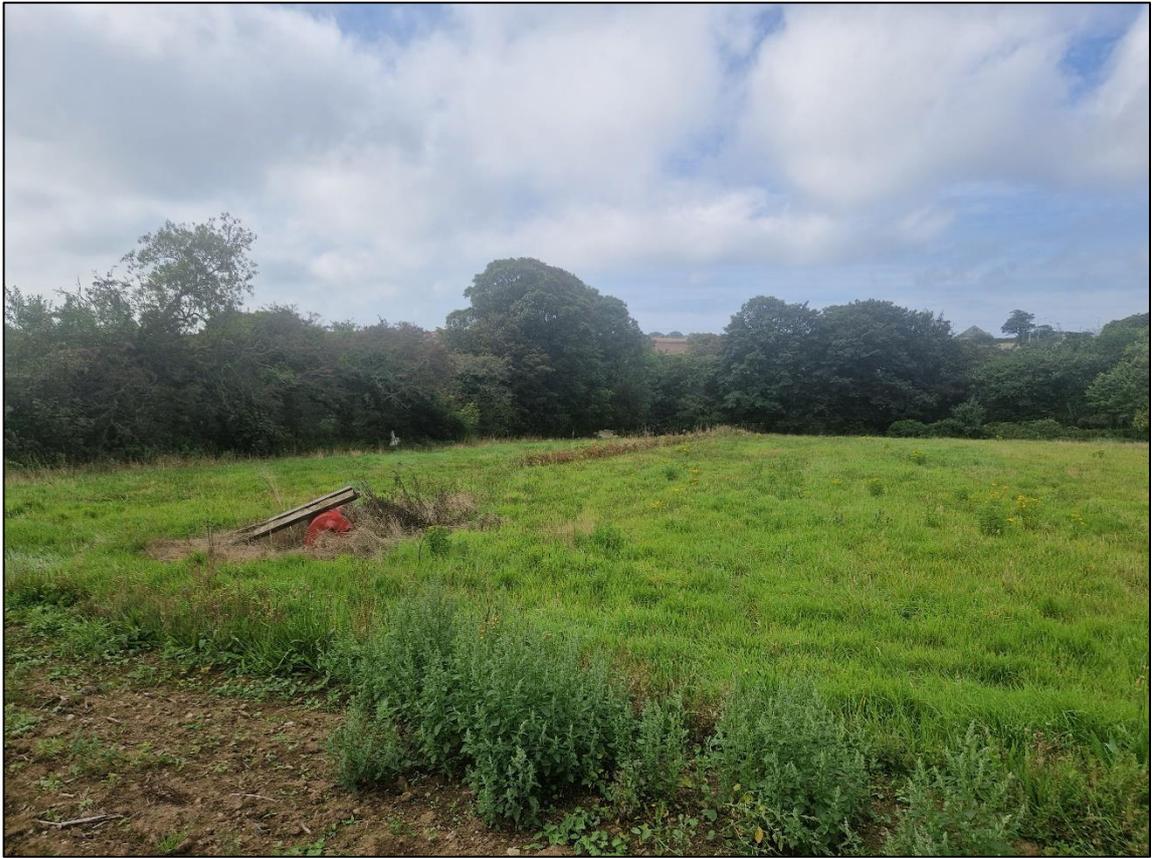
Mole Hills to the west and a small rotavated area south of the polythene, produced small assemblage of White refined earthenware and other industrial glazed wares, bottle glass, 2 clay pipe stem, 1x English tin glazed sherd, and 1x coarseware rim (a 17th -19th century finds assemblage. These finds were discarded on site, but demonstrate the post-medieval agricultural use of the site.

5. ROTAVATED AREA, PILE OF RUBBISH AND REMNANT CROP, VIEWED FROM THE NORTH.

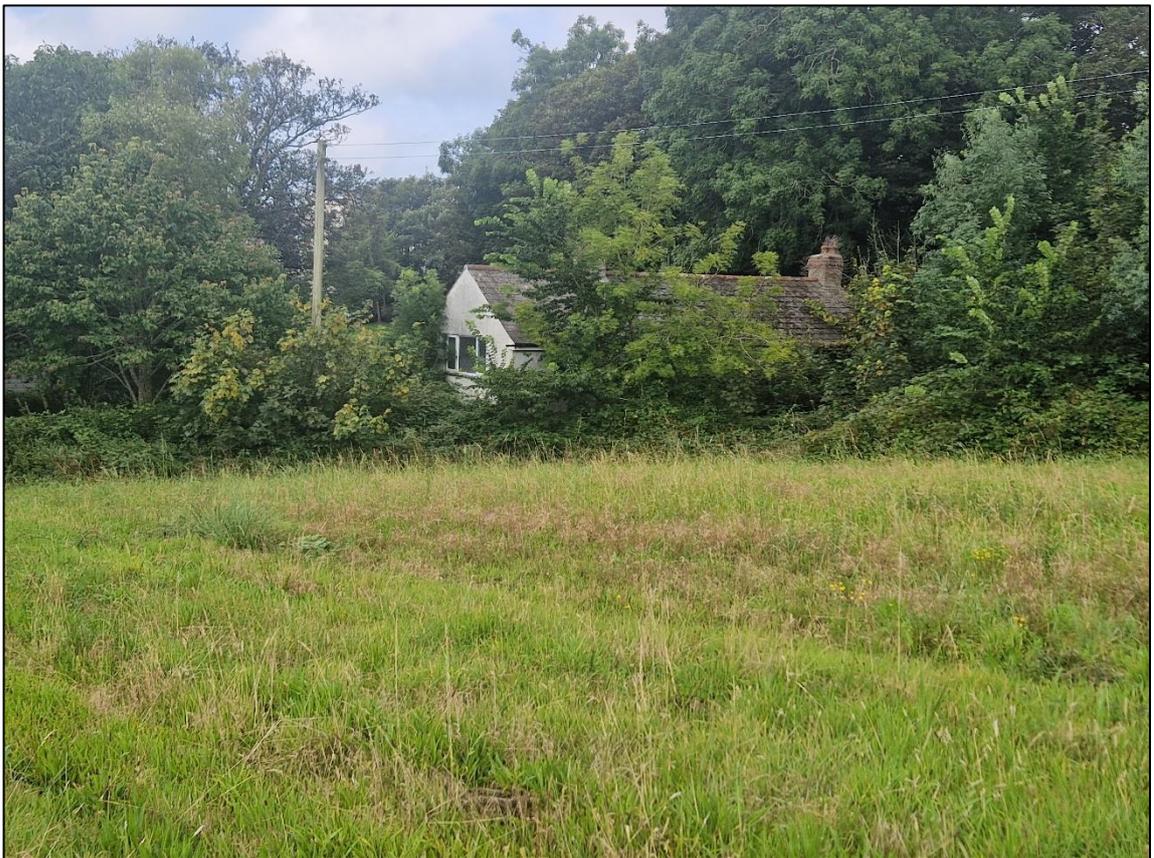
South boundary of site, is open to rest of the field. Hedge of brambles and sycamore separating this field from adjoining (18th of 19th century?) Tregilly Cottage. Tregilly Cottage appears unoccupied, and the garden is overgrown and the condition of the building deteriorating. Tregilly

Cottage is a low 18th or 19th century cottage, only the roof was visible from the site, but should shrubs and boundaries be cut, probably whole of first floor would have clear views of the site. Modern windows and concrete render to the cottage make it difficult to date, and it is clearly in deteriorating condition.

8. TREGILLY COTTAGE, VIEWED FROM THE NORTH.

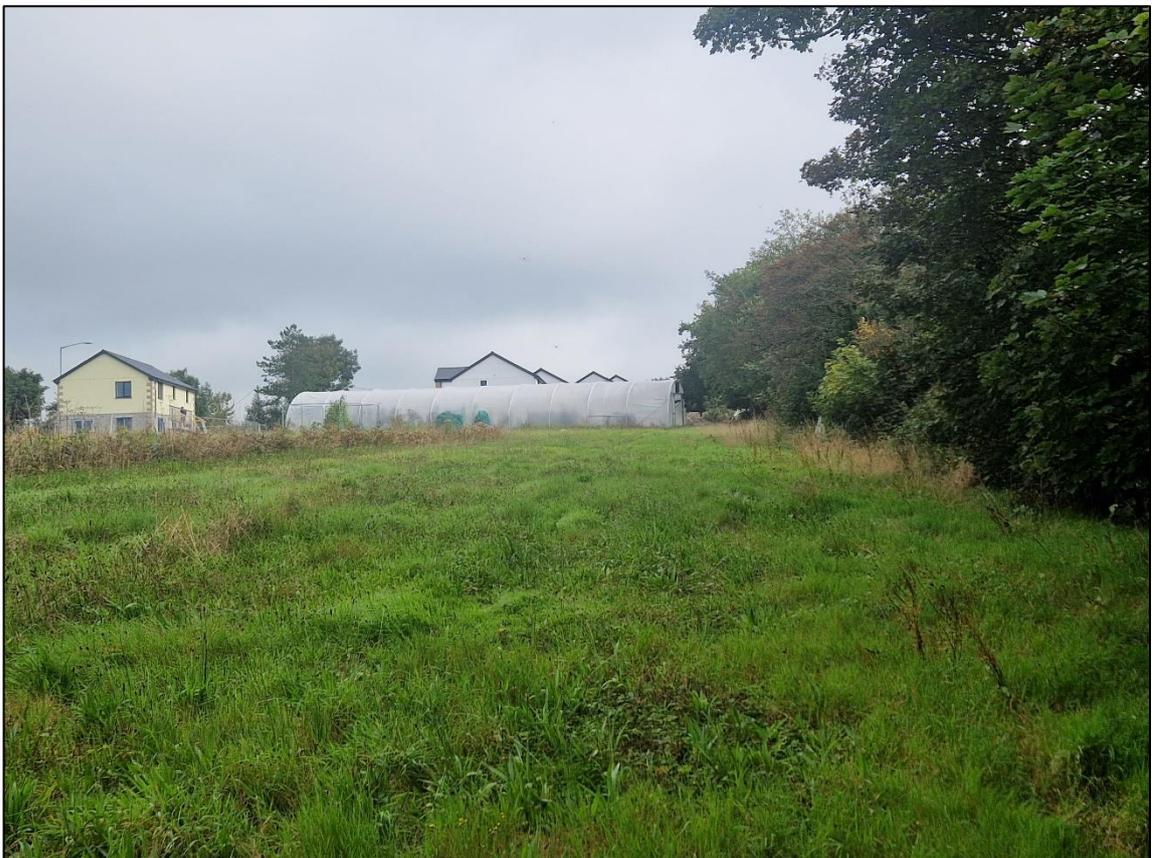
The east boundary is a 0.6-1m high earth bank with stone facing. Mixed deciduous trees, sycamore, Hawthorn and Ash, mature examples mostly beyond site limits. A few more mature examples to north end near the Polytunnels, including beech and Holly.

12. VIEW OF THE SITE AND MATURE EAST BOUNDARY, FROM THE SOUTH-WEST.
