Preliminary Bat & Bird Assessment

Garage at Carnon Crescent, Carnon Downs, Truro, TR3 6HL

11th May 2022

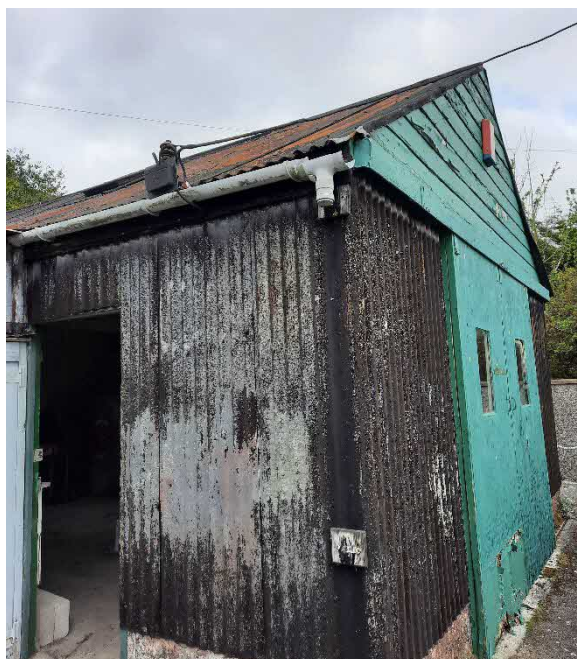
The garage on-site is a detached single storey building of mixed material construction (part corrugated metal, part likely asbestos sheeting and part timber panelling supported by a concrete base) (Figs 1-6). A lean-to projection is present off the western elevation and is of similar corrugated material construction and was well lit from light panels in the corrugated sloping roof; the lean-to had no suitable features for roosting bats (Fig 2 & 7). The garage roof is pitched and features similar corrugated metal material with a likely lead flashing ridge covering. The roof sheeting appears to be tight with no obvious gaps, the ends of the ridge appeared to be covered preventing bat access or suitable gaps for roosting bats (Fig 4). Double garage wooden doors with small windows were present on the southern elevation, a single doorway was present on the western elevation, both the doorways were largely tight with no obvious gaps. On the eastern elevation were two windows; one was glazed with some cracked panes and one was boarded up with a timber panel, these were also largely tight and densely cobwebbed on the exterior. There are wooden fascia's, window frames, and metal guttering and plastic down pipes on the east and west elevations; the north and south elevation feature wooden panelling at the apex, these were all largely tight and densely cobwebbed with no suitable bat accesses or roosting locations.

Figure 1: View of the south and west elevations of the garage at Carnon Crescent.

Although no current evidence of roosting bats was found, absence cannot be assumed. A precautionary approach should be adopted. The building contractors should be made aware that bats can roost unseen within the building structure. The fascia boards and the end ridge sheets should be removed carefully by hand. In the unlikely event that a bat is uncovered during demolition works, the bat must not be handled, and works must stop immediately (as soon as it is safe to do so). Advice must be sought from an experienced and licensed bat ecologist (Plan for Ecology Ltd: 01326 218839) or Bat Conservation Trust (Tel: 0345 1300 228). In this scenario, it may be necessary to undertake further survey work and subsequently obtain a bat licence from Natural England before works are permitted to resume. See Section 1.3 for relevant legislation.

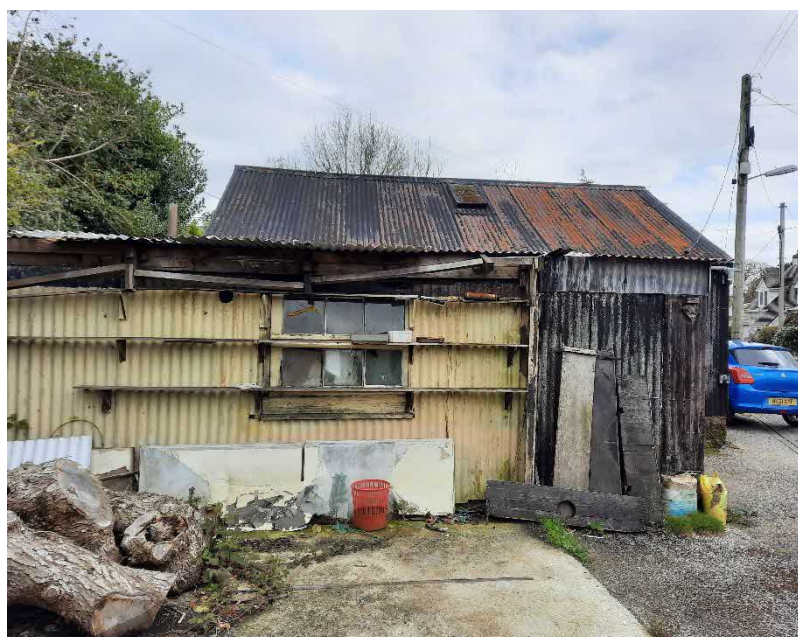
Figure 2: View of the west elevation and lean-to on the garage at Carnon Crescent.

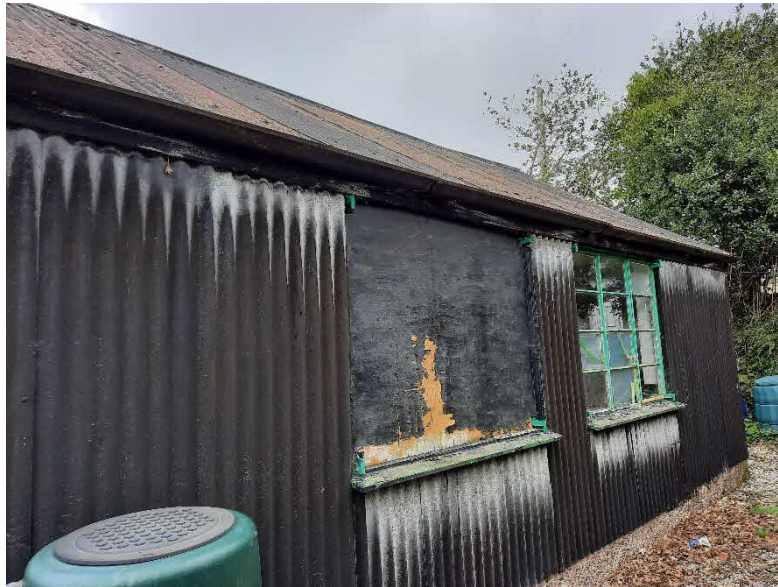
Figure 3: View of the eastern elevation of the garage at Carnon Crescent; one glazed window and one boarded window were present.

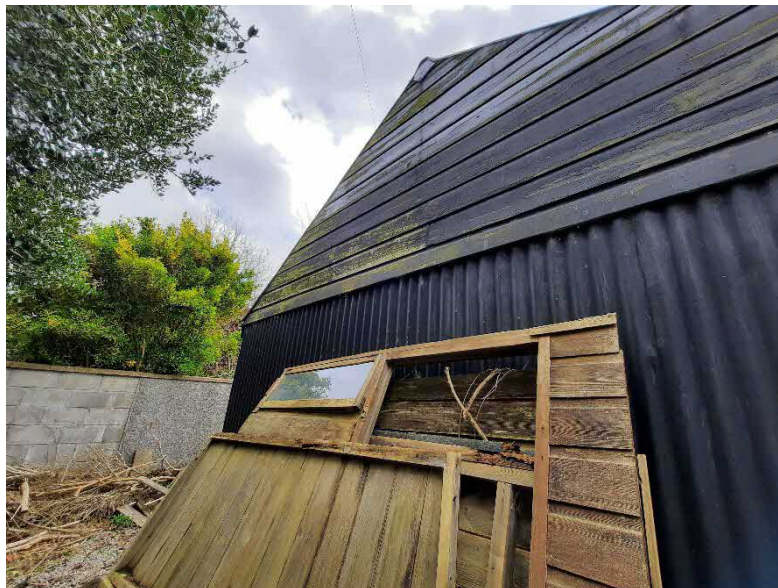
Figure 4: View of the northern elevation of the garage at Carnon Crescent.

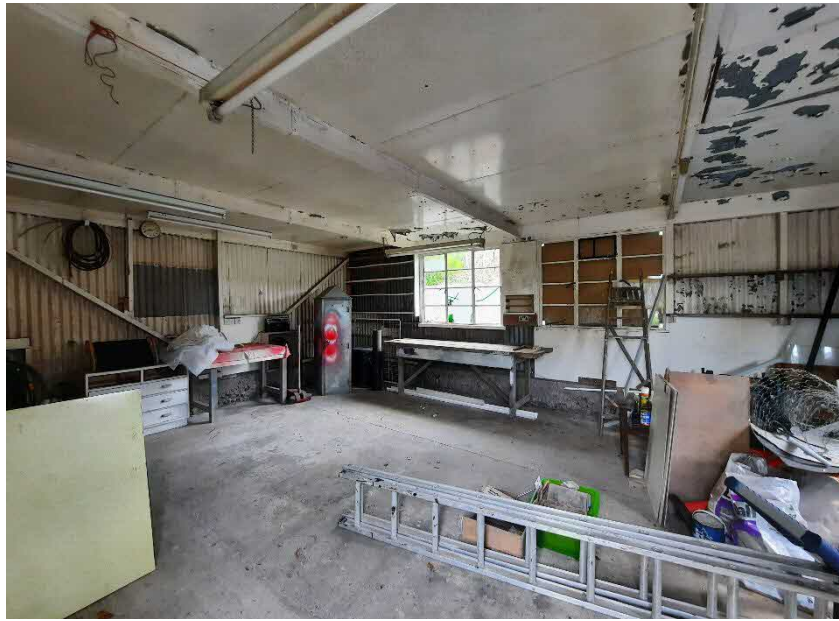
Internally, the garage comprises a single room with a void spanning the length and width of the room which was used for storage at the time of the survey (Figs 5-6). The roof structure is a traditional timber A-frame with an unlined corrugated roof supported in places by metal struts (Fig 6). The floor was boarded out and no insulation present. The timber apex and wall tops were densely cobwebbed. The northern gable end had some light holes where the wood panelling very slightly parted but no evidence of bats using the void for roosting was observed; furthermore, the roof was densely cobwebbed throughout, indicating that it is unlikely to be used for roosting by bats.

Figure 5: Interior view of the ground floor within the garage at Carnon Crescent.

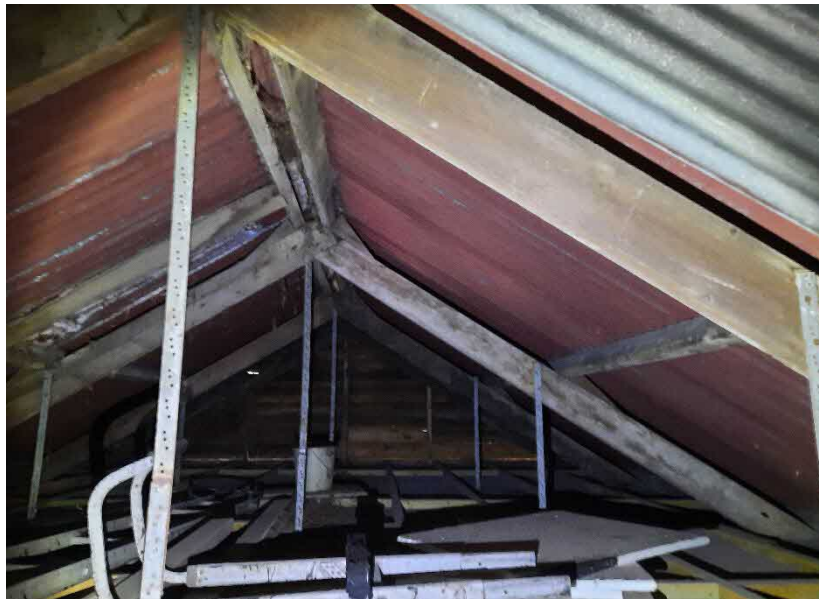
Figure 6: Interior view of the unlined pitched roof within the densely cobwebbed void above the garage at Carnon Crescent.
