HERITAGE STATEMENT

Four Gables

Nailsea

November 2023

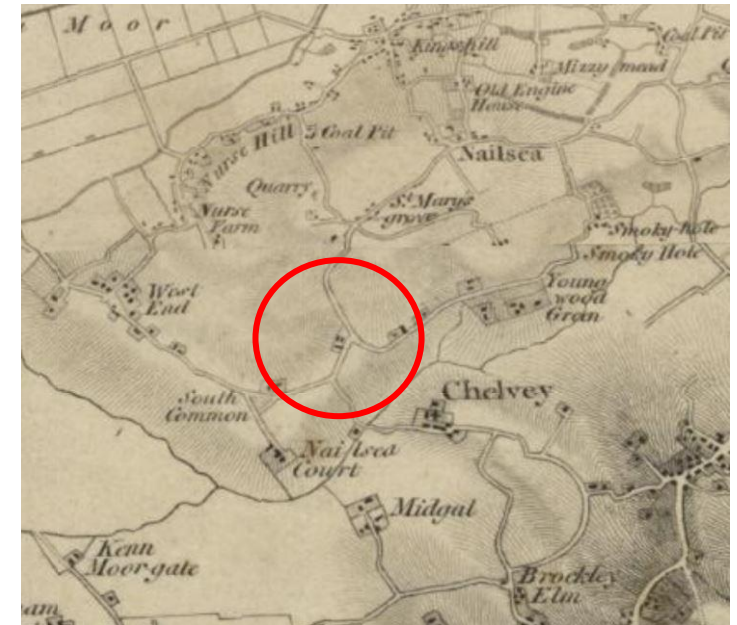
Cartographic Analysis

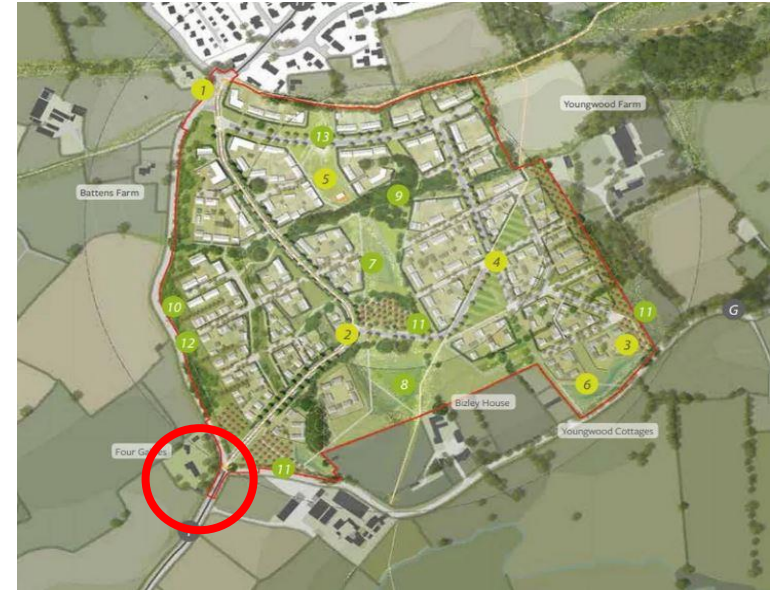
2021

The map image to the right is the approved Taylor Wimpy development of 450 new homes, known as Netherton Grange, over a 60-acre site. Four Gables can be seen to the south west of the site as circled, showing that the site will no longer be surrounded by open countryside but instead located very near a substantial residential development for which the settlement boundary of Nailsea has been extended. At the time of this application the new boundary remains unconfirmed and the Local Plan 2039 is still in consultation with the Secretary of State.

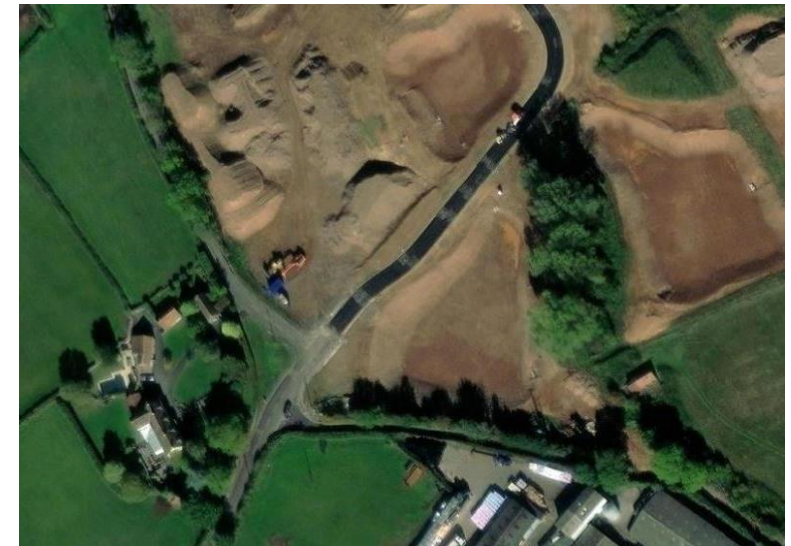
2023

The image right is taken from ARCHIUUK Lidar imagery. It shows the proximity of the excavations for the new housing estate of 450 home to the site at Four Gables and Cherry Orchard – formerly Bartlett’s Farm. In the medieval period much of the area was included in one of the large, commonly owned open fields of Nailsea. This was the area where the arable crops were grown, and some of the area was later converted to water meadows.

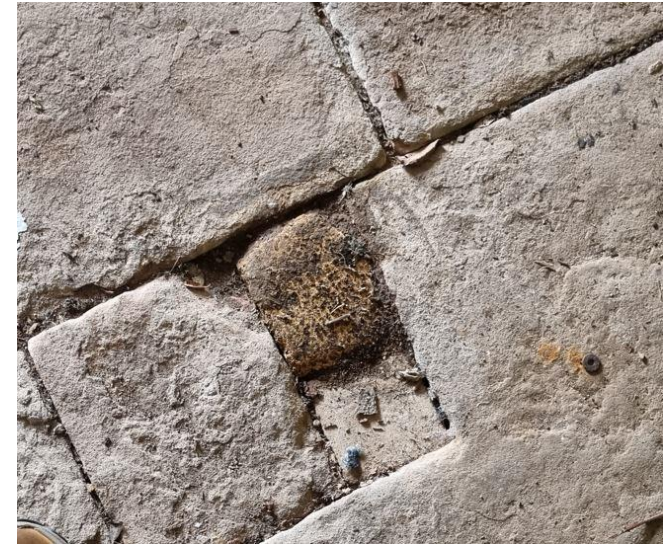
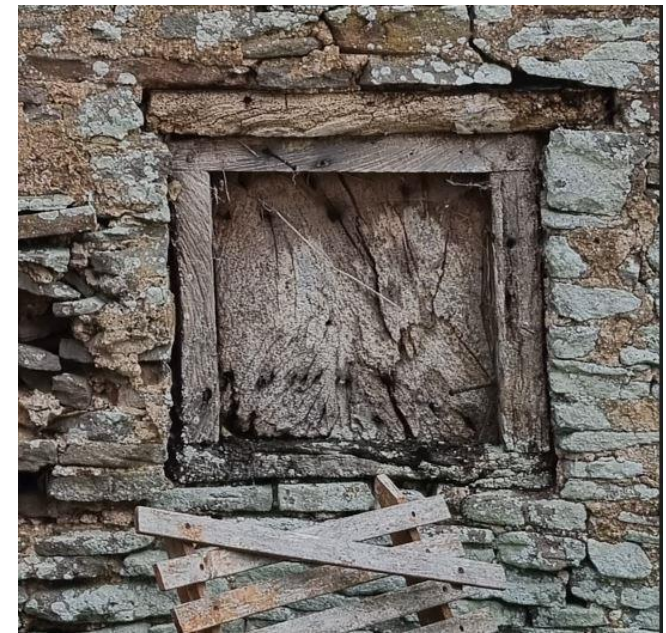
Right top & bottom - the west & south elevations show further evidence of historic development. The ghost outline of an earlier building, as on the 1880s map, can be seen.

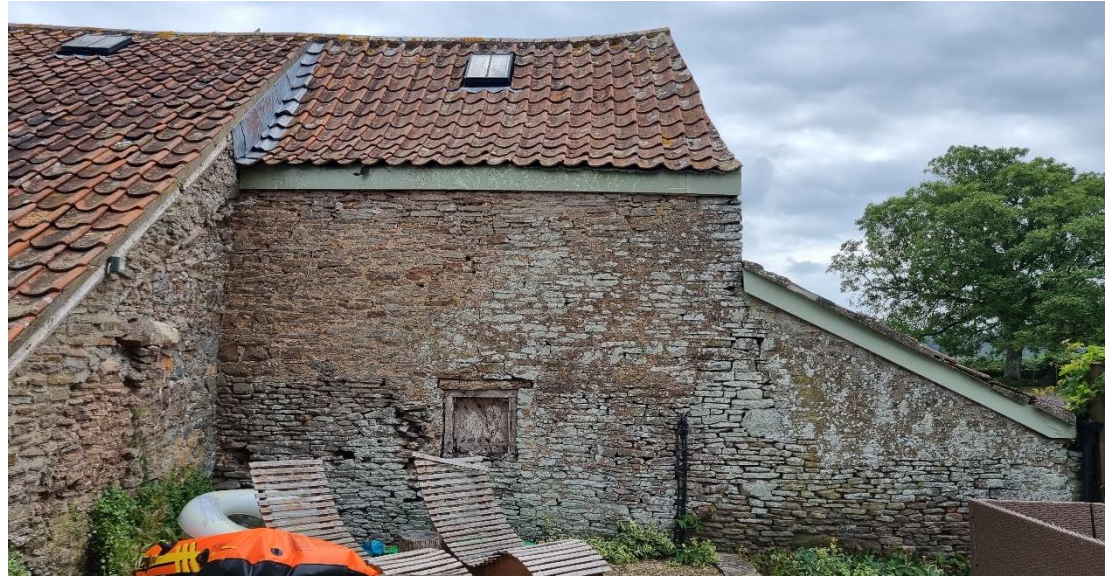
Below left – the north elevation shows the cart entrance to the threshing barn, with the clear line between that and the outshot extension, likely built after threshing was mechanised and possibly housed a threshing machine.

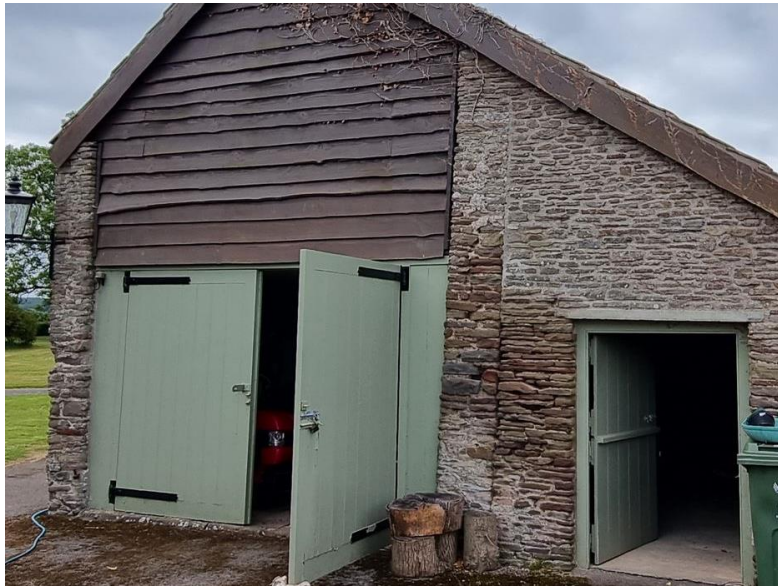
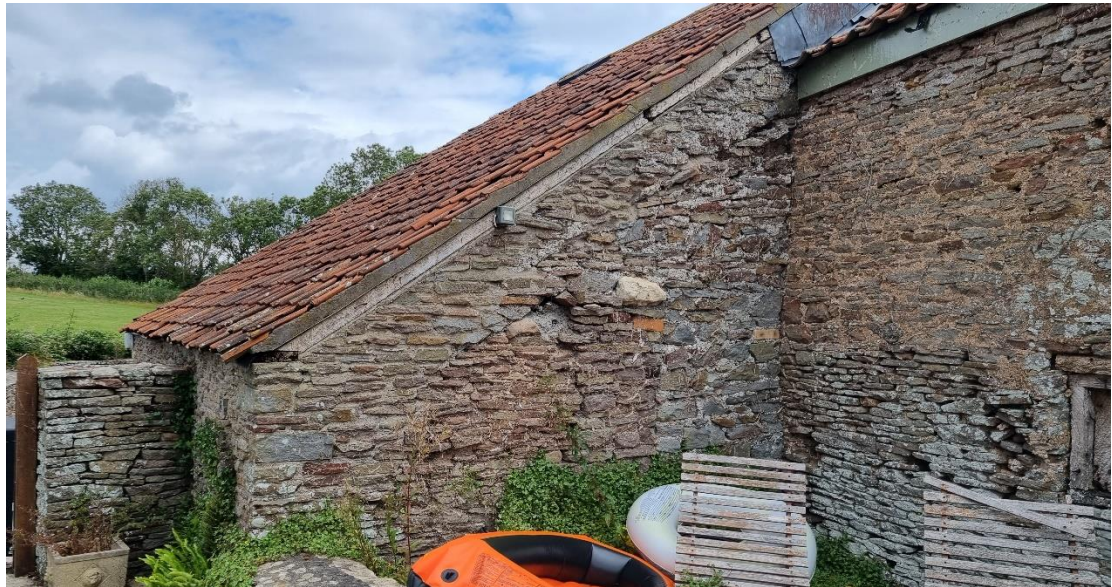
Right – The historic winnowing door situated between the threshing barn (store 3) and the outshot extension (store 4) is constructed from historic salvaged timber elements, as was common practice in vernacular buildings.

Below – The door shows historic 'Tally' marks, which are often found in agricultural buildings scribed on doors or walls and used to calculate grain sacks, but also have the potential to be apotropaic. It is proposed this door is retained unpainted and in situ.

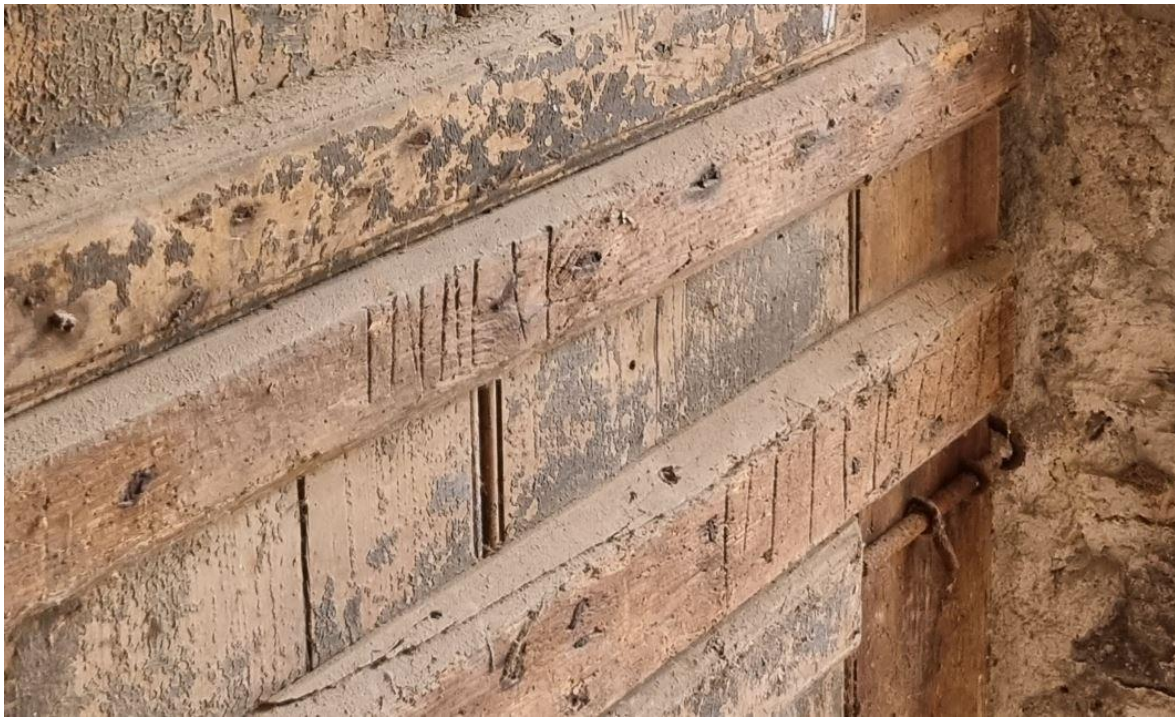
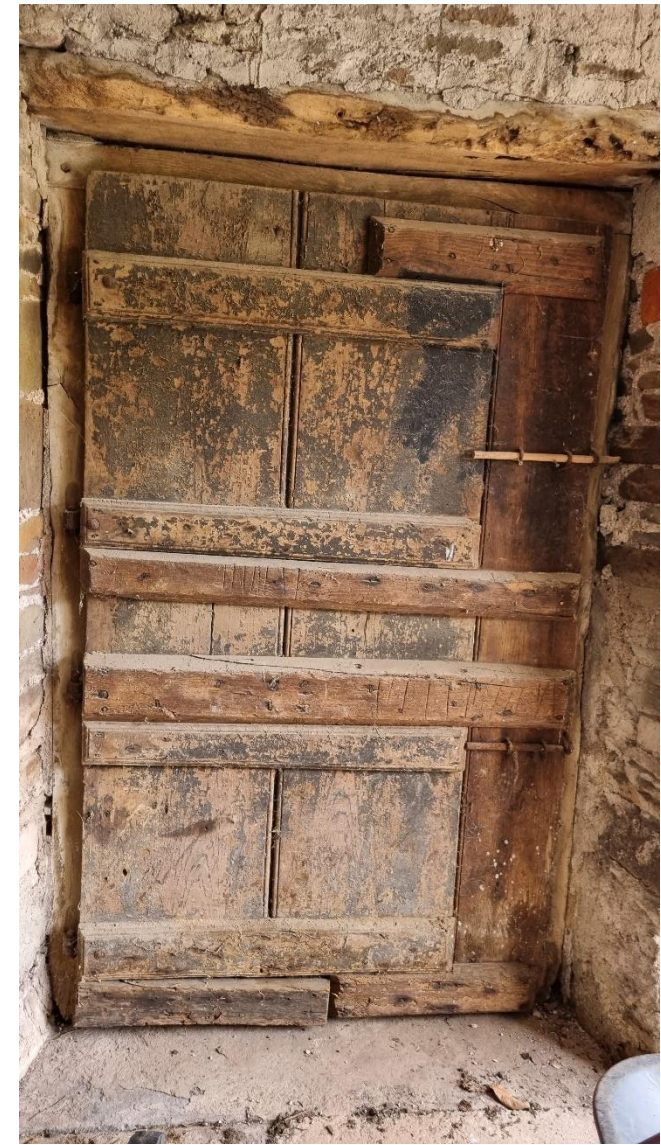
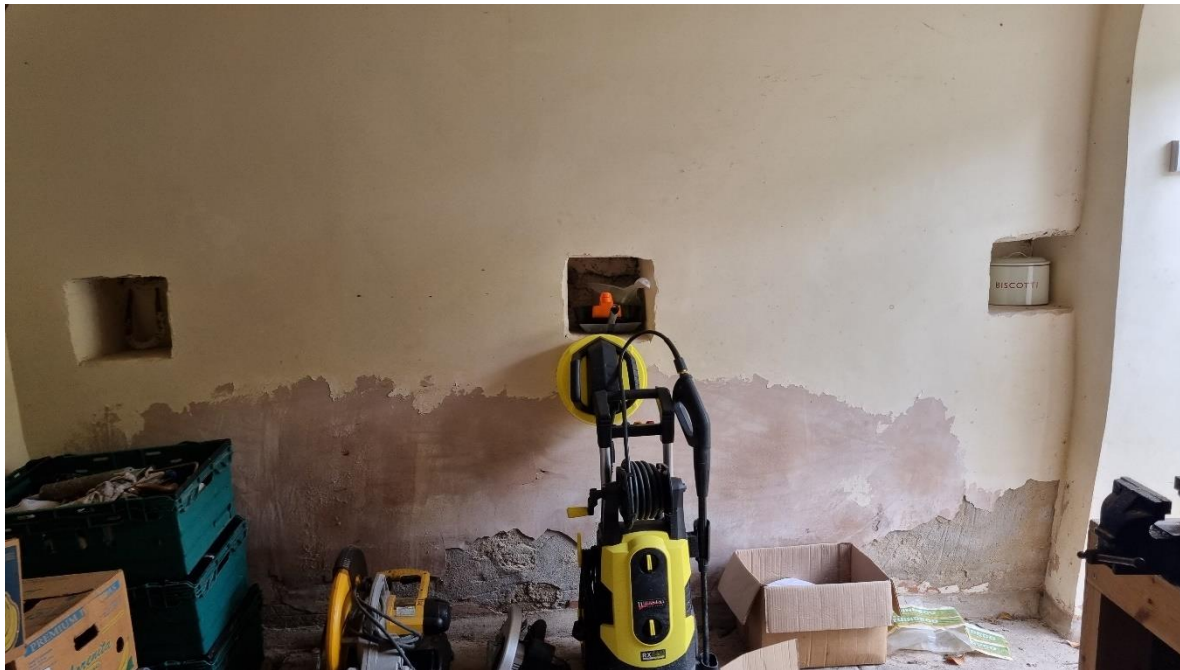
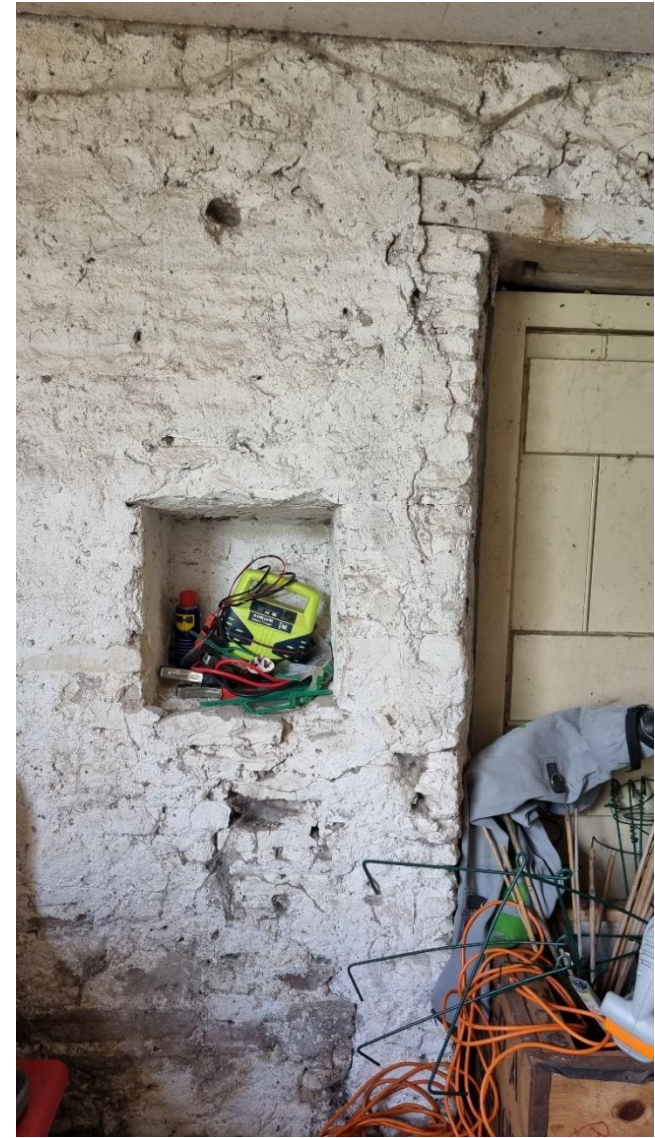
Right and below – ‘Fowl holes’ are located in several places in the barn and are evidence of the common practice of keeping chickens among other animals. Chickens were also allowed to ‘fatten’ themselves by gleaning in the threshing barn, which would also help clear up the leftover grain and reduce rodents. Dogs would be kept to catch rats and one of the outbuildings identified on the 1880s map was probably a kennel, along with the pigsties. The fowl holes will be retained in the current set of proposals.

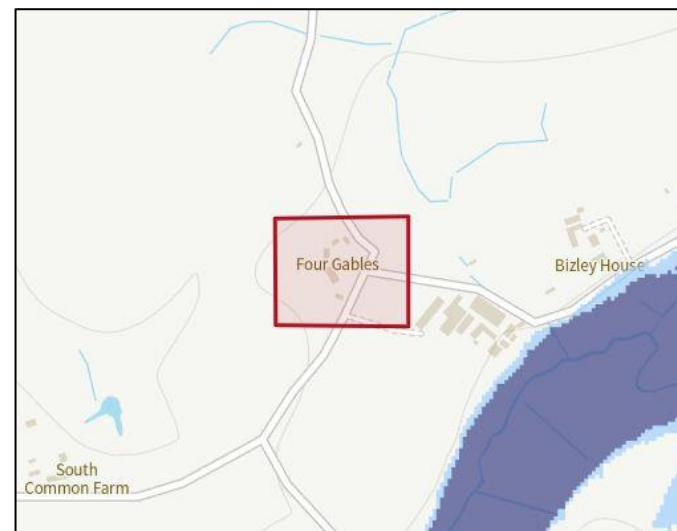
The site is located in Flood Zone 1 as indicated by the flood map for planning services at Gov.uk which means it has a low probability of flooding from rivers or sea.

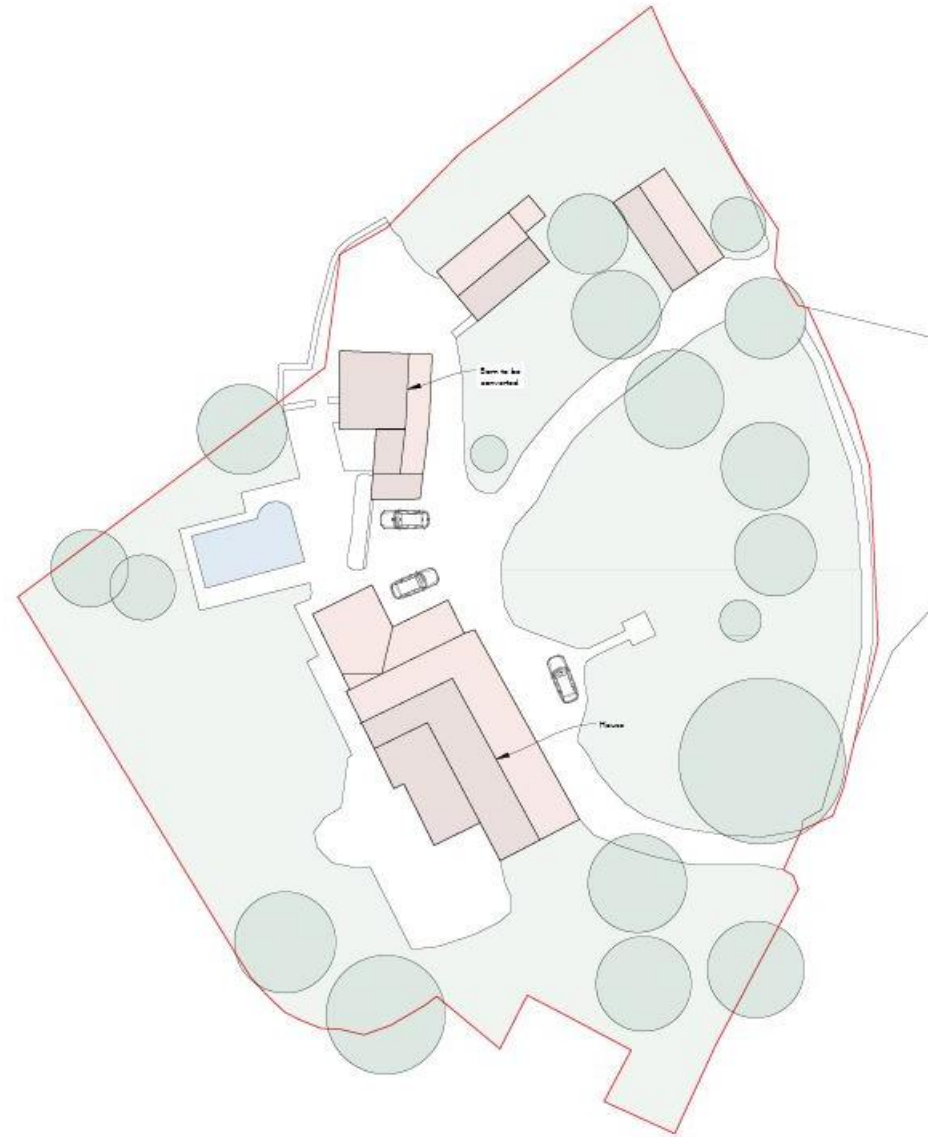
A measured survey has been undertaken of the site and the location of the trees plotted on the plan – right. The root protection area is defined by the canopy of the trees which do not encroach onto the areas of hardstanding allocated for site material storage.

Vehicular access for deliveries and off loading will be via the semi circular carriage drive and site parking will be restricted to the area of hardstanding between the main house and barn. The proposed works to the barn are not considered to have any potential to impact the trees.

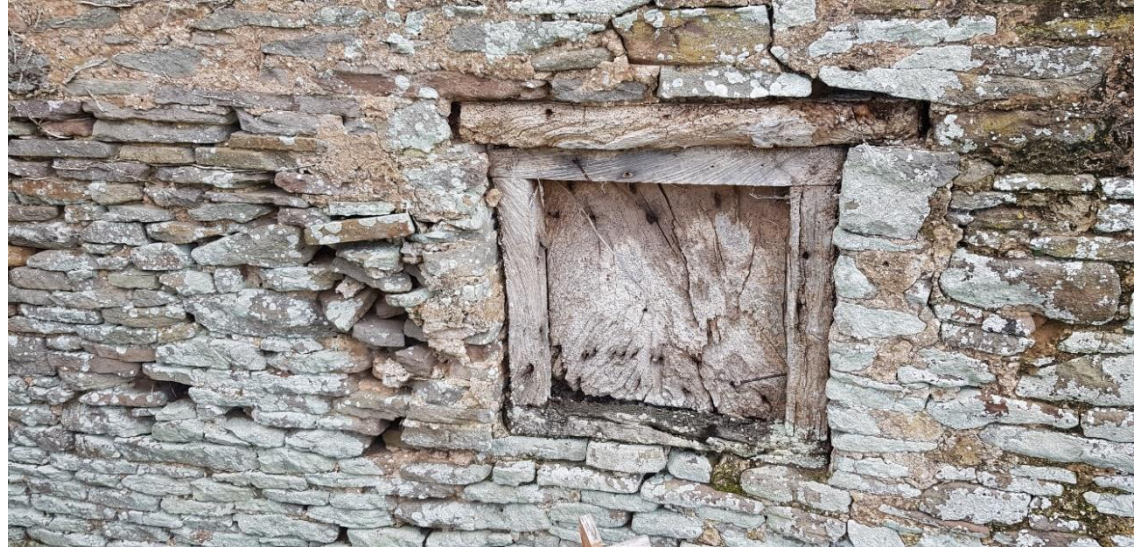
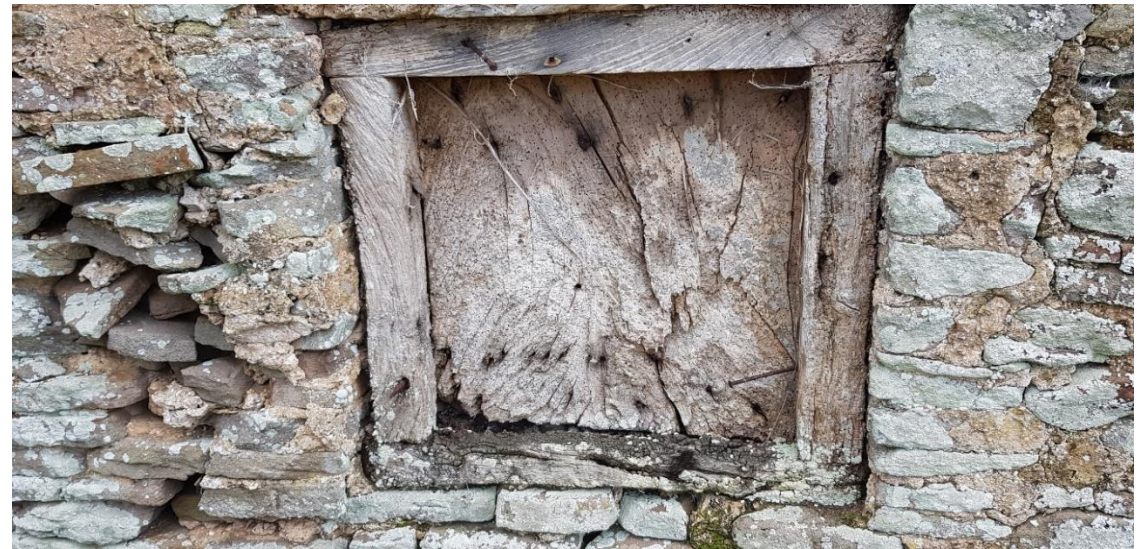
Additional Photos

These photos illustrate the extensive level of decay and worm damage in the 'pop hole' in the west elevation. The opening has been covered up and plastered over internally for several decades and the outer frame neglected. Structural repair and rebuilding is now necessary to save the wall from collapse and the weakened timber is considered beyond salvage.
