Four Gables, Netherton Wood Lane, Nailsea

Bat & Bird Survey Report

Prepared for: Lisa Matthews & David Pope

Date: September 2023

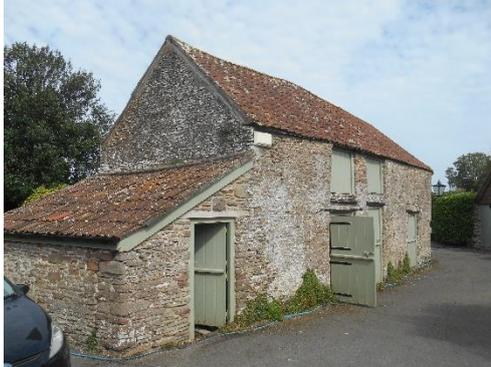
Plate 1: Outbuilding Viewed from the Southeast

The Outbuilding was a large, detached stone structure that had been partly converted by the previous owners (Plates 1-3). The exterior walls were constructed from stone and included several gaps where the mortar had washed away. These gaps were inspected and did not include evidence of bats. The Outbuilding included a lean-to in the south that was used to house the oil tanks. The lean-to included wooden fascia boards at the eaves. Fascia boards were also found on one small part of the Outbuilding's western wall. The northern gable wall included weather boarding, which included several gaps. Small gaps were present in the woodwork above the windows (Plate 4). The roof was pitched with the exception of the lean-to, which was sloping; both were clad in pan tiles (Plate 5). Three skylights were present on the western pitch. Gaps were present in the roof where the pan tiles did not sit flush with one another.

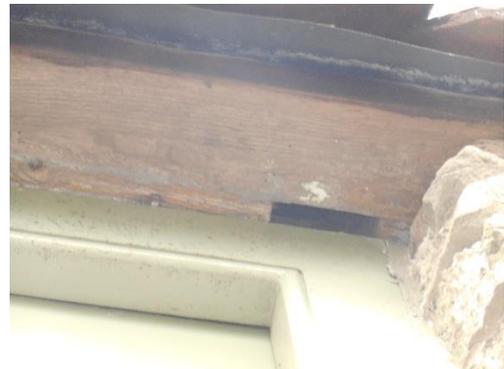
Plate 4: Holes Above Windows

Based on the building’s location, coupled with the holes in the wall tops and raised tiles, the Outbuilding was assessed as having Moderate BRP.

No evidence of bat activity was recorded within the Outbuilding; however, the building did include suitable roost features that could not be fully inspected (i.e. holes in wall tops and raised roof tiles). Based on the presence of these features and using published guidance (see Table 1), the Outbuilding was assessed as having Moderate BRP. During the subsequent surveys, no bats were observed emerging from, or showing interest in, the Outbuilding. Based on the combined data, the Outbuilding does not contain a bat roost. No further survey or mitigation is recommended. This conclusion is valid for two years; if no works have been started within this time, a resurvey should be undertaken. In the highly unlikely event that a bat is discovered, all works will stop and a bat ecologist will be contacted.

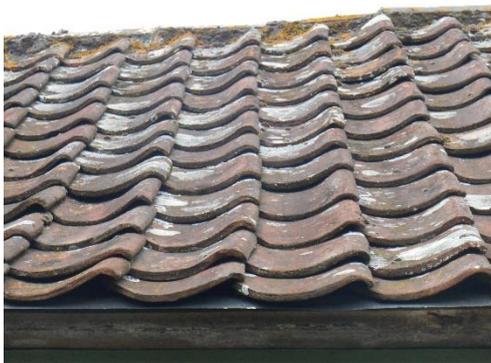
Plate 5: Roof with Raised Pan Tiles

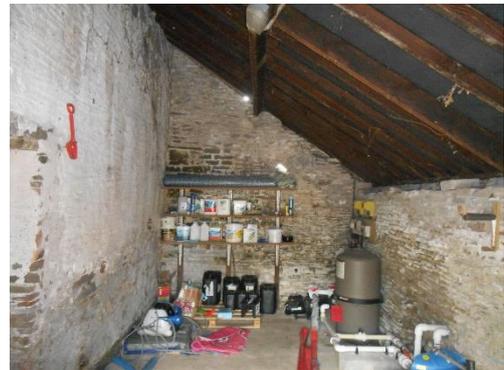
Plate 6: Lower Level – Pump Room

Internally, the Outbuilding was compartmentalised into separate rooms. The lower level included an oil storage room and a pump room both of which included sloping roofs lined with bitumen felt (Plate 6). The lower level also included two rooms used for storage that had ceilings (Plate 8). The interior walls comprised exposed stone, painted stone or render. The upper level, which extended across the whole building, had been converted by the previous owners (Plate 8).

Old, disused swallow (*Hirundo rustica*) nests were present in the oil room and pump room. It is understood that birds have also nested within the gaps in the exterior walls. No active nests were recorded.

No active nests were recorded; however, care should be taken to avoid disturbing nesting birds. Works will be timed to occur outside of the nesting period (i.e. carried out between September and February). If this is not practical, the Outbuilding would be inspected by an ecologist prior to works commencing.
