PRELIMINARY ROOST
APPRAISAL

15 HEBDEN AVENUE, WARWICK
CV34 5XD

Date: 16th January 2024

Martin Ecology

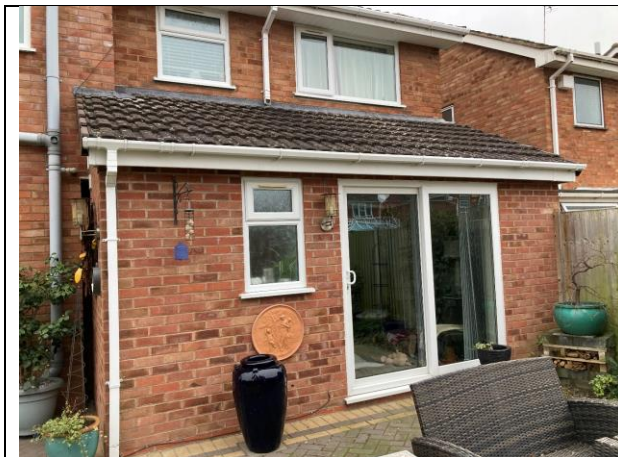
3.1.1 The building was a detached, two storey brick dwelling that appeared to have been built during the late twentieth century. The building included a single storey section to the west elevation and this were clad with concrete interlocking roof tiles which were well-sealed. A single PRF was noted at the flashing of the west section where the lead as raised forming a small gap that bats could potentially enter. This was a minor PRF, and the lead was carefully lifted by hand to check for evidence of bats. None was present, and this was considered to be clear evidence that no bats or other animals had used the feature in recent years.

Photo 1 West section sealed

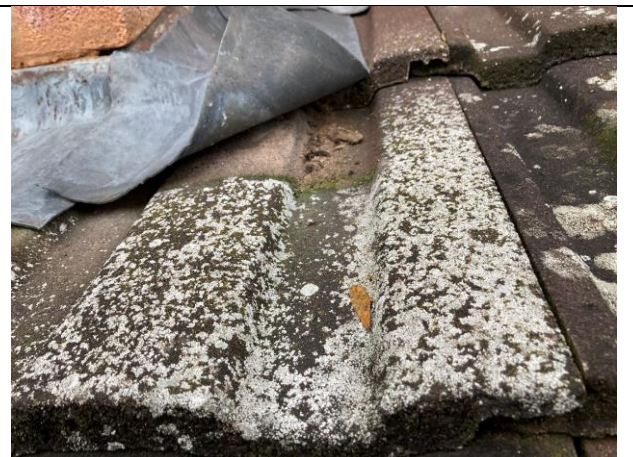
Photo 2 No evidence beneath raised flashing
