39 Woodfield Park Road,
Emsworth,
PO10 8BE

PHASE 1 DAYTIME BAT SURVEY

14th September 2023

Phase 2 Bat emergence survey

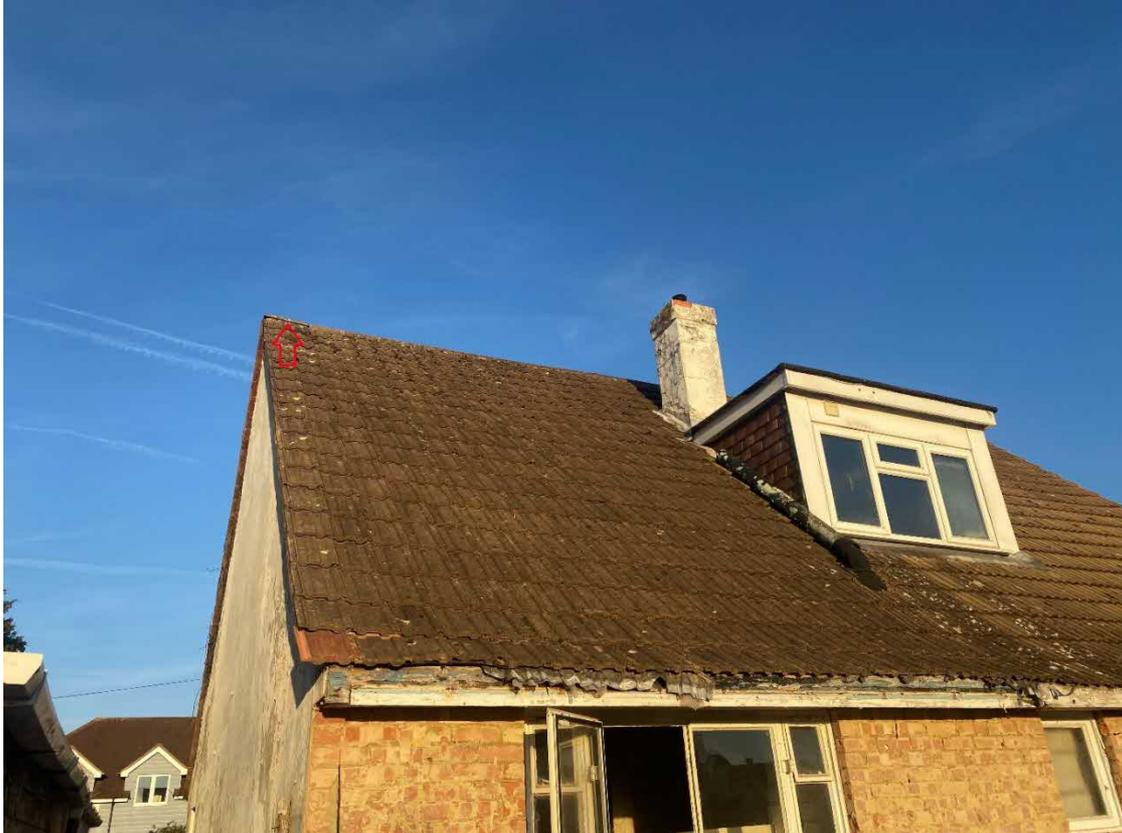
The property was subject to a full Phase 1 bat survey. It is a dormer bungalow dating to mid 20th century. The roof is covered with close-fitting cement tiles which are in poor order (see figures 1 and 2) The soffits and fascias are in dilapidated condition with some openings where the wood has rotted away (See figure 3).

Figure 1. North and west elevation looking east.

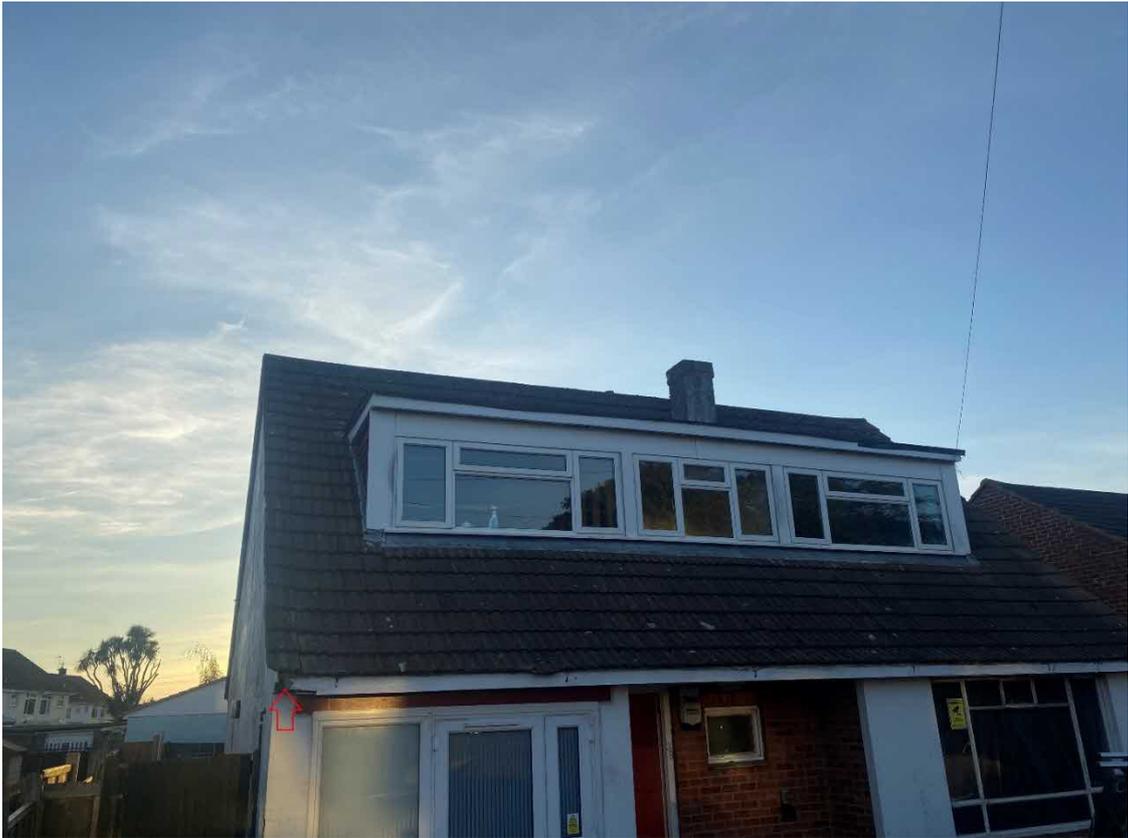
No evidence of bats was found within the dwelling, however there is a loose ridge tile and some potential openings in the soffits on the east face through which bats could enter.

Figure 2. Eastern and southern elevations looking west. Red arrow indicates potential opening for bats.

No evidence of bats was found within the dwelling, however there is a loose ridge tile and some potential openings in the soffits on the east face through which bats could enter. Therefore, the dwelling has low potential for roosting bats and a phase 2 bat survey is not recommended.

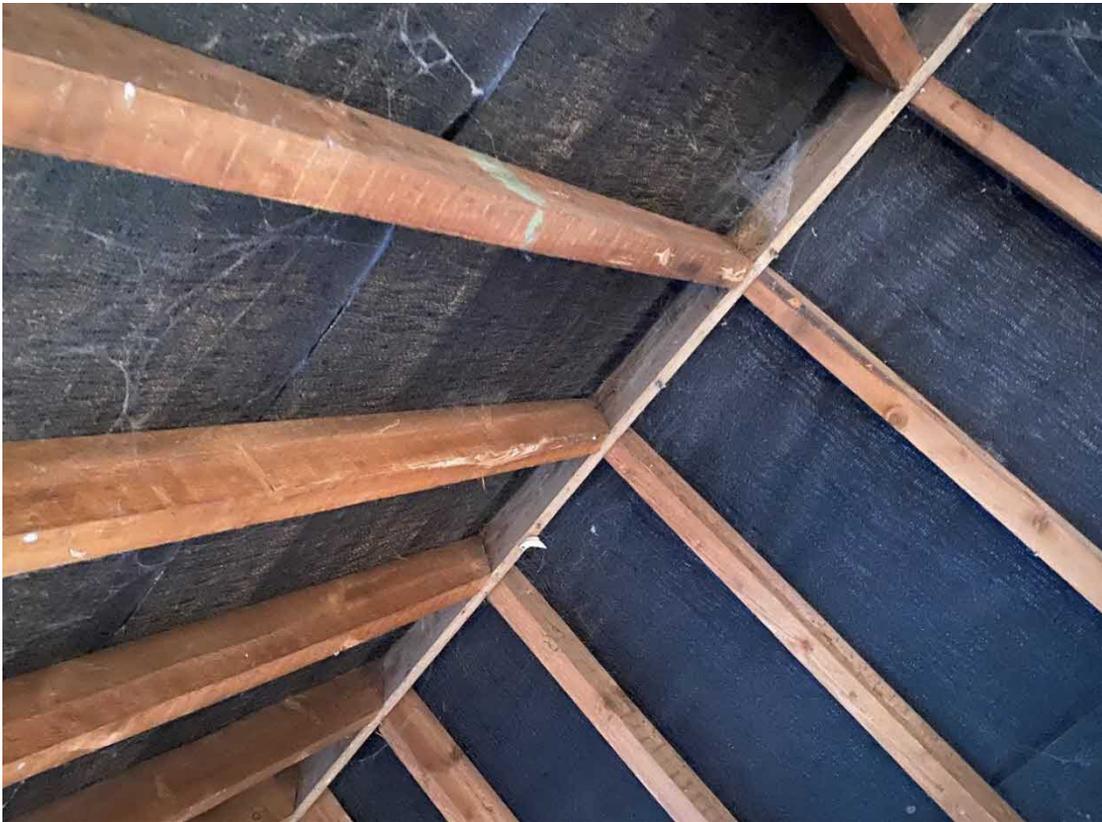
The loft is currently open as the ceiling has been removed. It is lined with bituminous felting which is in poor condition. (see figure 4).

Figure 3. Loft looking southwest

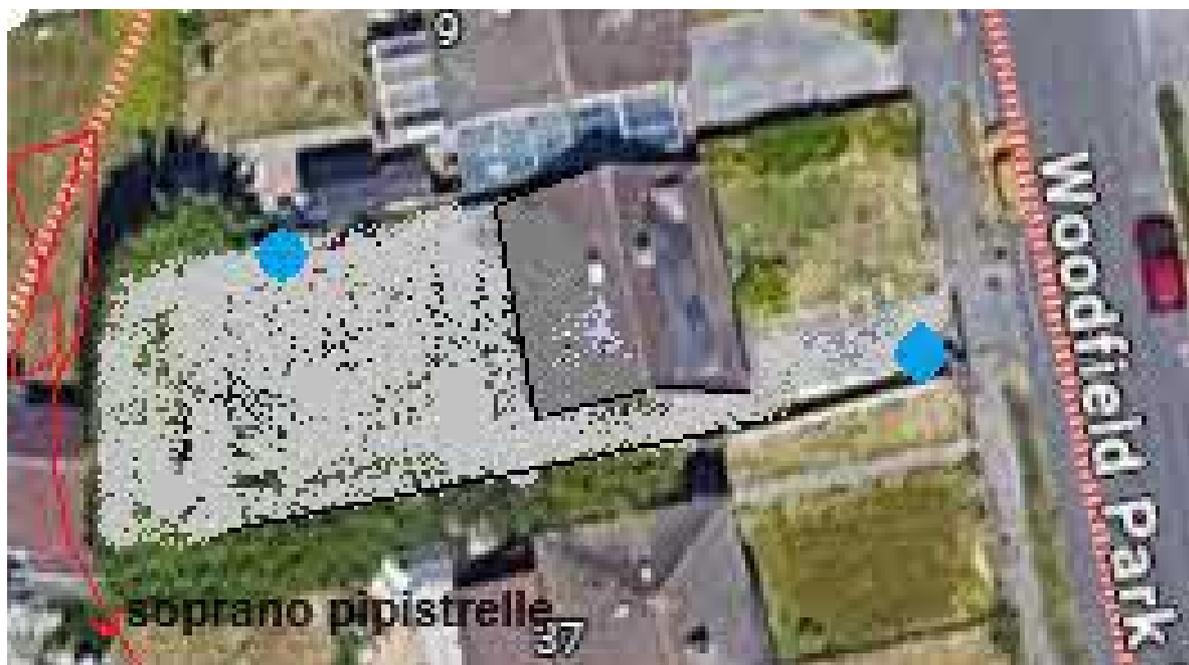
Surveyors were stationed to the west (viewing the western and northern elevations), and east viewing the southern and eastern elevation. Canon XA40 HD digital camcorders with IR illumination were also deployed (See figure 1). Survey commenced 30 minutes before sunset and continued until 90 minutes after sundown. EchotouchPro, Echotouch, and Batbox Duet detectors were employed to monitor and record bat activity. Walkie-talkie communications were maintained between surveyors to avoid multiple counting and help triangulate emergence and flight lines.

The night of the 22nd September was calm and clear with low activity with just a single soprano pipistrelle recorded foraging over the gardens to the west and southwest.

The raw data is shown in appendix 1 and the flight lines are shown on figure 1.

Figure 1. Locations of viewers, cameras (Blue stars) and flight paths (red line)
