**Hulse Ground Farm, Little Faringdon**

**Preliminary Ecological Appraisal Report**

**Project Code: JM2023034Av1**

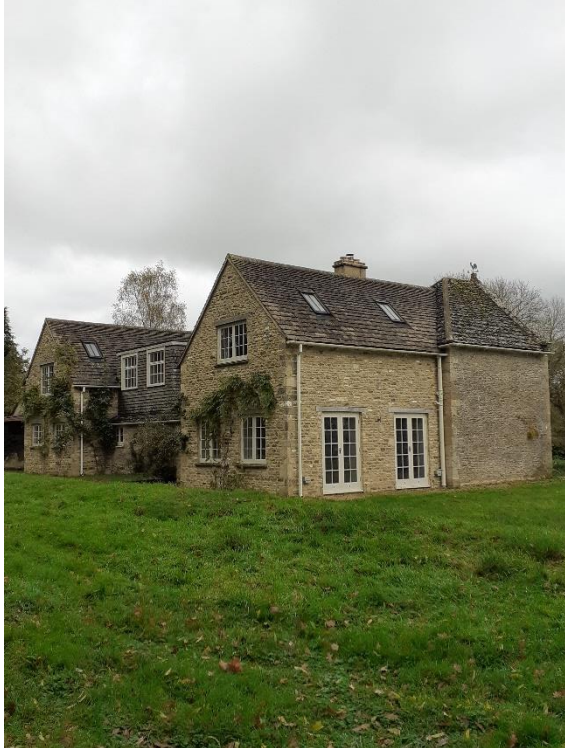
A photograph showing the main house from a south-west and north-west perspective. The house is a two-story stone building with a gabled roof and several windows. It is situated on a grassy field under an overcast sky.	South-west and north-west elevations of main house.
2

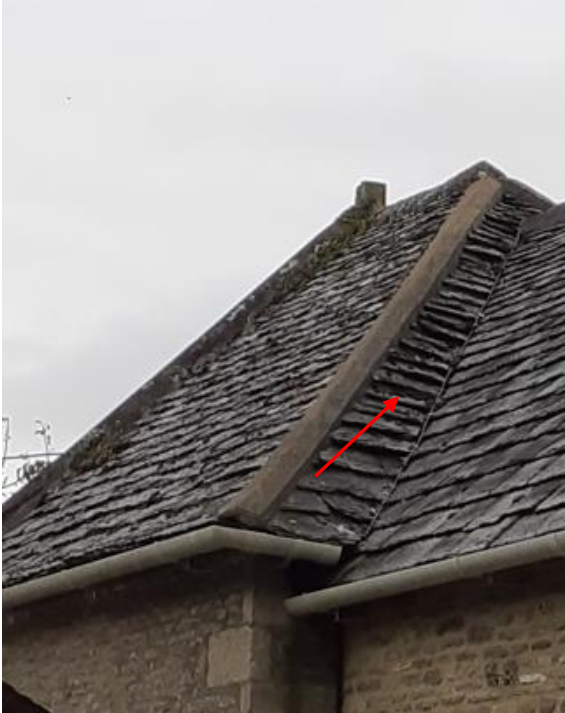
A close-up photograph of the roof tiles on the north-east gable end of the main house. A red arrow points to a gap between the tiles. The roof is made of dark grey tiles and has a stone chimney on the ridge.	Gaps under roof tiles on north-east gable end of main house.

4.5.1 Bats and their resting places are protected under the Wildlife and Countryside Act 1981 (as amended) and the Conservation of Habitats and Species Regulations 2017. The main house was assessed as having **moderate potential to support roosting bats**. As such, and in accordance with best practice guidelines (BCT, 2023) a minimum of two dusk emergence surveys are required to establish presence/absence of roosting bats. The surveys should be undertaken between May to August. Should bats be found to emerge then one further emergence/re-entry survey will be required to inform an EPS mitigation licence application to Natural England.

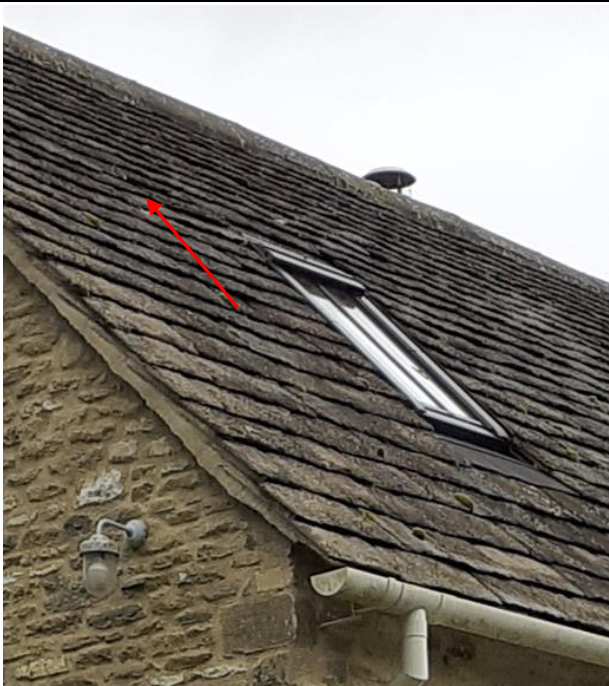
A close-up photograph of a roof covered in dark, weathered tiles. A skylight is visible in the center. A red arrow points to the space between the tiles near the gable end. The roof is attached to a stone wall with a white downspout and a light fixture.	Gaps under roof tiles on south-west gable end of main house.
4

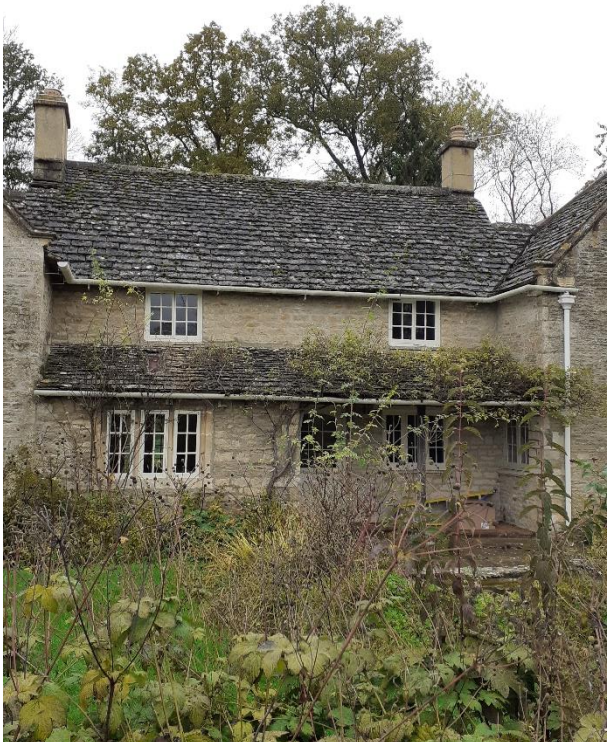
A photograph showing the south-east elevation of a main house. The house has a stone facade, a tiled roof, and two chimneys. There are several windows, some with white frames. The house is surrounded by dense green foliage and trees in the background.	South-east elevation of main house.

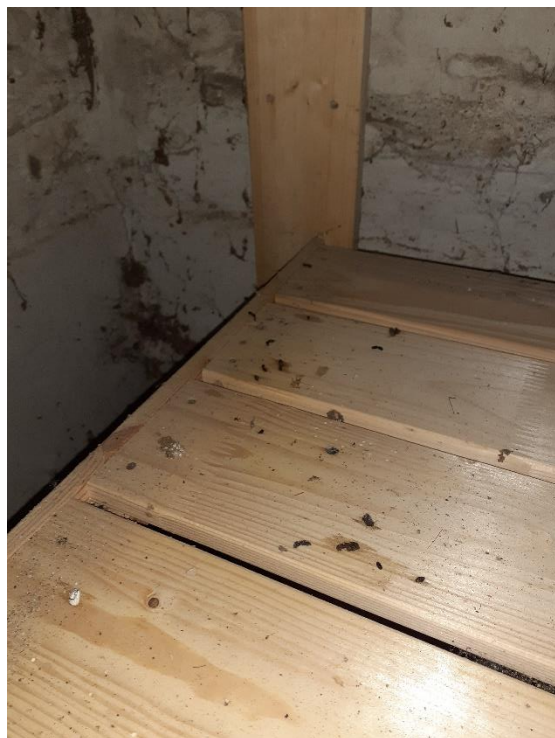
Fresh bat droppings on high shelf in north-west corner of B2.

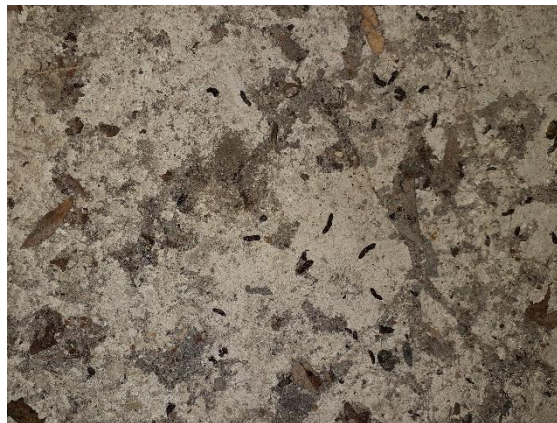
Fresh bat droppings in northern section of B3.

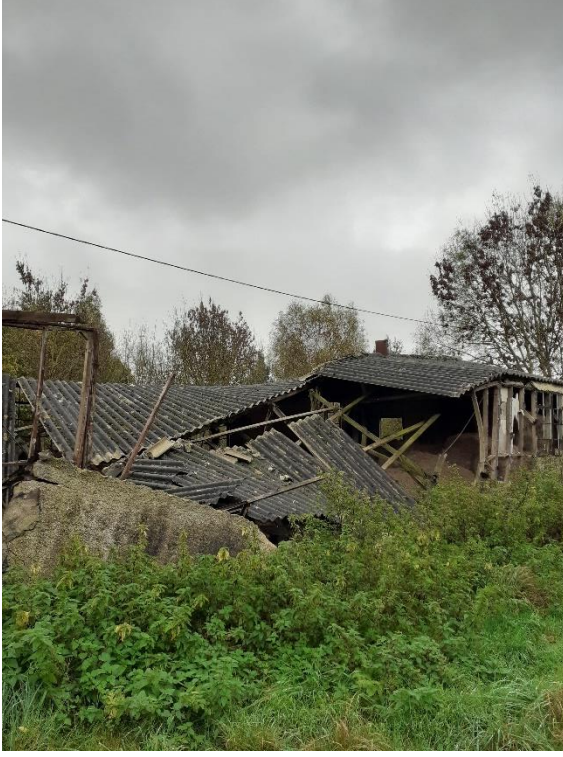
A photograph of a building with a severely collapsed roof. The roof structure is exposed, showing wooden beams and debris. The building is surrounded by tall grass and weeds. The sky is overcast and grey.	Outbuilding B6 with collapsed roof.

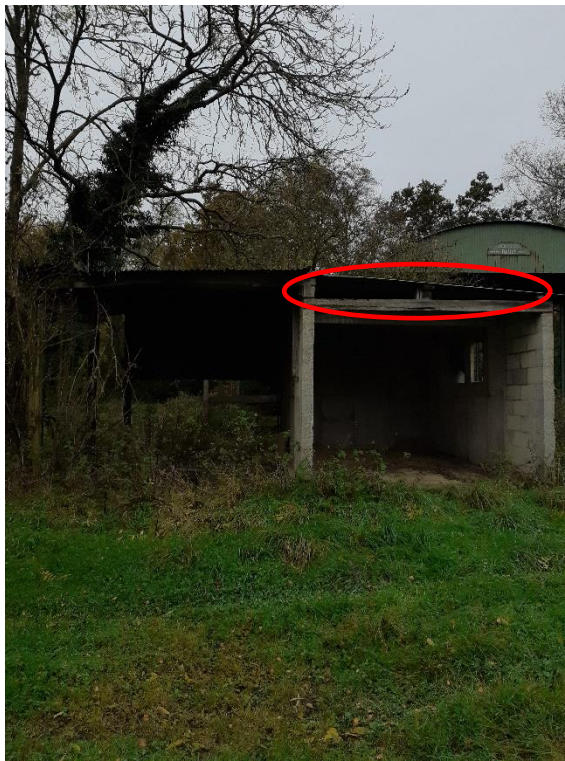
Outbuilding B7 and flat roof section which may be used by nesting barn owls (circled in red).

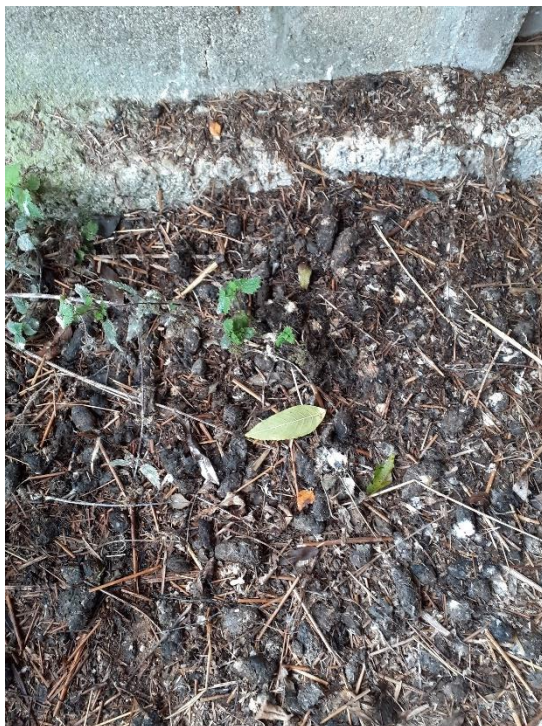
Large pile of barn owl pellets inside B7.

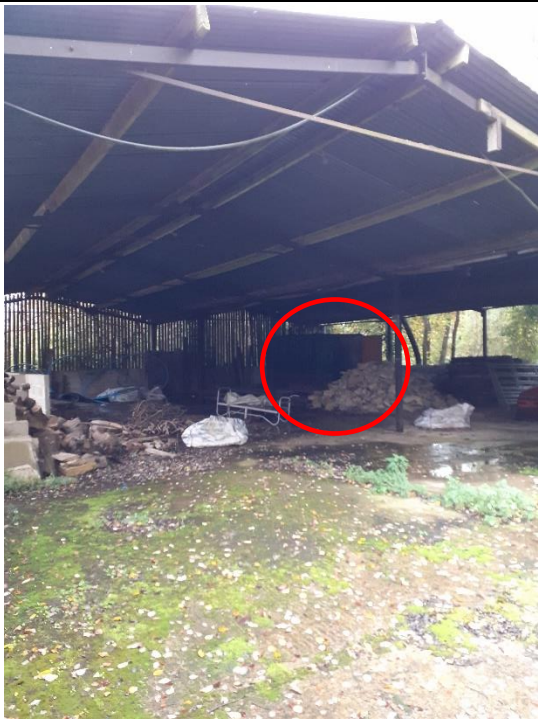
A photograph showing the interior of a shed or barn. The floor is covered with moss and fallen leaves. In the background, there is a metal storage container in the corner, which is circled in red. The structure has a corrugated metal roof and walls.	View of interior of B1, with metal storage container in corner (circled in red).
20

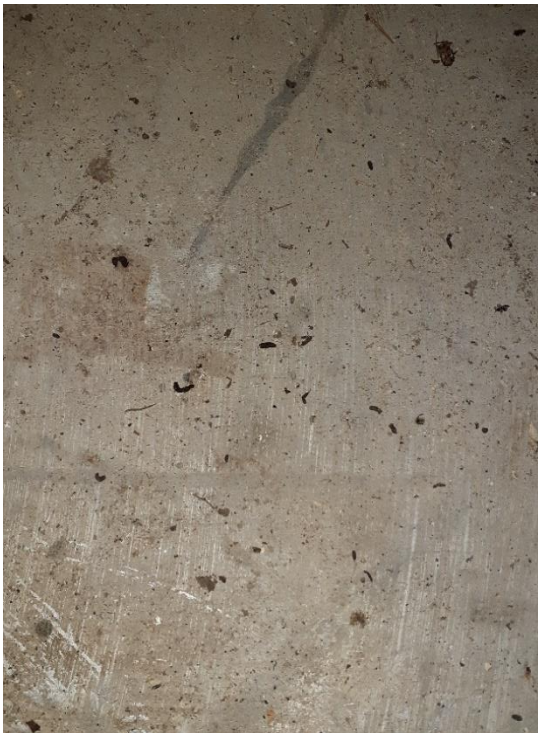
A close-up photograph of a concrete floor. The floor is covered with numerous small, dark, irregular droppings, which are identified as bat droppings in the description. The droppings are scattered across the surface.	Scattered bat droppings inside metal container in B1.

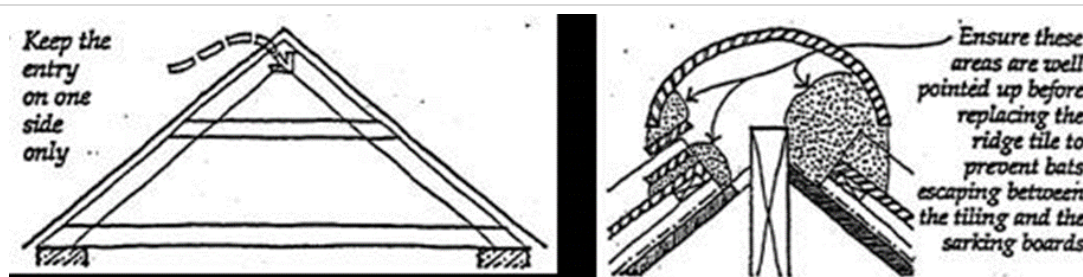
**Diagrammatic view of ridge tile and cross section through ridge tile** showing access point (taken from Scottish Natural Heritage 1996). Bitumastic lining must be used near/on the ridge beam to ensure bats can only have contact with this type of membrane to avoid any possible entanglement with a breathable membrane.
