**Preliminary Ecological
Appraisal
Of
Silver Birches, Heronsgate
WD3 5DN
On behalf of
Richard Warman**

Reference: GNP451
Written by: Kirk Harges MRes
Checked by: Ben Lansbury Msc MCIEEM
Date Issued: 10/04/2023

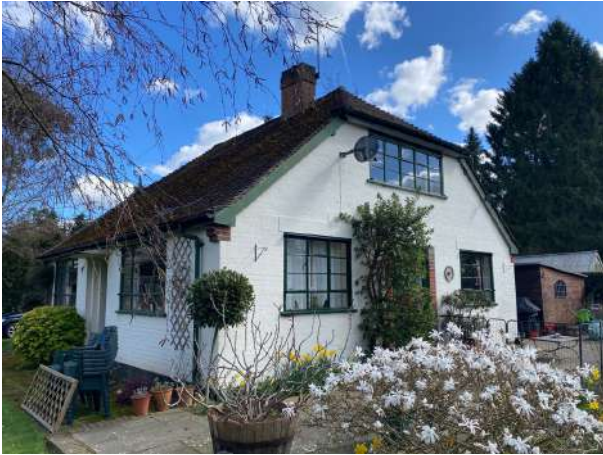
Figure 1. Eastern perspective showing residential property to be demolished under proposed scope of works.

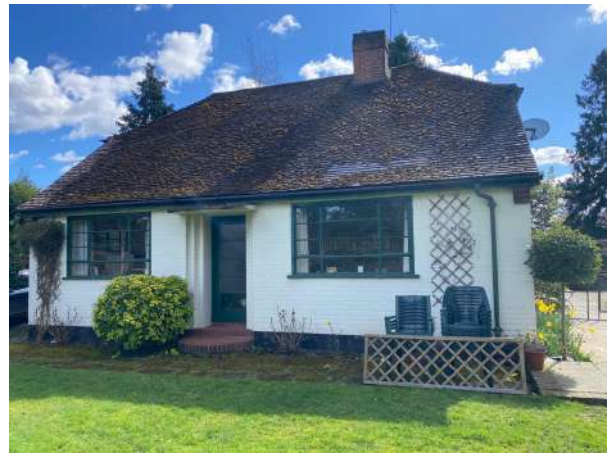
Figure 2. South-easterly perspective showing residential property to be demolished under proposed scope of works. Note brick build construction & well fitted concrete tiles.

4.2.2 There was one residential dwelling present on-site, a two storey building brick construction. The second story of the house was largely made up of a converted loft space. This building also has some retained loft space in the top of the roof space as well at two long thin strips of loft space at either side of the roof space. The structural integrity of the exterior fabrications were in good condition from an ecological perspective. The roof of the main dwelling was composed of generally well fitted concrete tiles which were in places broken but generally well fitted. The wooden fascia and soffits were, from an ecological perspective, generally in good structural condition from the exterior but evidence of decay was present.

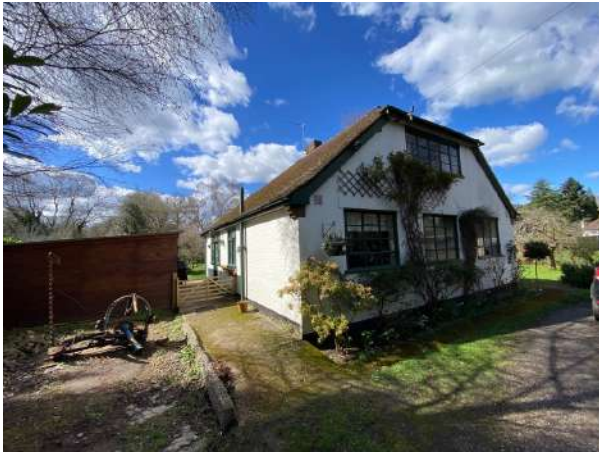
Figure 3. Westerly perspective showing residential property to be demolished under proposed scope of works.

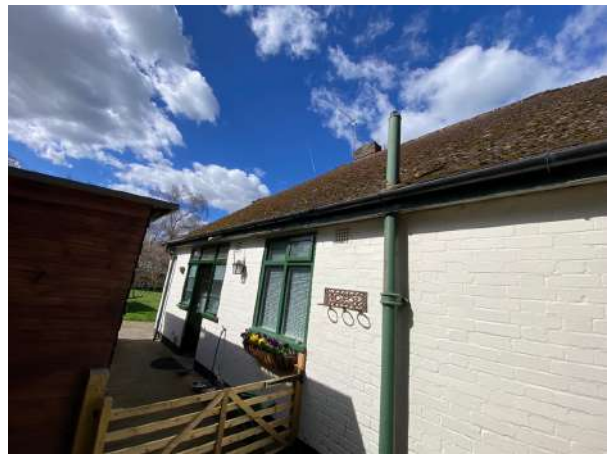
Figure 4. North-westerly perspective showing residential property to be demolished under proposed scope of works.

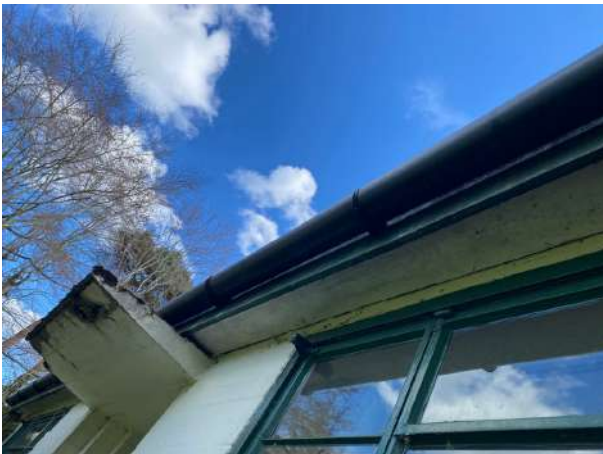
Figure 5. North-westerly perspective showing wooden fascia in good state of repair residential property to be demolished under proposed scope of works.

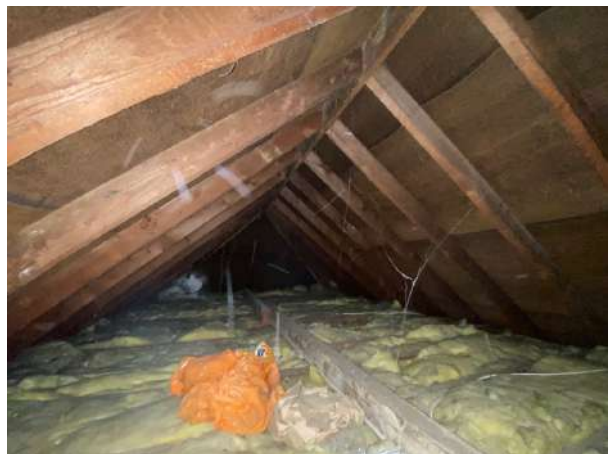
Figure 6. Image showing internal loft space in good state of repair in highest peak of roof.

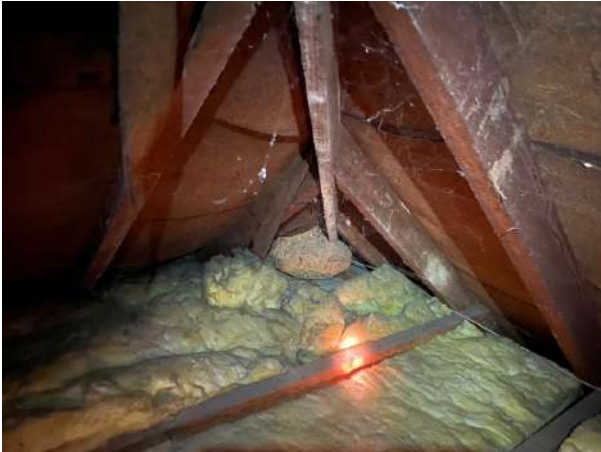
Figure 7. Image showing internal loft space in good state of repair in highest peak of roof. Note in active wasp nest.

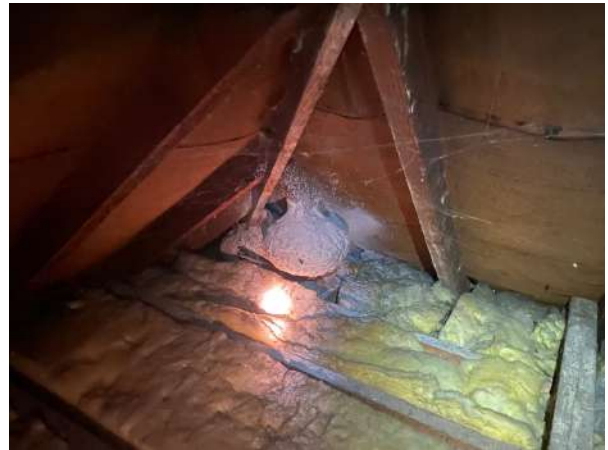
Figure 8. Image showing internal loft space in good state of repair in highest peak of roof. Note in active wasp nest.

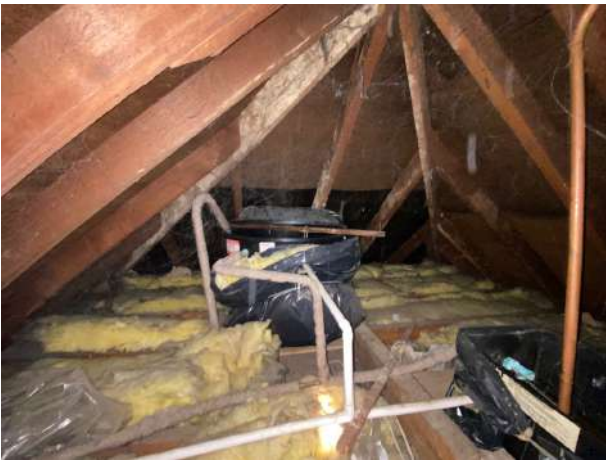
Figure 9. Image showing internal loft space in good state of repair in highest peak of roof.

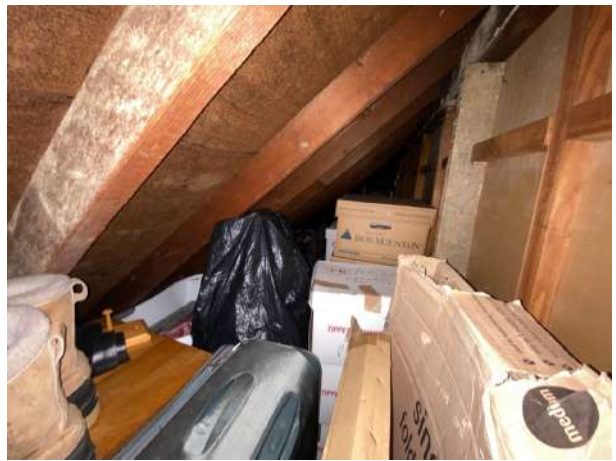
Figure 10. Image showing loft storage space in north-western roof space in good state of repair.

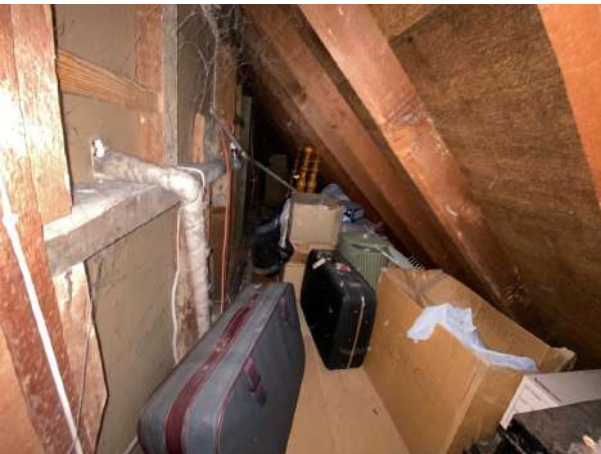
Figure 11. Image showing loft storage space in good state of repair in south-eastern roof space.

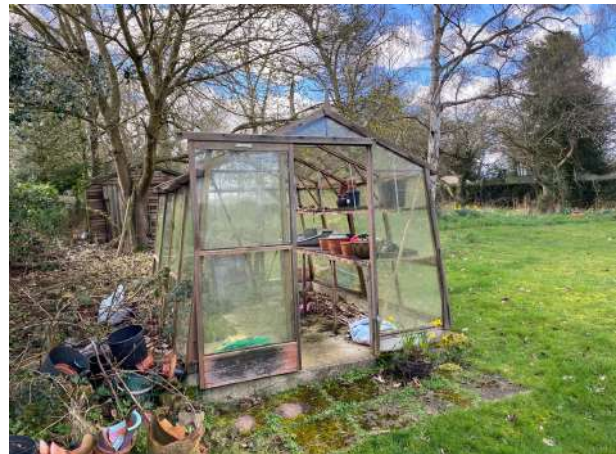
Figure 12. Western perspective showing greenhouse.

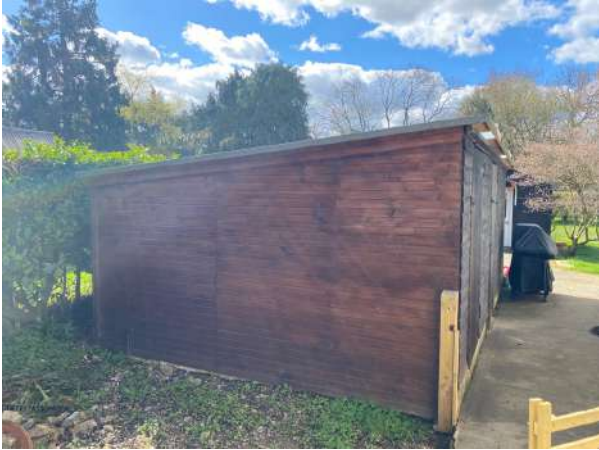
Figure 13. South-western perspective showing garden shed in good state of repair 1.

- 4.3.16 The three external garden sheds had bitumen lined roofs and were in a good state of repair. The third shed had a defunct roof space. The garage building had a single layer corrugated roof. The three sheds and garage building on-site are considered unsuitable to support roosting bats.

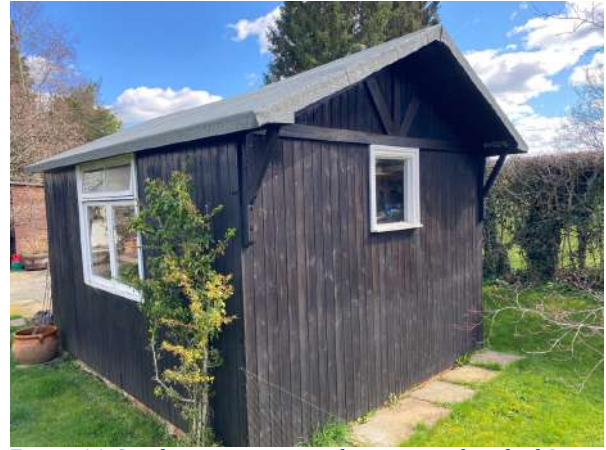
Figure 14. Southern perspective showing garden shed 2 in good state of repair.

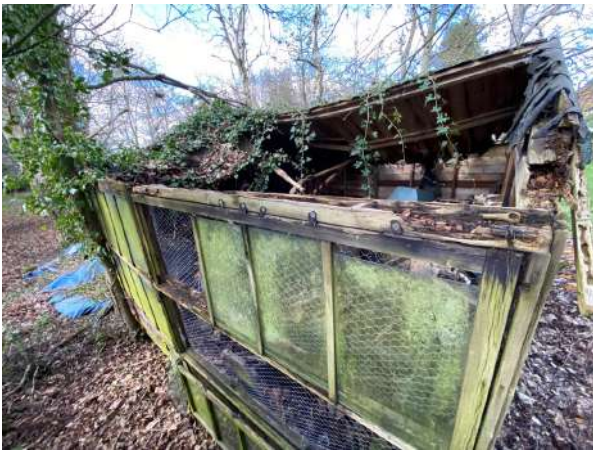
Figure 15. Northern perspective showing garden shed 3. Note defunct roof.

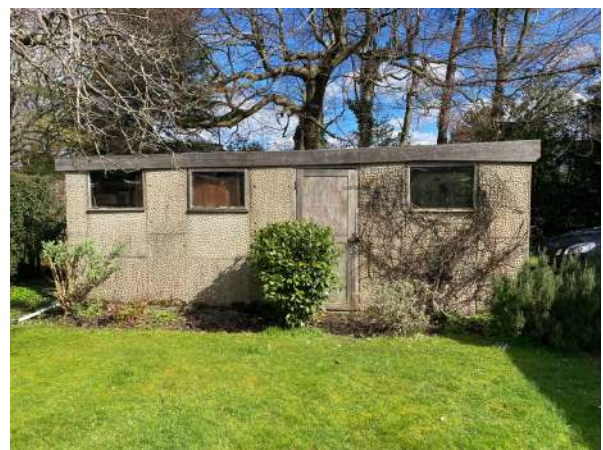
Figure 16. North-eastern perspective showing standalone garage building in good state of repair.

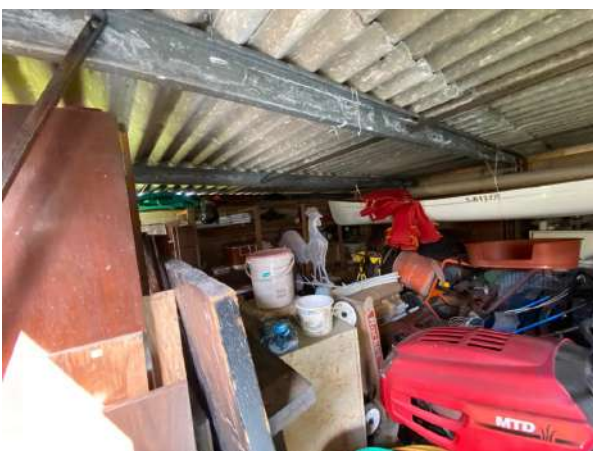
Figure 17. North-eastern perspective showing standalone garage building internal roof space.

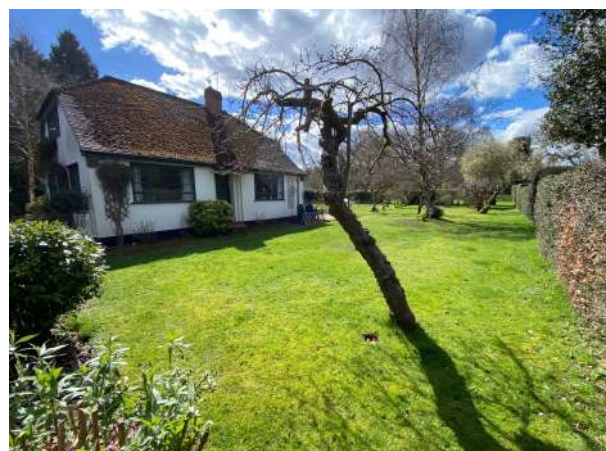
Figure 18. Southern perspective showing residential dwelling & proposed works area. Hedgerow to be removed under proposed works to the right-hand side of image.

- i. It is recommended that all hedgerow or tree vegetation clearance within the proposed works zone take place outside of the nesting bird season. If this is not possible, it is recommended that a pre-works nesting bird check is undertaken by suitably qualified ECoW within 48 hours of works commencing. Any active nests identified must be appropriately buffered and left undisturbed until the young have fledged. The nesting bird season runs from March to September inclusive. It is understood that all hedgerow or trees outside of the proposed works zone are to be retained under the current scope of works.

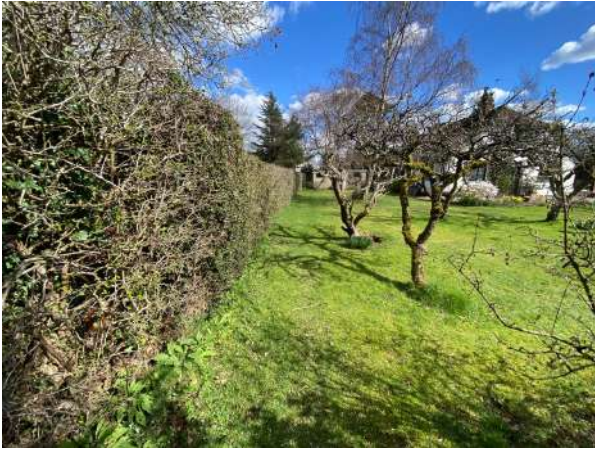
Figure 19. North-easterly perspective showing proposed works area. Hedgerow to be removed under proposed works to the left-hand side of image. Fruit trees to be removed in center of image within amenity grassland.

- 4.3.18 The low growing fruit trees within the proposed works area did not have any features such as broken limbs, hollows or loose bark that could have supported roosting bats.

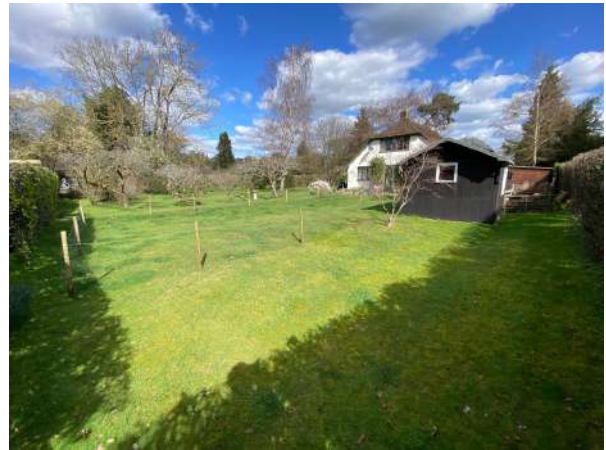
Figure 20. Northerly perspective showing amenity grassland within proposed works area.

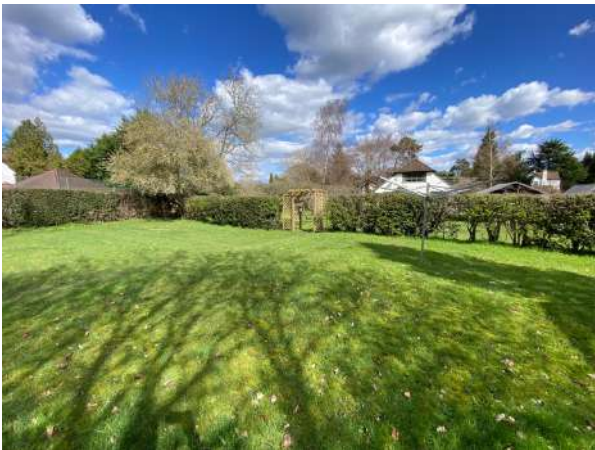
Figure 21. North-easterly perspective showing amenity grassland & hedgerow. Outside of proposed works area. South-west of residential dwelling.

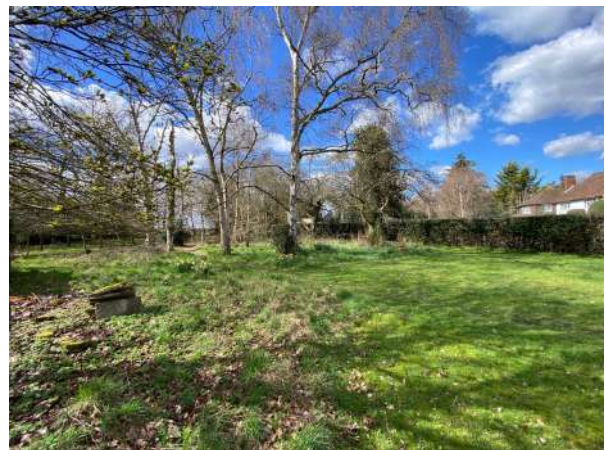
Figure 22. North-westerly perspective showing amenity grassland, woodland edge & hedgerow. Outside of proposed works area. South-west of residential dwelling.

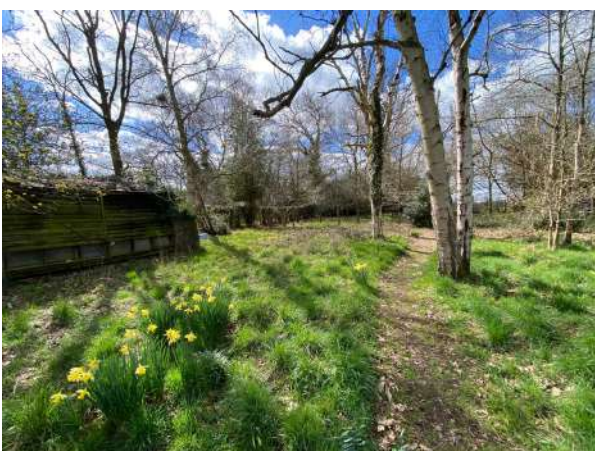
Figure 23. South-westerly perspective showing amenity grassland, woodland edge & hedgerow. Outside of proposed works area. South-west of residential dwelling.

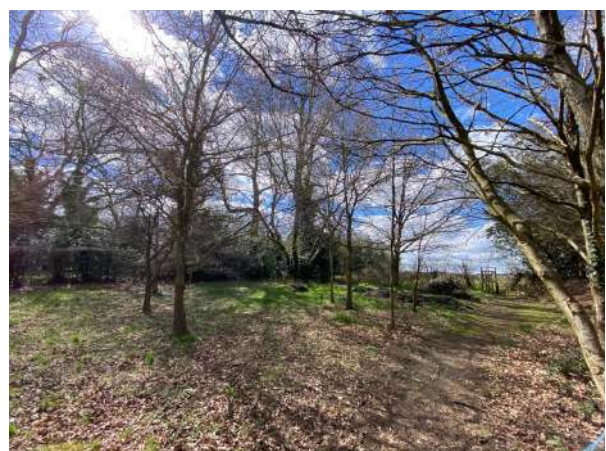
Figure 24. South-westerly perspective showing woodland area. Outside of proposed works area. South-west of residential dwelling.

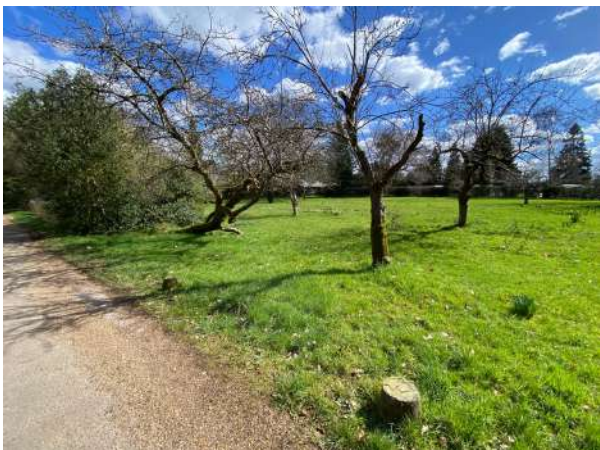
Figure 25. South-easterly perspective showing amenity grassland, & scattered trees. Cherry tree Lane to left hand side of image. Outside of proposed works area. North-west of residential dwelling.

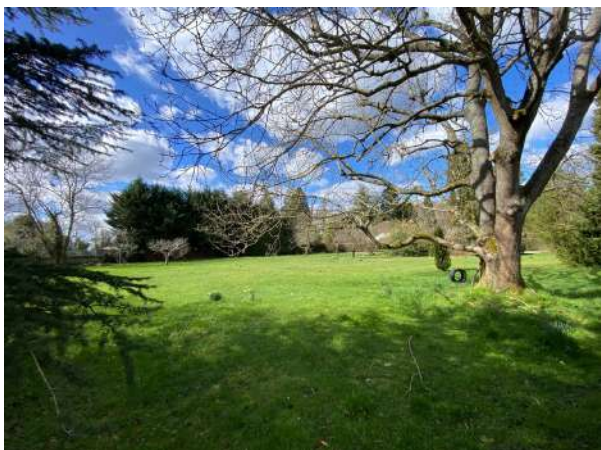
Figure 26. North-westerly perspective showing amenity grassland, & scattered trees. Outside of proposed works area. North-west of residential dwelling.

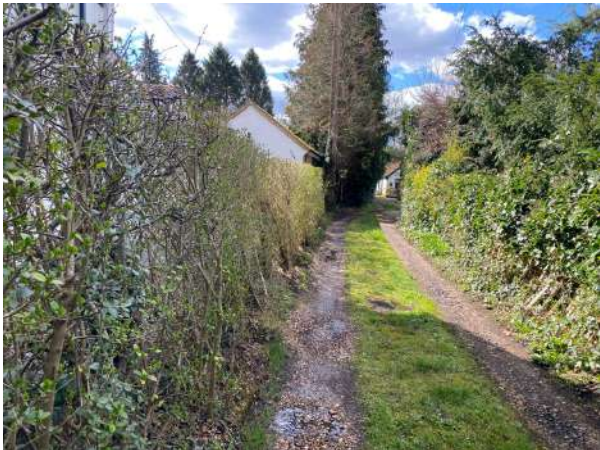
Figure 27. South-westerly perspective showing hedgerow & entrance road to property. Outside of proposed works area. North-east of residential dwelling.

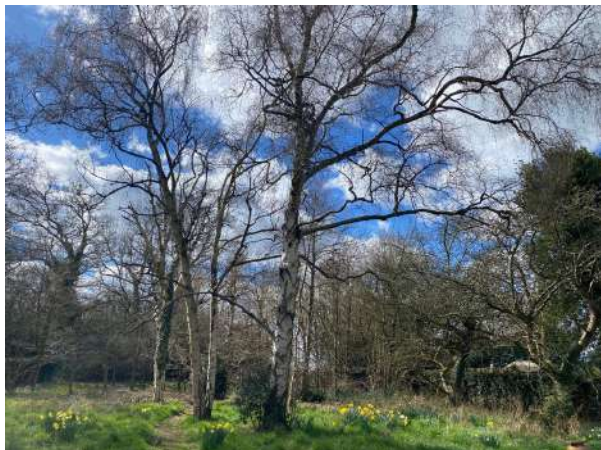
Figure 28. South-westerly perspective showing mature silver birch tree with moderate bat roost potential (TN1). Outside of proposed works area. South-west of residential dwelling.

- 1.6 Two mature trees within the woodland area to the west of the main dwelling contained features with potential to support roosting bats (TN1 & TN2), which were assessed as having moderate suitability to support roosting bats. It is understood that these trees are to be retained under the current scope of works.

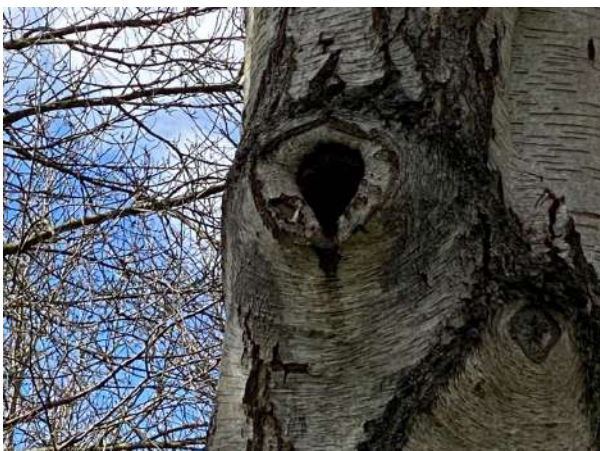
Figure 29. South-westerly perspective showing mature silver birch tree PRF1 (knot hole) with moderate bat roost potential (TN1). Outside of proposed works area. South-west of residential dwelling.

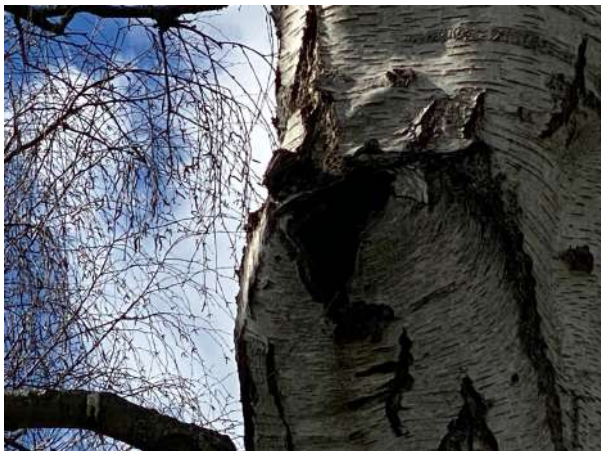
Figure 30. South-westerly perspective showing mature silver birch tree PRF2 (knot hole) with moderate bat roost potential (TN1). Outside of proposed works area. South-west of residential dwelling.

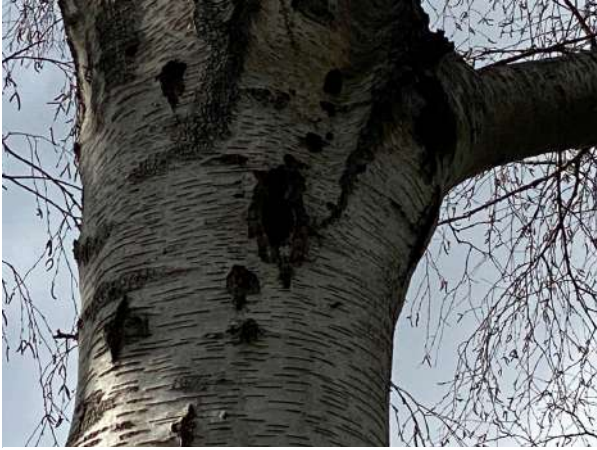
Figure 31. South-westerly perspective showing mature silver birch tree PRF3 (knot hole) with moderate bat roost potential (TN1). Outside of proposed works area. South-west of residential dwelling.

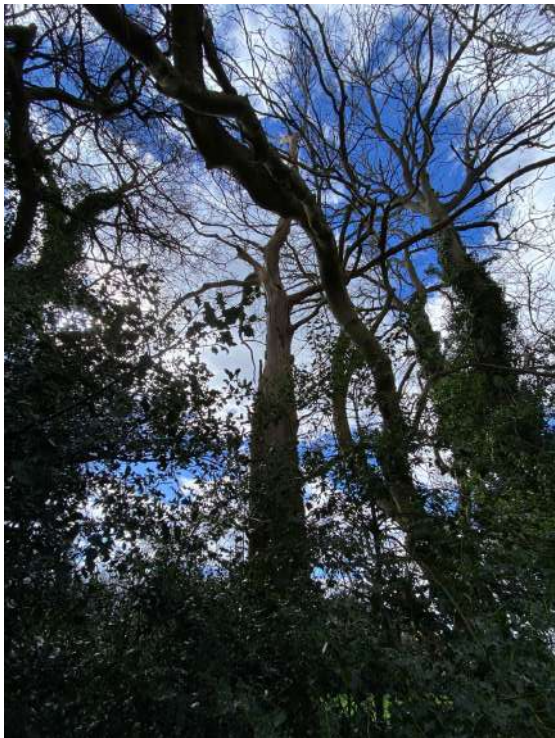
Figure 32. South-westerly perspective showing standing dead tree with moderate bat roost potential (TN2). Outside of proposed works area. South-west of residential dwelling.

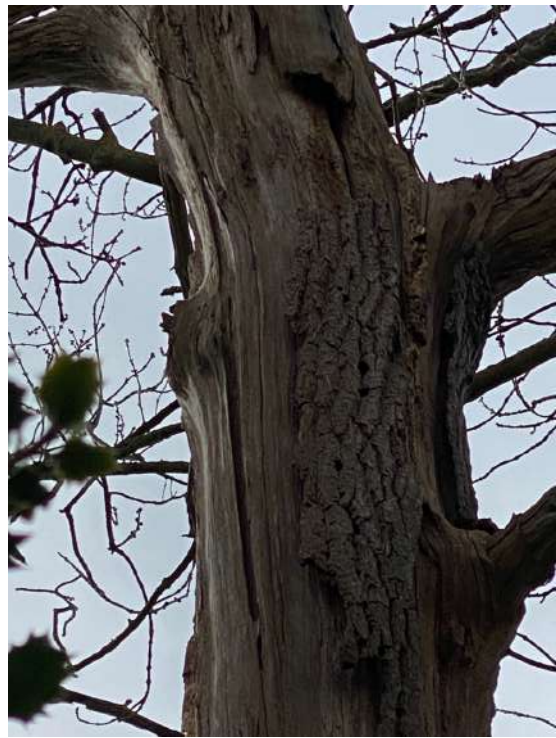
Figure 33. South-westerly perspective showing standing dead tree PRF's (split trunk & raised bark) with moderate bat roost potential (TN2). Outside of proposed works area. South-west of residential dwelling.

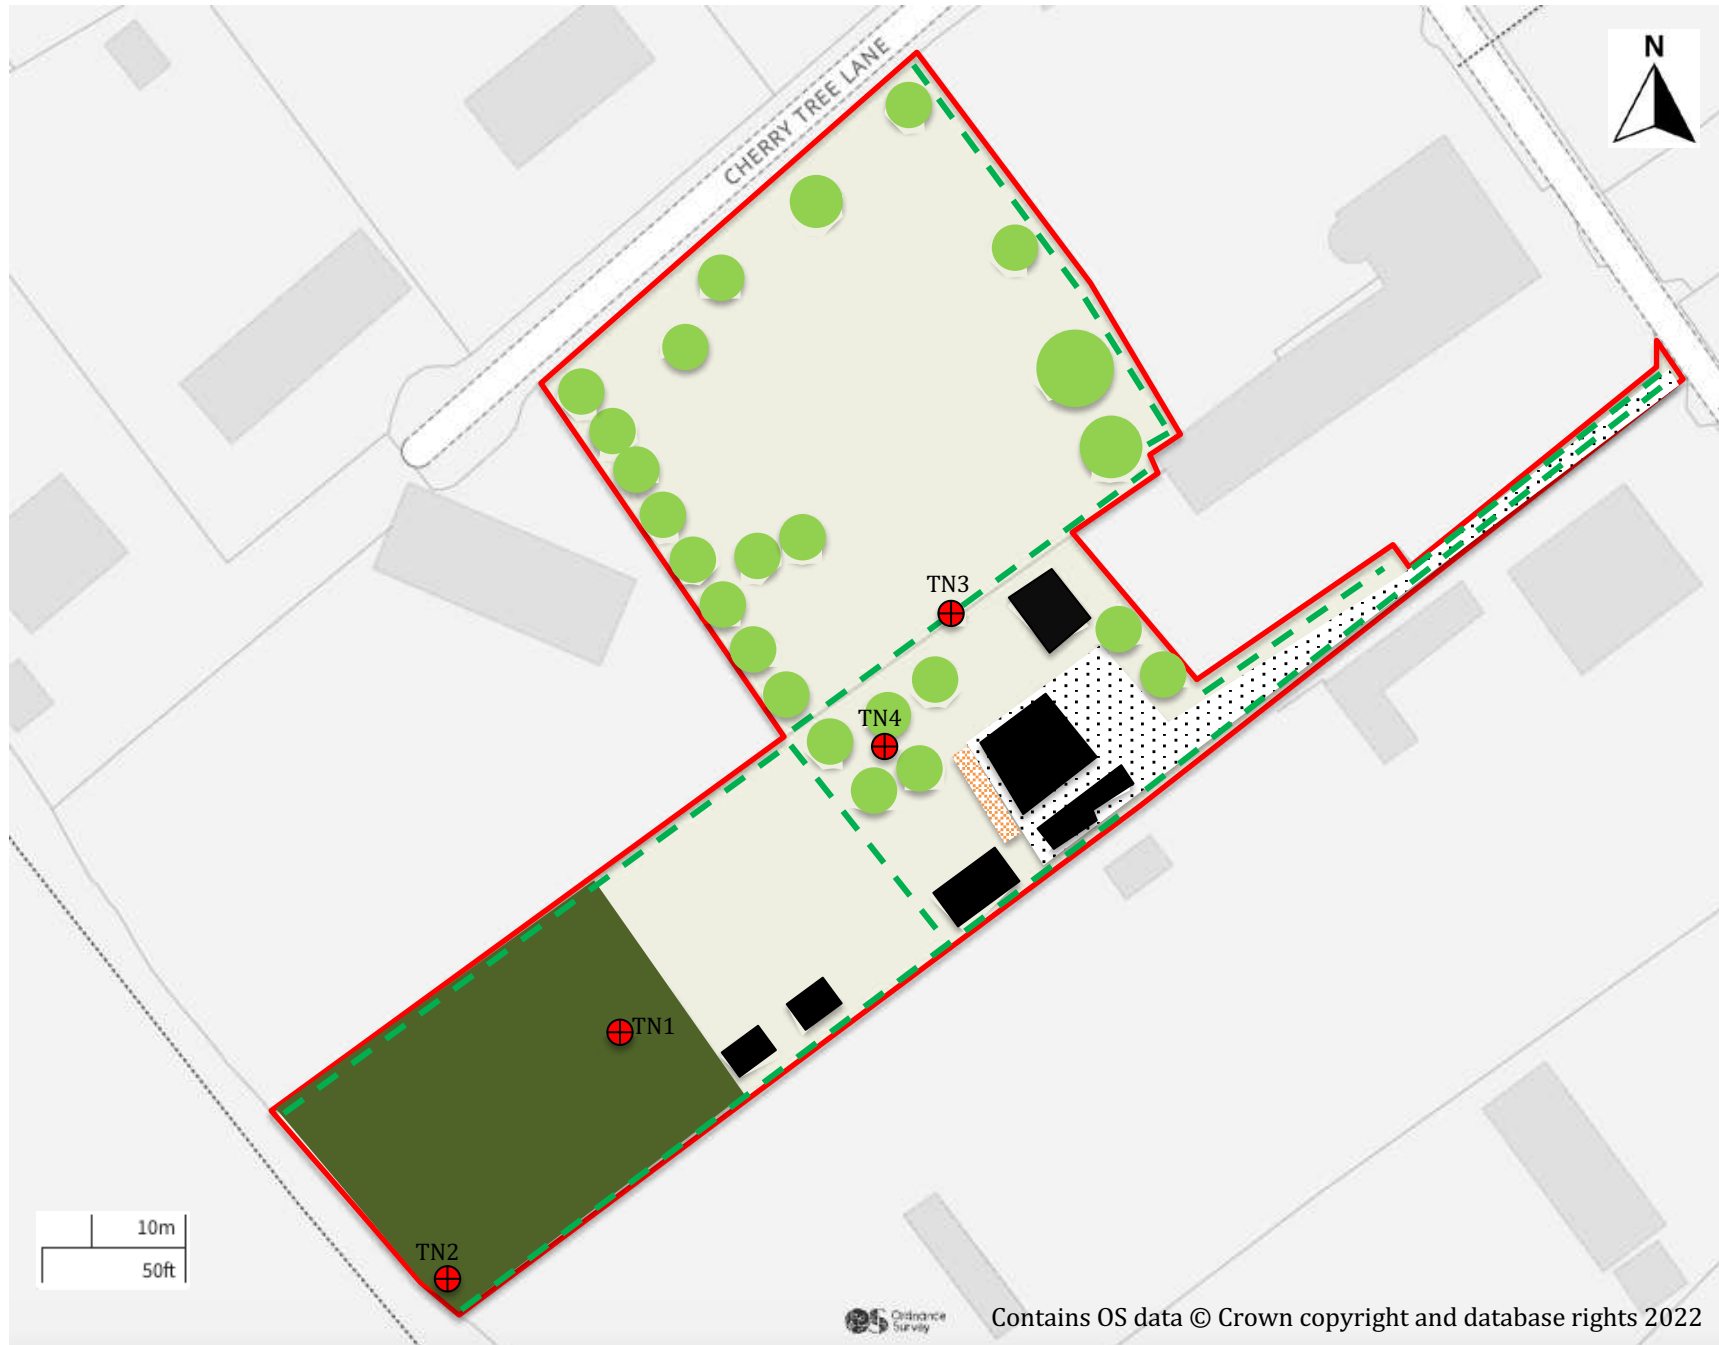
Target Note	Description
1	Approximate location of mature silver birch tree with moderate bat roost potential.
2	Approximate location of dead standing tree with moderate bat roost potential.
3	Approximate location of proposed hedgerow removal.
4	Approximate location of proposed fruit tree removal.

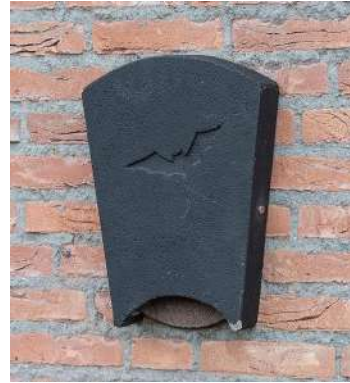
This bat box is made entirely from Woodstone, a robust material comprising concrete and wood fibres. This means that, not only does the box have excellent insulating properties maintaining a more consistent temperature throughout the year, it also provides excellent protection from predators. The Beaumaris box has a single narrow cavity which makes it suitable for crevice roosting bats such as the common pipistrelle, soprano pipistrelle, Nathusius' pipistrelle, Brandt's bat and whiskered bat. The interior of the box has a rough surface for bats to cling to and the front of the box features a subtle but attractive imprint of a bat in flight.

Suitable for attaching to external walls and available in two sizes: the Midi and the Maxi.

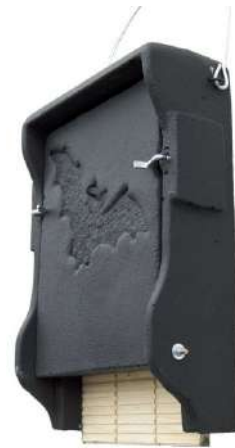
2F Schwegler Bat Box (General Purpose)

The 2F bat box can be sited on a tree or building and is best positioned at a height of between 3 to 6 metres in an open sunny position. A group of 3 to 5 boxes facing in different directions will provide a variety of micro-habitats. Please note that once bats have inhabited a roost site they may only be disturbed by licensed bat workers.

Position 3 metres or higher above the ground in a place where there is a clear flight path for bats entering and leaving the box.

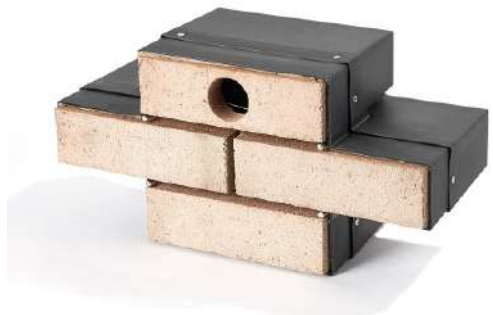
<p>Inbuilt Nest Box</p> <p>Standard box with 26mm hole for house sparrows and members of the tit family. 48mm entrance hole for larger species such as starling.</p> <p>Can be faced with a number of products to match building design.</p> <p>Example Suppliers: www.birdbrickhouses.co.uk www.habibat.co.uk</p> <p>Boxes to be installed at least 3m high within external wall, out of human reach and predators such as cats.</p> <p>Preferably on a north/ east facing wall.</p>

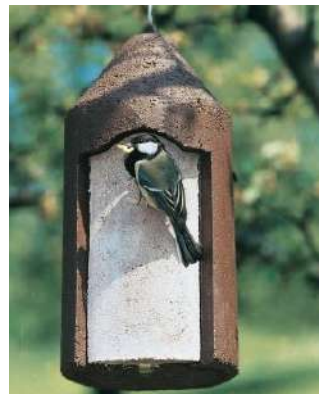
<p>2M Schwegler Nest Box</p> <p>Entrance hole 26mm:</p> <p>Blue-, marsh-, coal- and crested tit and possibly wren. All other species are prevented from using the nest box due to this smaller entrance hole.</p>

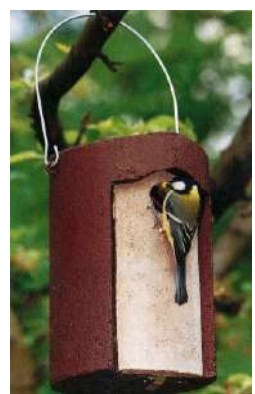
<p>1B Schwegler Nest Box</p> <p>32mm entrance hole will attract Great, Blue, Marsh, Coal and Crested Tit, Redstart, Nuthatch, Collared and Pied Flycatcher, Wryneck, Tree and House Sparrow and bats.</p>

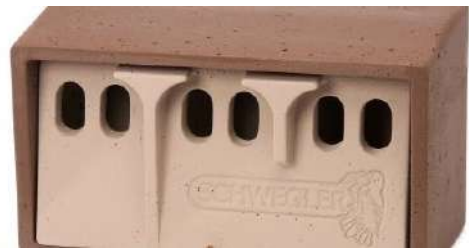
<p>Schwegler 1SP Sparrow Terrace (Inbuilt or external)</p> <p>Suitable for: Colonial nesting house sparrows and common birds such as individual blue & great tits.</p> <p>Two boxes to be installed on one side of a building, at a height of at least 3m upon external walls, out of human reach and predators such as cats. Preferably facing between north and east.</p>

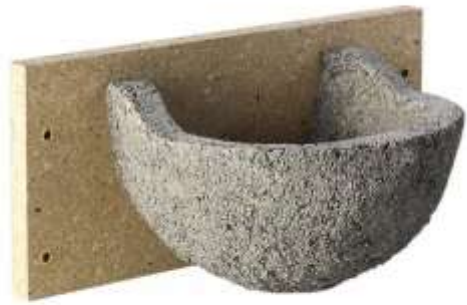
Schwegler No 10 Swallow Nest

Suitable for: Common swallow

Positioning: Inside of buildings or larger covered areas ensuring clear flight path in and out of the structure, at a height of 2m or above
