## **Bat Survey:**

**Holton Hall, Holton St. Mary, Suffolk**

**Mr. and Mrs. Greene**

Final - July 2023

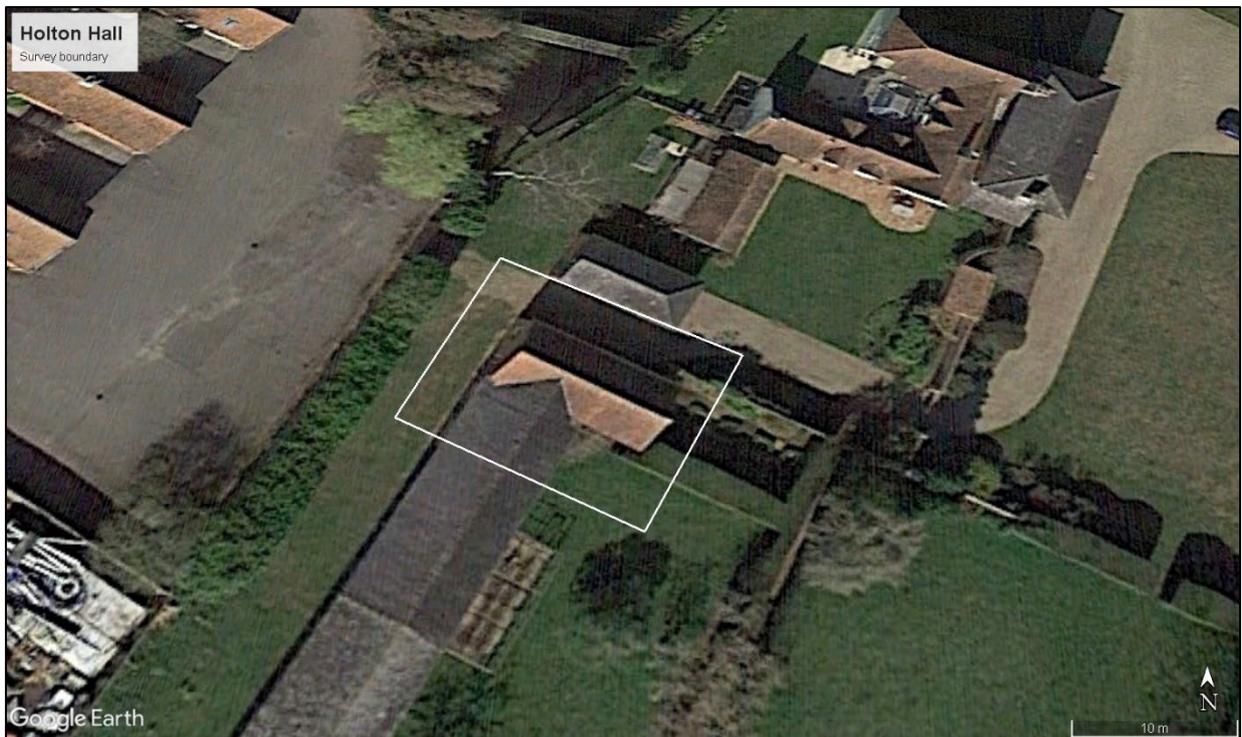
**Figure 2.** Survey boundary (approximate)

- 1.2 Hybrid Ecology Ltd. was instructed by Mr. and Mrs. Greene to undertake bat emergence and re-entry surveys at Holton Hall. A location plan is in Figure 1 and survey boundary is in Figure 2. The project involves the completion of a barn conversion.

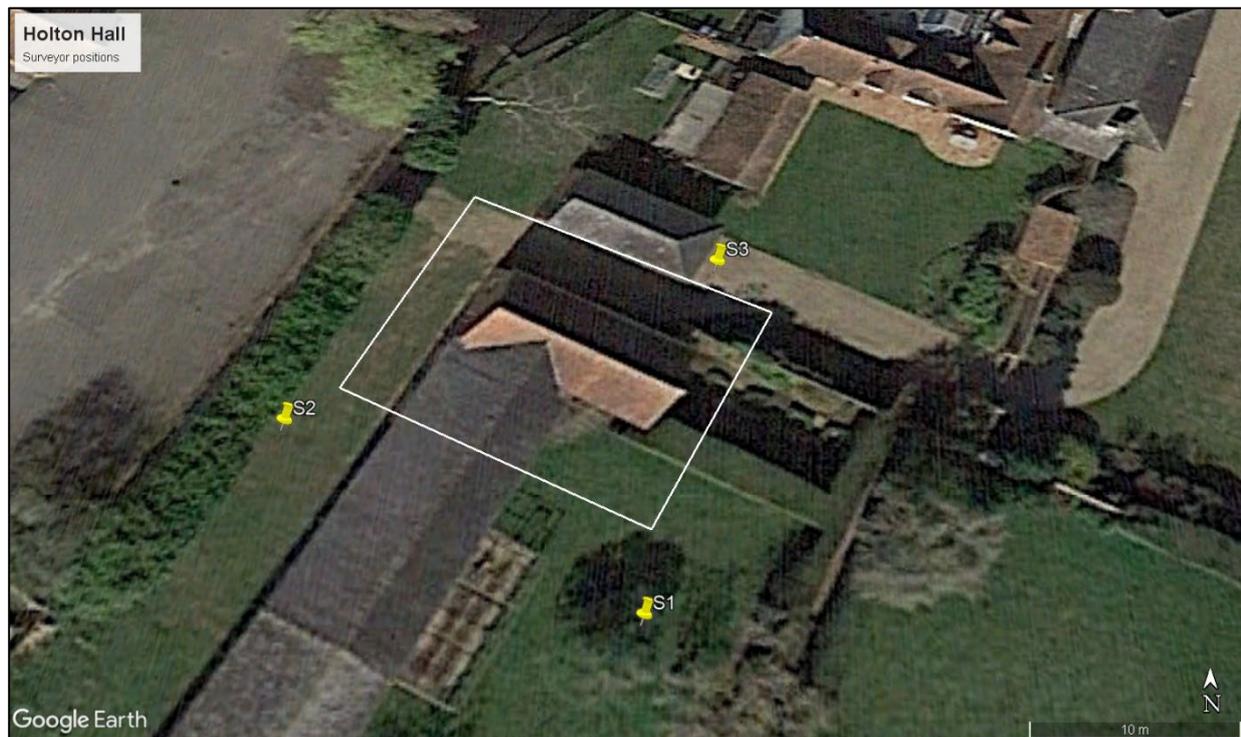
**Figure 3.** Surveyor positions

- 3.6 Surveyors were also equipped with night-vision aids including thermal FLIR A65 camera and Sionyx infra-red camera. All night-vision aids have a wide field of view and appropriate frame rate for this application. All footage was reviewed following the survey utilising relevant software.
- 3.7 Each surveyor watched for any bats emerging/re-entering, foraging or commuting and made notes accordingly. Recordings were made and stored on the Echo Meter Touch 2 Pro/Ipad.
- 3.8 Behaviour was recorded in 2-minute intervals, within which the number of “passes” were recorded. Levels of activity were determined as follows:
- Low: 8 or less passes
  - Moderate: 8 - 20 passes
  - High: Over 20 passes
- 3.9 Dusk surveys were carried out up to 30 minutes prior to dusk, until up to 2 hours after dusk. The dawn survey was carried out up to two hours prior to dawn, until sunrise.

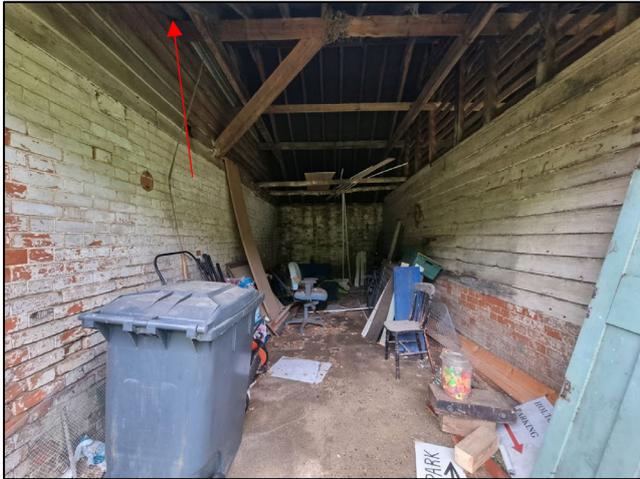
a) Common pipistrelle roost entry point in open bay.

- 6.1 The proposed work will impact the above roost in the absence of mitigation. Building work will therefore need to be carried out under licence. Since the roost comprises one bat, (i.e. low number, common species) a Bat Mitigation Class Licence (BMCL) can be used.

- 6.6 To replace the roost lost, it is recommended that at least one crevice style integrated roost feature is installed on the converted barn.
- Please refer to Appendix 1 for recommended bat roost features.*

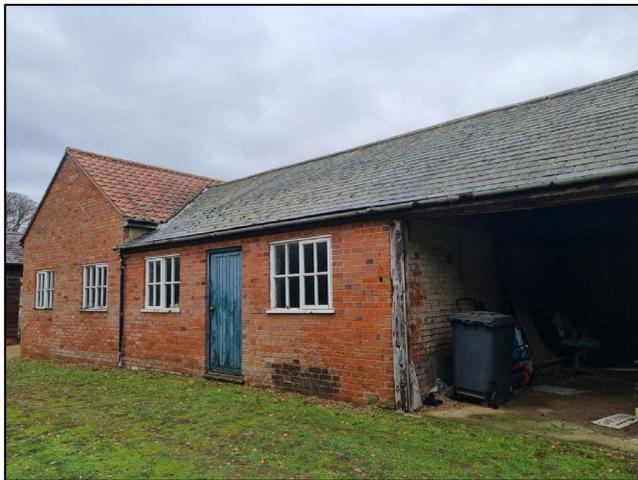
- 4.3 The barn is a single storey building arranged in an L shape, including three rooms, two used for storage and one open bay. The barn continues to the south with a series of open bays. We understand the barn was part-converted c.25 years ago. The barn has block/brick walls and a part slate part pan tile roof. The window and door frames are timber, and there are boxed timber soffits. There were no observable gaps around window frames.
- 4.4 There are several places bats could potentially access the barn:
- Gap via open bay.
  - Subsidence crack on the northern aspect.
  - Lifted ridge tiles.
  - Gap around lead flashing.
  - Small gaps under slate roof tiles facing east.

a) Western aspect and open bay.

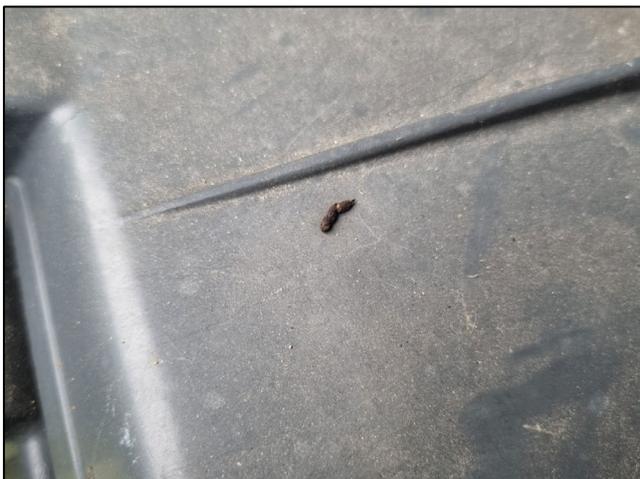
- 4.5 Bat droppings were identified in the open bay on a bin (maximum 5 droppings, well scattered) and in the northern room below the western gable apex, scattered close to the western wall. A small number of bat droppings were found scattered throughout the northern room on stored items. Holton Hall itself is a large, detached house with high roost suitability. This project will not impact the house or any other outbuildings.

b) Bat dropping found on bin in open bay.

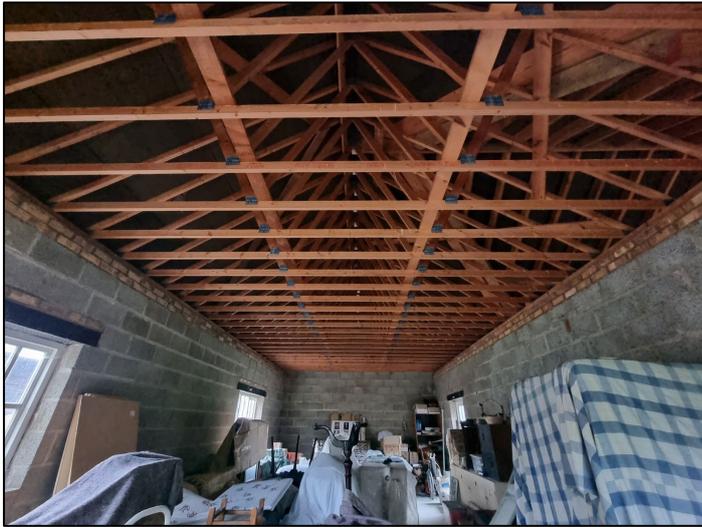
c) Northern room

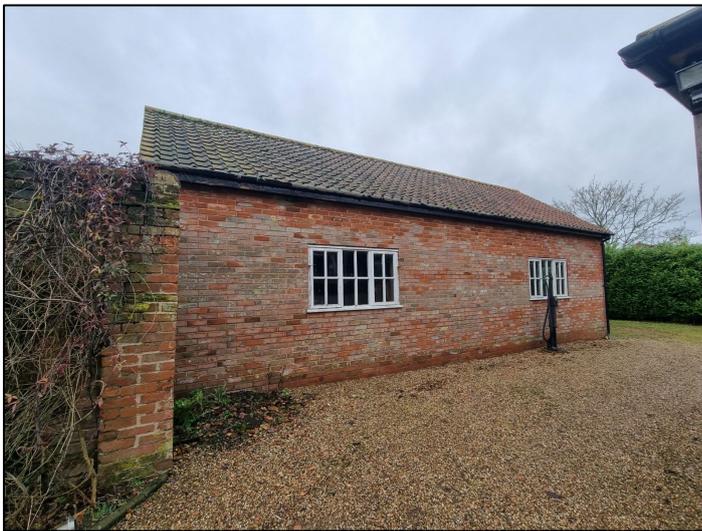
d) Northern aspect

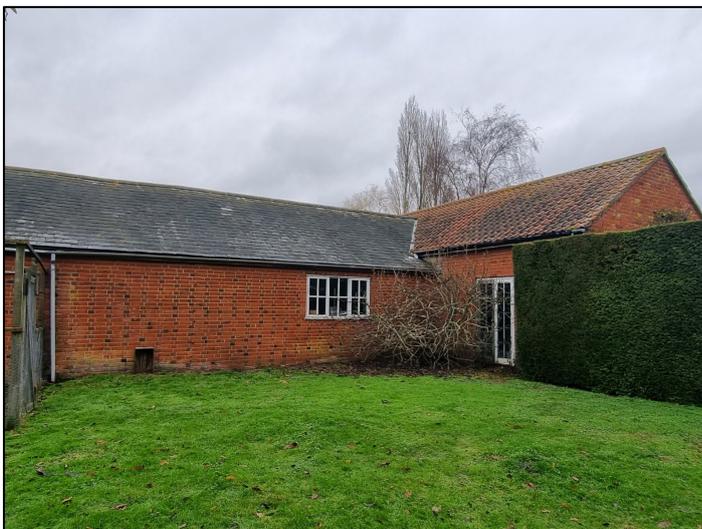
- 4.6 There are several places around the site that bats could reasonably use for foraging, notably the large lake to the north-west. The ornamental garden contains mature boundary trees, and the courtyard to the east of the barn is well-sheltered by ornamental hedgerows and climbers, creating a good environment for foraging. Overall, the landscape shows high suitability for foraging activity. There are no linear habitats on the site that are likely to be used by commuting bats.

e) Eastern aspect and garden.

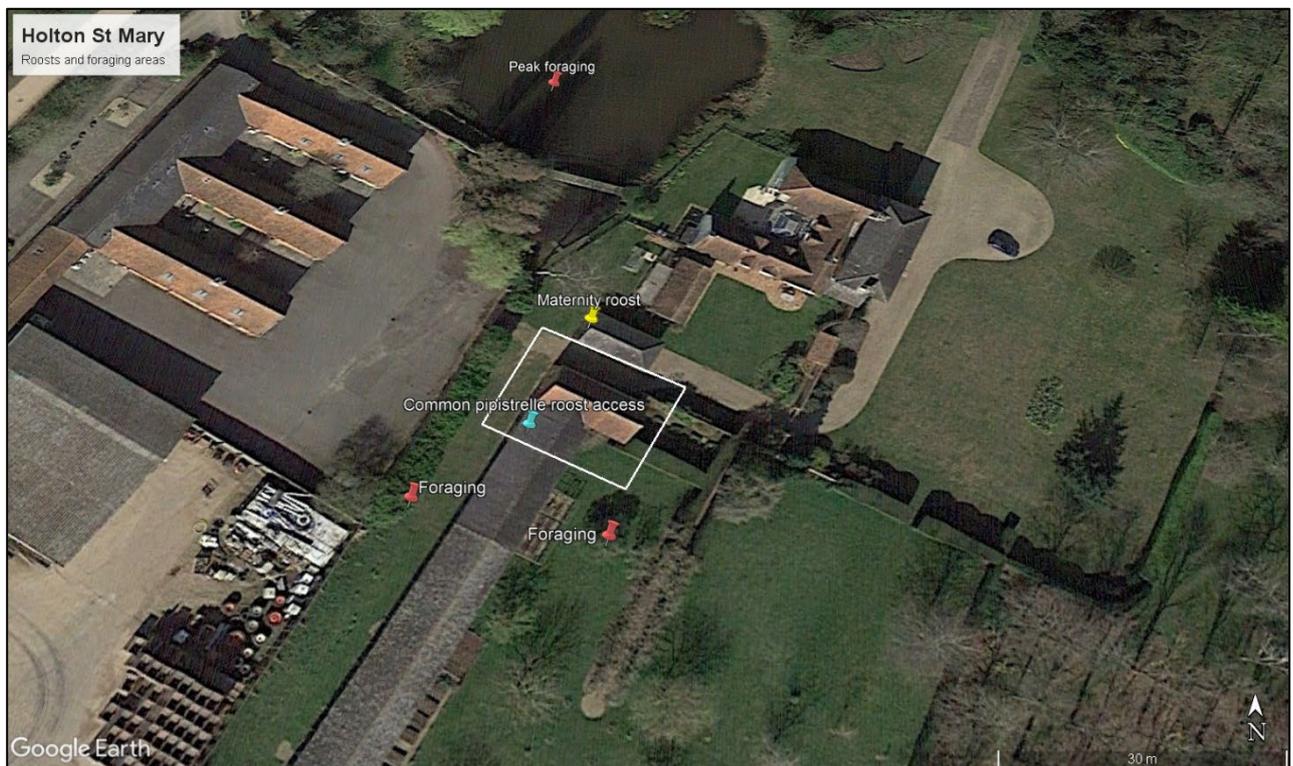
**Figure 5.** Roost access and foraging areas

The weather conditions and survey data are provided in Table 2 and Table 3. A map showing roosts and peak foraging locations is provided in Figure 5.

Roost	Number of bats	Roost location	Feature Type	Roost Type	Conservation significance
<b>Common pipistrelle</b>	1	Crevice in main barn, accessed via the open bay.	Crevice	Non-breeding, occasional summer roost	Low

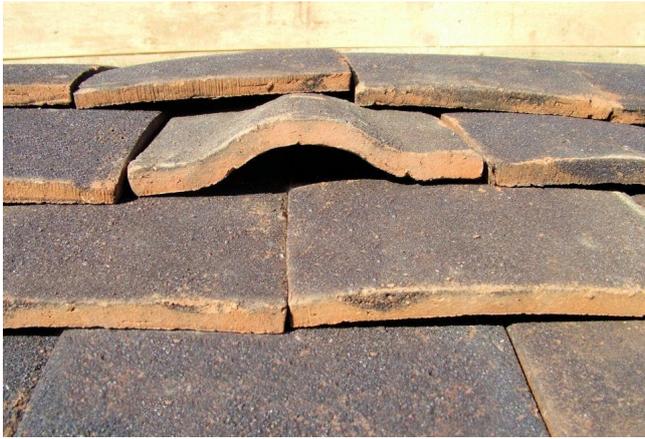
a) Bat access tile set - [Bat Access Tile Set | NHBS Practical Conservation Equipment](#)

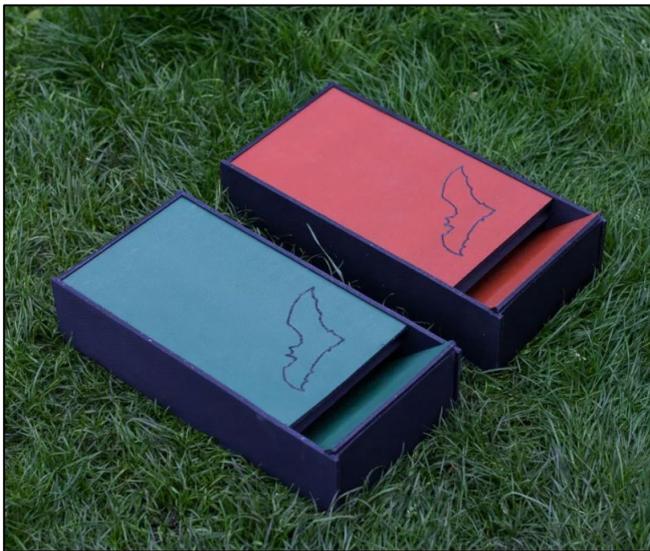
b) Integrated Eco Bat Box for buildings – [Integrated Eco Bat Box | NHBS Practical Conservation Equipment](#)
