Former Tidemill School (Block C)
Frankham Street
Deptford
London SE8 4RN

Verification Report

J18257C
Rev 0

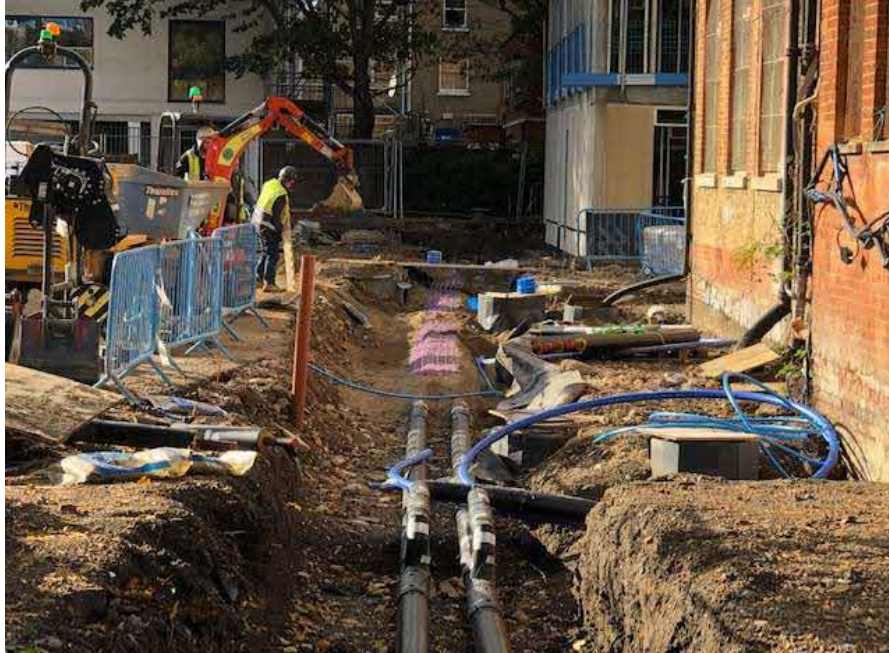
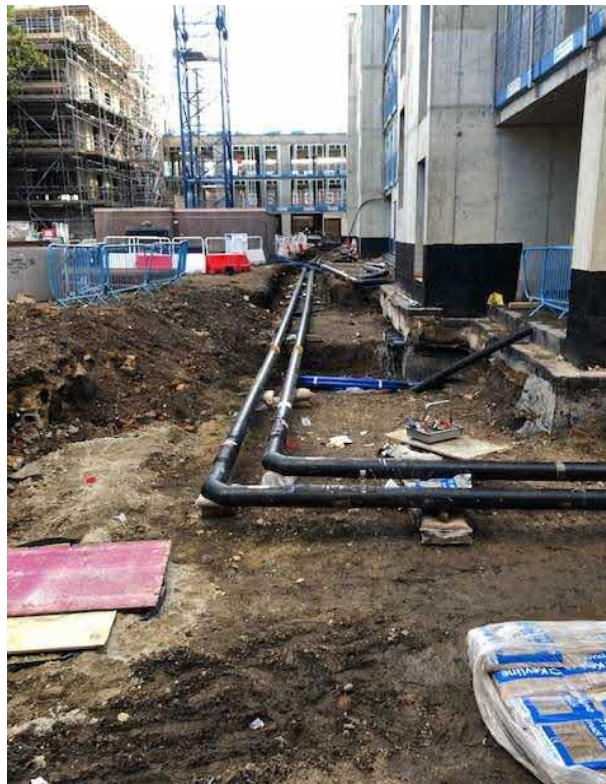
Photographs showing new pipe installations in oversized excavations

Photographs of the installation of the new services, taken by the contractor, are appended.
