The Cider Barn,
Gastrells Farm

Bat Survey Report

Project Name	The Cider Barn, Gastrells Farm
Report Type	Bat Survey Report
Client	Mr [REDACTED] Juggins
Site Address	Gastrells Farm, Portway, Upton St Leonards, Gloucestershire, GL4 8DS
Grid Reference	SO 87247 13922
Report Author	[REDACTED]
Revision Status	Final
Revision No.	1.0
Revision Date	20/12/2023

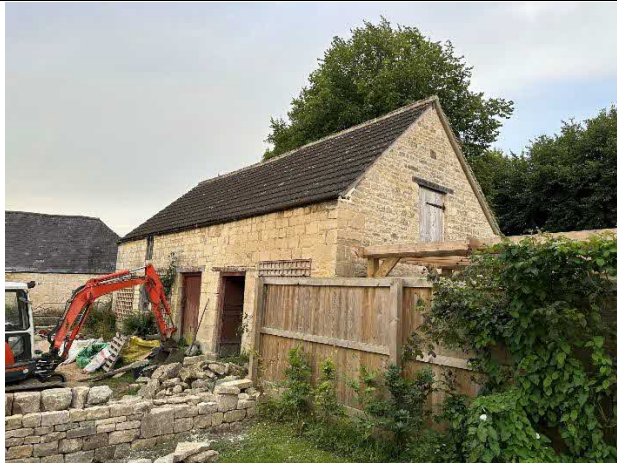
Photograph 1 – North west corner of building. Doorway to the proposed mitigation roosting space within western ground floor can be seen open in this image

- 6.1.6. To mitigate for the loss of the undisturbed building interior within the first floor, which will be turned into accommodation, the western ground floor store room will be modified to enable the use by Lesser Horseshoe. Its dimensions are approximately 2000mm high (floor to rafters), 6000mm long and 3000mm wide. It will be used as a log store only post development works.

- 6.1.8. Flight access to the western ground floor room will be created via a slot in the top third of the existing (or replacement) northern doorway (approximately 300mm x 200mm). The height of the access point in the doorway has been considered to reduce the risk of predation to Lesser Horseshoe, as cats are present on the wider site. This is also the reason providing access through the southern window was ruled out of consideration, as at the external point the window is at ground level, on land outside of the Client's ownership. The access point will be created at the start of works to allow the space to be used by Lesser Horseshoe throughout the development works.

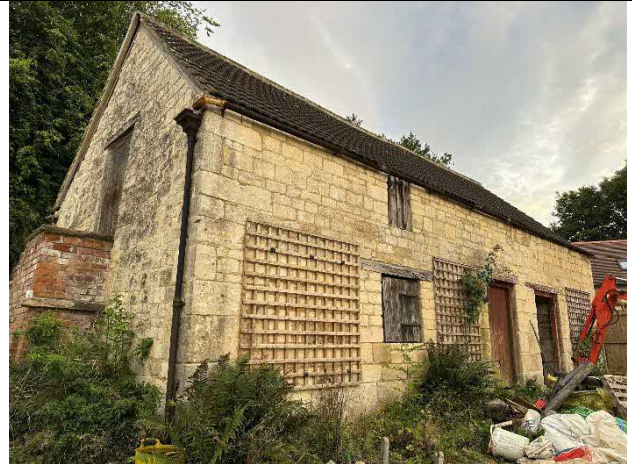
Photograph 2 – North east corner of the building. The concrete tiles that can be seen in this image will be replaced with stone tiles

-
- 6.1.12. The roof repair/replacement works (which must be done under licence and supervised by a licenced bat ecologist) will include the replacement of the concrete tiles on the southern roof pitch with stone tiles, backed with bitumen felt. This is considered desired, as it will be improving the Site for bats.
- 6.1.13. A compliance check will be completed by a licensed bat ecologist following completion of all the mitigation works. As the Site is considered to have low conservation significance monitoring checks, involving a dusk activity survey, will be required in year 1 or 2 after all proposed development works on site have been completed.

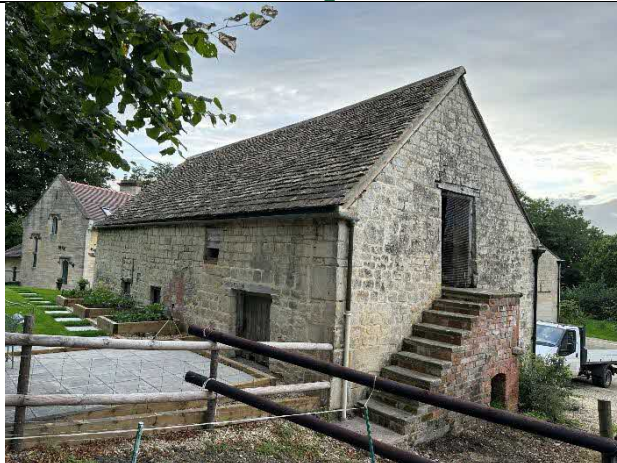
Photograph 3 – South east corner of building. Window with flight access can be seen in centre of image

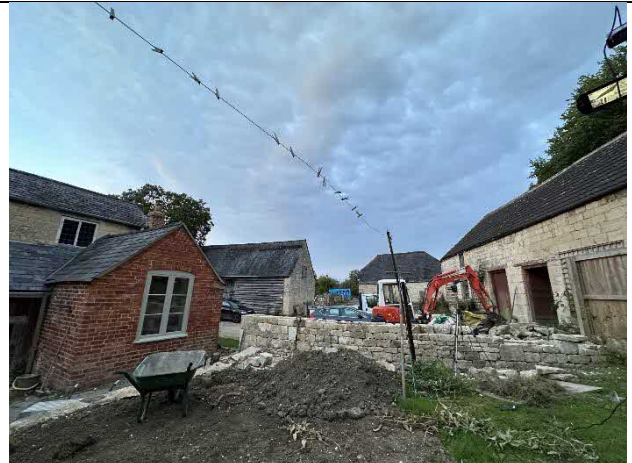
Photograph 4 – Distance between the Cider Barn (right of image) and the main house at Gastrell Farm. The wall that can be seen in the centre of the image has now been completed; however it is only marginally higher than what can be seen already

- 6.1.9. In front of the building on the northern elevation a small wall with built in planters will be erected to artificially force space between the new roost entrance and the ongoing use of the farm yard for parking.

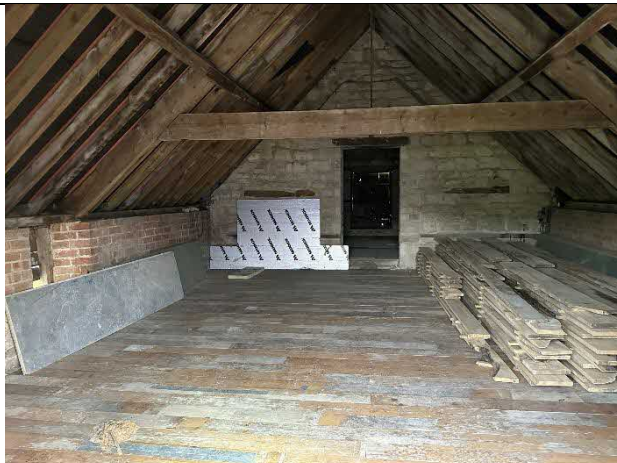
Photograph 5 – Eastern end looking west of first floor/roof space. Window with flight access can be seen to left of image

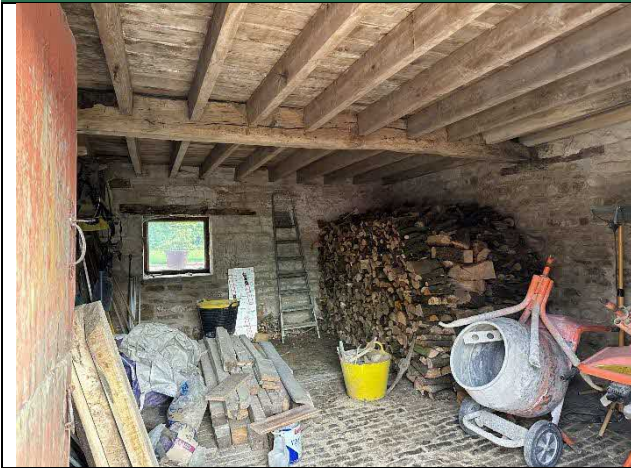
Photograph 7 – Western ground floor room

- 6.1.7. Two 'hot box' areas will be installed to provide pockets of secure and dark space suitable for use by roosting Lesser Horseshoe within the ground floor room, with additional rough sawn timbers installed within these areas to provide a surface for bats to hang from. These 'hot boxes' be creating by installing plyboard or similar down from the rafters, creating a boxed in area. They will have an approximate 500mm x 500mm footprint and a height of approximately 500mm. A flight entrance at the base of each 'hot box' will be created; approximately 300mm x 200mm.

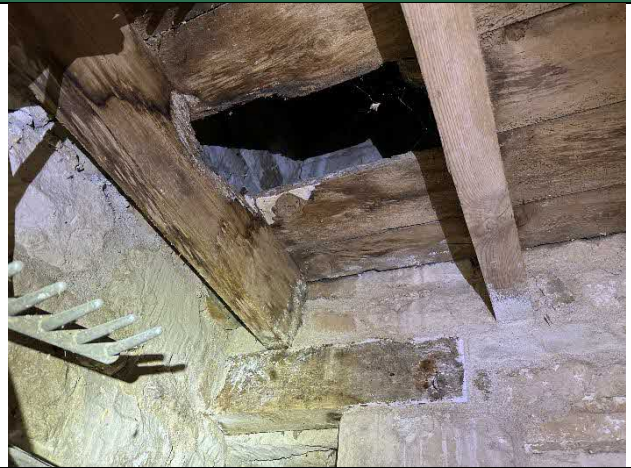
Photograph 8 – Example access between first and ground floors

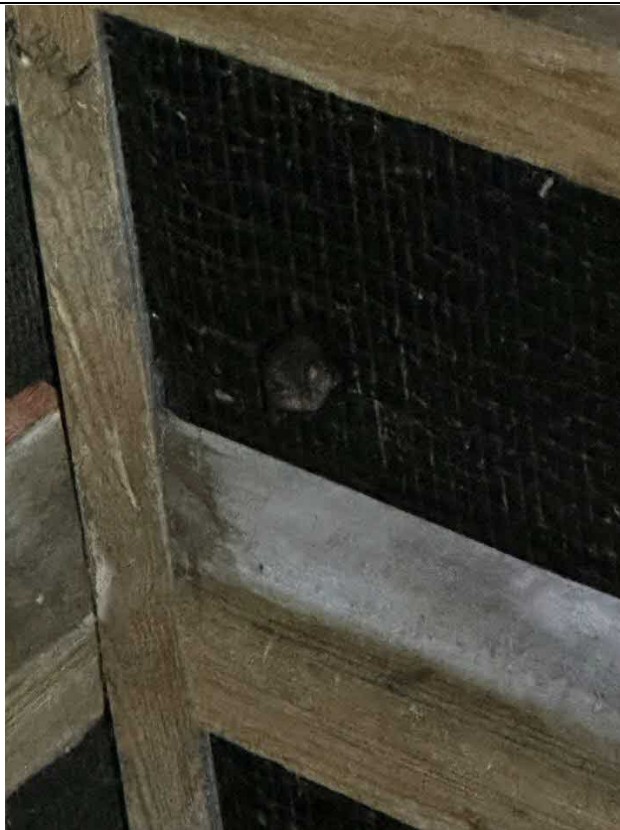
- 3.3.7. During this survey a single Lesser Horseshoe was observed hanging in the building prior to the survey. The Lesser Horseshoe was then observed light sampling before emerging at 21:20 from the first floor partially boarded window and then commuting north through the yard. A single Common Pipistrelle was also observed emerging from the tile end on the western gable at 20:53 before commuting further west.
- 3.3.8. The following bat species were noted as using the site to commute through/over during the survey; Soprano Pipistrelle, Common Pipistrelle and Lesser Horseshoe.
- 3.3.9. The following bat species were noted as using neighbouring land to commute through/over and/or forage in/over during the survey; Soprano Pipistrelle, Common Pipistrelle, Lesser Horseshoe, Noctule, Serotine, Myotis species and Long-eared species.

Photograph 9 – Lesser Horseshoe found hanging in first floor on 28/08/2023

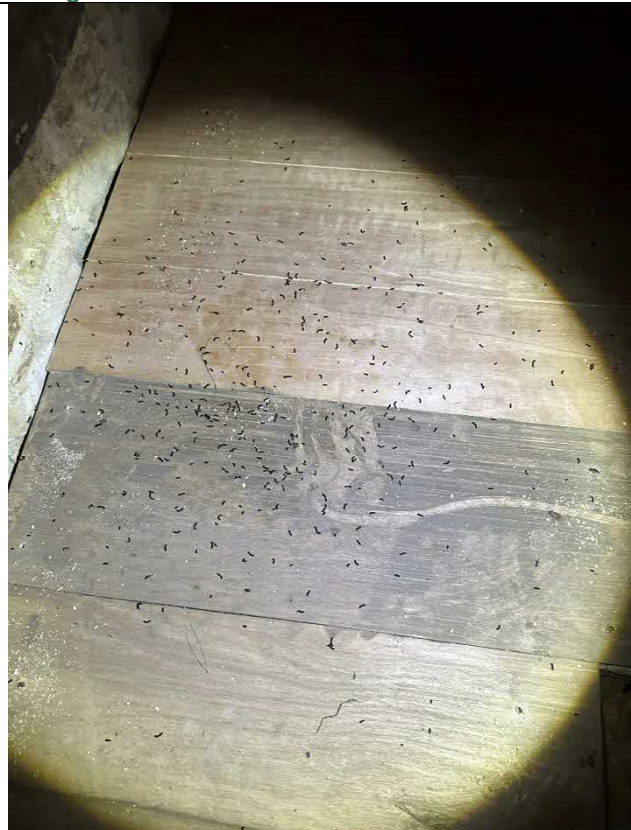
- 3.2.5. No evidence of bats was identified during the building inspection within either of the ground floor rooms. However, the first floor/roof space had scattered Lesser Horseshoe droppings towards the western end of the space, with a small cluster underneath the ridge beam adjacent to the hayloft door. Access under the stone tiles was also available to crevice dwelling bats. The concrete tiles of the northern elevation were predominantly tight, but some areas were lifting.

Photograph 10 – Lesser Horseshoe droppings at western end of first floor
