# OLD BEAMS, 145 THE HILL, BURFORD, OXFORDSHIRE

## HERITAGE STATEMENT

**PROJECT:** Old Beams, 145 The Hill, Burford, Oxfordshire

**DOCUMENT TITLE:** Heritage Statement

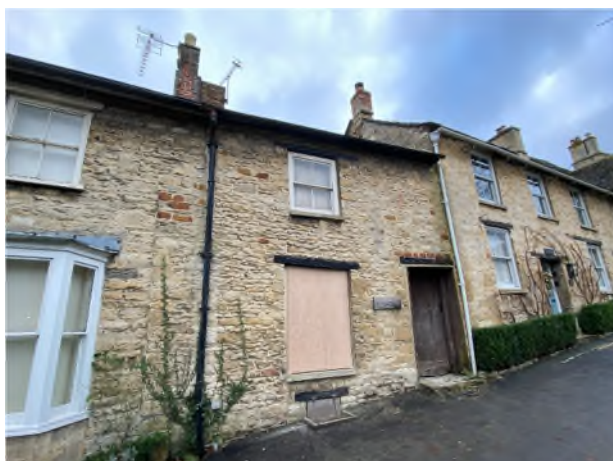
Figure 1: Front elevation of Old Beams

- 1.3.1 Old Beams was added to the statutory *List of Buildings of Architectural or Historic Interest* at Grade II on 12<sup>th</sup> September 1955 and the listing amended on 1<sup>st</sup> March 1990. The list description reads as follows:

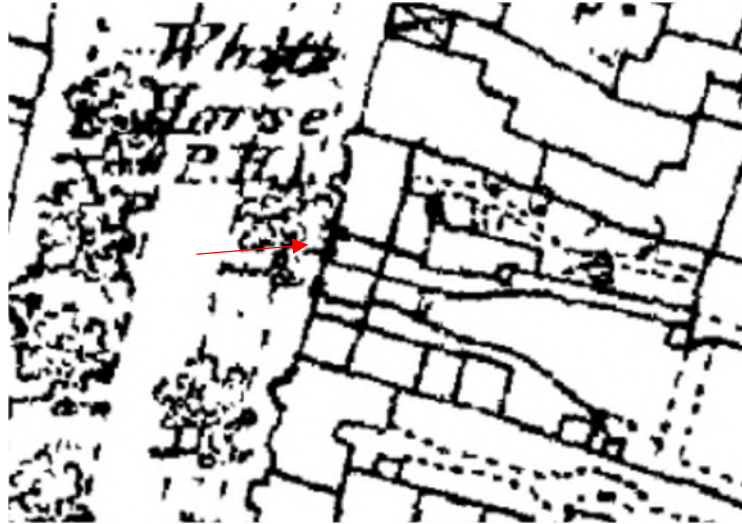
Figure 2: Extract from the 1<sup>st</sup> edition of the Ordnance Survey map (1880)

3.1.1 The 1<sup>st</sup> edition of the Ordnance Survey map (1880) shows the rectangular footprint of Old Beams and a thin narrow garden or access way to the rear.

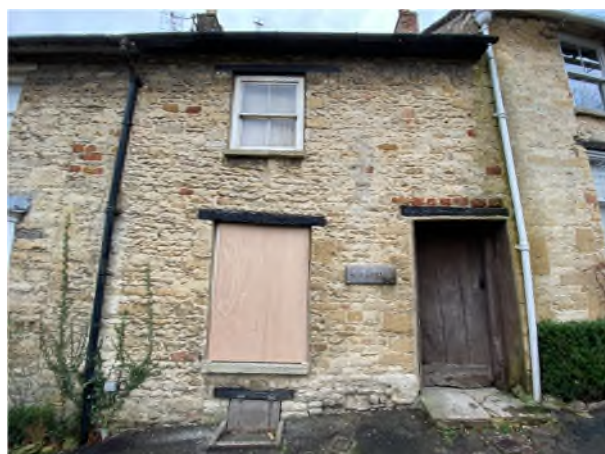
- 3.2.1 The original part of Old Beams is a 2-storey, single unit cottage of coursed rubble stone construction that fronts onto The Hill. The front elevation includes a plank and batten door with a timber lintel to an alley-way to the right. Off-centre to the left are a large ground floor window opening with a multi-paned sash window, a smaller 2-over-2 sash window on the first floor and a cellar opening, all with timber lintels. The sills of the ground and first floor windows are oolitic limestone.

Figure 5: Front elevation of Old Beams

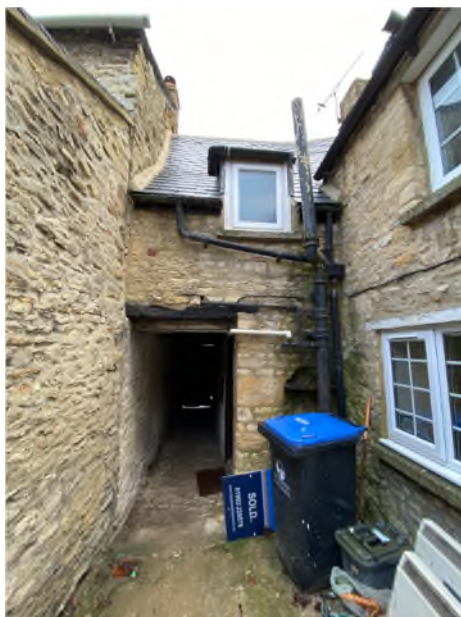
- 3.2.2 The rear elevation is mostly masked by the rear extension but the left hand side of the rear elevation remains visible. This is also of coursed rubble stone construction includes a lower

eaves level than the front elevation. The eaves are pierced by a dormer with a concrete sill and a modern upvc window. The ground floor includes the rear part of the alleyway which includes a timber lintel over the opening.

Figure 6: Rear elevation of Phase 1

Figure 16: Dormer with a upvc double glazed window on the rear elevation of Phase 1

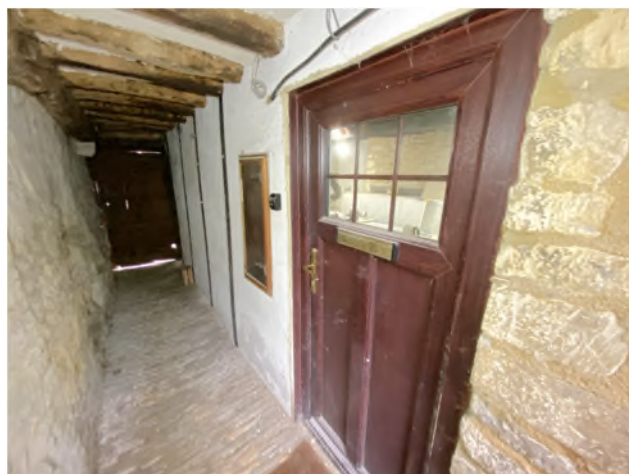
3.2.3 The alleyway includes a cobbled surface. The floor above is carried on joists which line up with the joists associated with the axial beam on the ground floor. The partition between the alley way and the ground floor of the Phase 1 cottage appears to be of 20<sup>th</sup> century construction and includes an expanded metal lath and plaster finish externally and an upright timber board finish internally.

Figure 7: Alleyway on the southern side of Old Beams

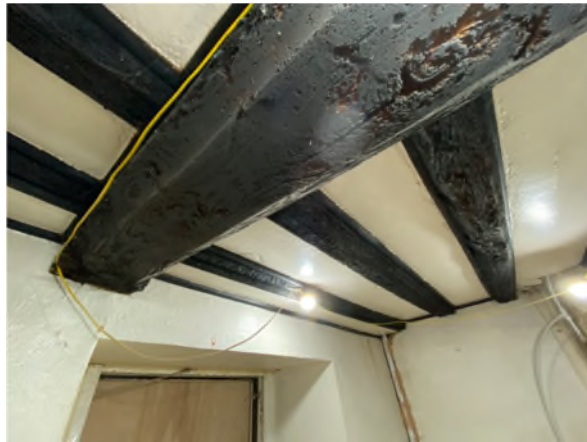
3.2.4 The ground floor is accessed through a modern 20<sup>th</sup> century part-glazed door. The ground floor includes an axial beam with wide chamfers and curved step stops. The joists are wide at around 160mm and include runout stops. These details suggest an early date for this part of the house, possibly late 16<sup>th</sup> century. There is a chimney breast on the northern side of Phase 1. There is a stone lined cellar beneath the ground of Phase 1 which is accessed by concrete steps to one side of the chimney breast. The floor over the cellar includes machine sawn joists

Figure 8: Detail of the axial beam and joists on the ground floor of Phase 1

- 4.1.3 The style of the axial beam and the dimensions of the joists on the ground floor and the style of roof truss, which appears to be a type of cruck, suggests an early date, possibly late 16<sup>th</sup> century or early 17<sup>th</sup> century, for the Phase 1 cottage.

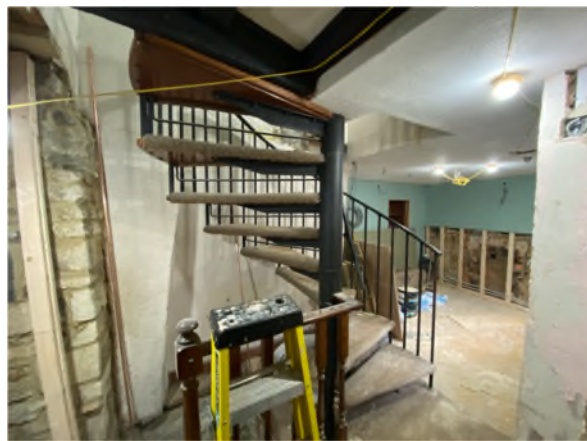
and is a 20<sup>th</sup> century replacement. A 20<sup>th</sup> century balustrade is located at the top of these steps. Also to the right of the chimney breast is a relatively modern spiral staircase.

Figure 9: Spiral staircase to the right of the stone chimney breast

5.2.1 The existing stair is a modern metal spiral staircase of no heritage value (**figures 9 and 11**). Based on the character of the wooden balustrades on the landing and at the top of the cellar steps, the previous stair was likely of of c. mid-20<sup>th</sup> century date. The removal of the spiral staircase would not impact on the significance of the listed building.

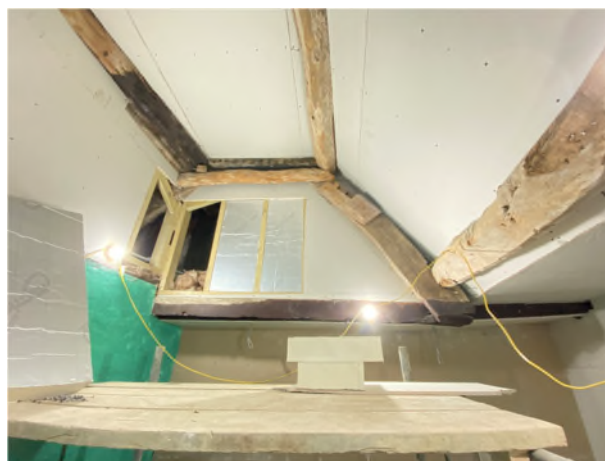
- 3.2.6 On the first floor there is evidence for a truncated truss which appears to be cruck-like in appearance and includes a trenched purling on the western side. This demonstrates that the original cottage would have had a much lower eaves level. A beam extends westward to support the original truss on the c. 19<sup>th</sup> century wall plate of the alteration to create a 2-storey front elevation.

Figure 10: Truncated truss on the first floor

- 4.1.2 The position of the truss on the first floor, which is offset towards the southern side of the first floor bedroom, suggests that Phase 1 may have formed part of a larger building that has been lost or incorporated into the adjacent properties. A cellar in a one-unit cottage is also quite unusual and further suggests that Phase 1 may originally been part of a larger cottage.

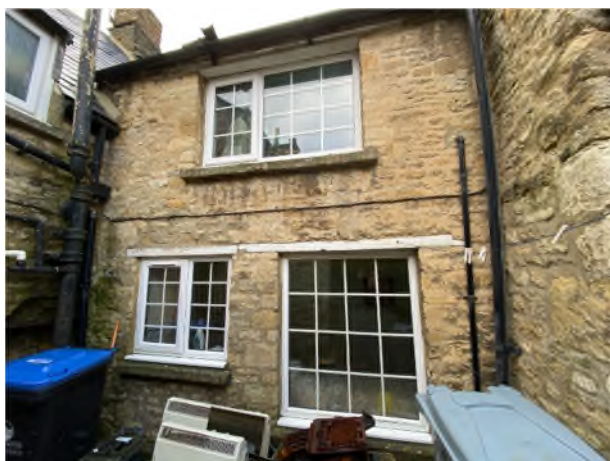
- 3.2.8 Phase 2 is a 2-storey rear extension of coursed rubble stone construction. The south elevation includes a window opening on the first floor with stone dressings and a timber lintel. The window opening to the right on the ground floor also has stone dressings, while this detail is absent on the window opening to the left. This perhaps suggests that the left hand ground floor window is a later alteration. Internal details as well as a change in the character of the stonework below sill level suggests that this opening was formerly a door. All these windows have concrete sills and upvc double glazed windows.

Figure 12: South elevation of Phase 2

- 4.2.1 Phase 2 is a rear extension which according to the listing was built in the 18<sup>th</sup> century. This may be the case but there is limited diagnostic information in the surviving fabric to confirm this. The south elevation of Phase 2 includes two windows with stone dressing which suggest that these openings are original. The window opening to the left on the ground floor does not include stone dressings and may be a later alteration, possibly an opening for a door originally. The timber lintels appear to replacements and the windows are modern double glazed upvc replacements.

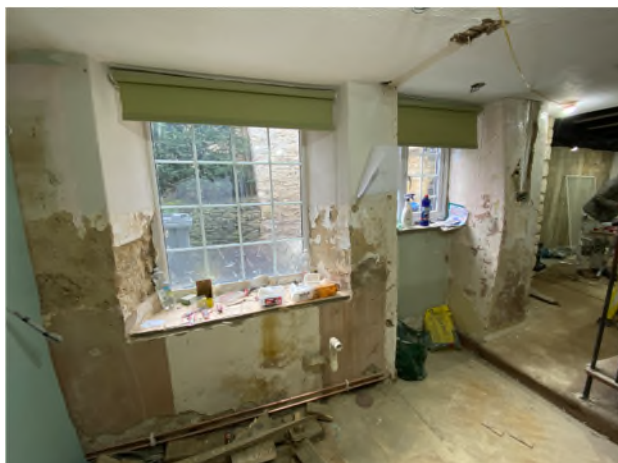
Figure 13: Window openings on the ground floor of Phase 2

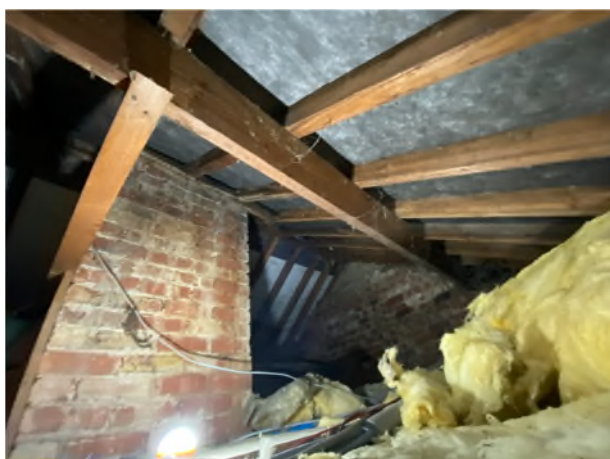
- 3.2.9 The ground floor includes a chimney breast centrally positioned along the north wall. The chimney visible in the roof void show that the upper part of the chimney was built with Fletton bricks and is therefore of late 19<sup>th</sup> or 20<sup>th</sup> century date. The character of the roof timbers for the shallow pitched roof to the rear is also indicative of a late 19<sup>th</sup> or more likely a 20<sup>th</sup> century date. There is evidence for a fireplace along the east wall on the ground floor. The chimney

breast along the north wall therefore appears to have replaced this fireplace. Similarly, the roof structure to the rear has been rebuilt.

Figure 15: Fletton brick chimney and replacement roof structure in Phase 2

- 4.2.2 The interior includes a single room on each floor. The ground floor room was heated by a fireplace on the eastern gable end where there is a stack associated with No. 143. The roof structure and the chimney on the northern side of Phase 2 appears to be much later in date and may be related to Old Beams forming part of No. 143 in the early 20<sup>th</sup> century.

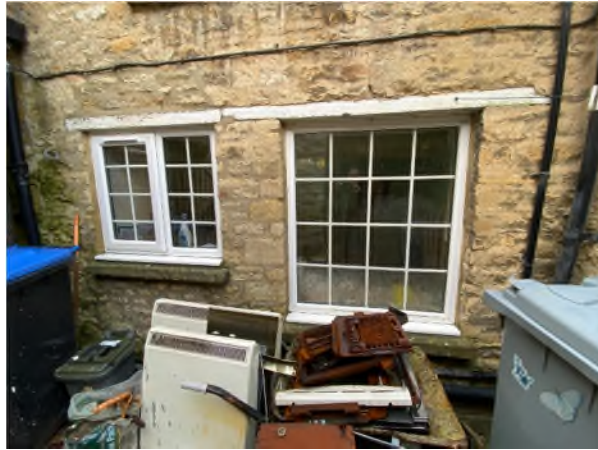
Figure 17: Upvc windows on the ground floor of the south elevation of Phase 2

5.3.1 It is proposed to replace four windows to the rear of the listed building. All four of the existing windows are upvc double glazed units and of no heritage value. The removal of these windows would not harm the character of significance of the listed building.

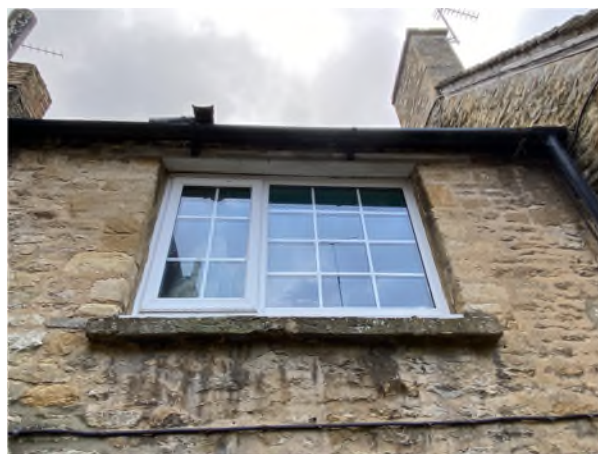
Figure 18: Upvc window on the first floor of the south elevation of Phase 2
