cornwall
environmental
consultants LTD

Bat and Barn Owl Assessment
Walter Bailey Ltd
St Andrews Road
Par
PL24 2LX

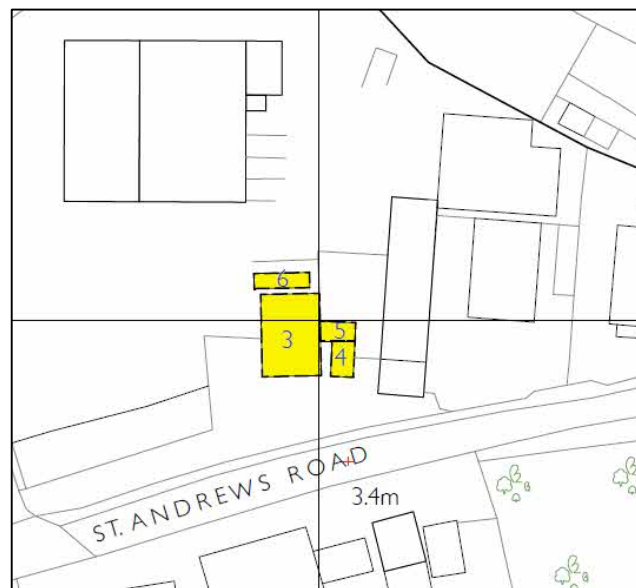
Four buildings were surveyed, shown as Buildings 3, 4, 5 & 6 in Figure 1.

Figure 1 Site plan showing buildings to be removed

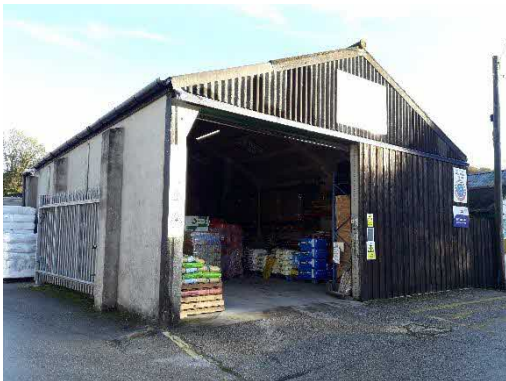
Building 3 is a storage shed with walls of single row concrete block and a pitched roof of corrugated fibre cement sheets (Figure 2). The floor, walls, stored items and roof were searched. The door is left open during business hours and locked at other times. There were no external features suitable for roosting bats, e.g. gaps behind fascia and barge boards.

Figure 2 South side of Building 3

Although no current evidence of roosting bats was found it cannot be assumed that bats are not present when works commence. If any bats are discovered during the work they must not be handled: works must stop immediately and advice sought from CEC (tel 01872 245510).

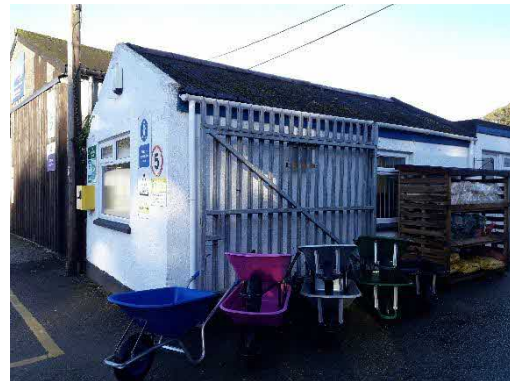
Building 4 is single storey with walls of single row concrete block and a pitched roof of

corrugated fibre cement sheets (Figure 3). It is used as an office and half of the building has a vaulted ceiling whereas half has a false ceiling and enclosed roof void but no access hatch into the roof space. There were no gaps where bats would be able to gain access into the roof and no external features suitable for roosting bats.

Figure 3 East side of Building 4

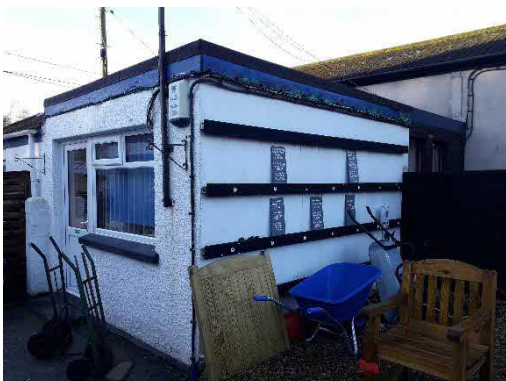
Building 5 is single storey with walls of single row concrete block and a flat roof (Figure 4). Half of the building is an office and half is a toilet block. There were no gaps where bats would be able to gain access and no external features suitable for roosting bats.

Figure 4 North side of Building 5

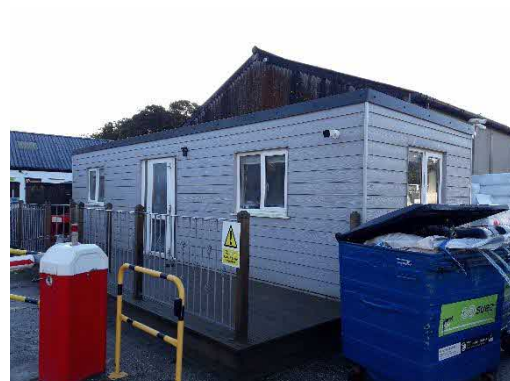
Building 6 is a portable building (Figure 5). It is used as an office and there were no external features suitable for roosting bats.

Figure 5 North side of Building 6
