Nethercourt, Hyde, Chalford

Bat Survey Report

Date: January 2024

Ref: C682

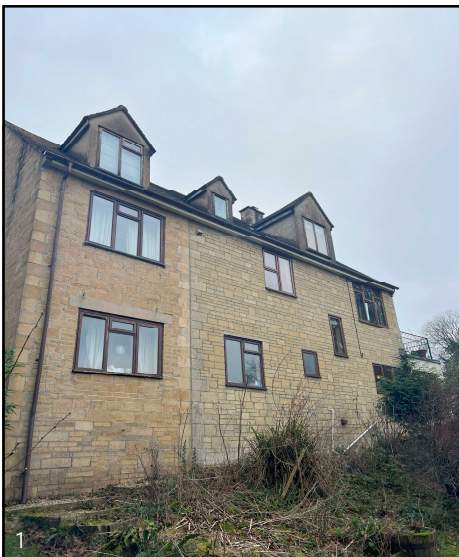
Plate 1. View of the northern elevation.

Nethercourt is a two storey house with the roof space converted into living space. The walls are constructed of stone and the roof is pitched and covered in concrete roof and ridge tiles. There are three existing dormer windows on the northern pitch and one dormer window on the southern pitch. There are windows on all elevations and the building is currently occupied. The dormer windows have a rendered finish with wooden bargeboards at the edges of the dormer roofs. There are plastic drainpipes fixed to plastic soffits. There is a stone chimney present and there is metal flashing where the dormers and chimney meet the roof.

The ridge and roof tiles are in a good condition and no potential bat-access points were observed that would allow bats to access the space between the tiles and the lining, or access the open space of the loft void. The rendering around the dormer windows does not provide any gaps around the apex or edges that would also allow potential roosting locations. The bargeboards are also tight fitting with no gaps between the boarding and the walls that would allow potential bat-access.

The roof was only surveyed from ground level using binoculars and a high powered torch. It is therefore possible (although unlikely) that there are locations where potential bat-access points are present, but hidden from view. As a result, the building was classified as having Negligible Bat Roosting Potential, not 'None'. Contractors should therefore be vigilant when dismantling the dormer roofs and soffits. In the unlikely event that bats or evidence of roosting is recorded, a licensed and appropriately qualified ecologist should be contacted for advice. Otherwise works should be able to continue without further regard to bats.

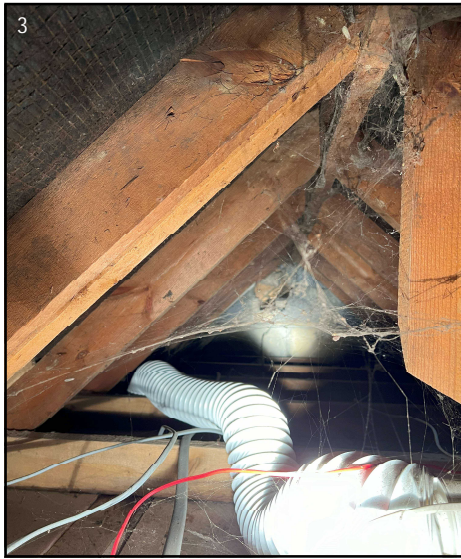
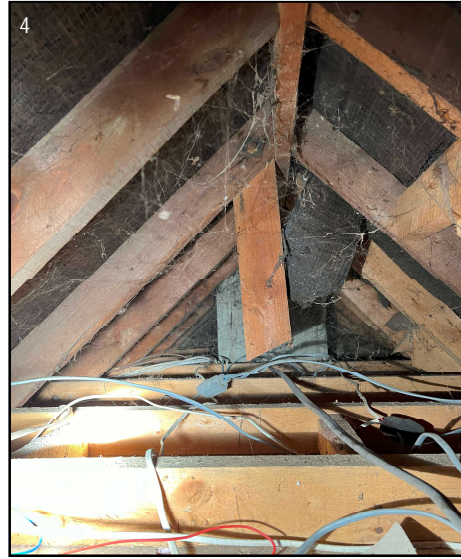
Plates 3 and 4. Internal views of the loft void.

Internally the building is occupied and in use on all floors. The roof space is converted into living space but there is a small loft void present at the very apex of the roof. The loft void can be accessed via a loft hatch but is only approximately 0.6 m from floor to apex and contains obstructions (e.g. chimney, internal partition wall) and was therefore not able to be fully inspected.

Internally, the loft void is suitable for roosting but given the lack of access points, it could not be used for roosting. The loft void is full of old cobwebs and it is clear that bats have not been flying around the open space of the void.

Although the entire extent of the loft void could not be viewed, no evidence of bats was observed from the accessible areas of the loft void or any other area of the building. The loft void is full of cobwebs and the lack of potential bat-access points would mean that the loft could not be used for roosting. As a result, the lack of full access for survey is not considered a constraint in this instance.
