CONTAMINATED LAND RISK ASSESSMENT REMEDiation VERIFICATION REPORT

95 Preston Drove
Brighton
BN1 6LD

PH3-2023-000013

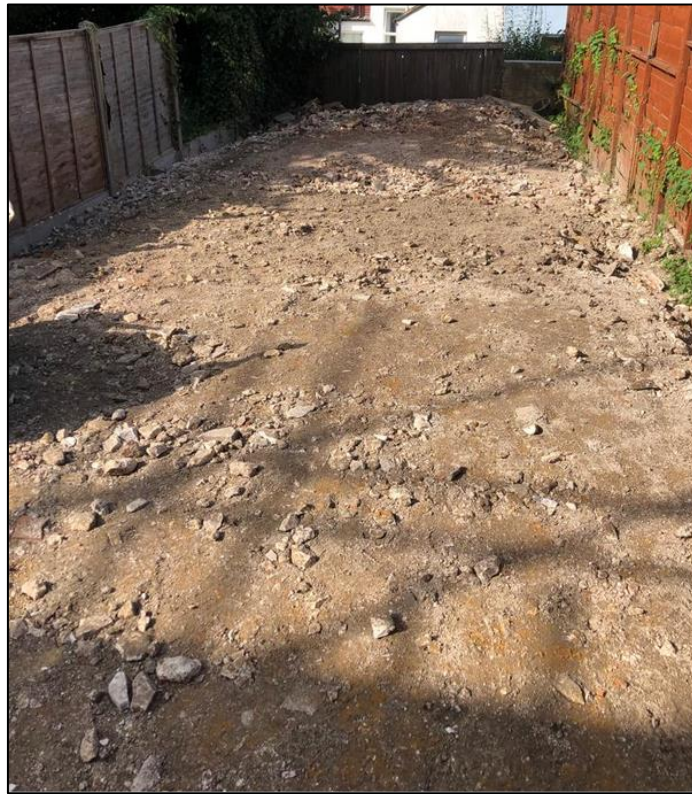
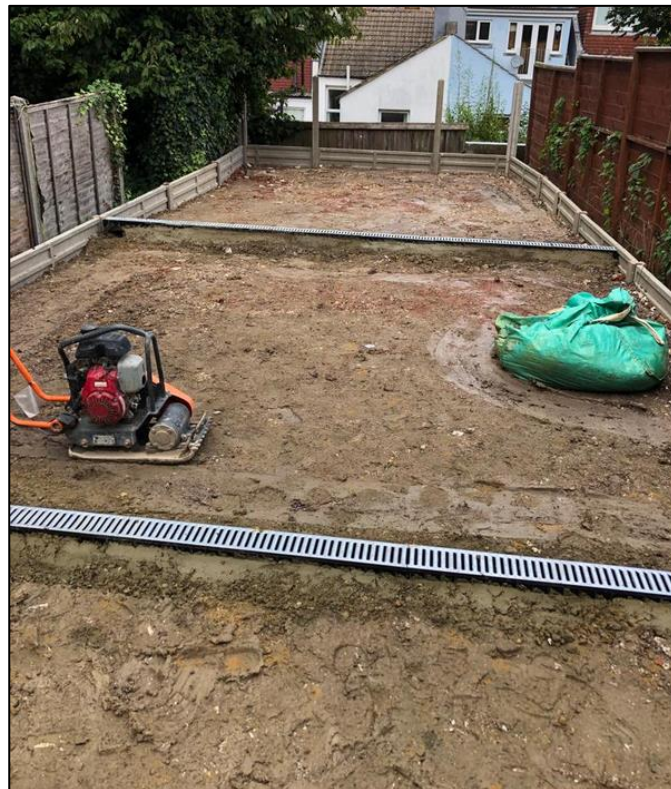
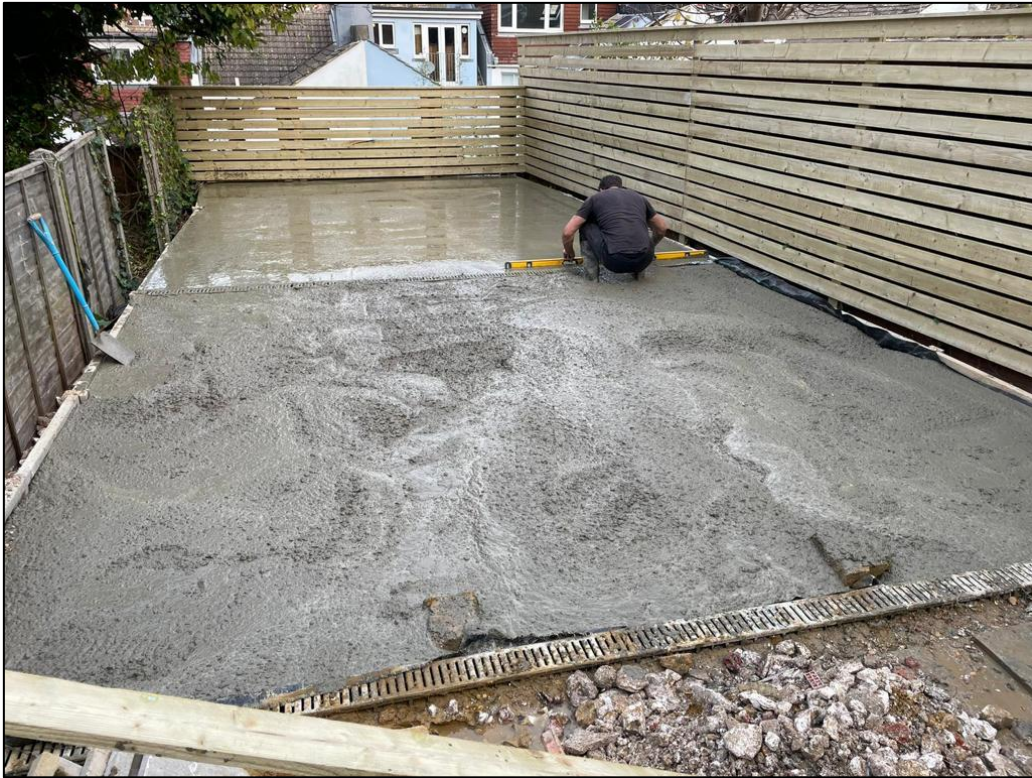
9.1 Appendix 1 – Photographs

The Client provided photos showing that the proposed garden area is now covered entirely by permanent hardstanding. The photographs, which can be seen in [Appendix 1](#), show the laying of the concrete cover which is understood to have a minimum thickness of minimum of 150mm, in December 2023. The concrete will be covered by a layer of astroturf, as can be seen in [Appendix 2](#).

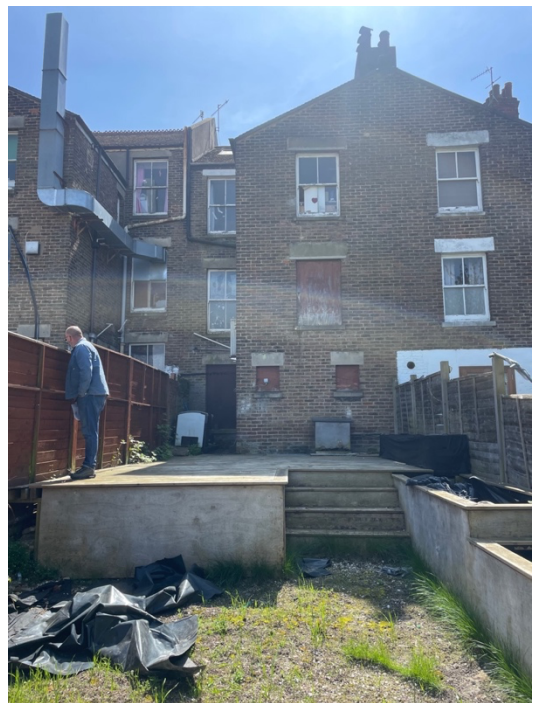
9.2 Appendix 2 – Built Drawings of Implemented Scheme

Remediation strategy for garden:

- Hard landscape with concrete
- Create drainage throughout garden to ensure stormwater is diverted.
- Create stepped level garden covering concrete with both patio and AstroTurf for visual appeal.

= Concrete slab underneath, patio on top

= Soakaway, 5m from the building line

= Concrete slab underneath, AstroTurf on top
