PRELIMINARY ROOST & NEST ASSESSMENT

Conifers
Merley Park Road
Ashington
BH21 3DD

October 2023

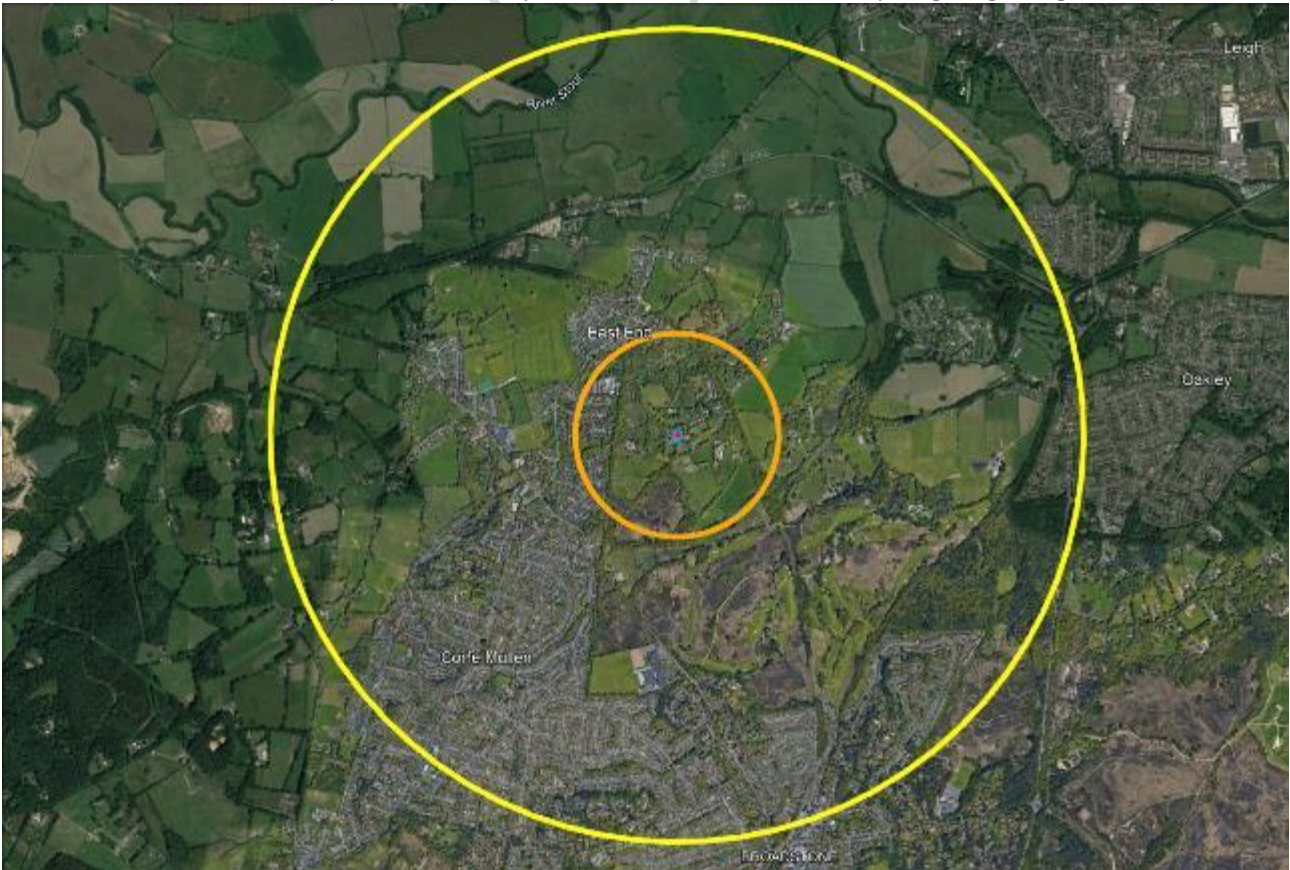
Map of Site Location – 500m- 2km

Assessment of adjacent and surrounding habitat: The structure surveyed is not located within or adjacent to any significant land or marine designations which it would negatively impact. It is relatively close to Cogdean Elms LNR (approx. 300m west), Corfe & Barrow Hills LNR (approx. 160m southwest), Corfe Hills LNR (approx. 460m southwest), Dorset Heathlands SPA & Ramsar, Dorset Heaths SAC and Corge & Barrow Hills SSSI (approx. 550m southeast), but as the proposal is only for a single storey extension, the designated sites are unlikely to be negatively impacted.

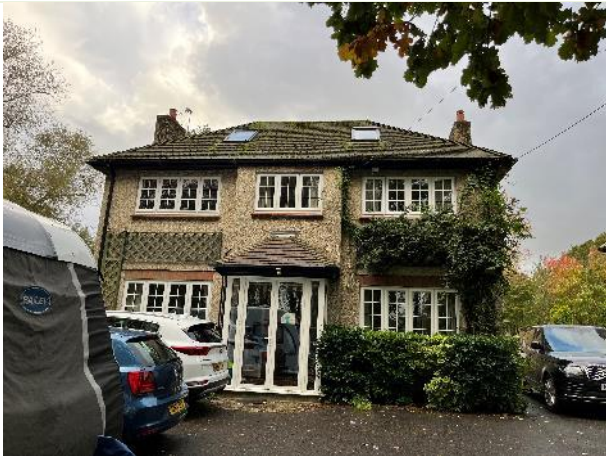
External features: The surveyed house is a pebbledash rendered structure with a multiple pitched tiled roof. The roof tiles and ridge tiles at the rear elevation of the upper floor has low potential for bat access.

Assessed Structure – front of the surveyed house (northern orientation)

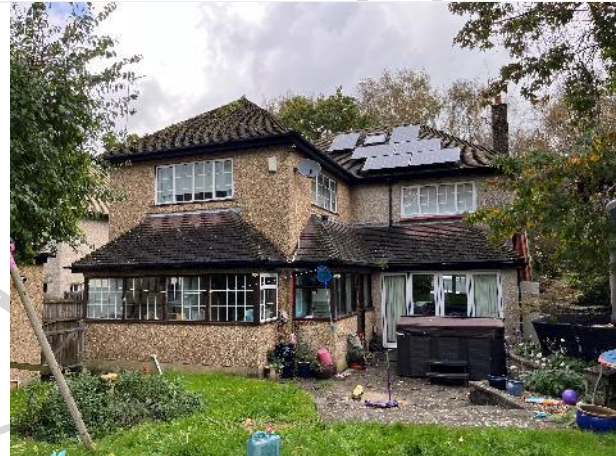
Rear of the surveyed house (southern orientation)

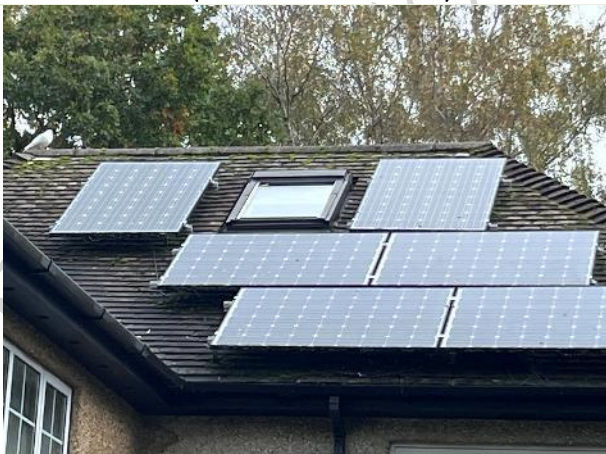
External Feature: roof tiles and ridge tiles at the rear elevation of the upper floor with low potential for bat access

Works are prohibited to rear roofing features at the upper floor of the main house unless 1 Bat Emergence Survey is undertaken and completed and the results have informed a Mitigation Strategy. This includes any works which would partially or fully block or seal through repair of otherwise, rear roof and ridge tiles at the upper roof, which might be allowing ingress into the gaps between lining and tile or the inaccessible loft void under the ridge. Introducing any sustained artificial lighting towards the area with bat access potential is also prohibited.

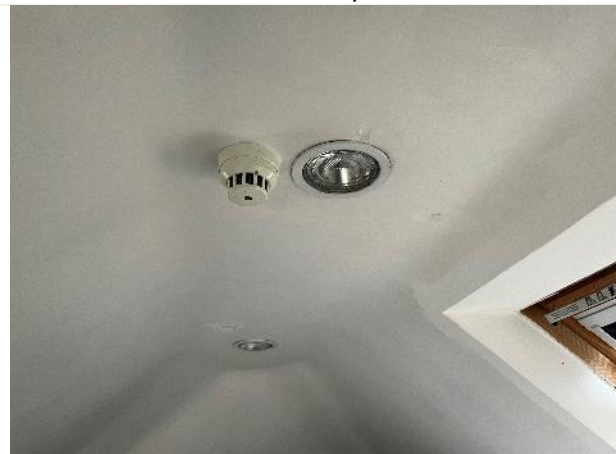
Internal features: The loft void under the ridge is inaccessible but the side lofts are accessible. The roof under the side lofts is lined with sarking. No evidence of bat roosting or bird nesting was found. The sarking is tight with no visible gaps, and therefore if bat are present, the evidence is likely to be hidden within the gap between the sarking and the tiles.

Internal Feature: the inaccessible loft void under the ridge

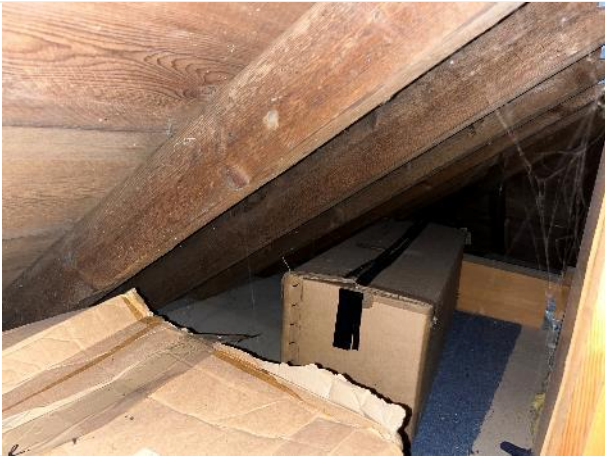
Internal Feature: the accessible side loft

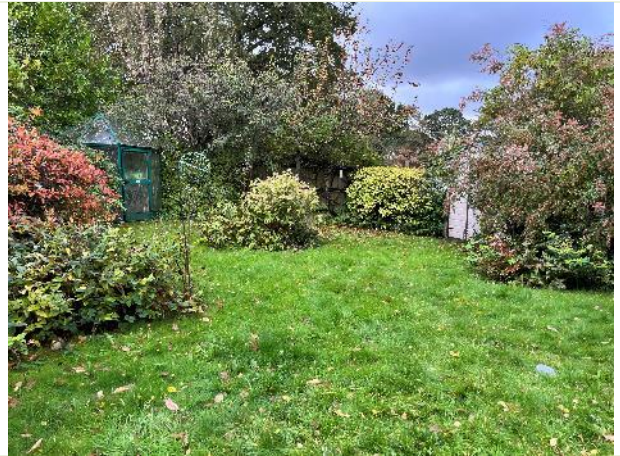
Residential garden

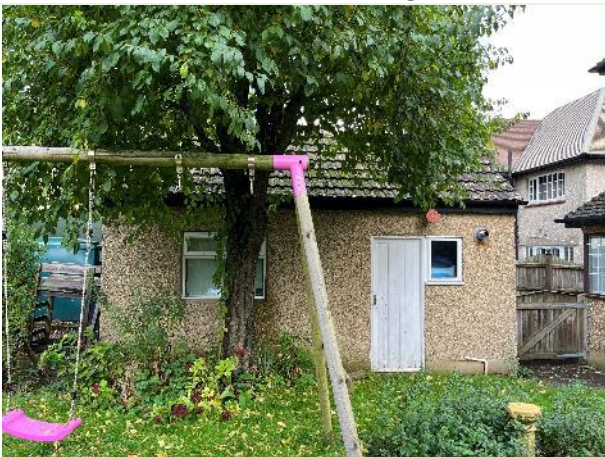
External features: The surveyed garage is a pebbledash walled structure with a pitched interlocking tiled roof. The interlocking tiles are all tight with no potential bat access point found. The garage has negligible potential for bat roosting.

The side of the garage

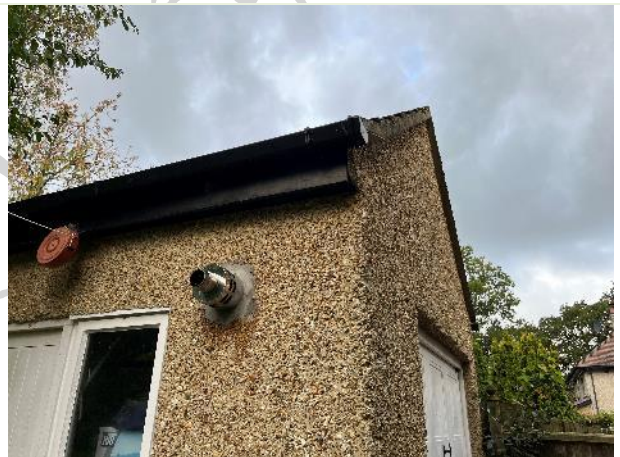
The front of the garage

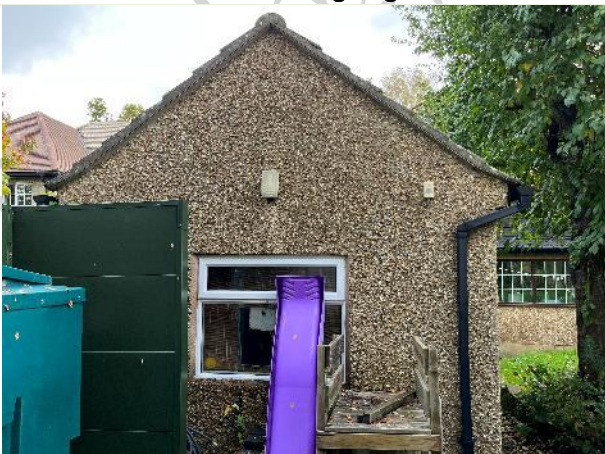
The rear of the garage

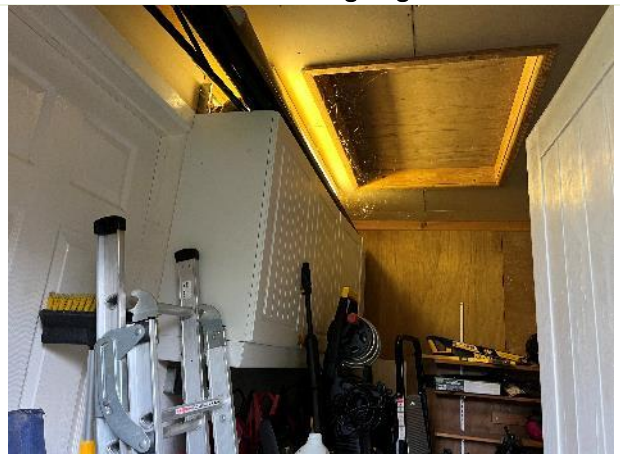
The internal structure of the garage
