Ecology report

1. Commissioned by Mr James Harvey
2. Planning application details

Application for the conversion of the existing Nissen Hut to a single detached C3 dwelling, in addition the conversion of the existing Garage Out-building with associated landscaping and a new/revised vehicle access and parking layout on land to the rear of, but separate to, The Bull Public House, Langley Lower Green, Essex. CB11 3SB

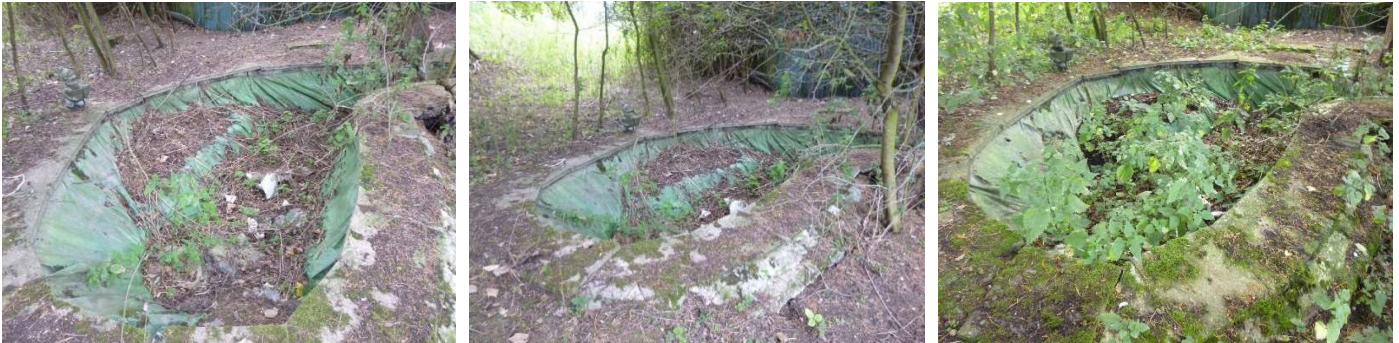
Below, the ex-pond north of the application boundary and the dry ditch and hollow. This northern boundary is not marked on the ground with a fence or even marker posts.

The defunct pond, left and centre 2022, right September 2023

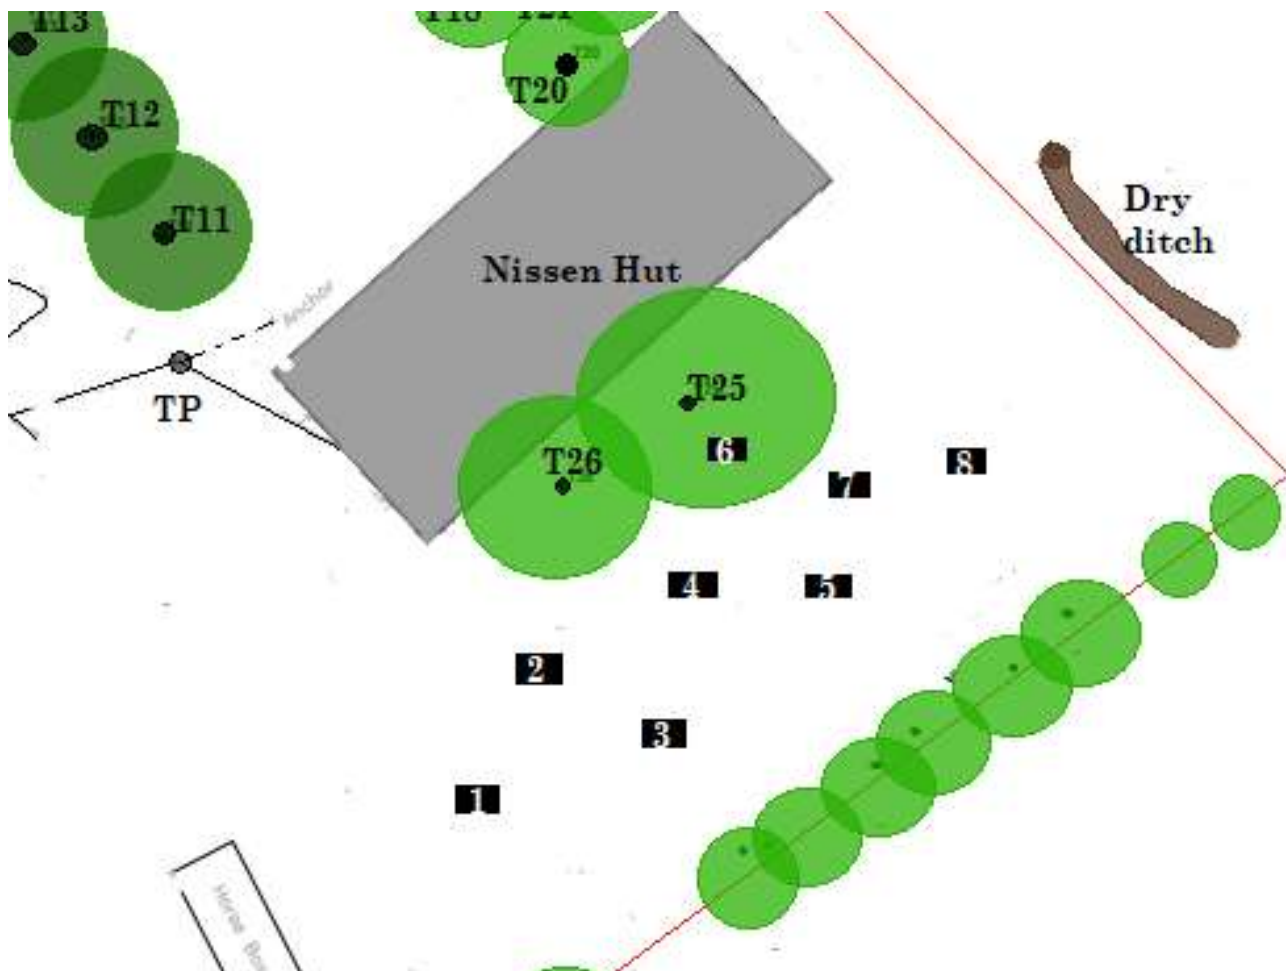
8 refugia were placed within this small area as shown below in early September 2022. Recording commenced on the 15th September until 28th September.

The NAARS Methodology was used although some of the refugia were less than 6000 mm apart in order to capture more sunlight.

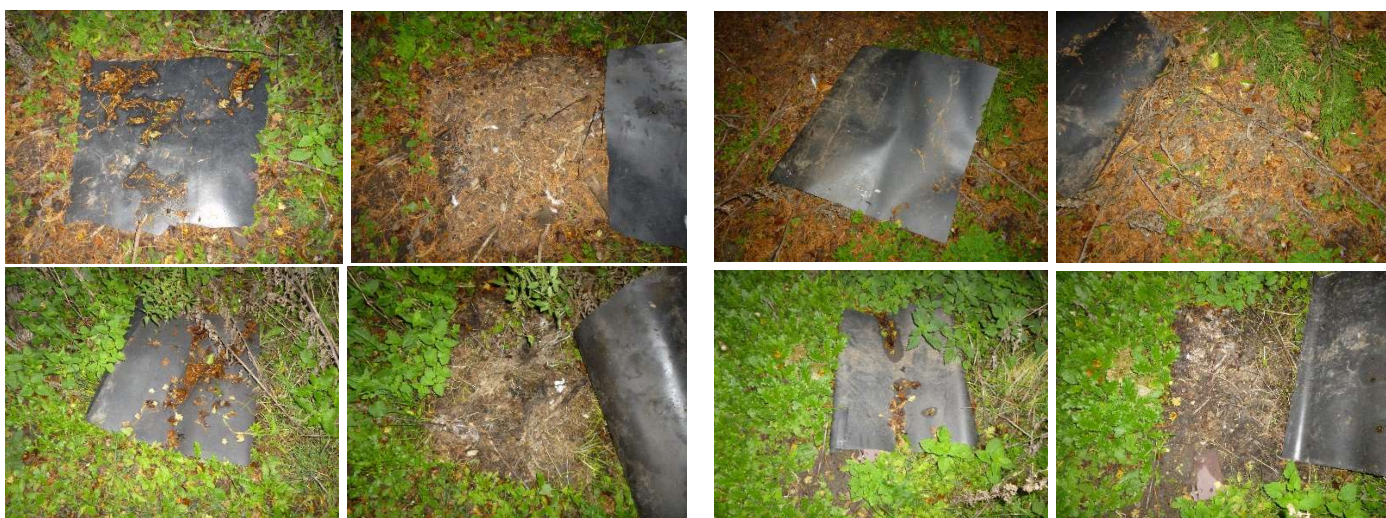
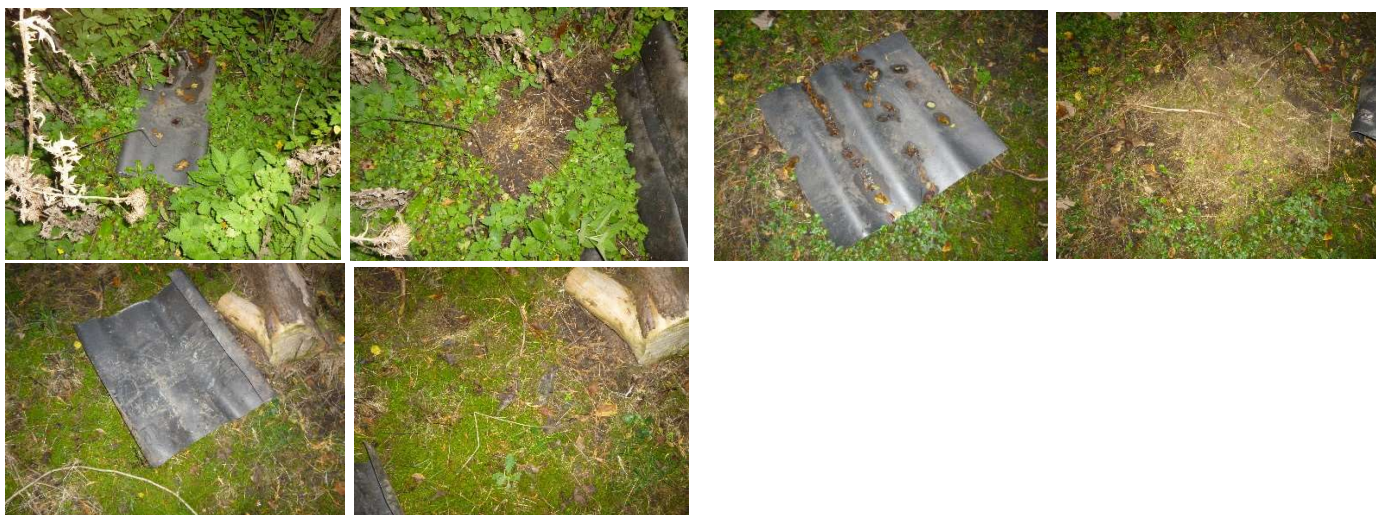
Above, some before and after images of the refugia; only common invertebrates recorded over the seven visits.

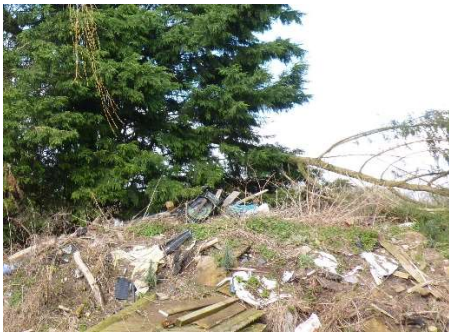
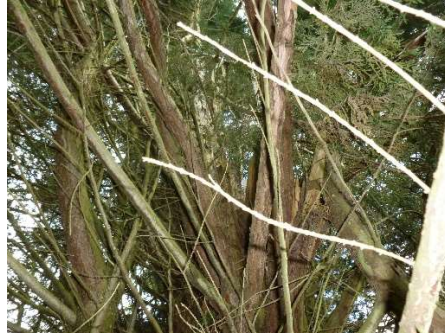
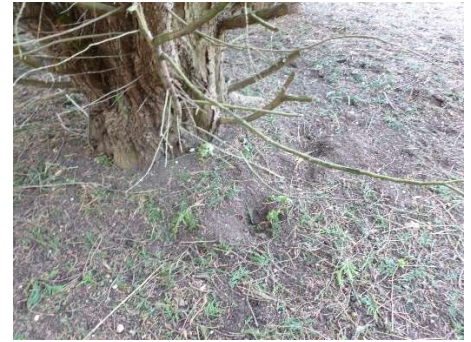
The disturbance caused through daily use and movement of material within the site is a great deterrent to nesting passerines. The application requires the removal of a number of trees, the vast majority of which are semi-mature, non-maintained, unstable *Cupressocyparis x leylandii*, Leyland Cypress. The nesting opportunities within this group of trees are significant. However, limb failure and unstable roots amongst this group is becoming increasingly common.

Images show limb failures and unstable roots within the group of *Cupressocyparis x leylandii*.

It is axiomatic that if planning consent is granted, all trees scheduled to be removed would undergo an intensive search for nests. The applicant is fully aware of Section 1b and 1c of the WCA 1981 as amended.

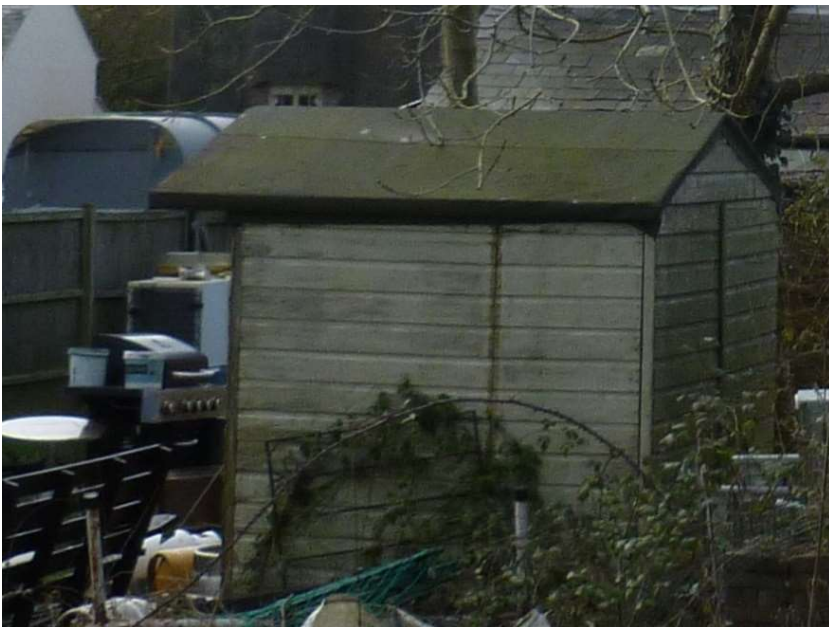
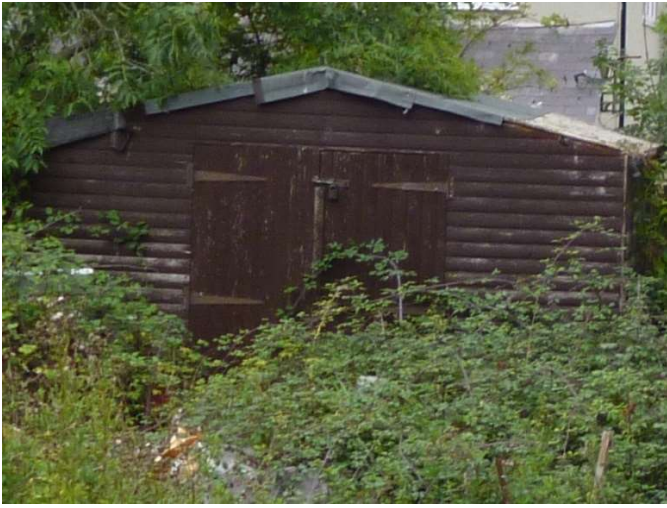
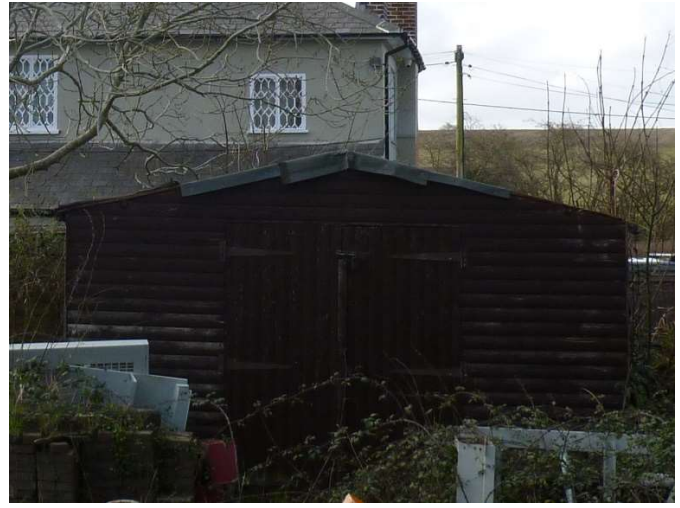
The second building is an old wooden structure with an apex roof covered in roofing felt. The felt has deteriorated over the last few years, some parts are now missing. The first survey in late May 2022 was compromised by aggressive vegetation, see image on left below. A full assessment could not be completed at that time. The opportunity to inspect did not come until late November 2022, once the vegetation had diminished, see image on right below.

Although the roofing felt had come away in some areas it was permanently glued to the single skin plywood roof in all other places. Where it has come away it flaps in the wind, enough to dismiss this structure as having potential for any type of roost. The sidewalls are all intact and offer no realistic entry point. Access from the east is rather compromised by the, Fraxinus excelsior, Ash tree that covers that aspect. No change up to 3rd September 2023.

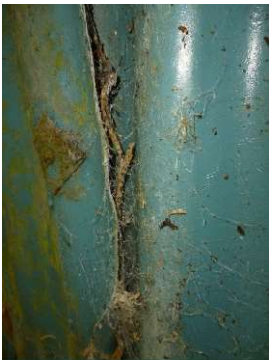
The only other building within the area designated for the proposed new dwelling is the Nissen Hut; this was also inspected using the same methodology above for PRFs, Potential Roosting Features. Any small crevices on the outside of this building were filled with cobwebs, indicating a negative entry point. *Cupressocyparis x leylandii* covered most of the east side, again deterring any kind of realistic entry.

Cobwebs filled all the crevices.

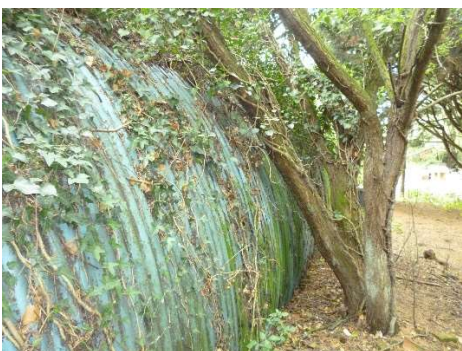
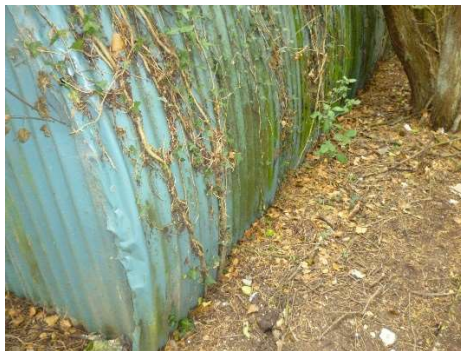
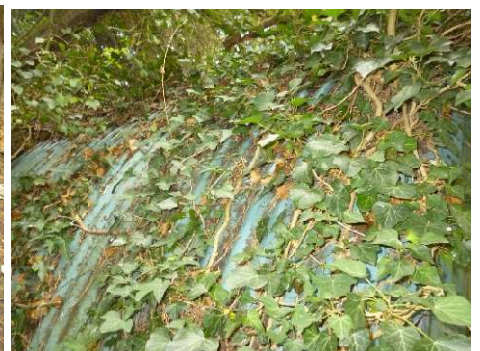
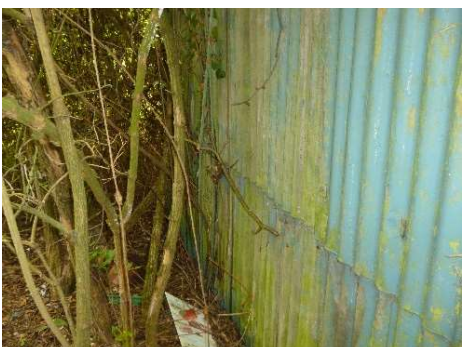
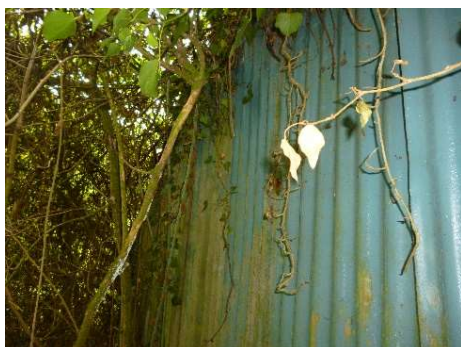
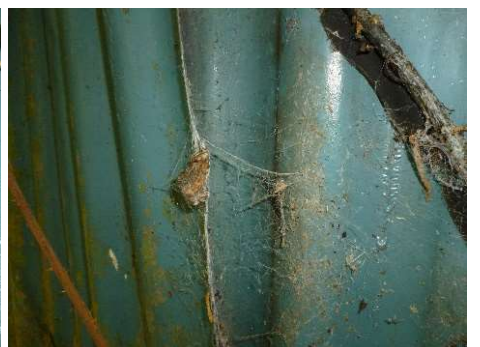
Image of the rest of the Nissen Hut below; all sound.

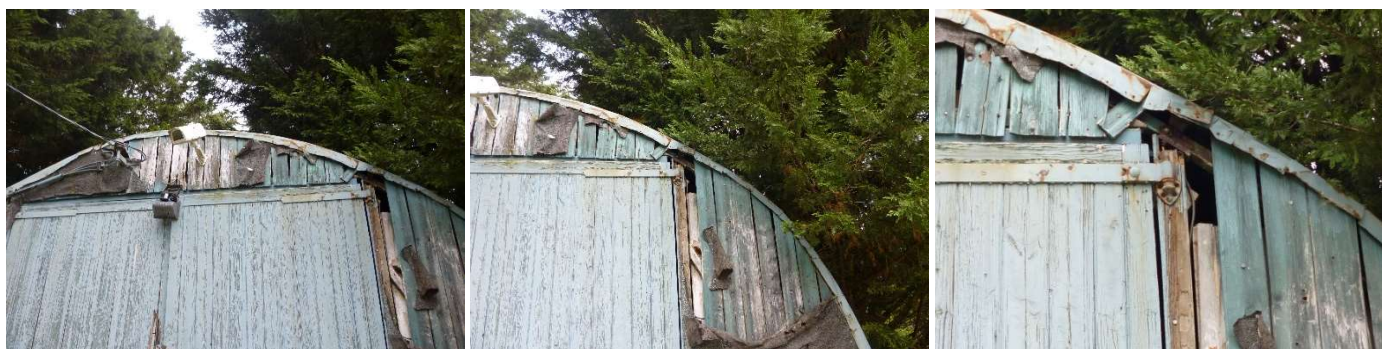
The only possible access point for any species of bat was the gap in the top right-hand part of the wooden door, see below.

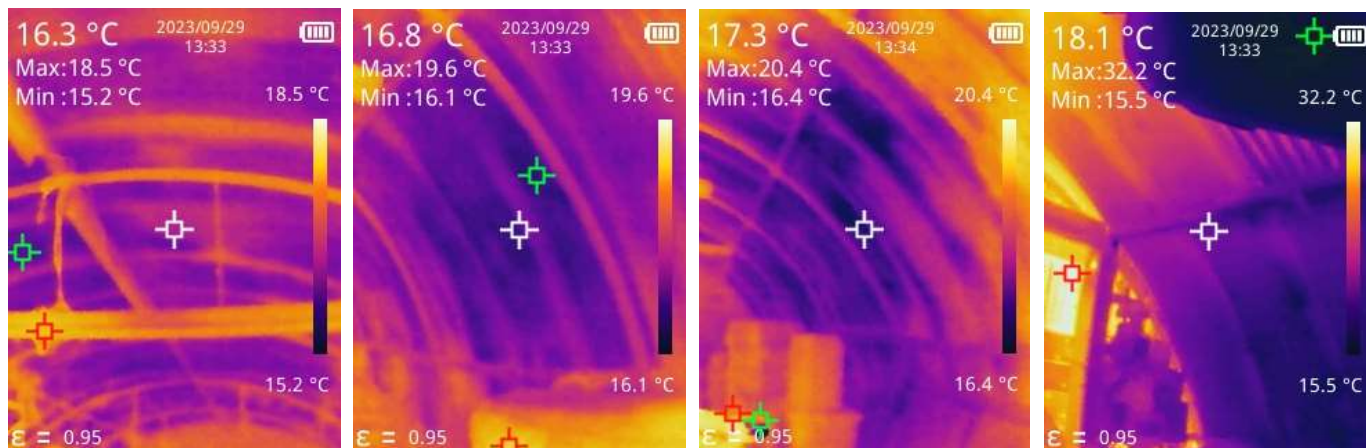
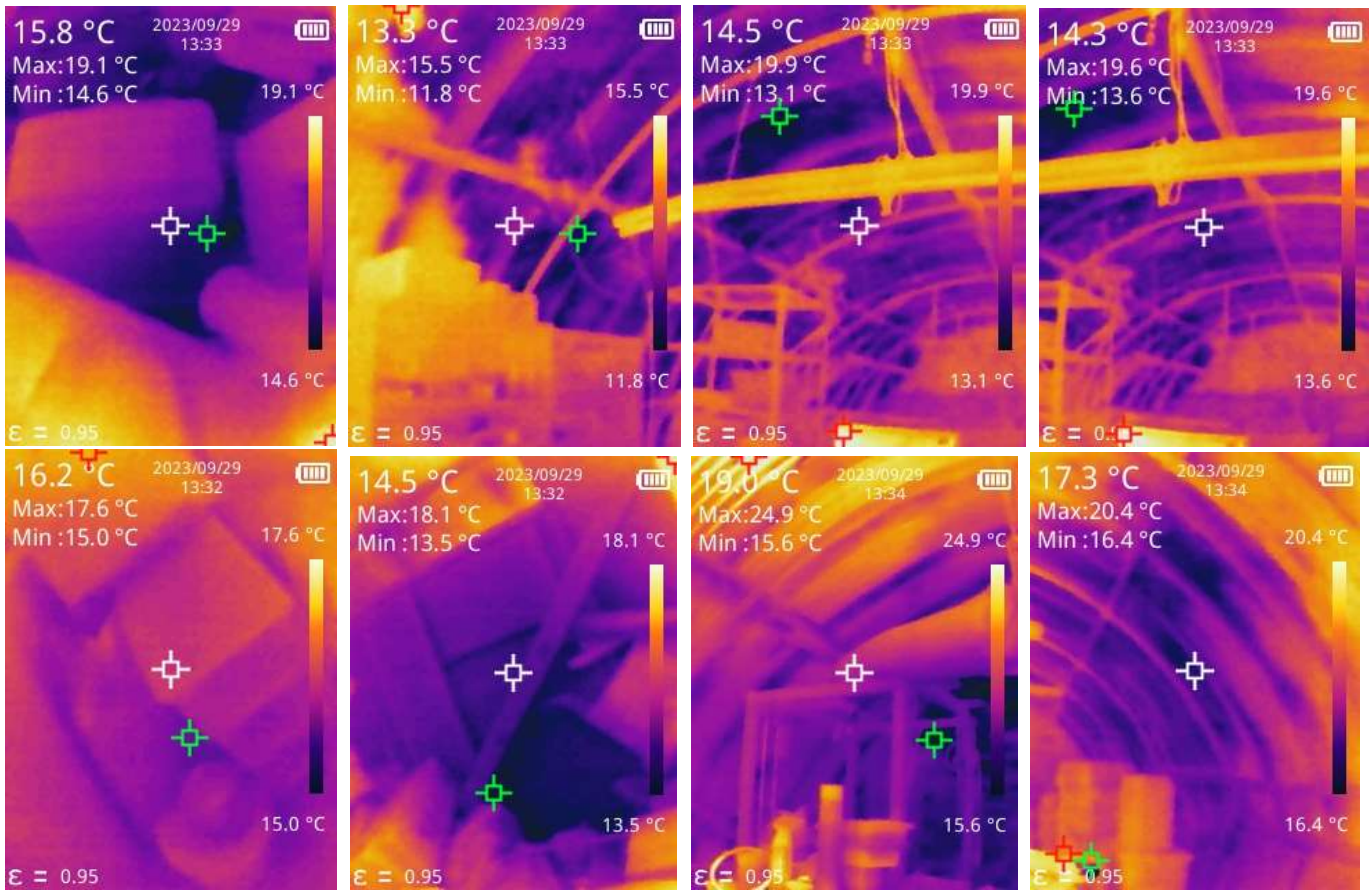
On 29th September 2023, due to the publication of Collins Edition 4 2023, the inside of this Nissen Hut was surveyed with a thermal imaging camera. See images below. Although there was an entry point the inside of the building was very unsuitable for any kind of roost site, negligible potential. The TI survey searched for roost hotspots with a live camera over all parts inside. The equipment a Topdon TC004 is limited at long distance but at close to medium range it is quite able to record by still frame and video the elevated IR of a roost or a single individual.

No evidence from this imagery of any occupation.
