Preliminary Bat & Bird Assessment

Derna House, Beach Road, Porthtowan, Cornwall, TR4 8AD

19th January 2024

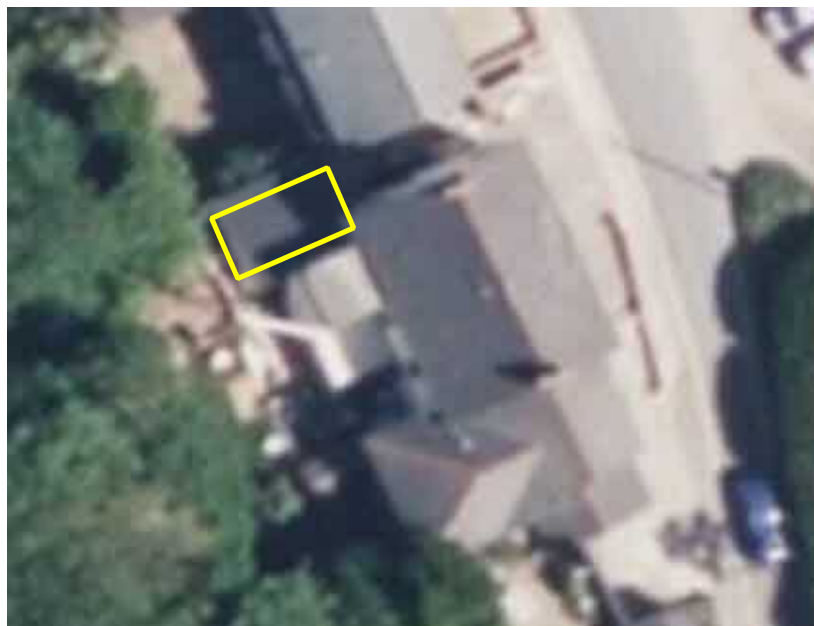
Figure 1: View of the location of the garage surveyed (yellow outline); located off of the northern elevation of Derna House.

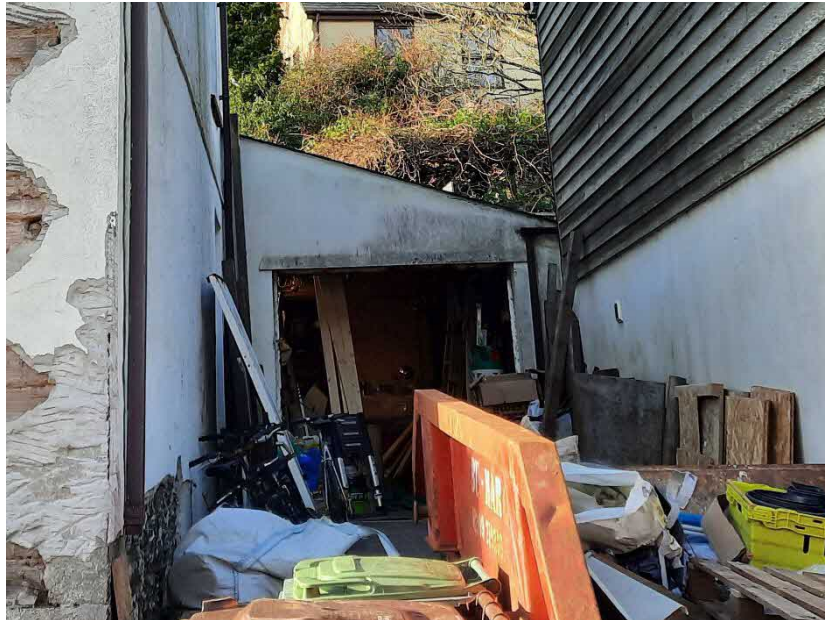
The building surveyed is a single storey open fronted garage on the northwest corner of the dwelling 'Derna House'. The garage is of block construction with a concrete base and a mono-pitched sloping roof (south to north). No fascia/ wall top coverings were present (Figs 2-3). Plastic guttering and downpipes were present on the north and east elevations of the garage. No metal garage door was present at the time of survey, leaving the eastern elevation open (the main dwelling was undergoing works and so the garage is in constant use as access to the rear of the property). A single uPVC glazed door is present on the south elevation of the garage. The roof comprised slate tiles which were tight with none slipped or lifting. Overall, the exterior of the garage had very few features that could support roosting bats.

Figure 2: View of the eastern elevation of the garage at Derna House.

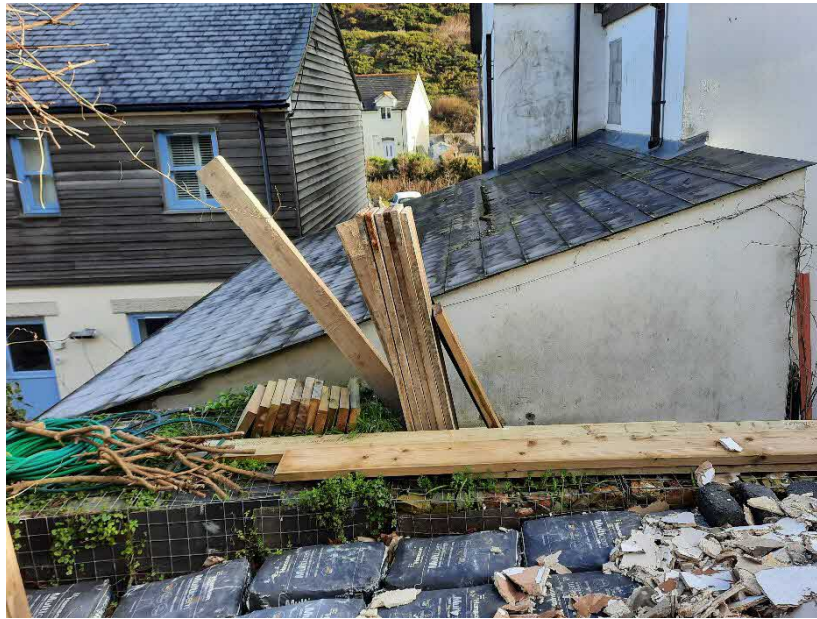
Figure 3: View of the roof and partial view of the western elevation of the garage at Derna House.

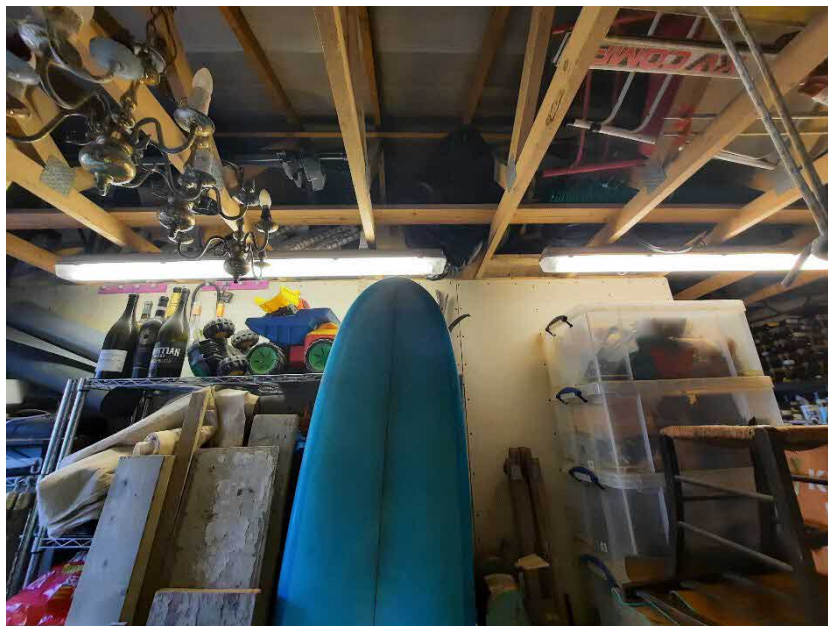
Internally, the space features a partition separating the space into two sections, the northern section was used for storage and access and the southern section, which is much smaller, was a sink room and also used for storage (Fig 4). The roof is supported by timber joists, measuring c. 2.5m to the underside of the roof material, which is lined with a synthetic roof membrane. The roof lining was damp in places (Fig 5). The space is well lit and draughty from the open nature of the garage and the floor is concrete. No gaps were observed at the wall tops or between the blockwork. No evidence of bats was found within the interior of the garage.

Figure 4: Interior view (towards the south) of the garage at Derna House, showing the timber roof joists and stored items.

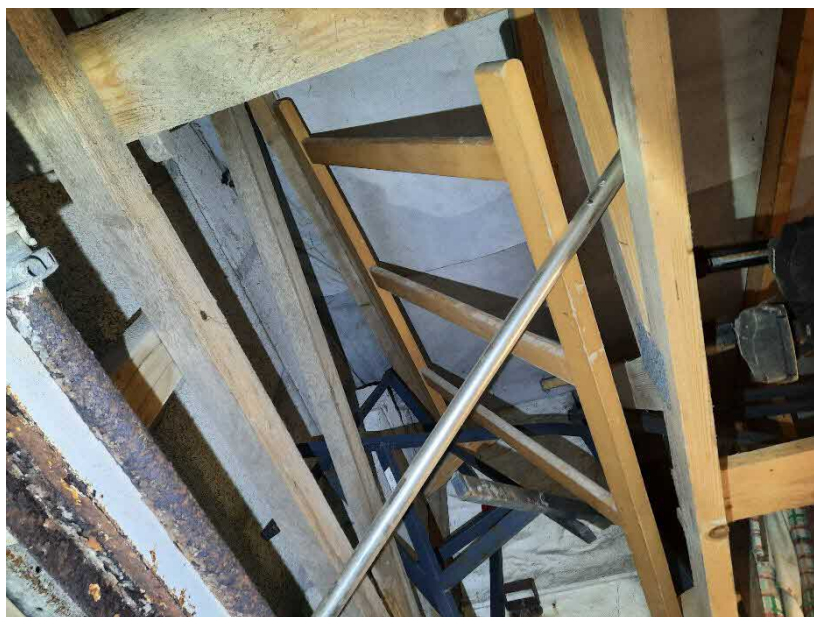
Figure 5: Interior view of the synthetic lining on the roof of the garage at Derna House.
