cornwall
environmental
consultants LTD

Bat and Barn Owl Assessment
8 Nancevallon
Higher Brea
Camborne
TR14 9DE

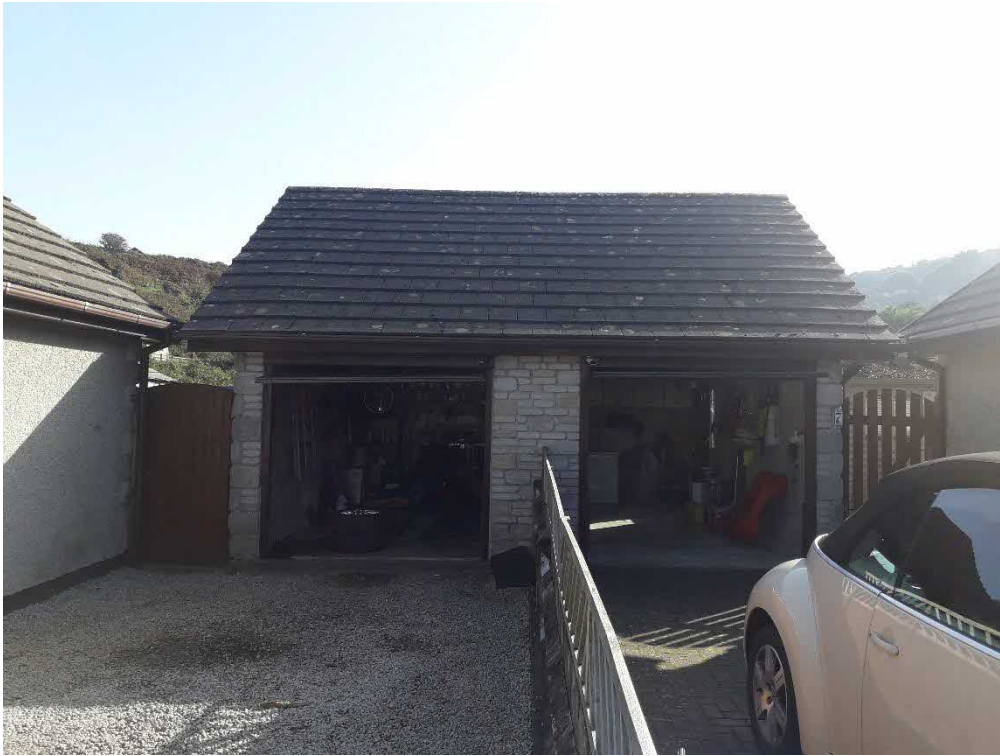
Figure 1. Garage to be part demolished.

The main property is built from cavity walled concrete blocks and is covered with cement tiles which are underlined with a breathable membrane. The garage is built from single row concrete block and is also underlined with a breathable membrane and is in use by the owner as a workshop and store. The proposal will entail the demolition of 50% of the garage and extend the property. The main property has recently been sealed with new fascia and soffit boards which are tightly fitted as the tiles and the ridge of the property. A search of all areas considered to have some potential for use by bats, including the exterior and interior of the garage was undertaken; no evidence of use by bats was noted.

Although no evidence of use by roosting bats was found, roosting opportunities change, and bats may move between roosts, therefore it cannot be assumed that bats are not present when works commence. Care should, therefore, be taken during the work as bats could roost unseen deep within crevices in the structure. If any bats are discovered during the work, they must not be handled: works must stop immediately, and advice sought from CEC (tel 01872 245510).

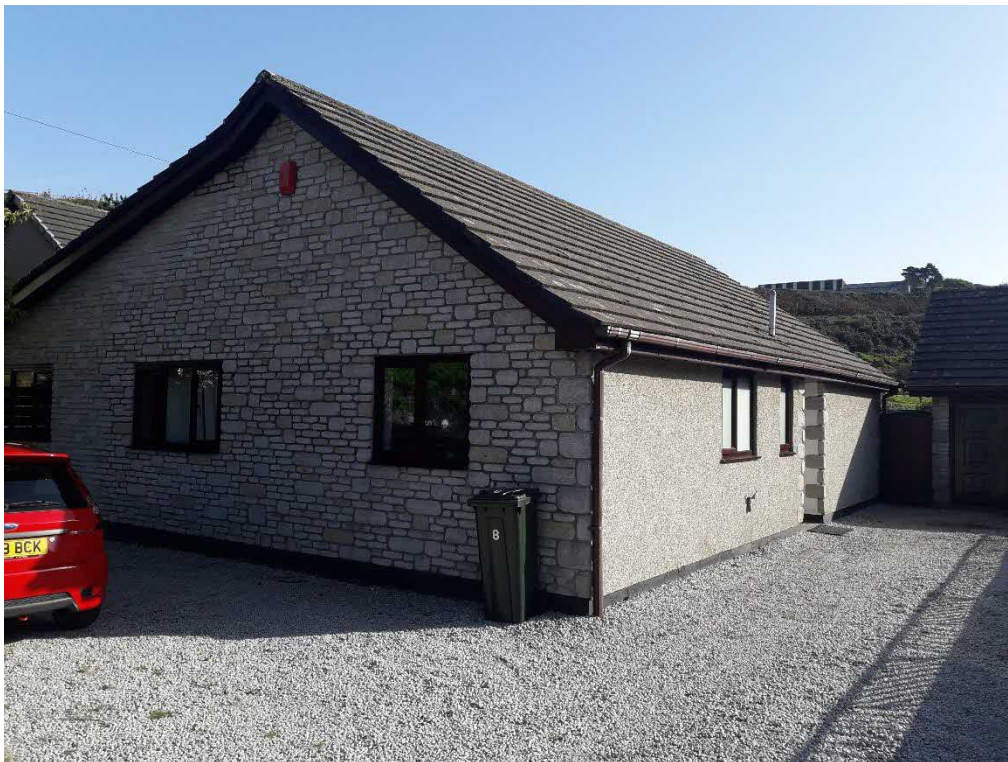
Figure 2. 8 Nancevallon
