**Kerris Manor
Farmhouse**

**Bat and Breeding
Bird Survey**

**Client: The Bolitho
Estate
Project no. 2324097
Issued: January 2024**

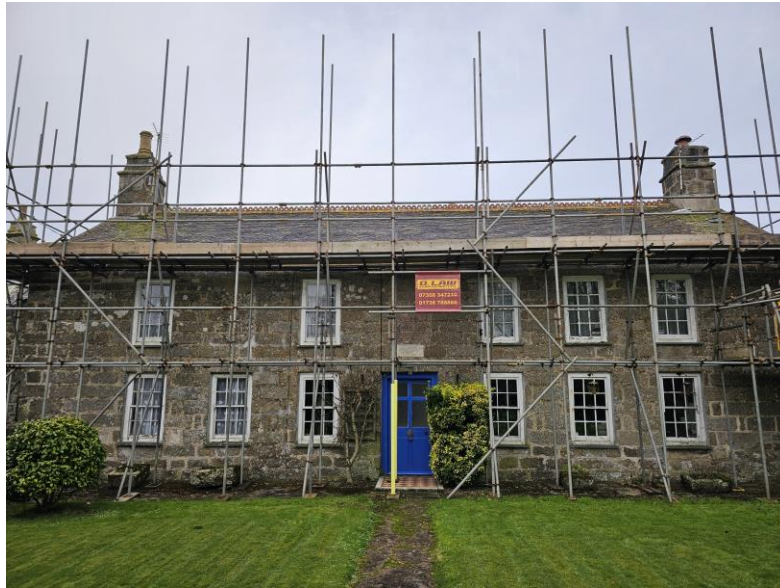
Photograph 1: Front elevation of the farmhouse

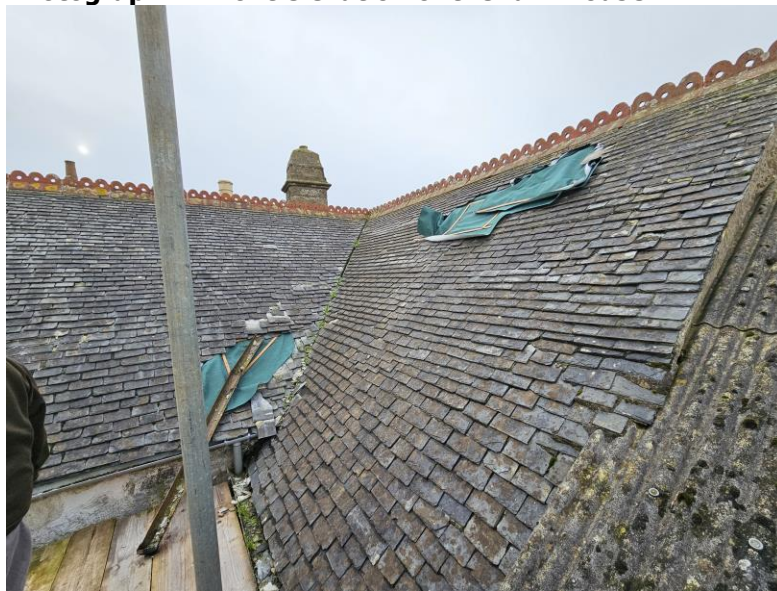
The survey was commissioned due to significant damage to the roof covering of the farmhouse which was patched in numerous places with roofing membrane to minimise water ingress.

Photograph 2: Typical patch repairs

There appear to be two methods to deal with the issues created by the roof damage, one is to patch repair the roof as soon as is reasonably possible. This would ensure limited potential disturbance to any potential undetected bat use at the site and deliver a rapid positive outcome to the tenant. The second option would be a full re-roofing. If this option is to be chosen it should be preceded immediately prior to commencement by a full re-inspection of the roof space to ensure no adoption by bats has taken place. To further ensure no unfavourable bat outcomes no breather membrane must be used. Instead bitumen felt should be used. This is because bats have been identified as roosting in an adjacent roof space and may in time prospect for potential roost sites within the farmhouse. Cloth backed breather membranes have been shown to pose a risk to bats as fibres pill from the surface and can entangle bats as they crawl across it. In addition to the above it is advised to avoid the period from end May to mid August to ensure no inadvertent disturbance of a maternity colony takes place (there is no evidence to suggest that bat use of this type takes place on site however the local bat presence in the adjacent annex raises the potential issue of a colony moving into the farmhouse roof space). If this period is unavoidable then an emergence survey should be undertaken during May to July to confirm bat absence from the roof space ahead of works commencing.

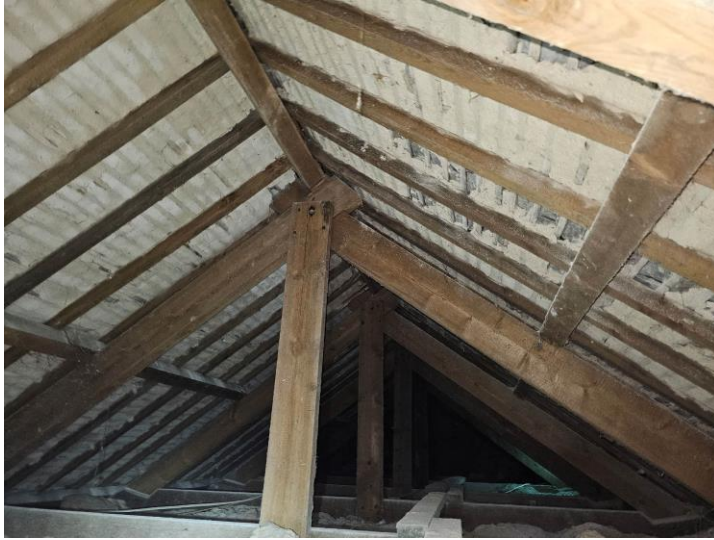
No bat field signs were found in the main roof spaces. The roof spaces were draughty and light due to the large holes. The lime mortar lining to the slates was detached in large areas and laying within the roof space. Anecdotal evidence of roosting bats was given by the tenant who described summer use of a single storey ancillary accommodation section attached to the main farmhouse, where bats had been observed emerging from under the gutter board.

The only potential limitation with regard to bats at the site is the effect of the lime mortar on the loft floor. This may have caused the rapid degradation of any bat field signs such as droppings or dead bats, or recently fallen mortar may have covered field signs.

Photograph 3: Roof space interior showing detaching lime mortar

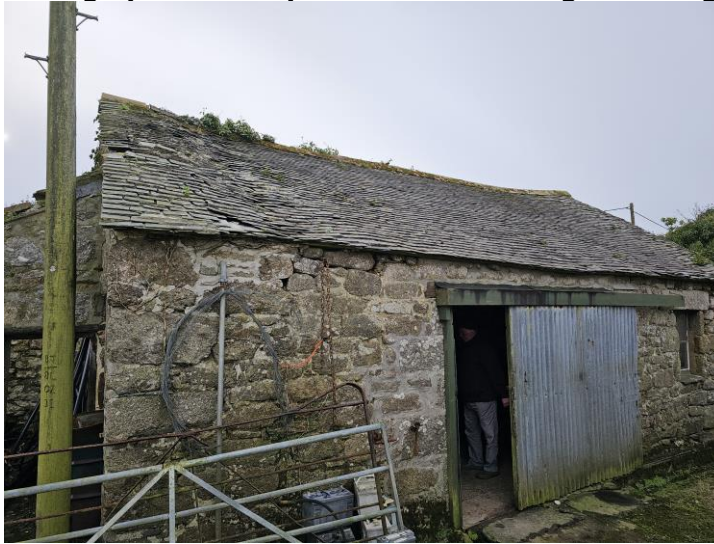
The two "donor" barns were surveyed and no bat field signs were found. Both these buildings had very large holes in the roof giving no dark, sheltered areas for bats to use.

Photograph 4: Donor barn 1

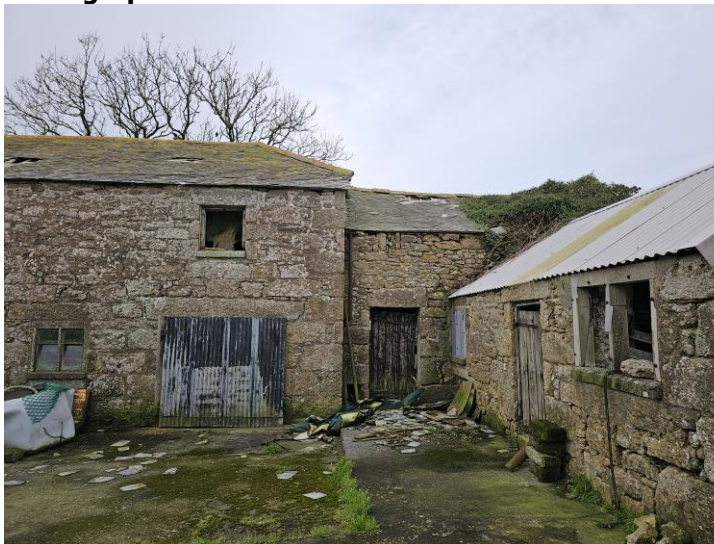
Photograph 5: Donor barn 2

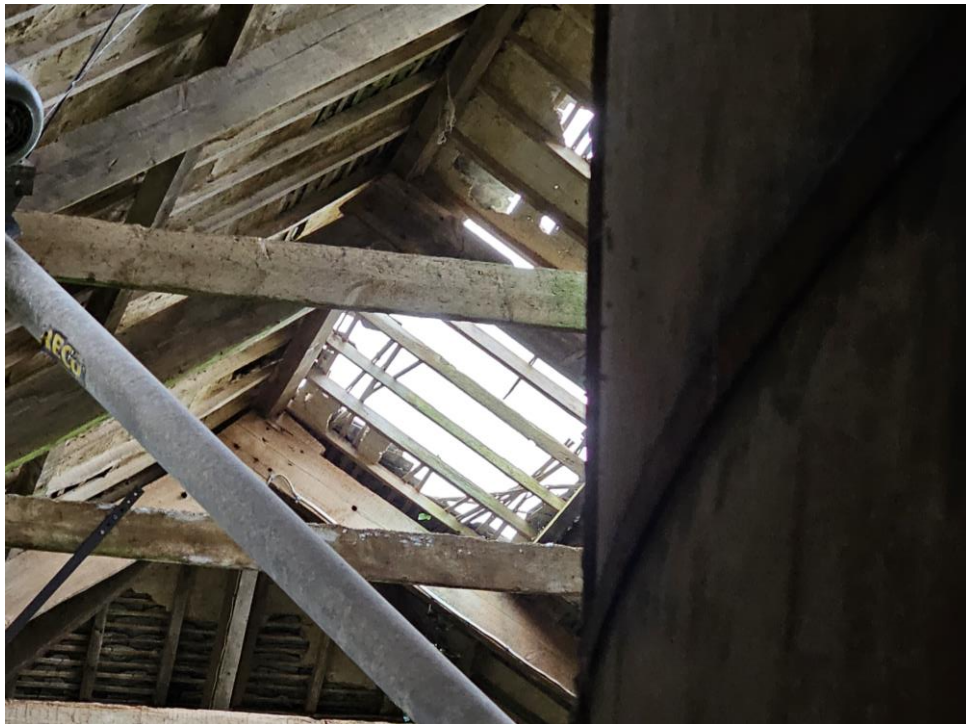
The donor barns both had roof coverings that were in very poor condition (refer to Photograph 6). Large holes existed in both roofs which gave high internal light levels and high air movement. No bat droppings were noted in either barn and both were assessed as being of low bat roost potential due to the roof covering condition.

Photograph 6: Donor barn 2 roof covering condition
