# VALIDATION REPORT

Site Address:	Barn at Moles Farm, Ware, SG12 0UG
Report Date:	January 2024
Project No.:	17612
Prepared for:	Harvey Construction
Planning Application	East Herts Council - 3/23/0046/FUL

## *VALIDATION REPORT - PHASE 4*

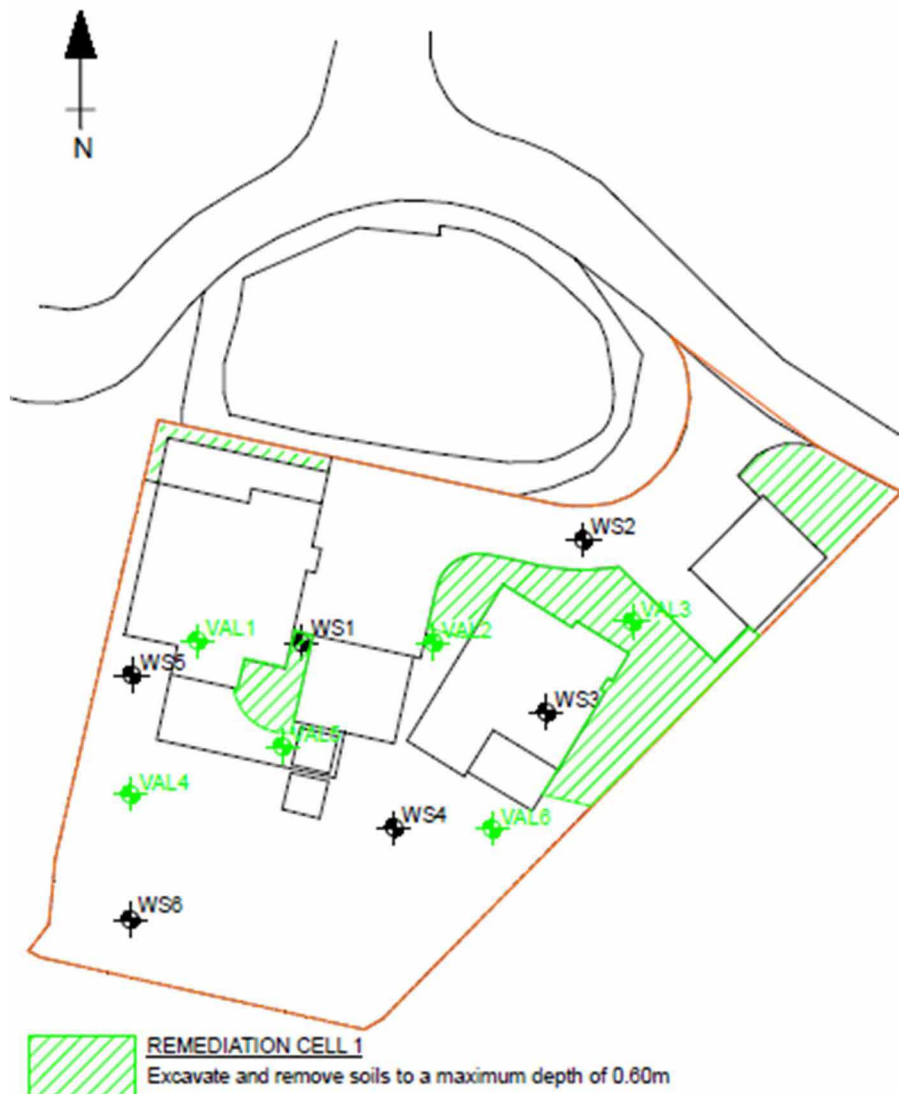
Figure 1 Remediation Plan

The strategy adopted for the remediation of the site are defined as follows :-

***Remediation Cell 1 –Lead & PAH's –Isolated to WS1, WS2 & WS3 and VAL1 & VAL3***

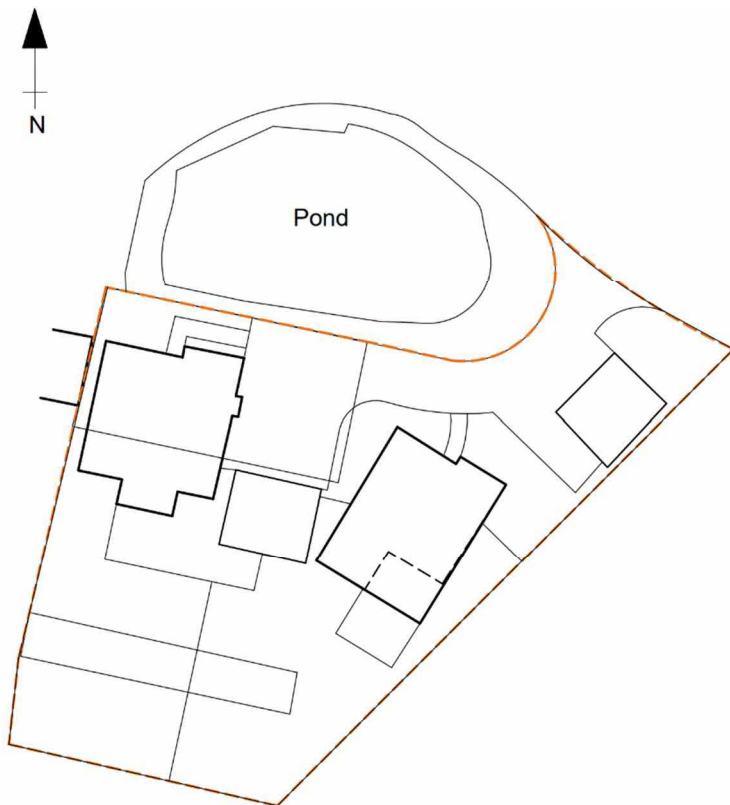
**OLD LAYOUT**

The layout of the site has been altered which will change the Source –Pathway –Receptor analysis for the project. Where areas of the site were previously soft landscaping, they are now hard landscaping which will remove specific capping or remediation processes through the placement of hard cover which were previously identified as soft landscaping. A revised layout plan is shown below.

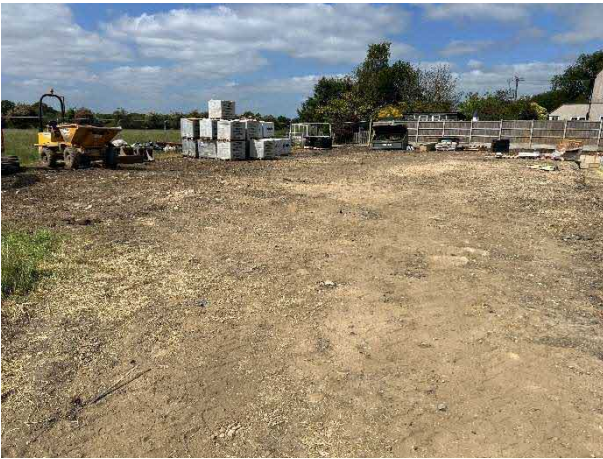
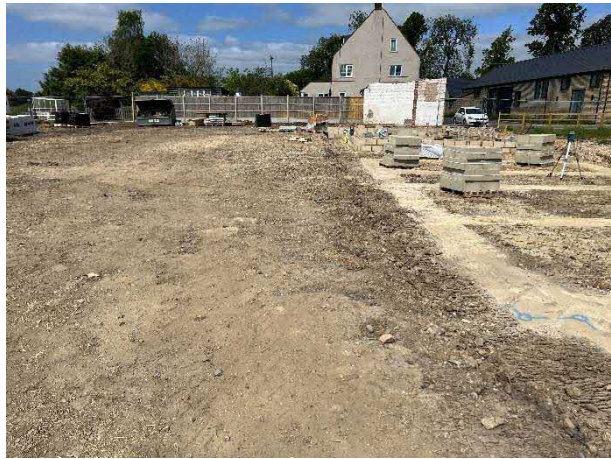
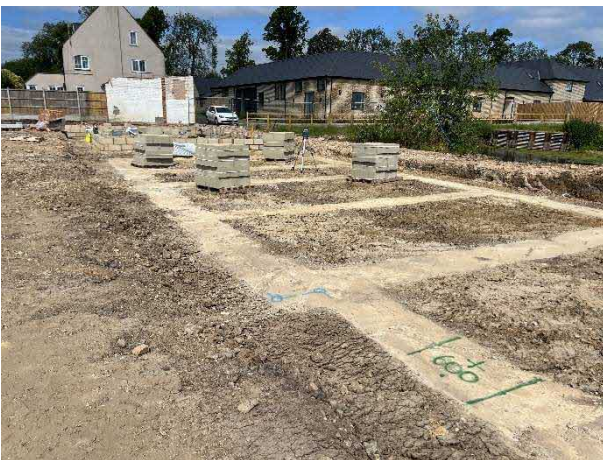
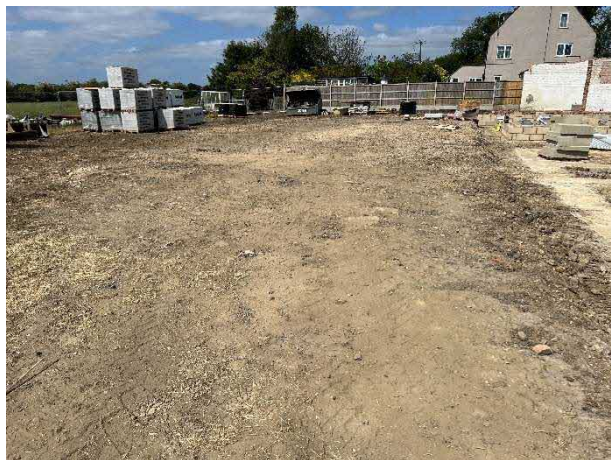
Post completion of the site strip and preparation of the site, further excavations site wide was completed across the site to reduce the ground level to the top of the foundations which was identified as at least 0.60 meters below the finished site level. The top of foundations was shown in the photographs identified below and confirm the depth of reduced dig.

Based on the information obtained, we can confirm that no obvious visual and olfactoral risk is identified in place at the reduced dig excavation across the site has likely removed risk in full. Nonetheless, the reduced dig is in excess of 0.60 meters below the finished site level and as such, provided the soils to make up the site are fit for residential land use, risk is removed.

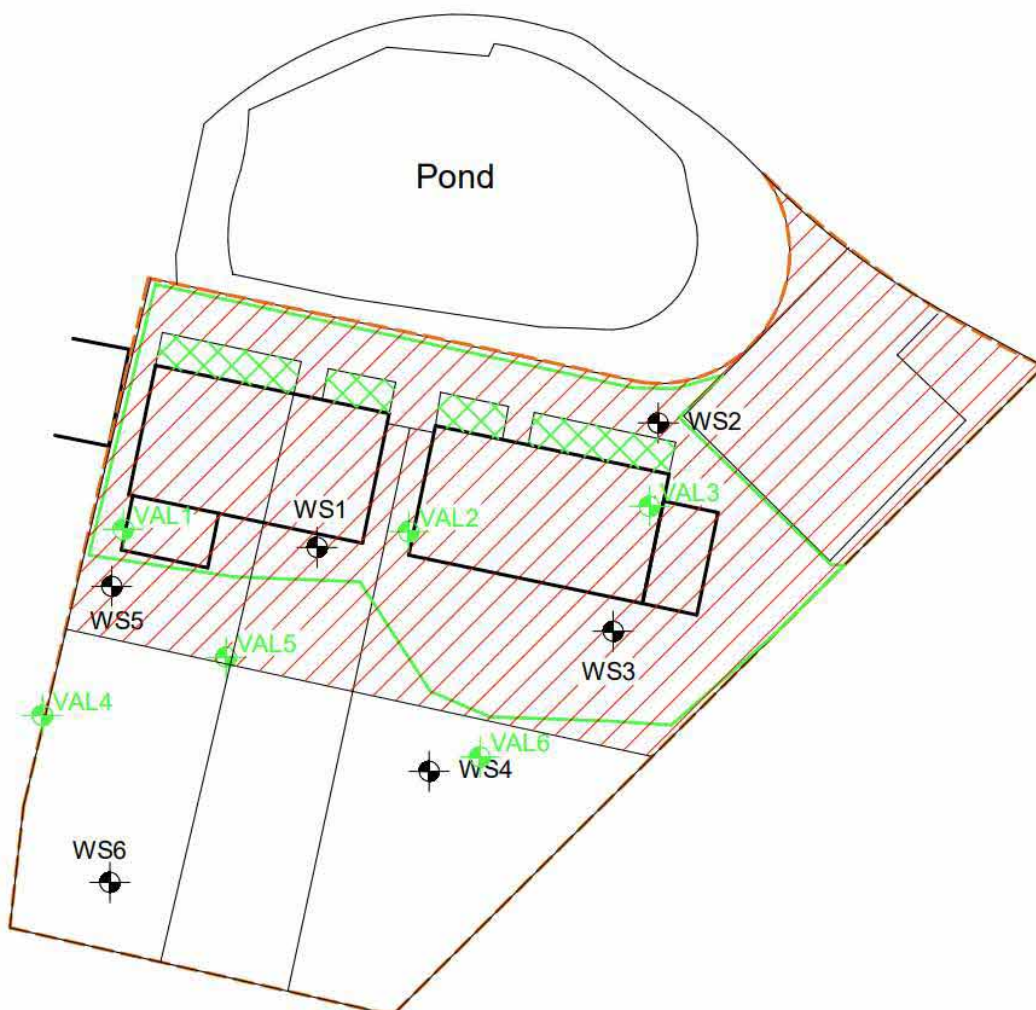
Construction of the site has then taken place to develop the main site including buildings and services. Backfill has ultimately taken place to bespoke small areas of garden which effectively placed topsoil in place to form a suitable depth growth medium for both grass and shrub planting. This ultimately formed 600mm in shrub planting areas to the front of the site.

The remediation area and subsequent remediation processes implemented is as follows :-

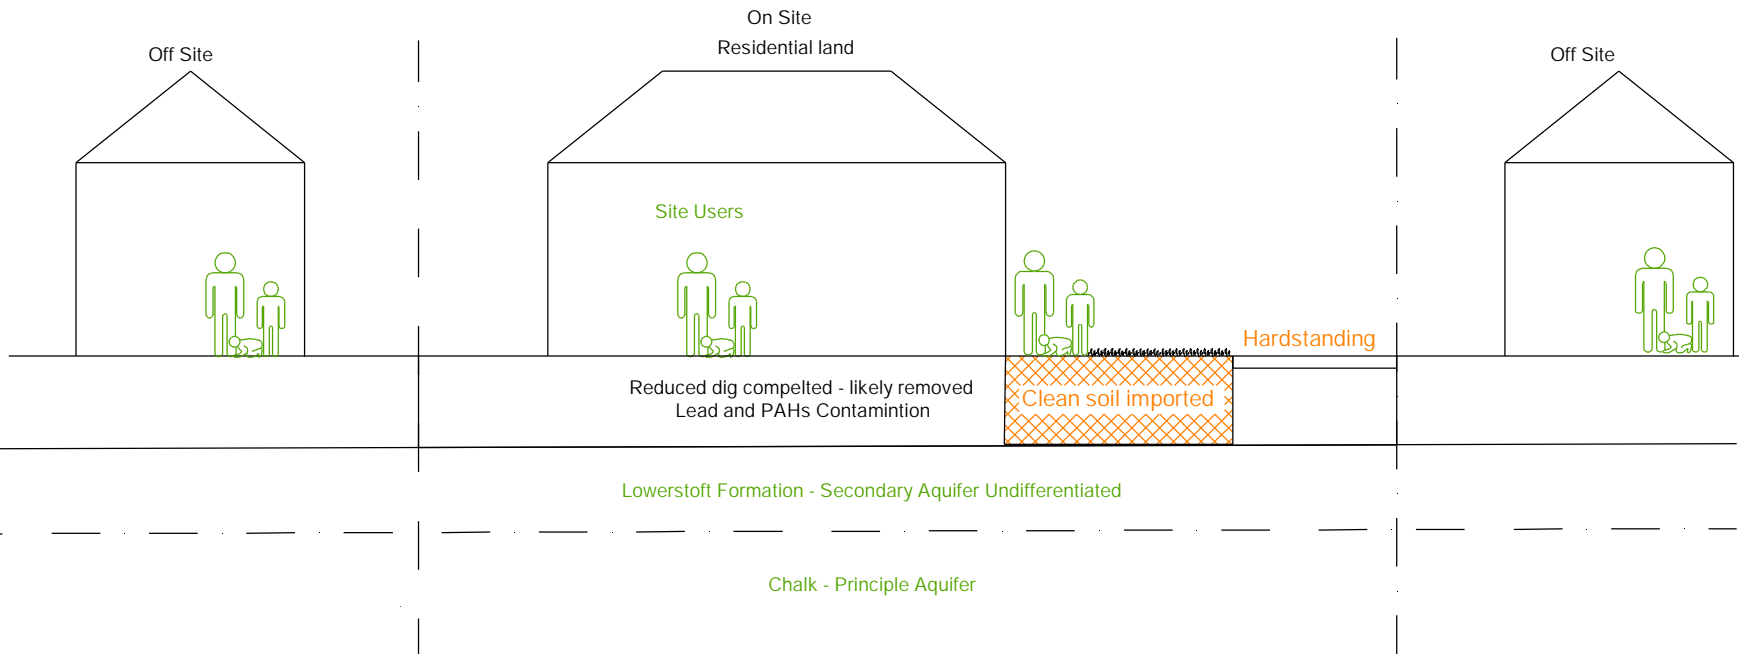
Not to Scale  
 Sketch No. : VAL / 17612 / A / 01

- Purple =Potential pathways applicable to site
- Green =Potential receptors applicable to site
- Red =Potential sources applicable to site
- Blue =Potential pathway/source/receptor
- Orange = Remedial measure put in place to remove either pathway/ source/receptor
